KOST ENVIRONMENTAL SERVICES, INC.

August 21, 2009

Re: **Glaro Inc.**
Site ID No. 1-52-124
Groundwater Quality Results for Down-Gradient Multi-level Well MW-8

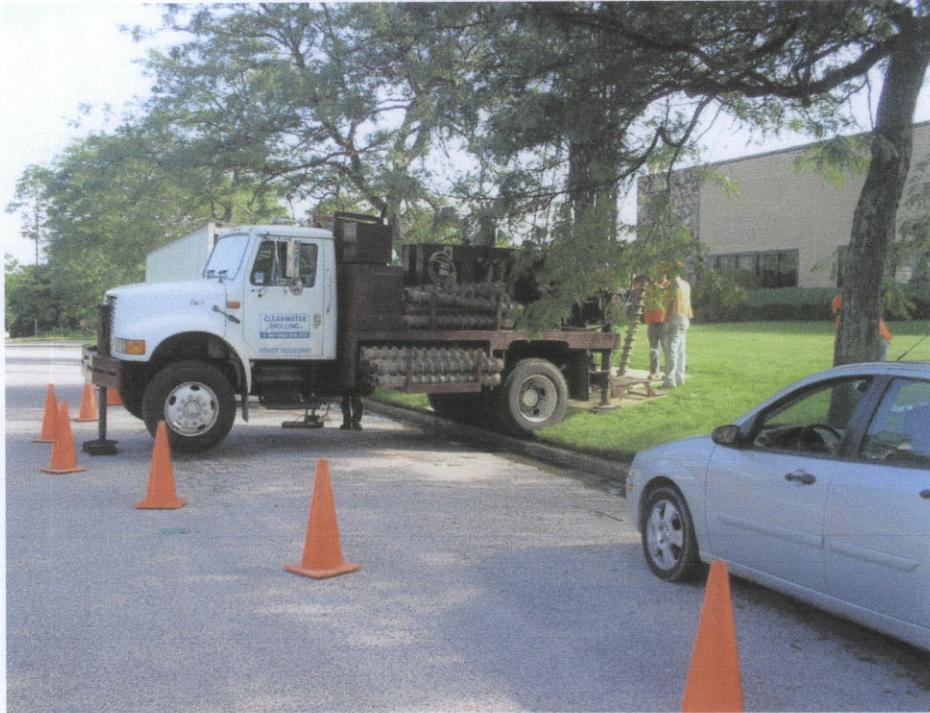
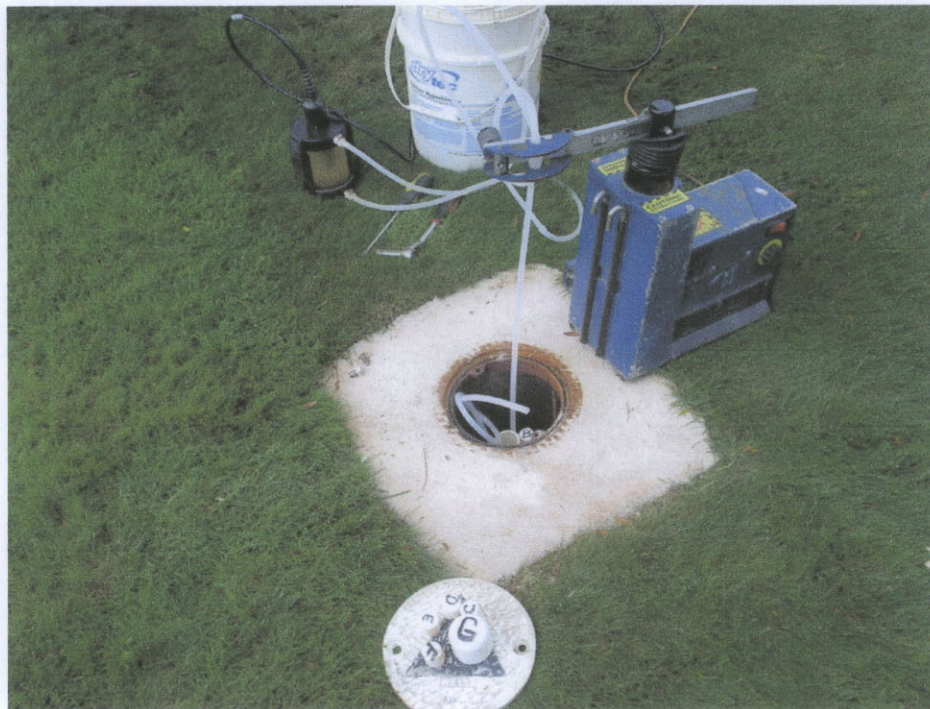
ML-8 INSTALLATION

Environmental Assessment & Remediation (EAR)/Clearwater Drilling performed the installation of relocated ML-8 on June 23, 2009. Groundwater was encountered at a depth of 71.81'. Sampling intervals were constructed at depths of approximately 70'(ML-8A), 80'(ML-8B), 90'(ML-8C), 100'(ML-8D), 110'(ML-8E), 120'(ML-8F), and 130'(ML-8G) below grade. PID readings were taken on the drill cuttings, which ranged between 4 and 9 ppm. Numerous attempts were made to drill below the 130 foot depth but was not obtainable due to subsurface conditions (Boring Log is attached).

GLARO-ML-8-06/23/09

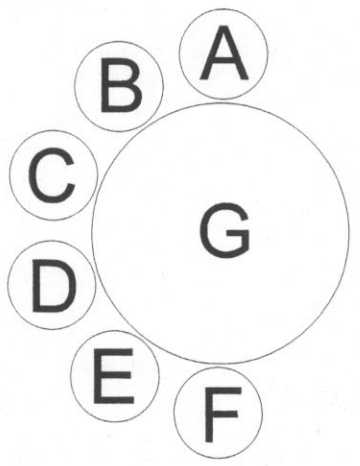
PLAN VIEW	PIEZOMETER DETAILS																								
<p>WELL I.D. <u>ML-8</u></p>

<p style="text-align: center;">Not to scale.</p>	<p>6 - 0.5" diameter and 1 - 1.5" diameter with 1' - 0.020" screened section at 10' intervals.</p>

<table><tr> <th>Piezometer</th> <th>Depth below grade</th> <th>Diameter</th> </tr><tr><td>A</td><td>70'</td><td>0.5"</td></tr><tr><td>B</td><td>80'</td><td>0.5"</td></tr><tr><td>C</td><td>90'</td><td>0.5"</td></tr><tr><td>D</td><td>100'</td><td>0.5"</td></tr><tr><td>E</td><td>110'</td><td>0.5"</td></tr><tr><td>F</td><td>120'</td><td>0.5"</td></tr><tr><td>G</td><td>130'</td><td>1.5"</td></tr></table>
