Project: National Heatset Printing Site - 1 Adams Boulevard, Farmingdale, NY - Site Management Contractors: AECOM and Preferred Environmental Services AECOM Job No: 60135649 Site No: 152140 AECOM Project Manager: Walt Howard						Li	AECOM erican Boulevard Airport Park atham, NY 12110 e: 518.7951.2242
	DAILY REPOR	<u>RT</u>					
Day: S	M T W TH F S	WEATHER	Bright Sun	Partly Cloudy	Overcast	Rain	Clear
Date: 23	-Jan-13	TEMP	To 32	32-50	50-70	70-85	85 and up
REPORT No.		WIND	Light	Moderate	High		
PAGE No. 1		HUMIDITY	Dry	Moderate	Humid		
		WIND DIR	NE	NW	SE	SW	
PREPARED BY: Th	omas Fitzpatrick TITLE: Site Rep.	WIND DIK	N	S	E	W	
AVERAGE FIELD FORCE							
Name of Contractor	Title	Hours Worked			Rem		
Thomas Fitzpatrick Daniel Prisco-Buxbaum	Technician Technician	9:54 - 11:10 9:54 - 11:10			Preferred Preferred		
VISITORS			Į.				
Name	Time (From - To)	Representing			Rem		
NA	NA	NA			N	A	
EQUIPMENT AT THE SITE		W = Working

National Heatset Printing Site, Farmingdale, NY Contract No., Site No. 152140 Monitoring Table January 23, 2013

TCE Groundwater Treatment System #1 STATUS: ON OFF

TCE Groundwater Treatment System #2 STATUS: ON OFF

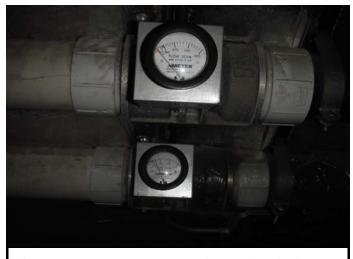
Comments: Flow meters are set on return pipes to wells. Fl-01 in non-functioning and needs to be replaced. DAY: Wednesday

<u>Picture 389</u> - Flow Gauge, Fl-01, is non-functioning and needs to be replaced.

replacing light bulbs and evaluate FI-01 next event

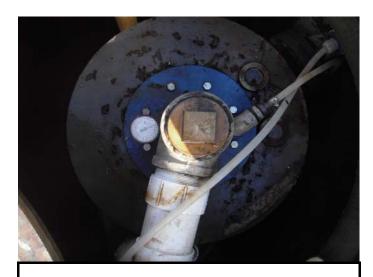
<u>Picture 399</u> - View of the DDC-4 well with its associated pressure gauge reading 0.4 PSI.
