Project: National Heatsheet Printing Site - Off-Site - Site Management
Contractors: AECOM and Preferred Environmental Services
AECOM Job No: 60135649
Site No: 1-52-140
AECOM Project Manager: Walt Howard

DAILY REPORT

O&M DATA SHEET - NATIONAL HEATSET - OFF-SITE SYSTEM

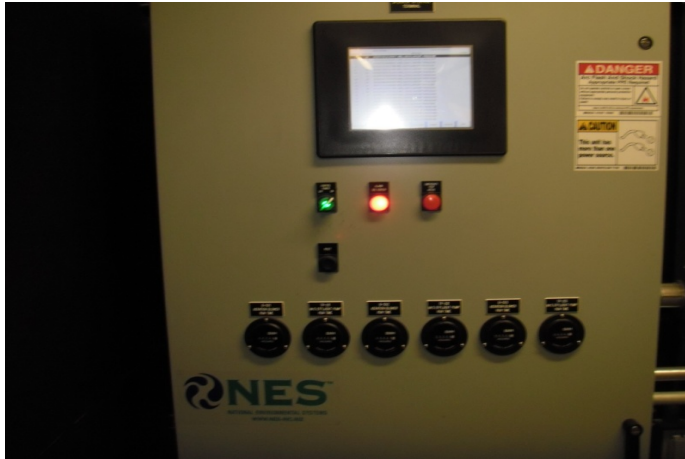
Picture 395- Six (6) alarms were triggered on the control panel upon arrival.

PHOTO	DATE	TIME	DESCRIPTION	COMMENTS
Picture 390	1/31/2013	8:35	Six (6) alarms were triggered on the control panel upon arrival.	
Picture 396	1/31/2013	8:50	The temperature gauge (TSH-512) on the B-5012 blower panel was reading 155 degrees Fahrenheit.

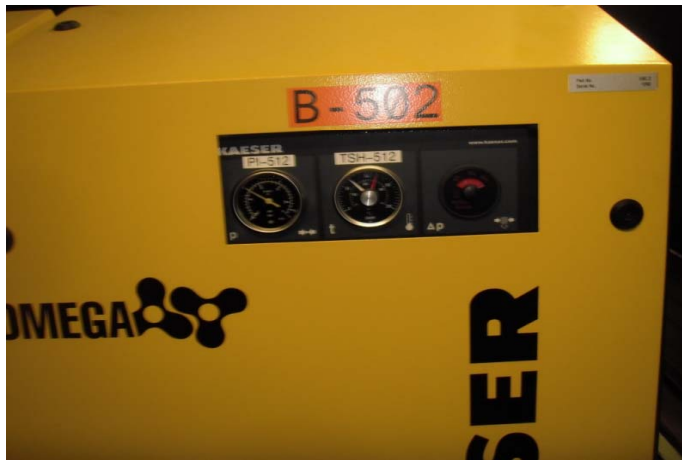
Picture 396- The temperature gauge (TSH-512) on the B-5012 blower panel was reading 155 degrees Fahrenheit.
