Project: National Heatsheet Printing Site - Off-Site - Site Management
 Contractors: AECOM and Preferred Environmental Services
 AECOM Job No: 60135649
 Site No: 1-52-140
 AECOM Project Manager: Walt Howard

DAILY REPORT

O&M DATA SHEET - NATIONAL HEATSET - OFF-SITE SYSTEM

National Heatset Printing Site - Off-Site

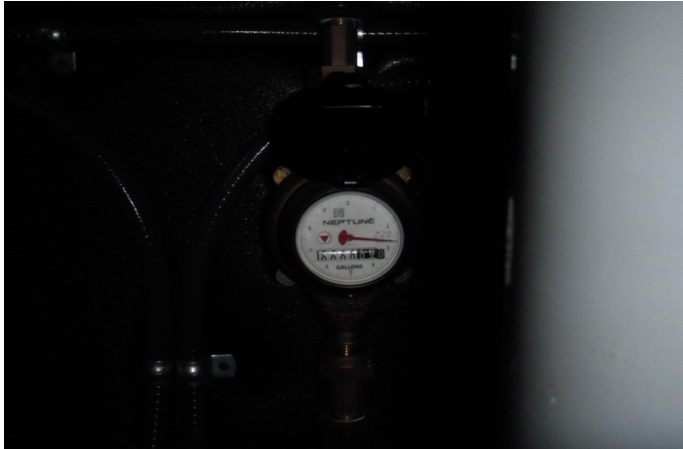
Picture 458- No additional water has been observed to have discharged out of the shed from the moisture separators as per the FM-601 gauge.

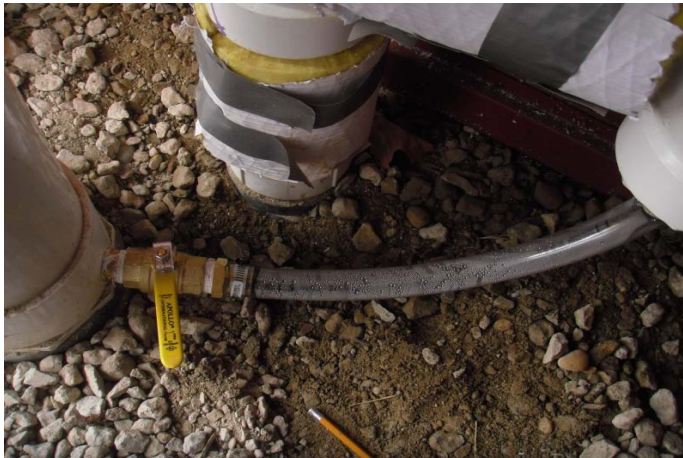
Picture 462- The one (1)-inch condensate line was observed no pooled water.
