Project: National Heatset Printing Site - Off-Site - Site Management  
 Contractors: EA Engineering, P.C. and Preferred Environmental Services  
 AECOM Job No: \_\_\_\_\_  
 Site No: \_\_\_\_\_  
 AECOM Project Manager: James Hayward

## DAILY REPORT

# O&M DATA SHEET - NATIONAL HEATSET - OFF-SITE SYSTEM

**PHOTOGRAPHIC LOG**  
**Date: 5-14-13**  
**EA Engineering, P.C. Job No.**  
**National Heatset Printing Site - Off-Site**

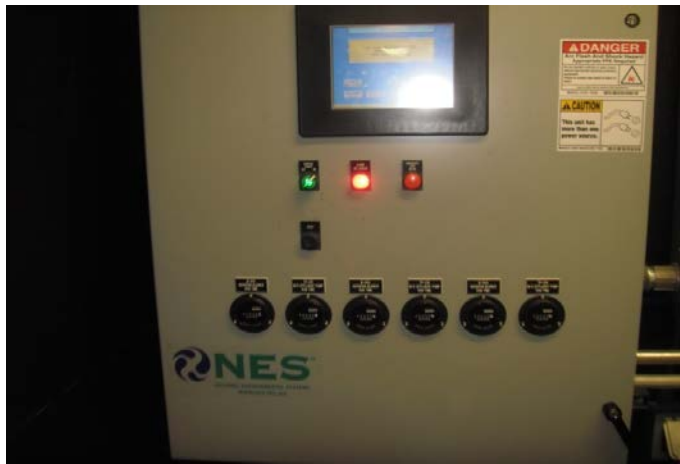
PHOTO	DATE	TIME	DESCRIPTION	COMMENTS
Picture 0074	5/14/2013	12:34	Five (5) alarms were triggered on the control panel upon arrival.	
Picture 0081	5/14/2013	13:04	An Interface probe was utilized in the gauging of the on and off-site piezometer wells.

**Picture 0074-** Five (5) alarms were triggered on the control panel upon arrival.

<b>AECOM/Preferred Site Representative:</b> Thomas Fitzpatrick - Preferred
<b>DESCRIPTION OF WORK PERFORMED AND OBSERVED</b>
<b>10:25</b> - Preferred and EA representative arrived on-site. Both systems are up with five (5) alarms triggered:
5/13/2013 11:59 W12: WELL DDC7 LOF DIFF. PRESSURE
5/13/2013 11:59 W9: WELL DDC10 LOW DIFF. PRESSURE
5/13/2013 11:59 W8: WELL DDC5 LOW DIFF. PRESSURE
5/13/2013 11:59 W6: B-502 Low Vacuum (VT202)
5/13/2013 11:59 A1: Emergency Stop. This was done manually at the site in order to test/verify the newly configured remote communication system was working properly.
<b>10:35</b> - Weekly O&M started.
<b>11:24</b> - Gauged piezometer wells along Benjoe Avenue.
<b>12:10</b> - O&M completed.
<b>12:20</b> - Preferred locked both sheds and all parties off-site. All alarms were reset, with blowers B-501 & B-502 up upon departure.

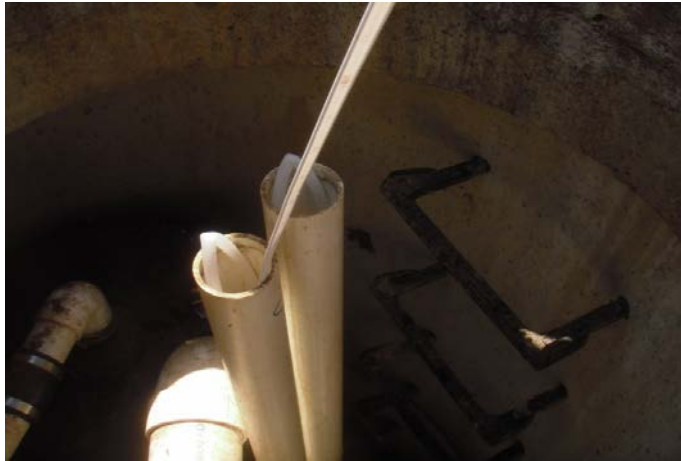
**Picture 0081-** An Interface probe was utilized in the gauging of the on and off-site piezometer wells.
