INSTALLATION RESTORATION PROGRAM

SITE INVESTIGATION REPORT

VOLUME I - REPORT

106TH RESCUE GROUP
NEW YORK AIR NATIONAL GUARD
WESTHAMPTON BEACH, NEW YORK
FRANCIS S. GABRESKI AIRPORT

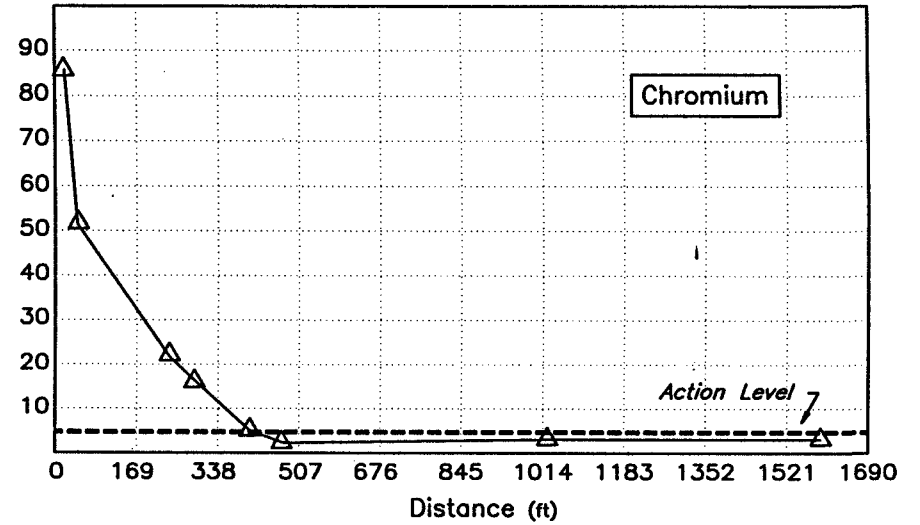
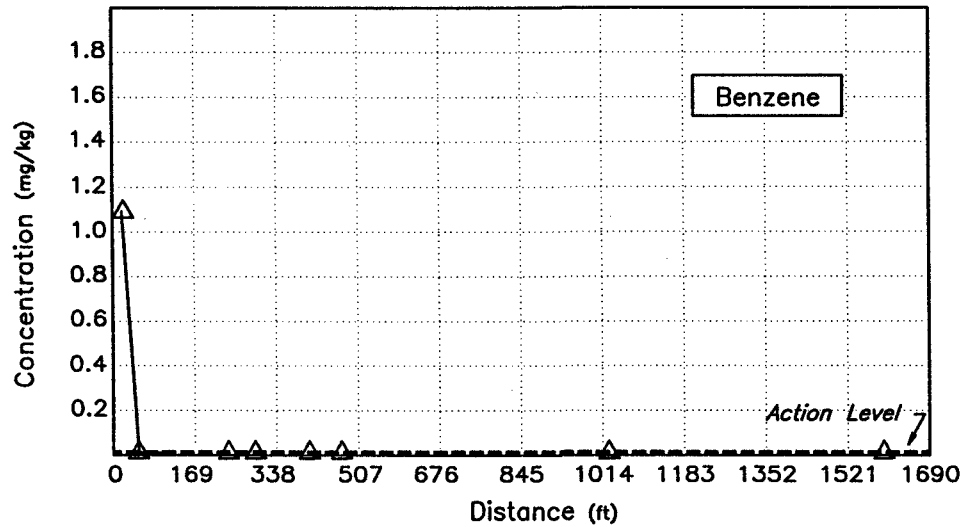
FIGURE 8-24
SEDIMENT CONCENTRATIONS VS. DISTANCE
SITE 5 - SOUTHWEST STORM DRAINAGE DITCH
106TH RESCUE GROUP, NYANG
WESTHAMPTON BEACH, NEW YORK

NOTES:
Sediment samples were collected in October and November 1994.
mg/kg milligrams per kilogram
