Focused Remedial Investigation

**Eugene's Dry Cleaners Site
Village of Babylon, Suffolk County
Site Number 1-52-157**

Prepared By:
NYS Dept. of Environmental Conservation
Division of Environmental Remediation
50 Wolf Road
Albany, NY 12233

February 2000

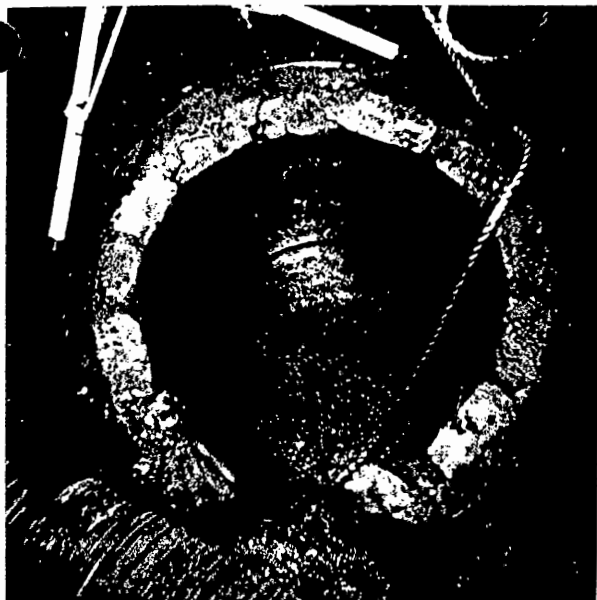
Eugene Dry Cleaners site # 152157
10/22/88
View of Sump in basement
before 'Vac' operation

The S1 clean out IRM that was performed on October 22, 1998 included power washing the basement and power vacuuming contaminated water and soil; power vacuuming out a 4 foot contaminated soil column source in the sump S1; power vacuuming contaminated soil and groundwater from beneath the sump; and securing the fuel oil storage tank. Clean sand material was replaced in the sump after power vacuuming was complete. The expected result of this clean out IRM was improved groundwater conditions at exterior points outside the Eugenes Dry cleaners facility.
