**Site Address: Brandt-Airflex Corp.  
937 & 965 Conklin St  
East Farmingdale, NY  
NYSDEC Site No: 152183  
Progress Report – December 2025**

## Daily Field Report

**Site Activities:** Remedial Action – SSDS OMM Inspection

**Sub-Slab  
Depressurization  
Systems**

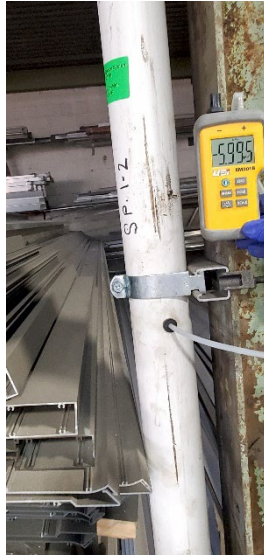
| <b><u>System-1 - 965 Conklin Street</u></b> | | | |
|---|---|---|---|
| SP 1-2 | -5.995 | 0.2 | 100 |

View of suction point, SP 1-2 and associated vacuum gauge with manometer reading.

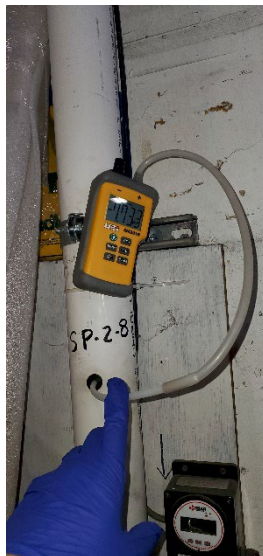
| <b>System-2 – 937 Conklin Street</b> | | | |
|---|---|---|---|
| SP 2-8 | -7.733 | 1.2 | 100 |

View of suction point, SP 2-8 and associated vacuum gauge with manometer reading.
