RESUME OF STAFF VISIT

SITES VISITED: Camp Hero, NY

DATE VISITED: 26-27 May 2009

Conduct a five year Munitions and Explosives of Concern (MEC) review of the approximately 415 acres of the Former Camp Hero.

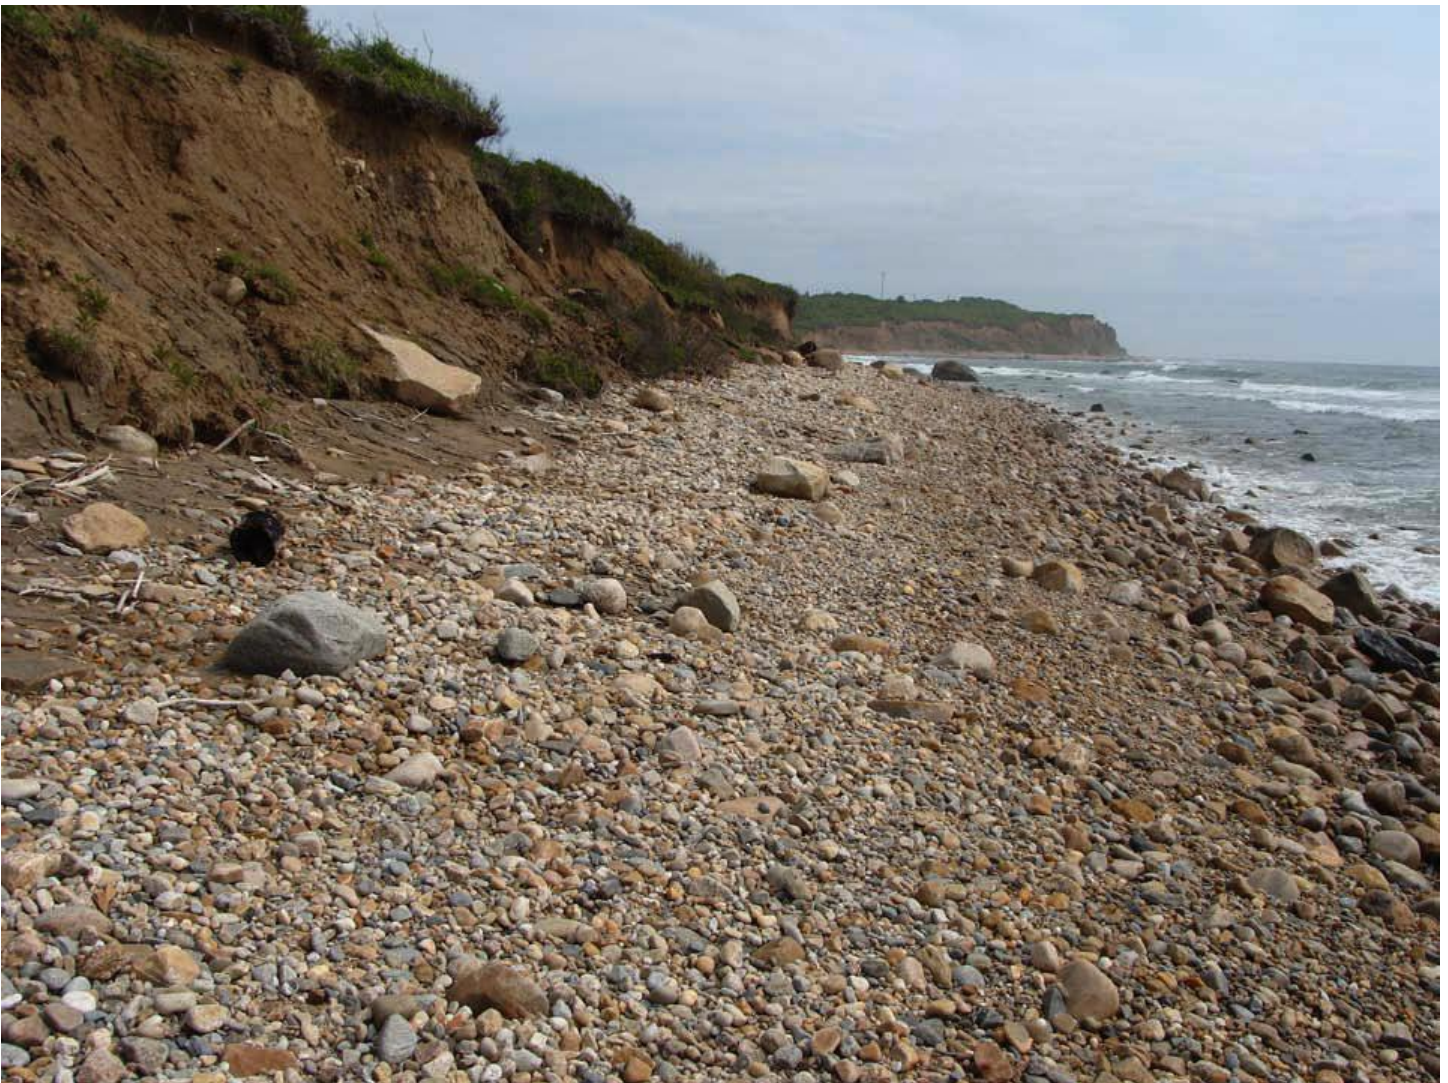
View from the beach looking North East

An instrument assisted visual inspection was conducted on approximately 2 miles of transects. This consisted of the entire beach (see photos) and the parts of the site I could access. I was the USACE Ordnance and Explosive Safety Specialist (OESS) on site for most of the original removal action and was able to access most of the areas where the removal action was conducted. A large portion of the site is extremely overgrown (see photos). During the course of this inspection, I found nothing but cultural debris along the beach, and no subsurface metallic anomalies with the exception of those related to active and abandoned utilities.

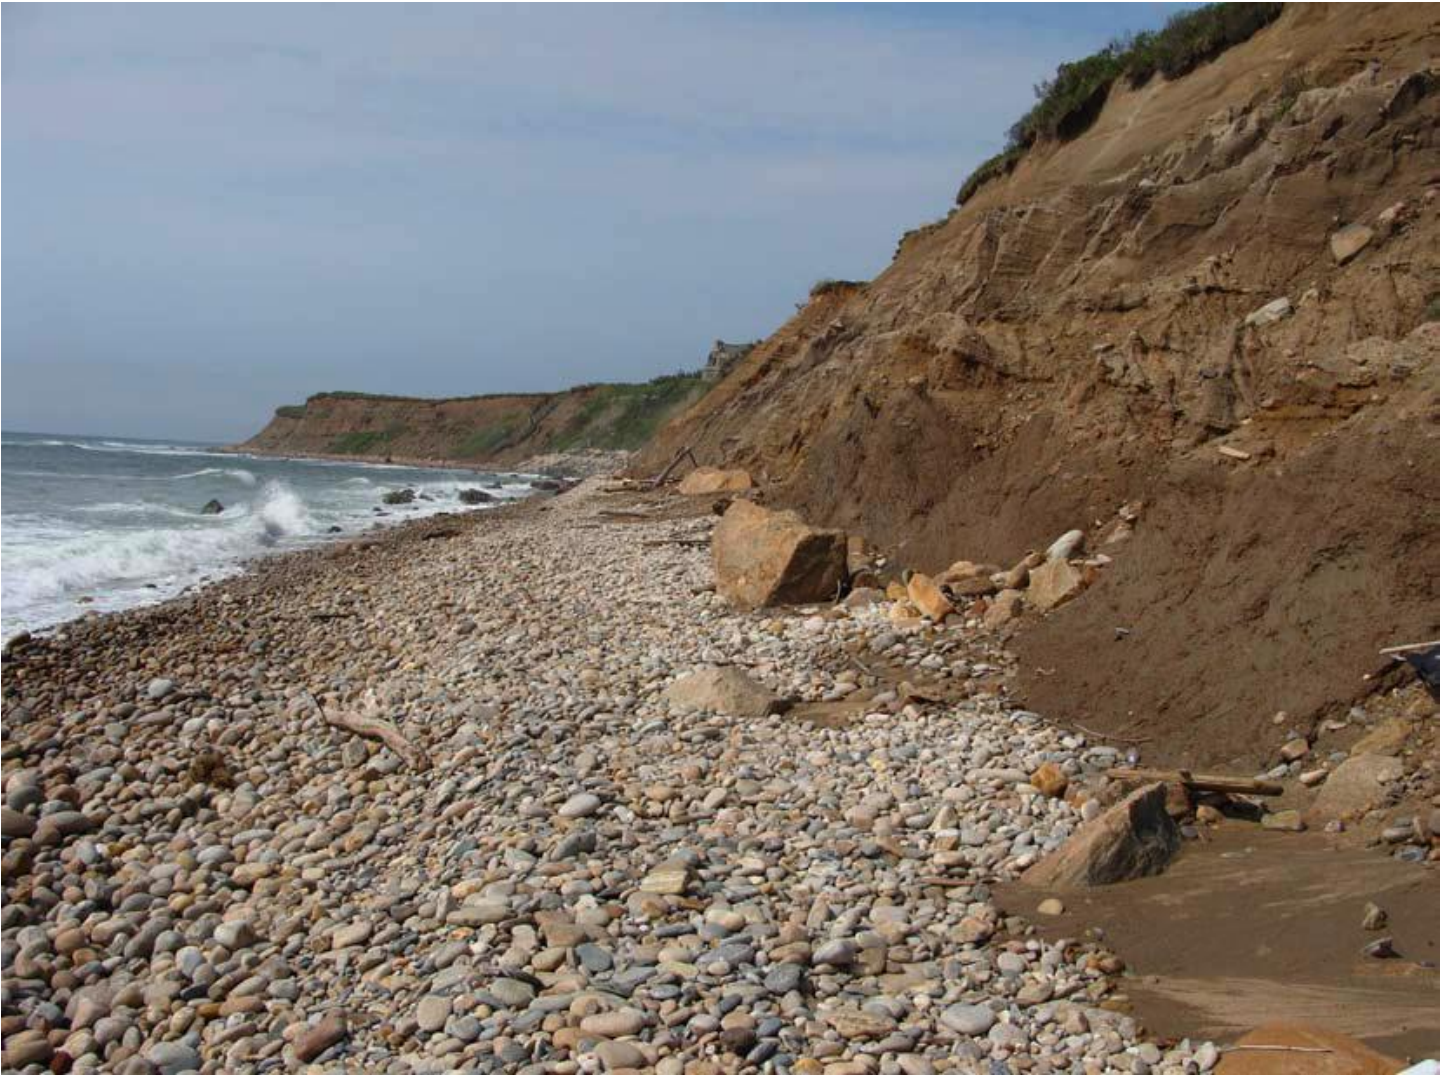
View from the beach looking South West

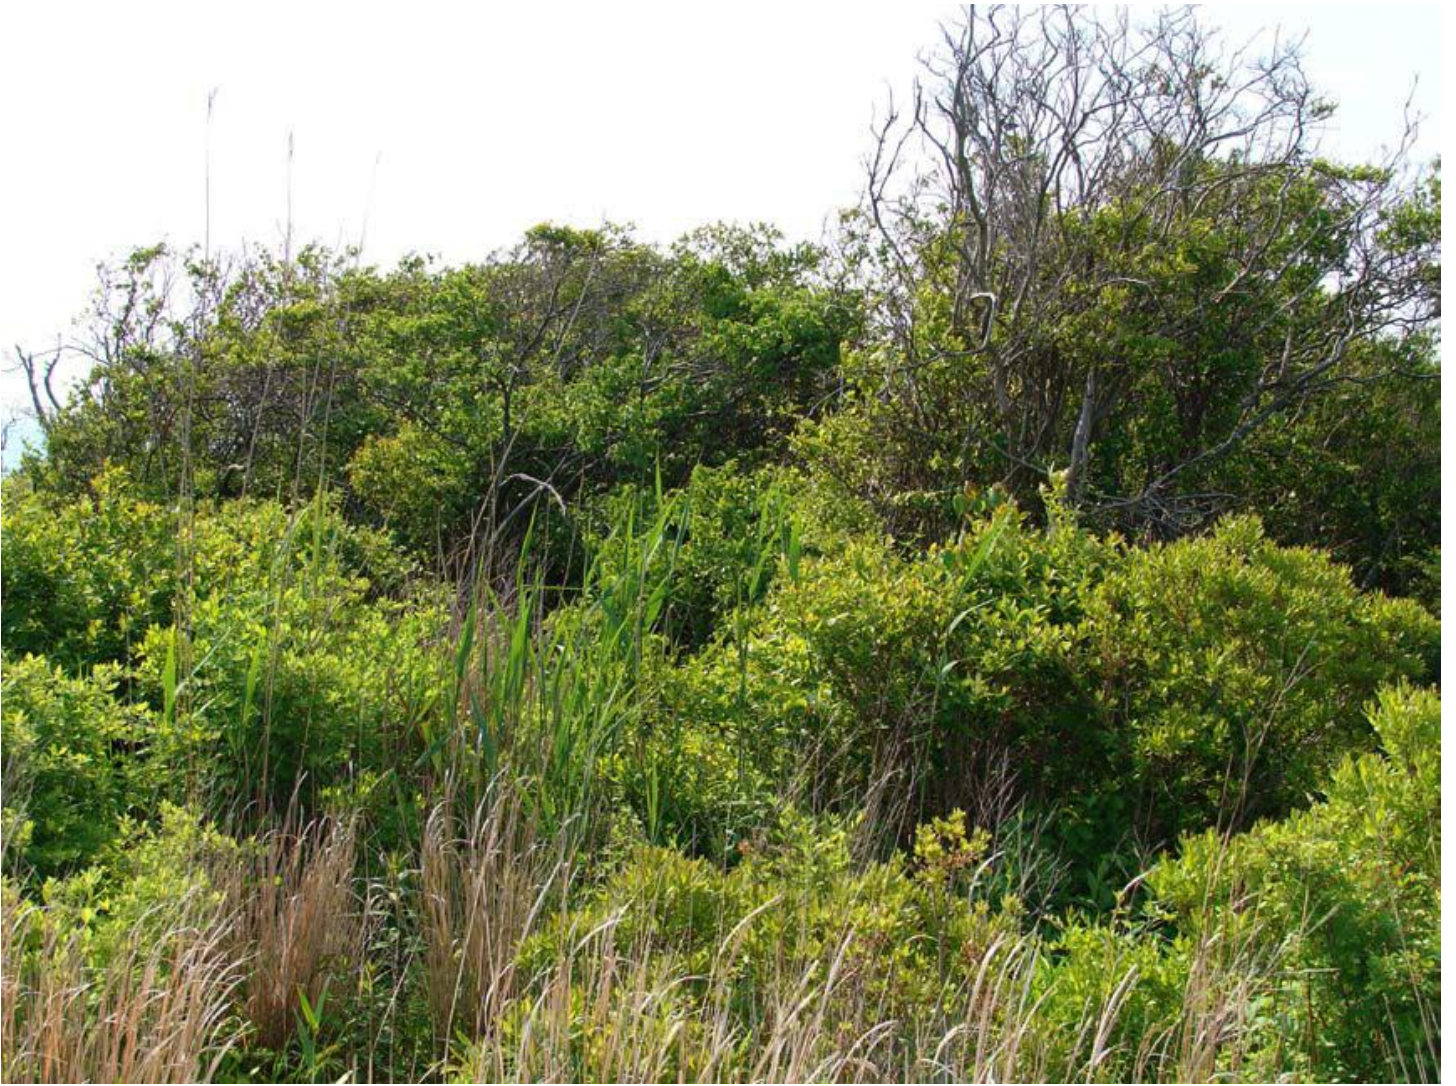
1. No MEC or Munitions Debris (MD) was encountered nor is there any record of MEC/MD being reported since the completion of this removal action.
2. Signs are all still in place and in serviceable condition.
3. Large portions of the original remediation site have become extremely overgrown and difficult for public access. (see photo)

Typical view of vegetation on remediated areas

1. Maintain all current protective works, i.e. signs, pamphlets and continue to allow the site to revert to its original vegetated state. This will keep the public on the maintained trails and out of areas where they could potentially contact MEC.

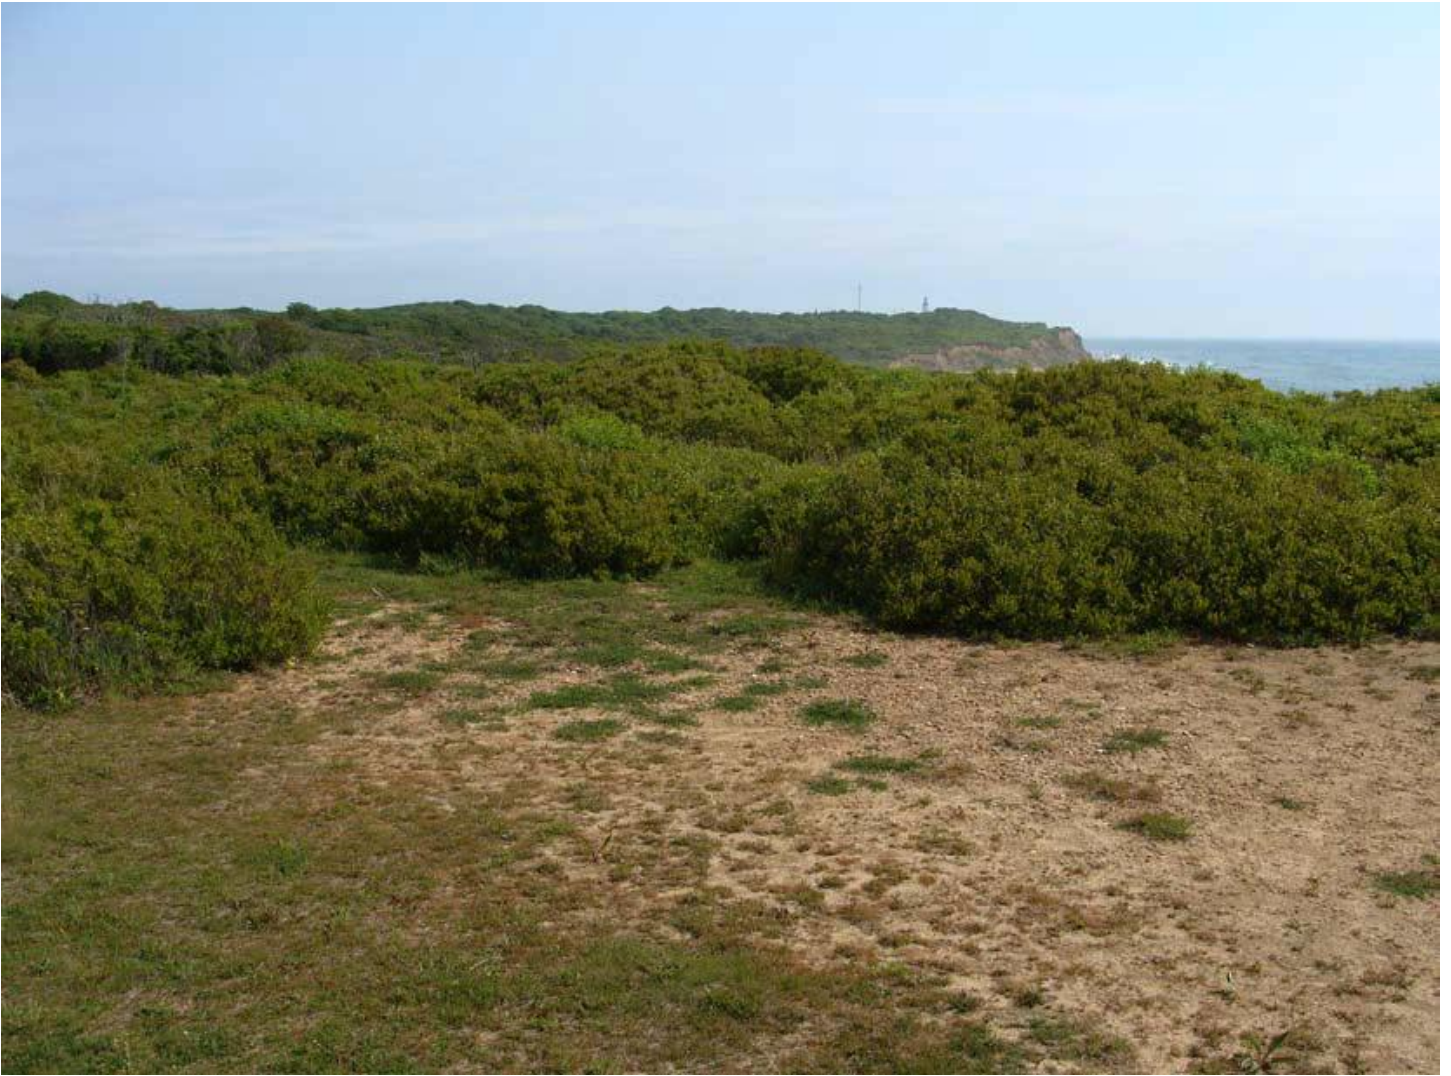
Typical view of vegetation on remediated areas

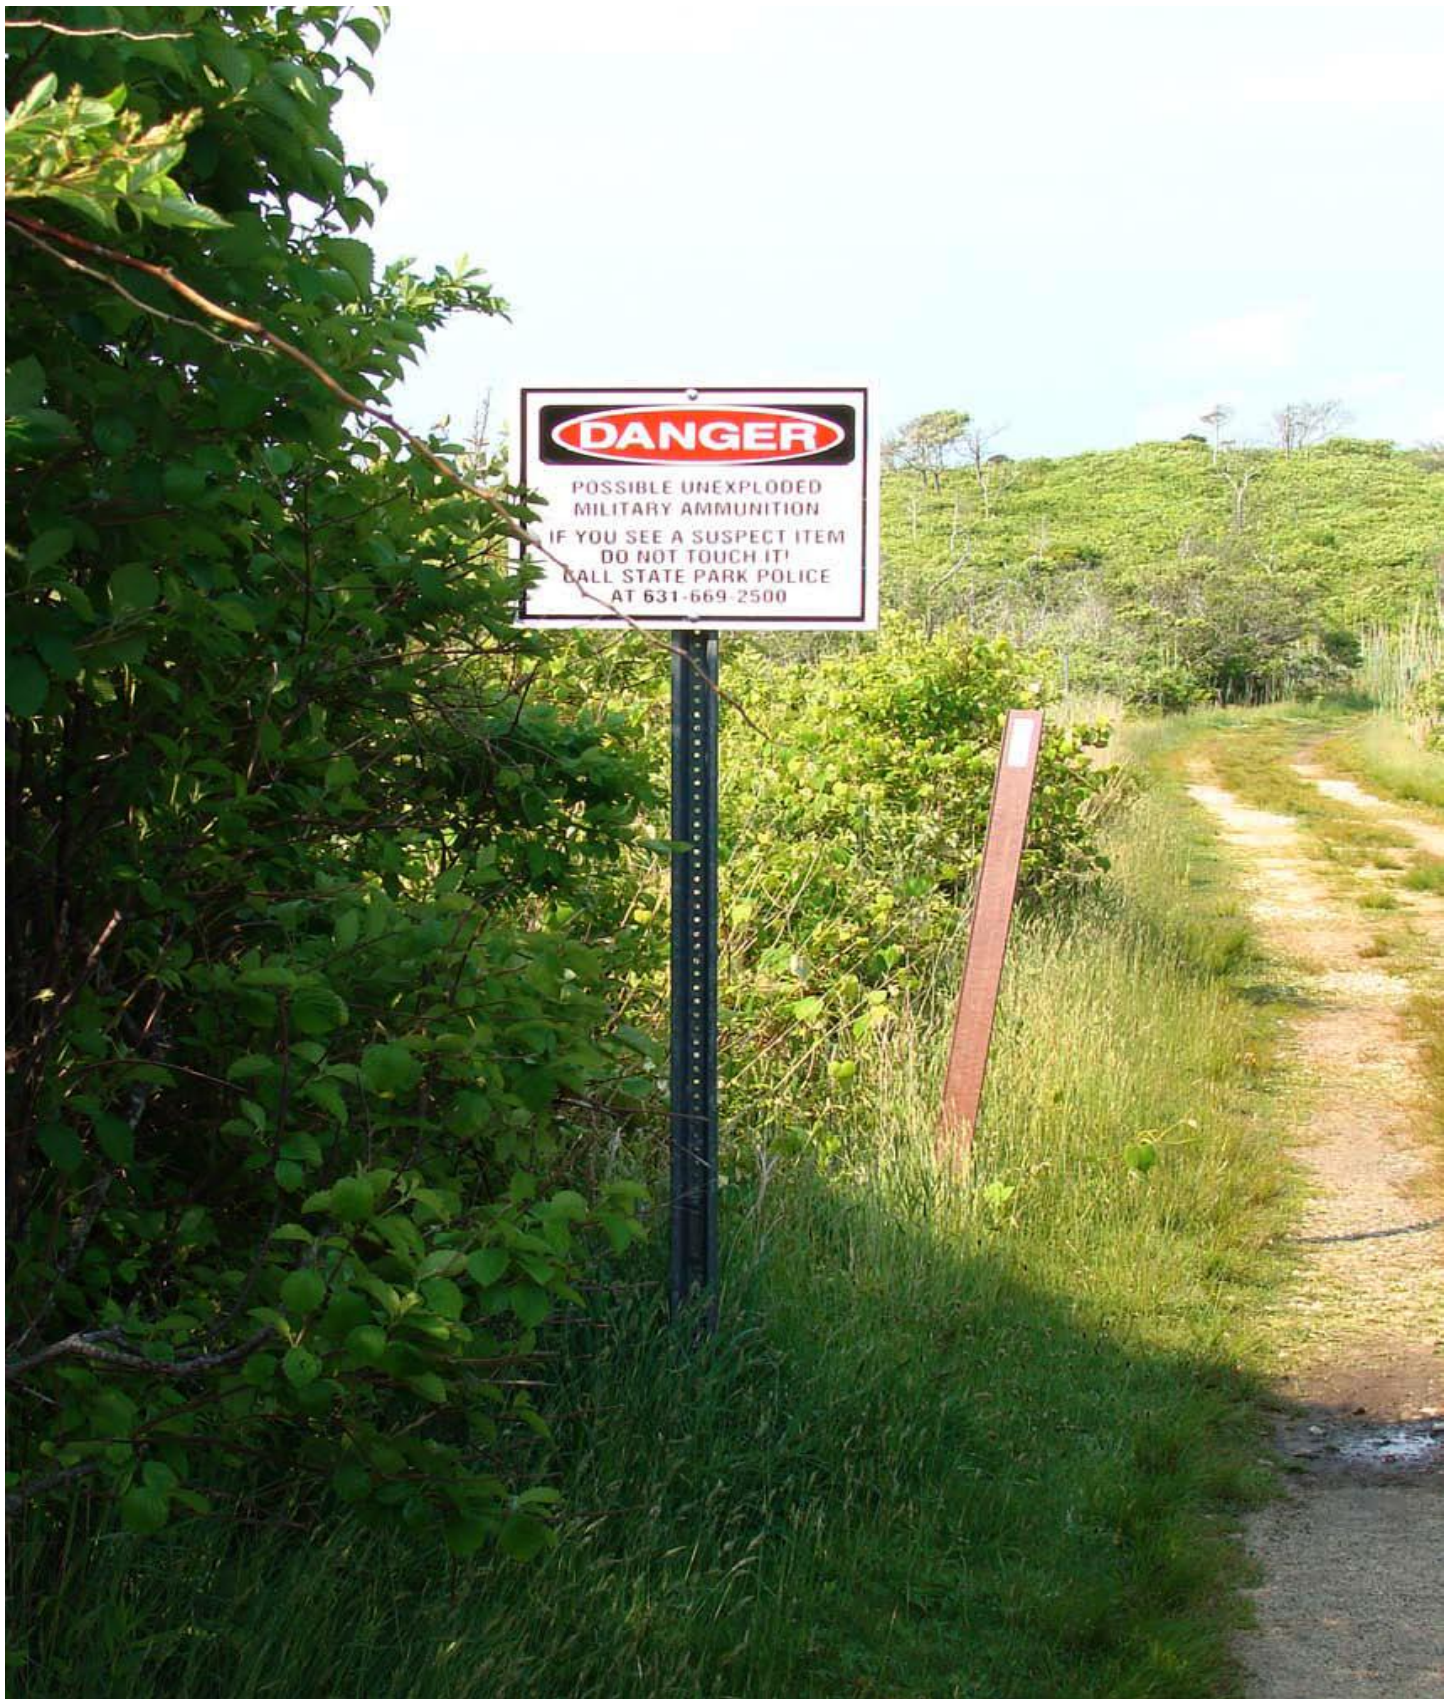
On 26th May an Explosive Safety Representative from USACE Baltimore District, Timothy Holland, arrived on site and contacted Mr. Tom Dess, Superintendent of the Montauk State Park to set up a meeting for the following day. Mr. Dess stated that he would not be available to meet but he would ensure that Mr. John Rocker, Assistant Superintendent of the Montauk State Park would be available. After talking with Mr. Dess I conducted a recon of the site in order to plan the following days work. I Noted a very large amount of wildlife on the property I also noted the condition of Unexploded Ordnance (UXO) notification signage. All the signs I seemed in very good condition and in the proper location. (See photos)

Danger” sign on Old Montauk HWY at entrance from main parking lot.
