**Pennsylvania Avenue Landfill  
Brooklyn, New York  
NYSDEC Site No. 224002**

**Annual Post-Closure Operation, Maintenance  
and Monitoring Report  
January 2017 through December 2017**

**March 2018**

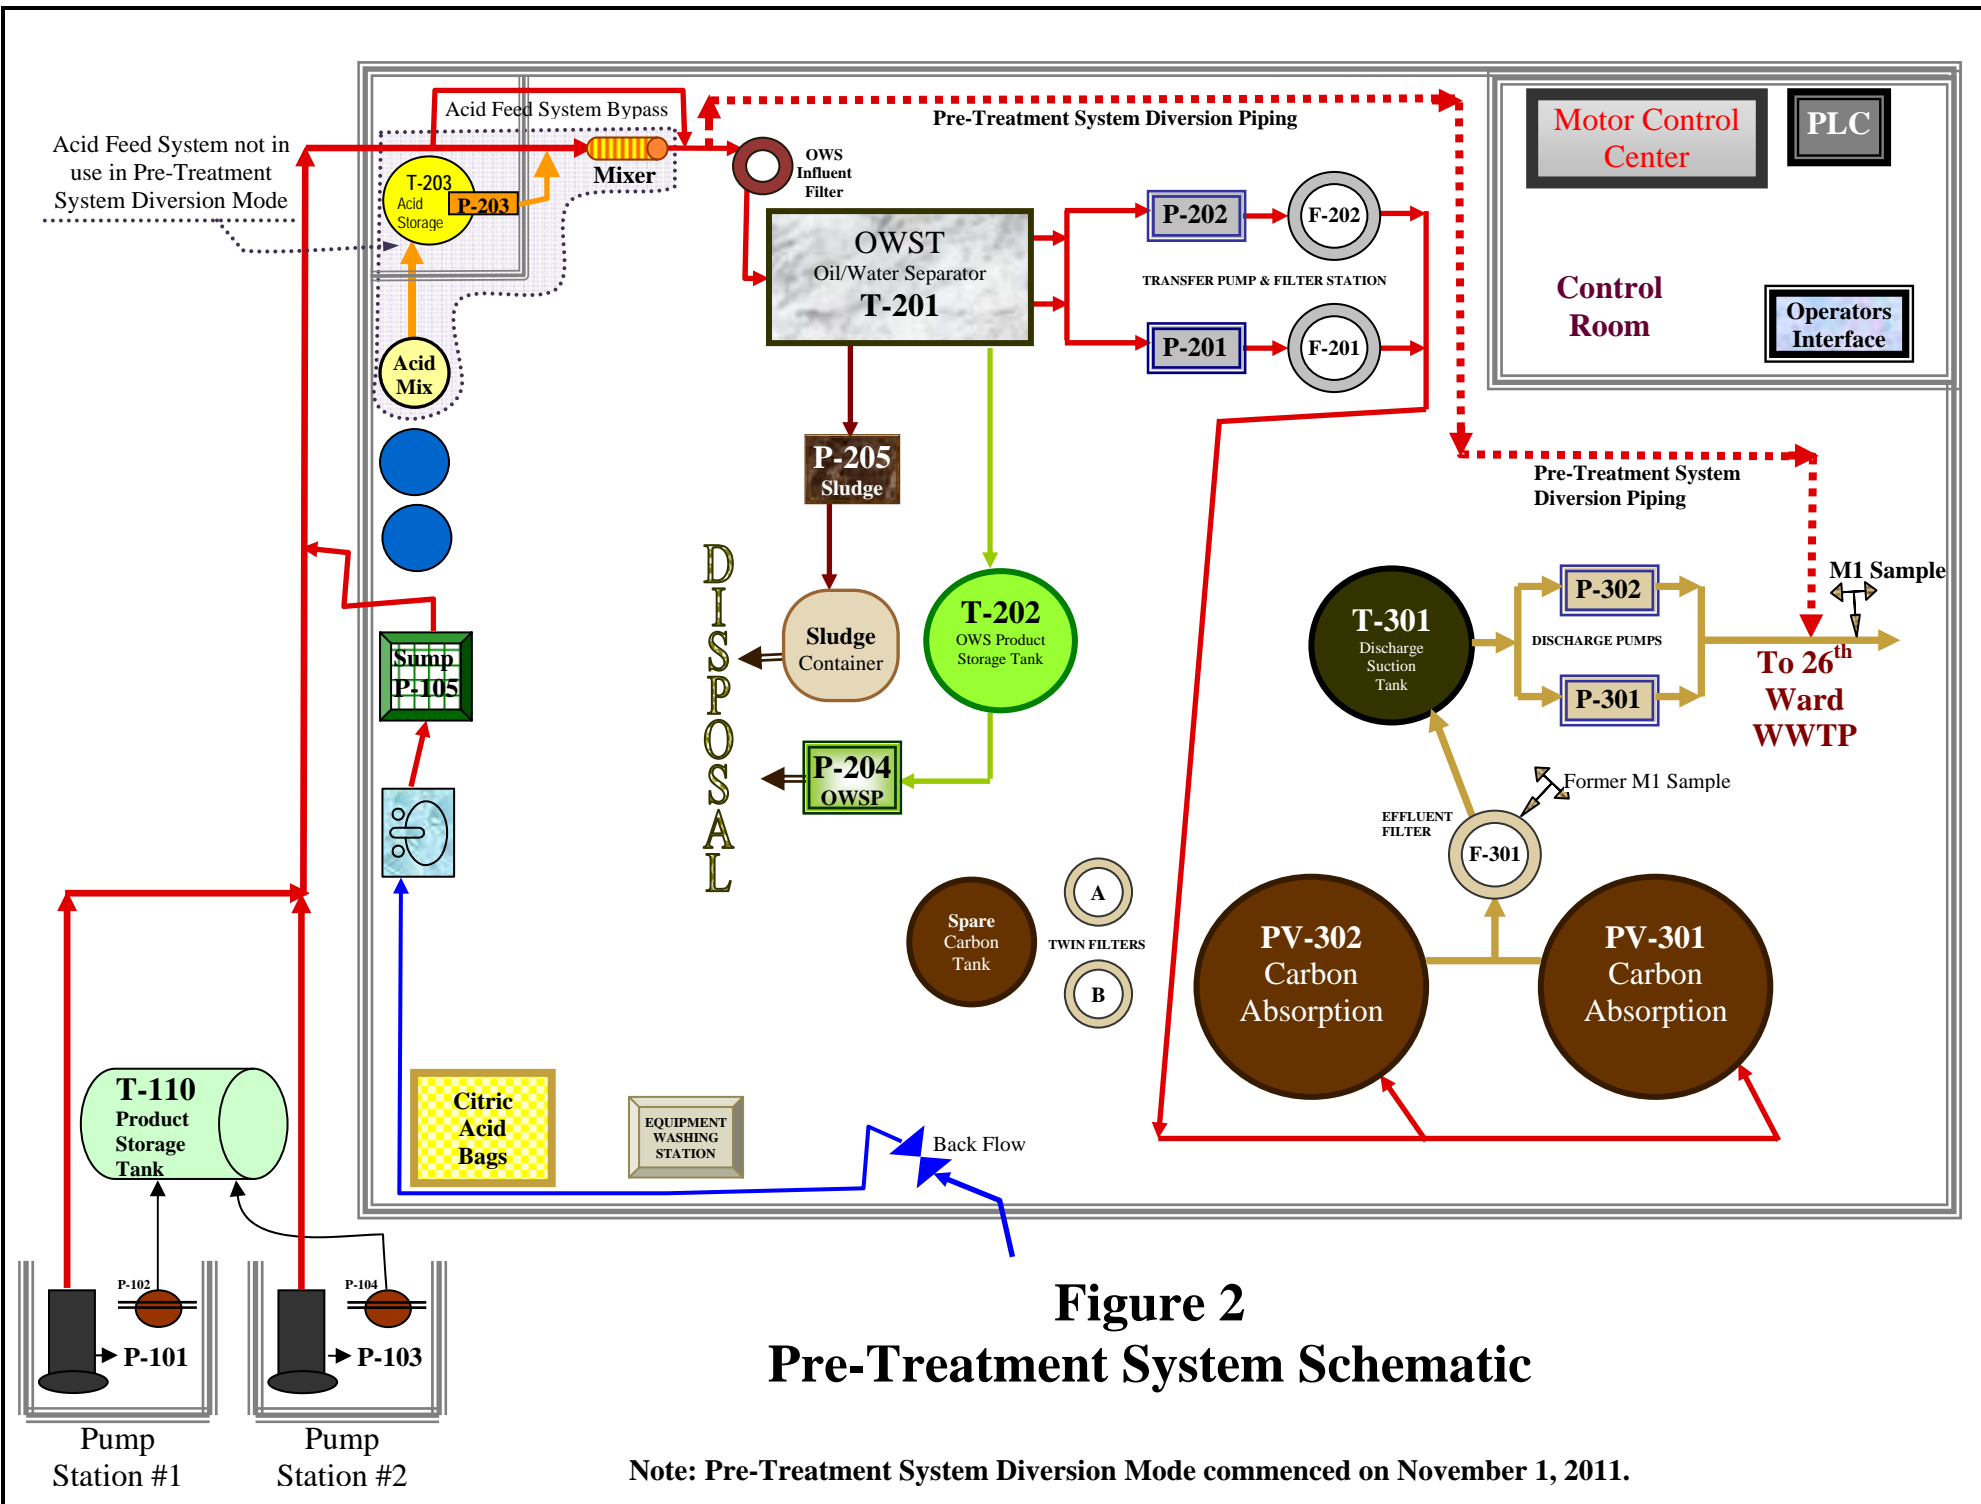
**Figure 2**  
**Pre-Treatment System Schematic**

The facility's components include oil-water separation with citric acid conditioning, bag filtration and carbon adsorption.

Note: Pre-Treatment System Diversion Mode commenced on November 1, 2011.
