<b>PROJECT:</b>	Fulton Works Former MGP – Parcels III and IV (Site No.: 224051)
<b>ADDRESS:</b>	545 Sackett St., Brooklyn, NY
<b>PREPARED BY:</b>	Roux Environmental Engineering and Geology, D.P.C.
<b>DATE:</b>	January 12th, 2023
<b>WEATHER:</b>	Temp: 39 - 46°F, Overcast, RH: 83% Pressure: 30.13" Hg Wind: E @ 8 mph
<b>TIME:</b>	07:00 – 16:00

**Remedial Action Work Summary**Work Activities Performed Onsite:

**DAILY STATUS REPORT**

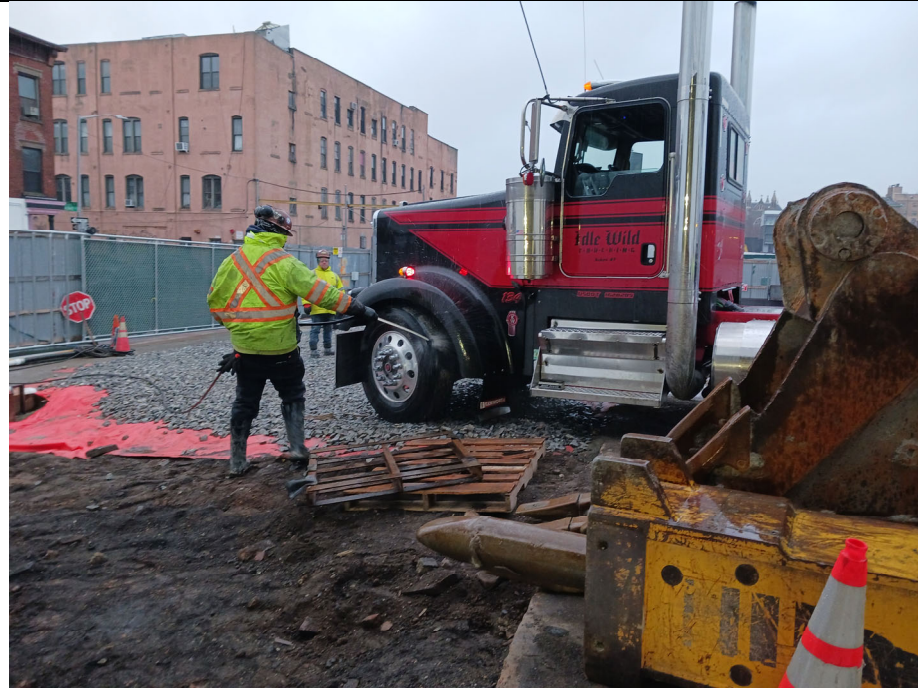
**Photo 1:**

CEI washing truck wheels before leaving the site.

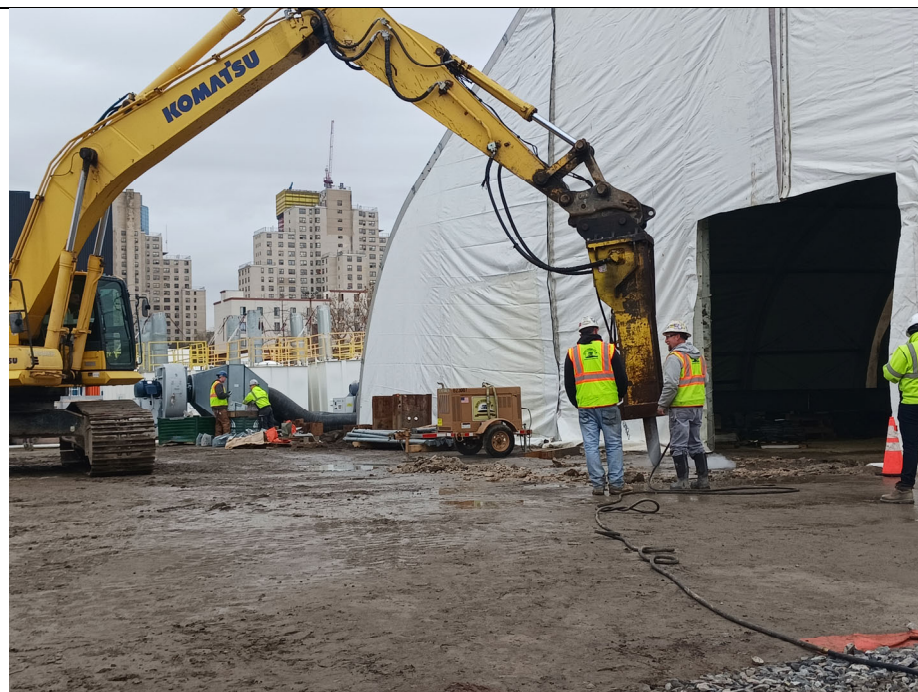
**Photo 2:**

Preparation the west entrance of TFS for construction tracking pad installation.

CEI continued installation of TFS and installed weight bars and cables to seal the structure. CEI began to prepare steel beams for wale installation and prepared the west entrance of TFS for construction tracking pad installation.
