<b>PROJECT:</b>	Former Fulton MGP – Parcels III and IV (Site No.: 224051)
<b>ADDRESS:</b>	545 Sackett St., Brooklyn, NY
<b>PREPARED BY:</b>	Roux Environmental Engineering and Geology, D.P.C.
<b>DATE:</b>	July 08, 2024
<b>WEATHER:</b>	Temp: 74-91°F, Sunny, RH: 85% Pressure: 30.04 in Hg Wind: NNE @ 4 mph
<b>TIME:</b>	07:00 – 15:15

**DAILY STATUS REPORT**

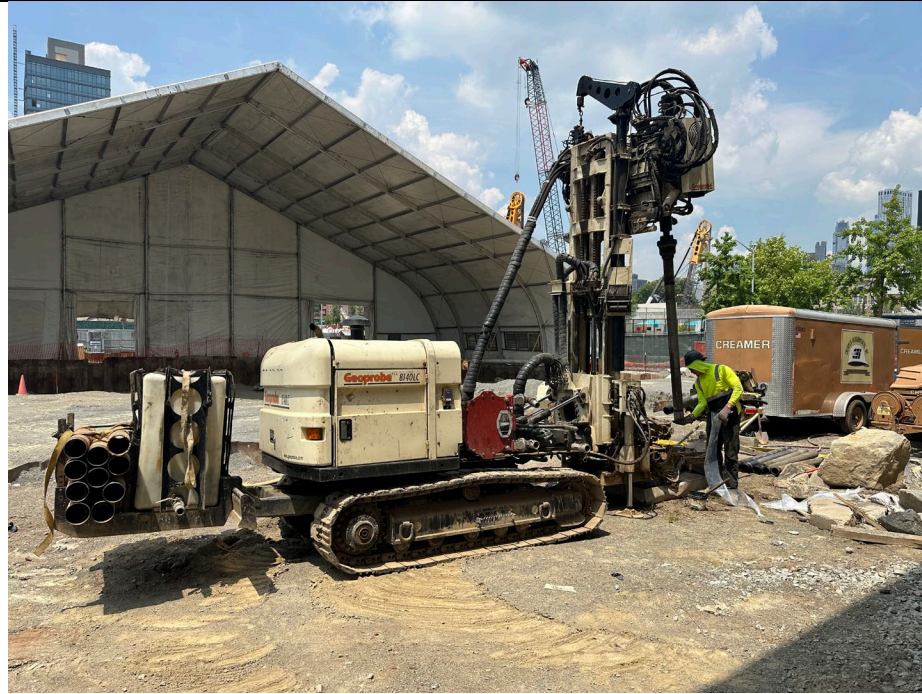
**Photo 1:**

Looking northwest, view of AARCO performing drilling activities in waste characterization grid WC-GH4-3.

AARCO Environmental Services (AARCO) and Roux Environmental Engineering and Geology, D.P.C. (Roux) performed drilling activities utilizing a sonic drill rig Geoprobe 8140LC within waste characterization grids WC-GH4-1 and WC-GH4-3 to collect waste classification samples for compliance with disposal facilities. Dust and odor control measures (wetting, tarping, limiting vehicle speeds, etc.) continued to be performed to ensure there were no impacts to the neighborhood.

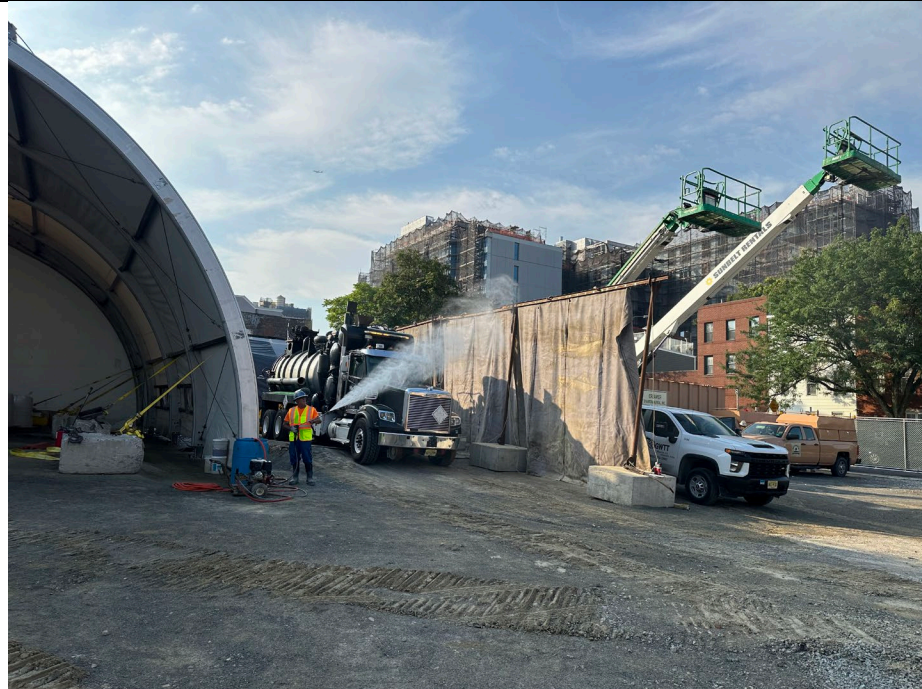
**Photo 2:**

Looking southeast, view of McVAC vacuum truck removing spend filter media from WTS, application of Biosolve and sound barrier position.

Creamer Environmental, Inc (CEI), McVAC Environmental (McVAC) and Gound/Water Treatment and Technologies (GWTT) removed spent filter media from the water treatment system (WTS) with a vacuum truck and staged the material for future disposal. A temporary sound barrier was installed prior to vacuum truck operations and Biosolve was sprayed to neutralize any odors being emitted from the vacuum truck exhaust. CEI also applied Atmos odor suppressant foam and at the end of the day, covered the staged filter media with poly sheeting to prevent odors.

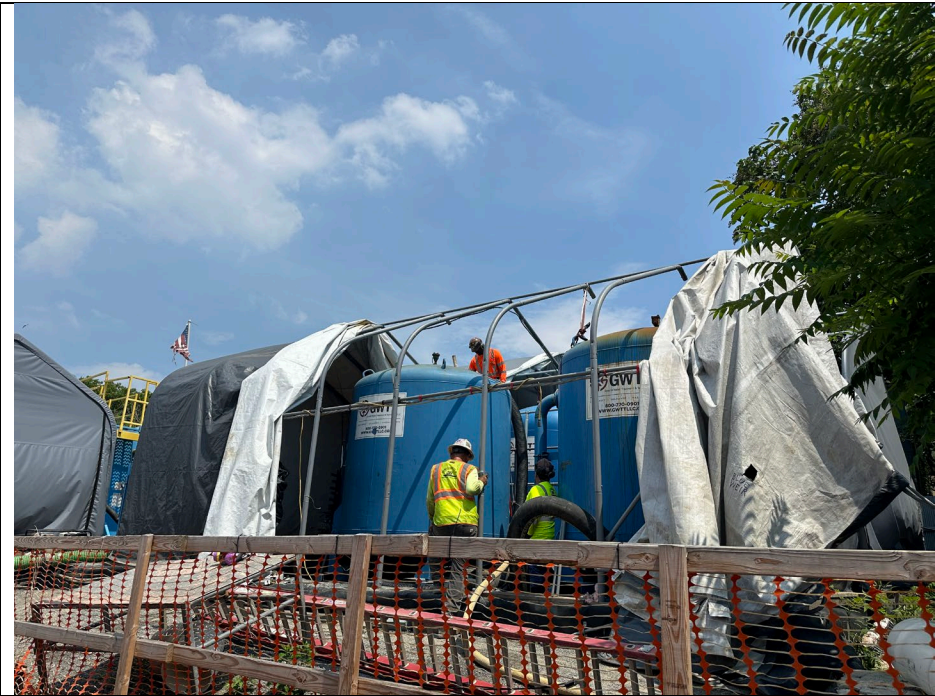
**Photo 3:**  
Looking east, view of CEI removing spent filter media from the WTS via a vacuum truck.
