Weekly Report No.: 113

Period: 10/07/24 through 10/13/24

This Weekly Air Monitoring Report summarizes perimeter air monitoring data collected during the referenced period in accordance with the Community Air Monitoring Plan (CAMP) which was included as part of the NYSDEC approved Remedial Action Work Plan for the Former Fulton Manufactured Gas Plant (MGP) Site – Parcel III and Portion of Parcel IV.

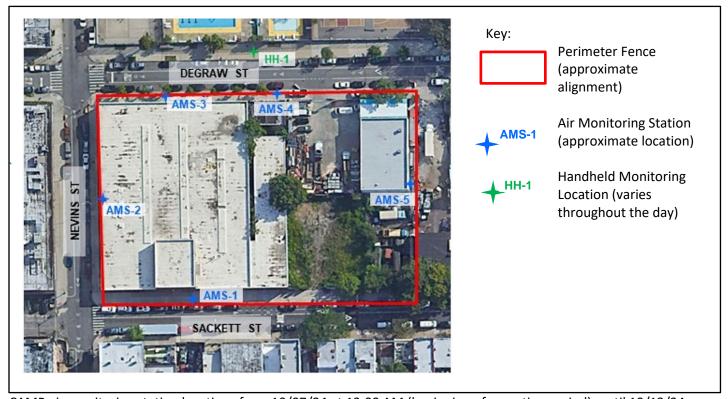
Figure 1 – CAMP Station Locations

Air monitoring was performed during the reporting period in accordance with the CAMP. Air Monitoring location for the reporting period is shown on **Figure 1.** The air monitoring program consists of:

CAMP air monitoring station locations from 10/07/24 at 12:00 AM (beginning of reporting period), until 10/13/24 at 11:59 PM (end of reporting period).

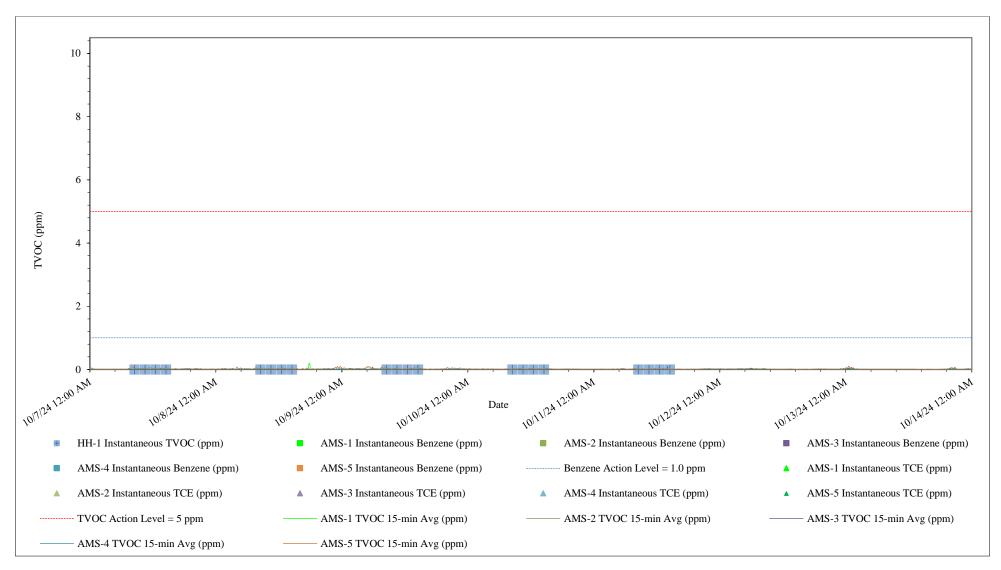
Figure 2 – Summary of TVOC, Benzene, and Tri-chloroethylene Concentrations 10/07/24 through 10/13/24

There were no TVOCs or PM_{10} concentrations above the CAMP-established action levels during the reporting period. Figures 2 and Figure 3 summarize the TVOC and PM_{10} concentrations, respectively, recorded during the reporting period.
