## Monthly Progress Report 2023 No. 5

Former NuHart West Site

NYSDEC Site No. 224136

Reporting Period: May 1, 2023 – June 1, 2023

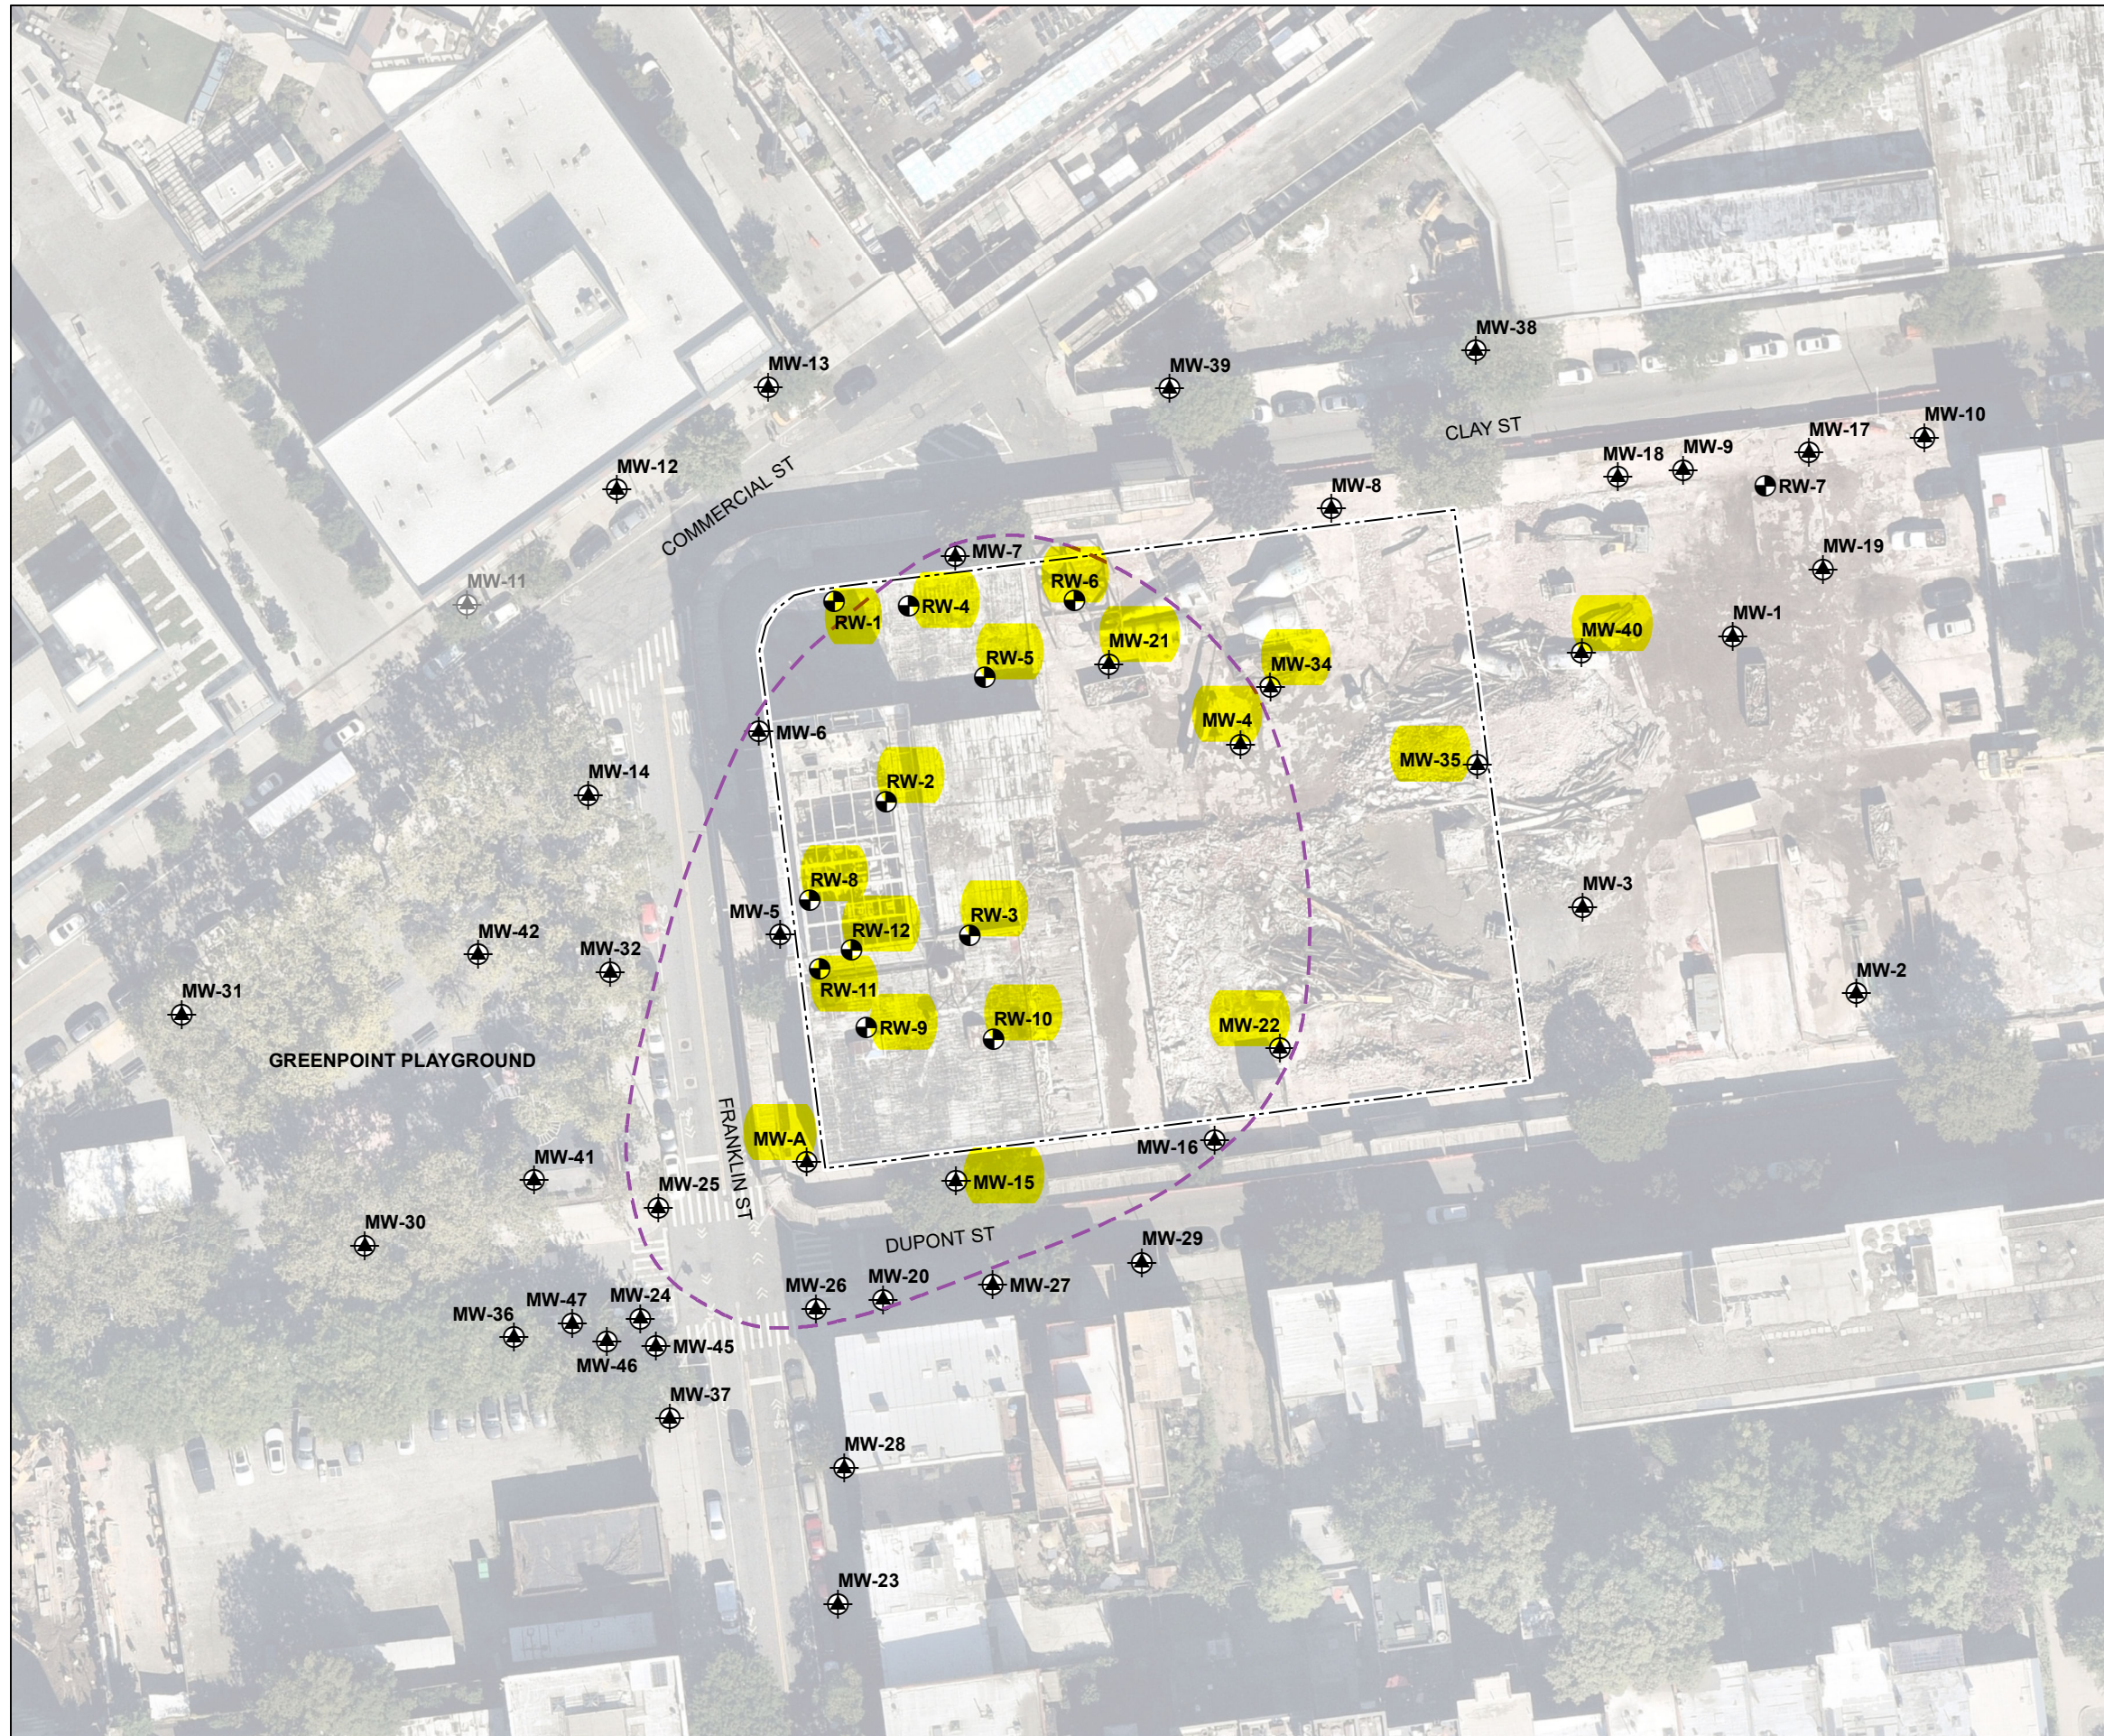
**FIGURE 2**

to construction activities. The wells that could not be accessed are identified in the attached figure.

**SITE PLAN**
