**Re: Remedial Investigation Report - Final
688-700 Court Street Site, Brooklyn, New York
Amended Order on Consent, Case No.: D2-03811-10-08**

REMEDIAL INVESTIGATION REPORT NYSDEC SITE NO. 224145

Chemtura Corporation
688-700 Court Street
Brooklyn, New York

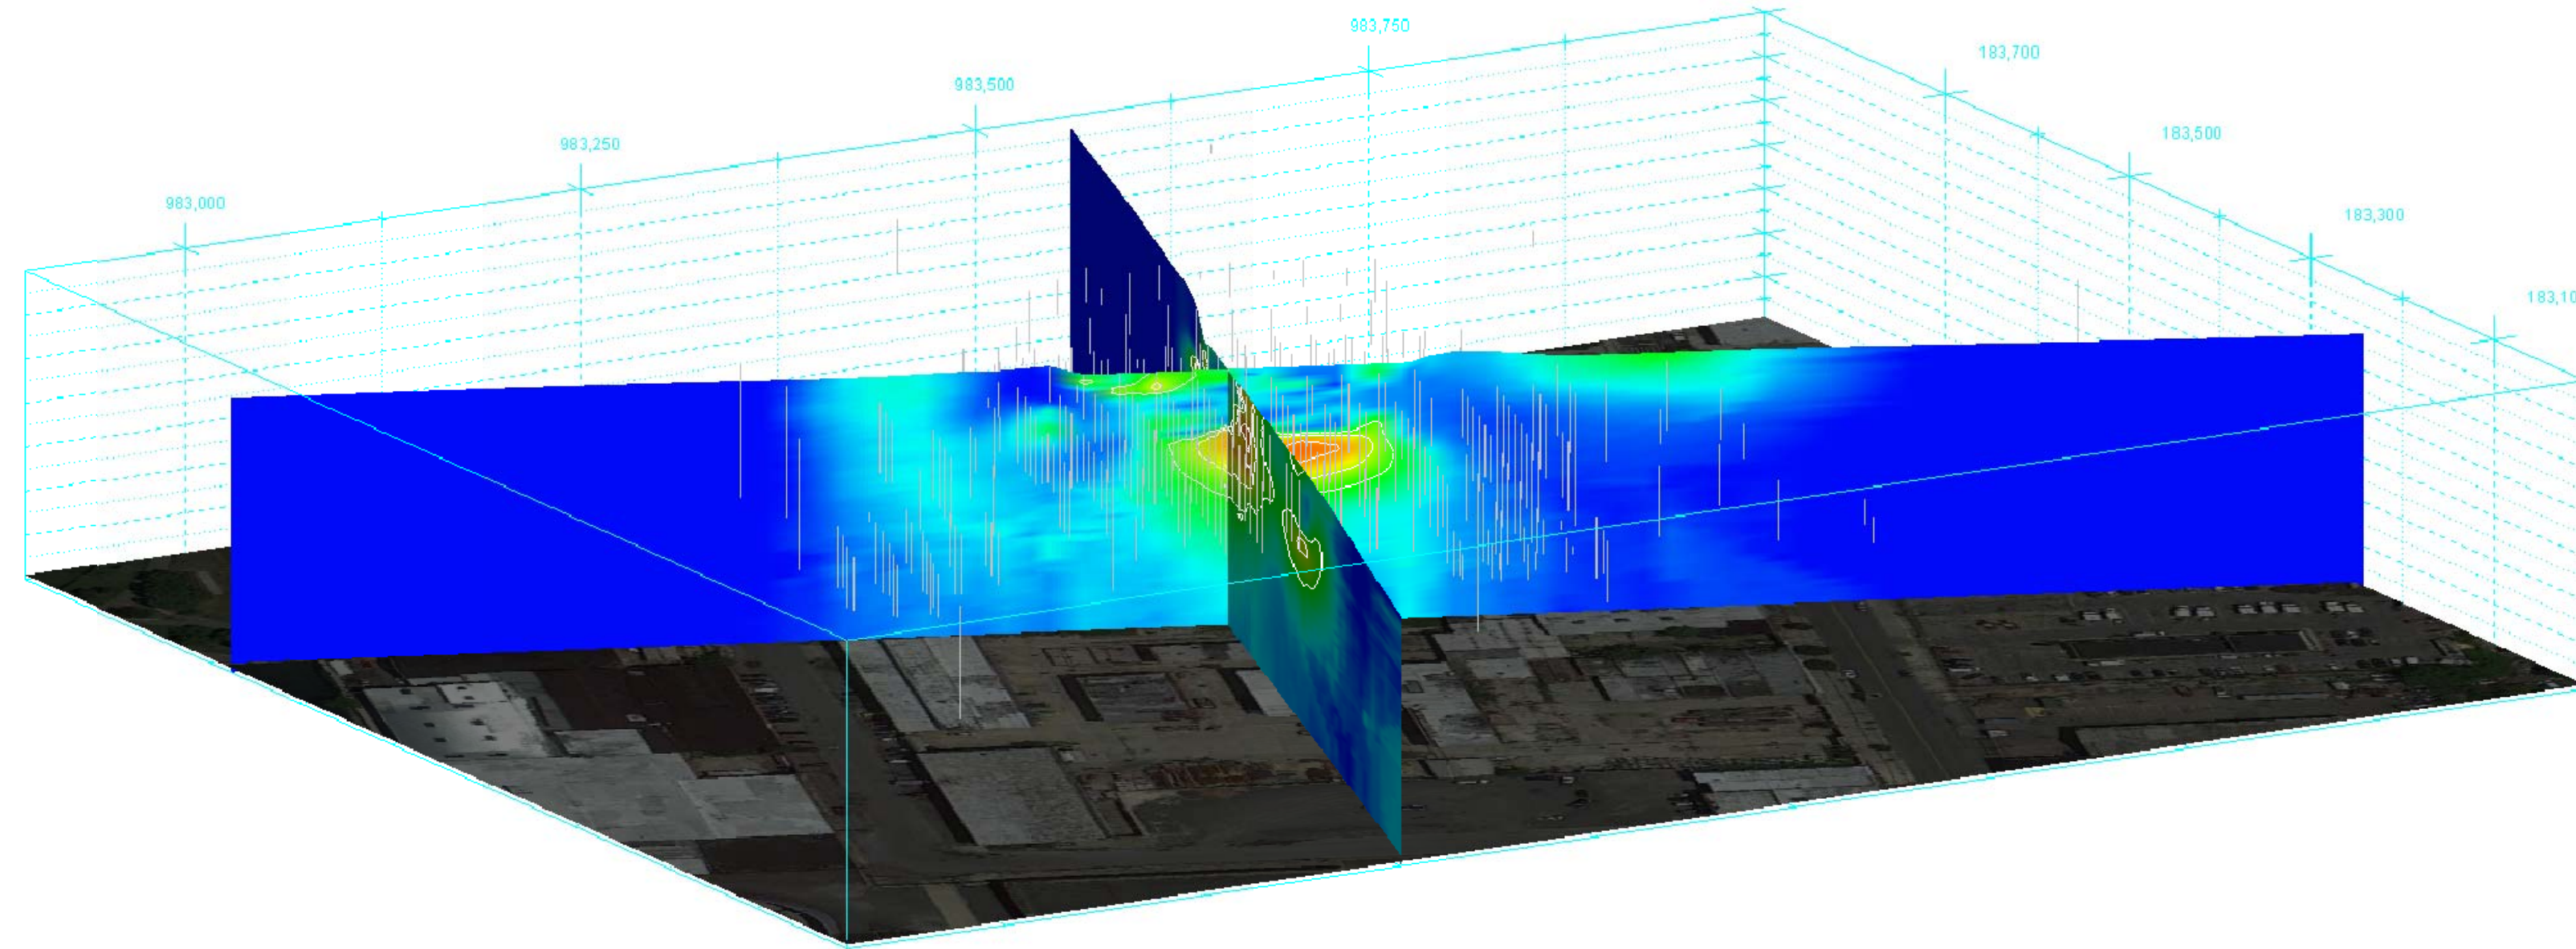
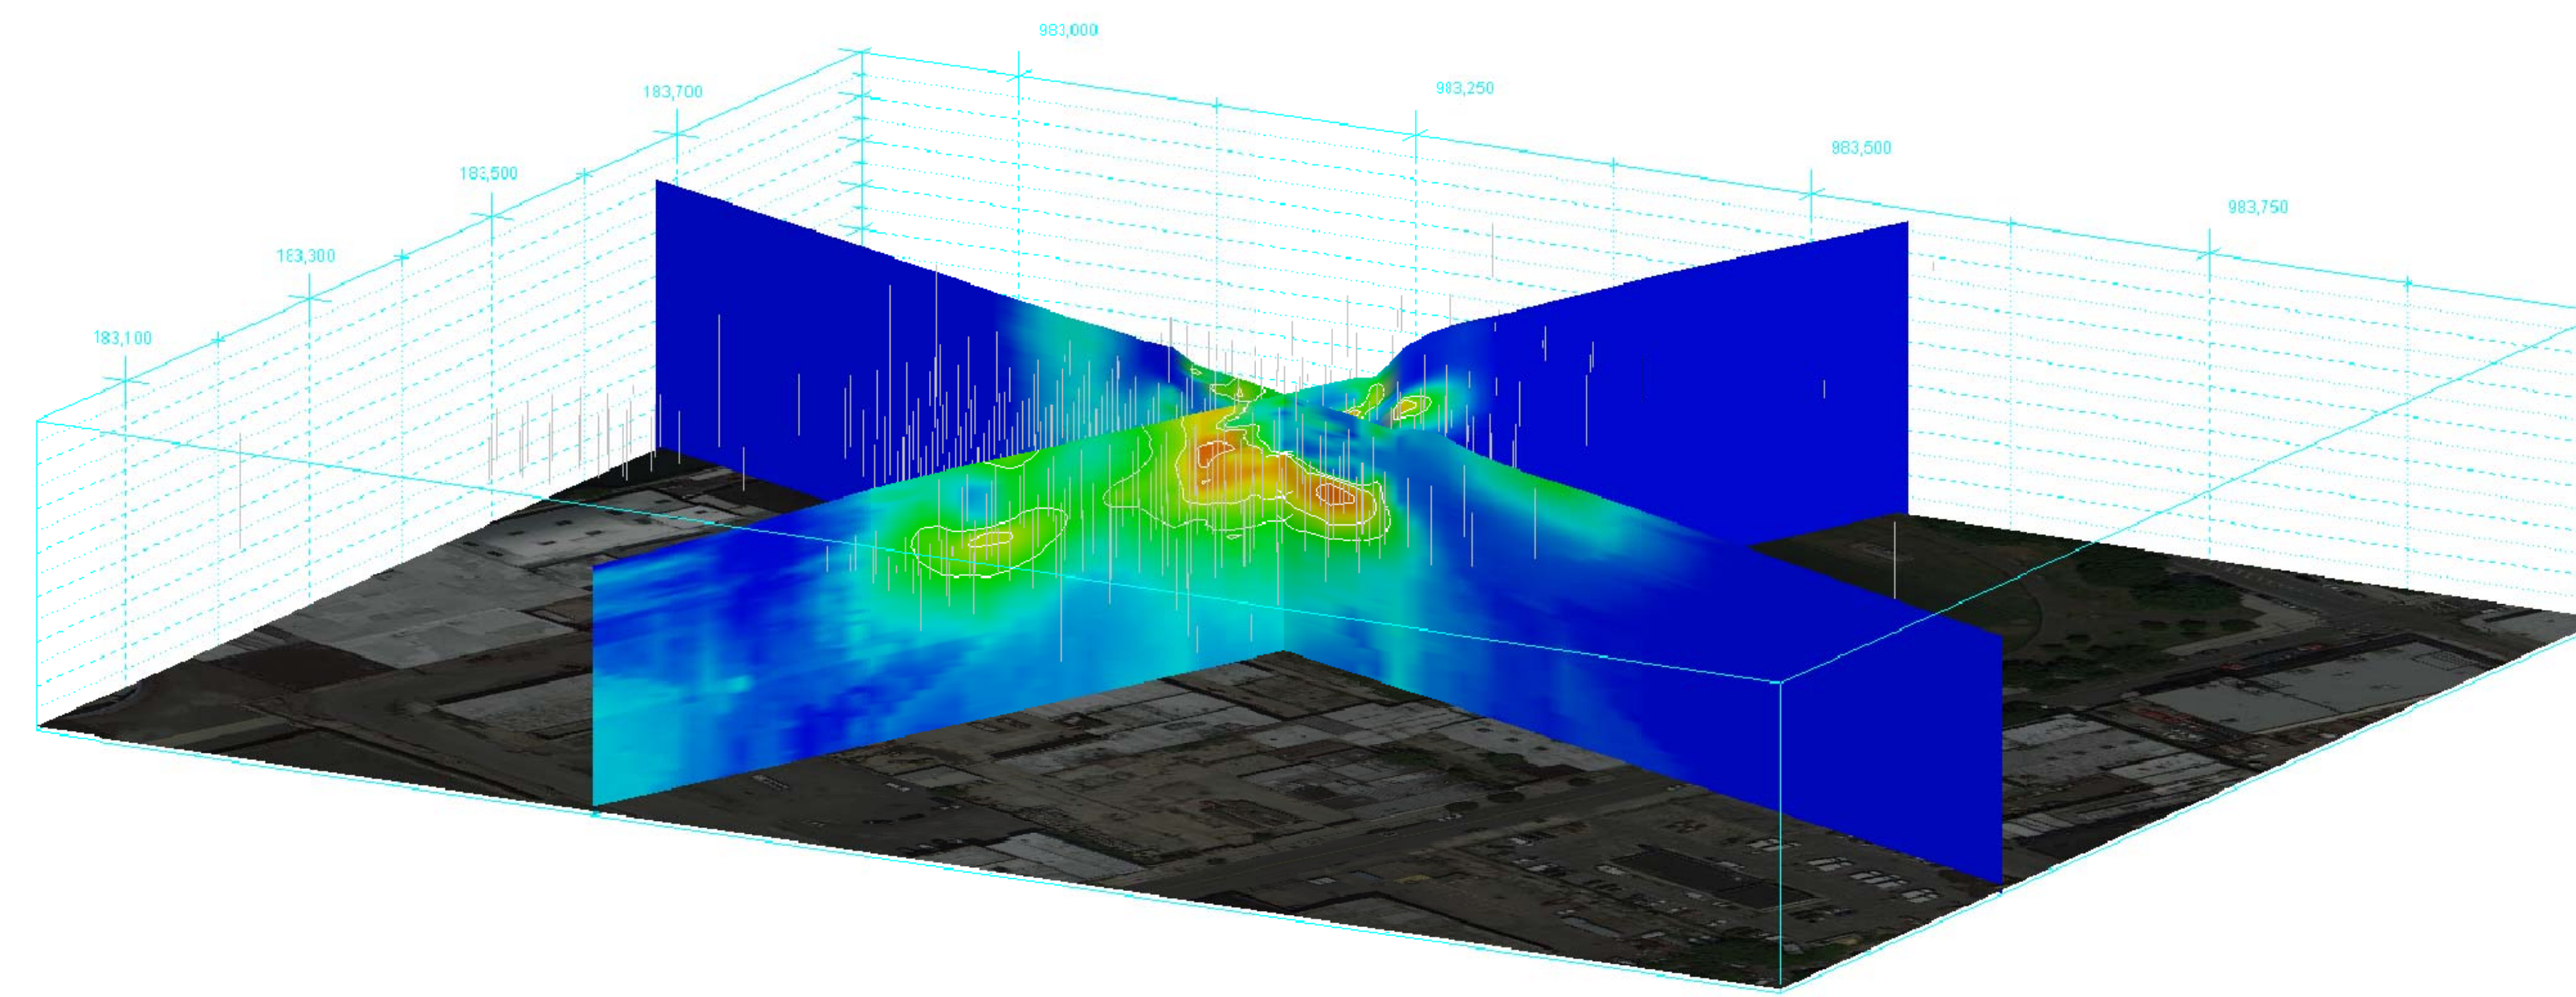
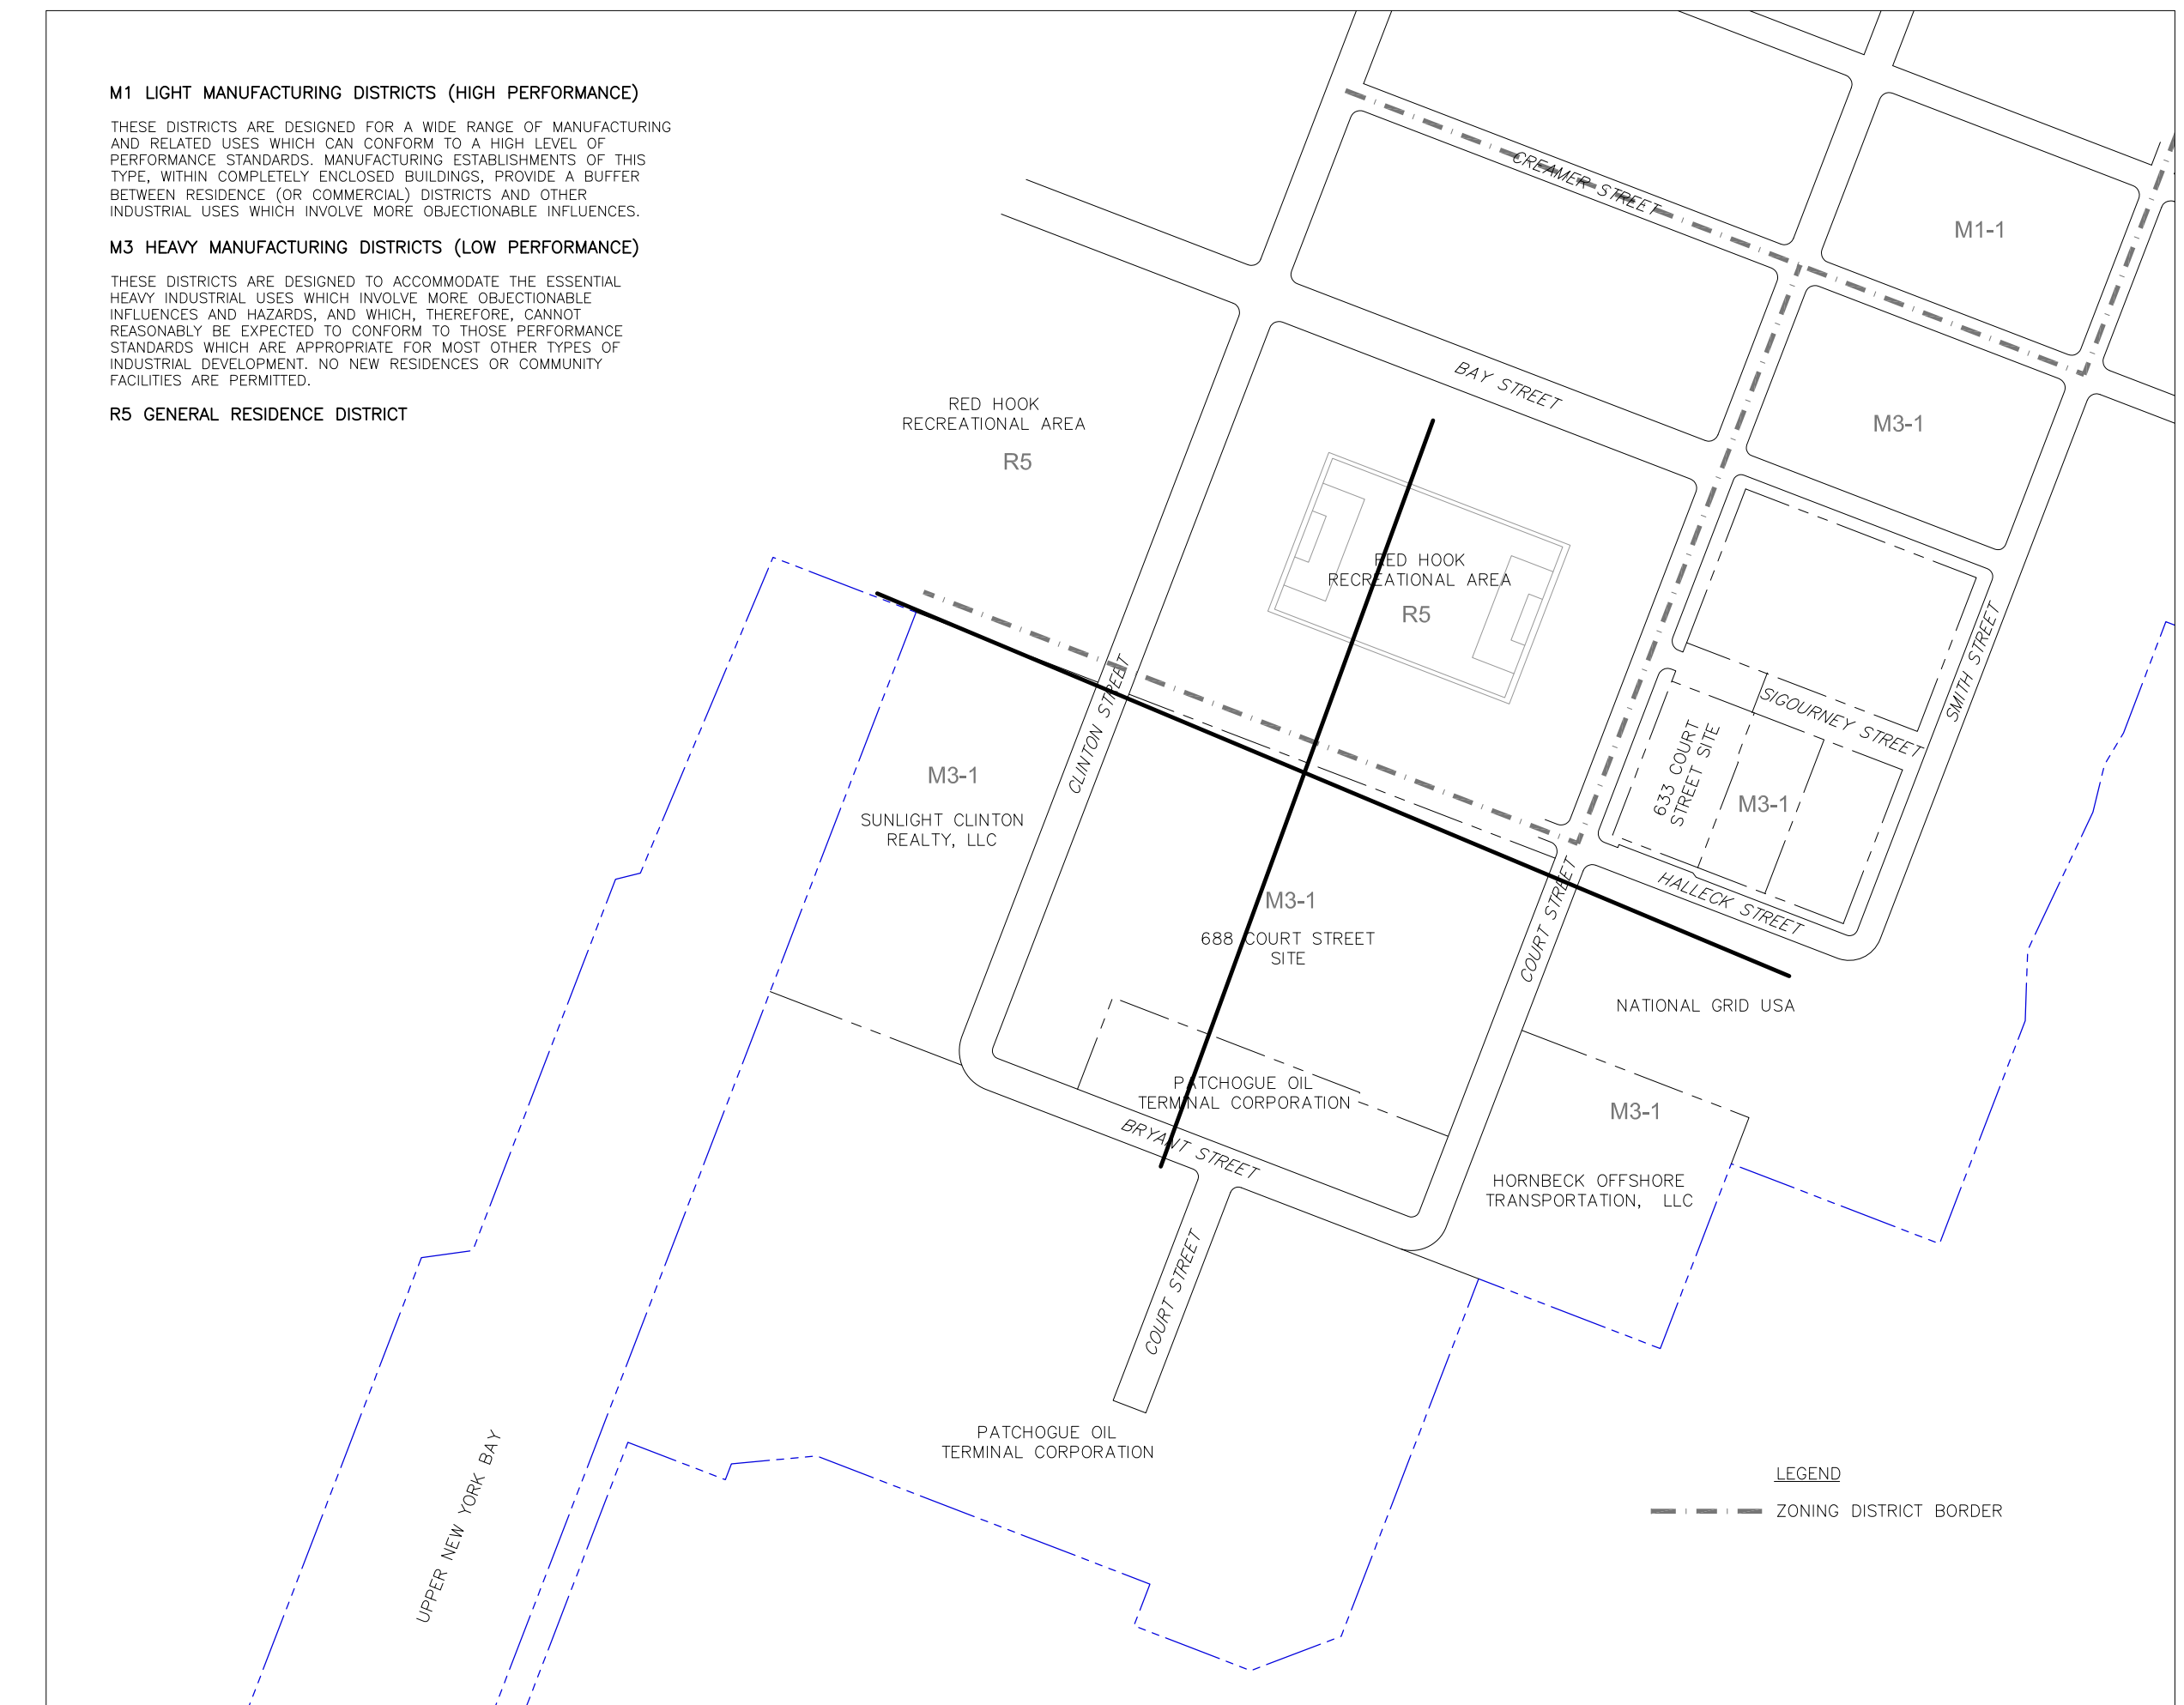
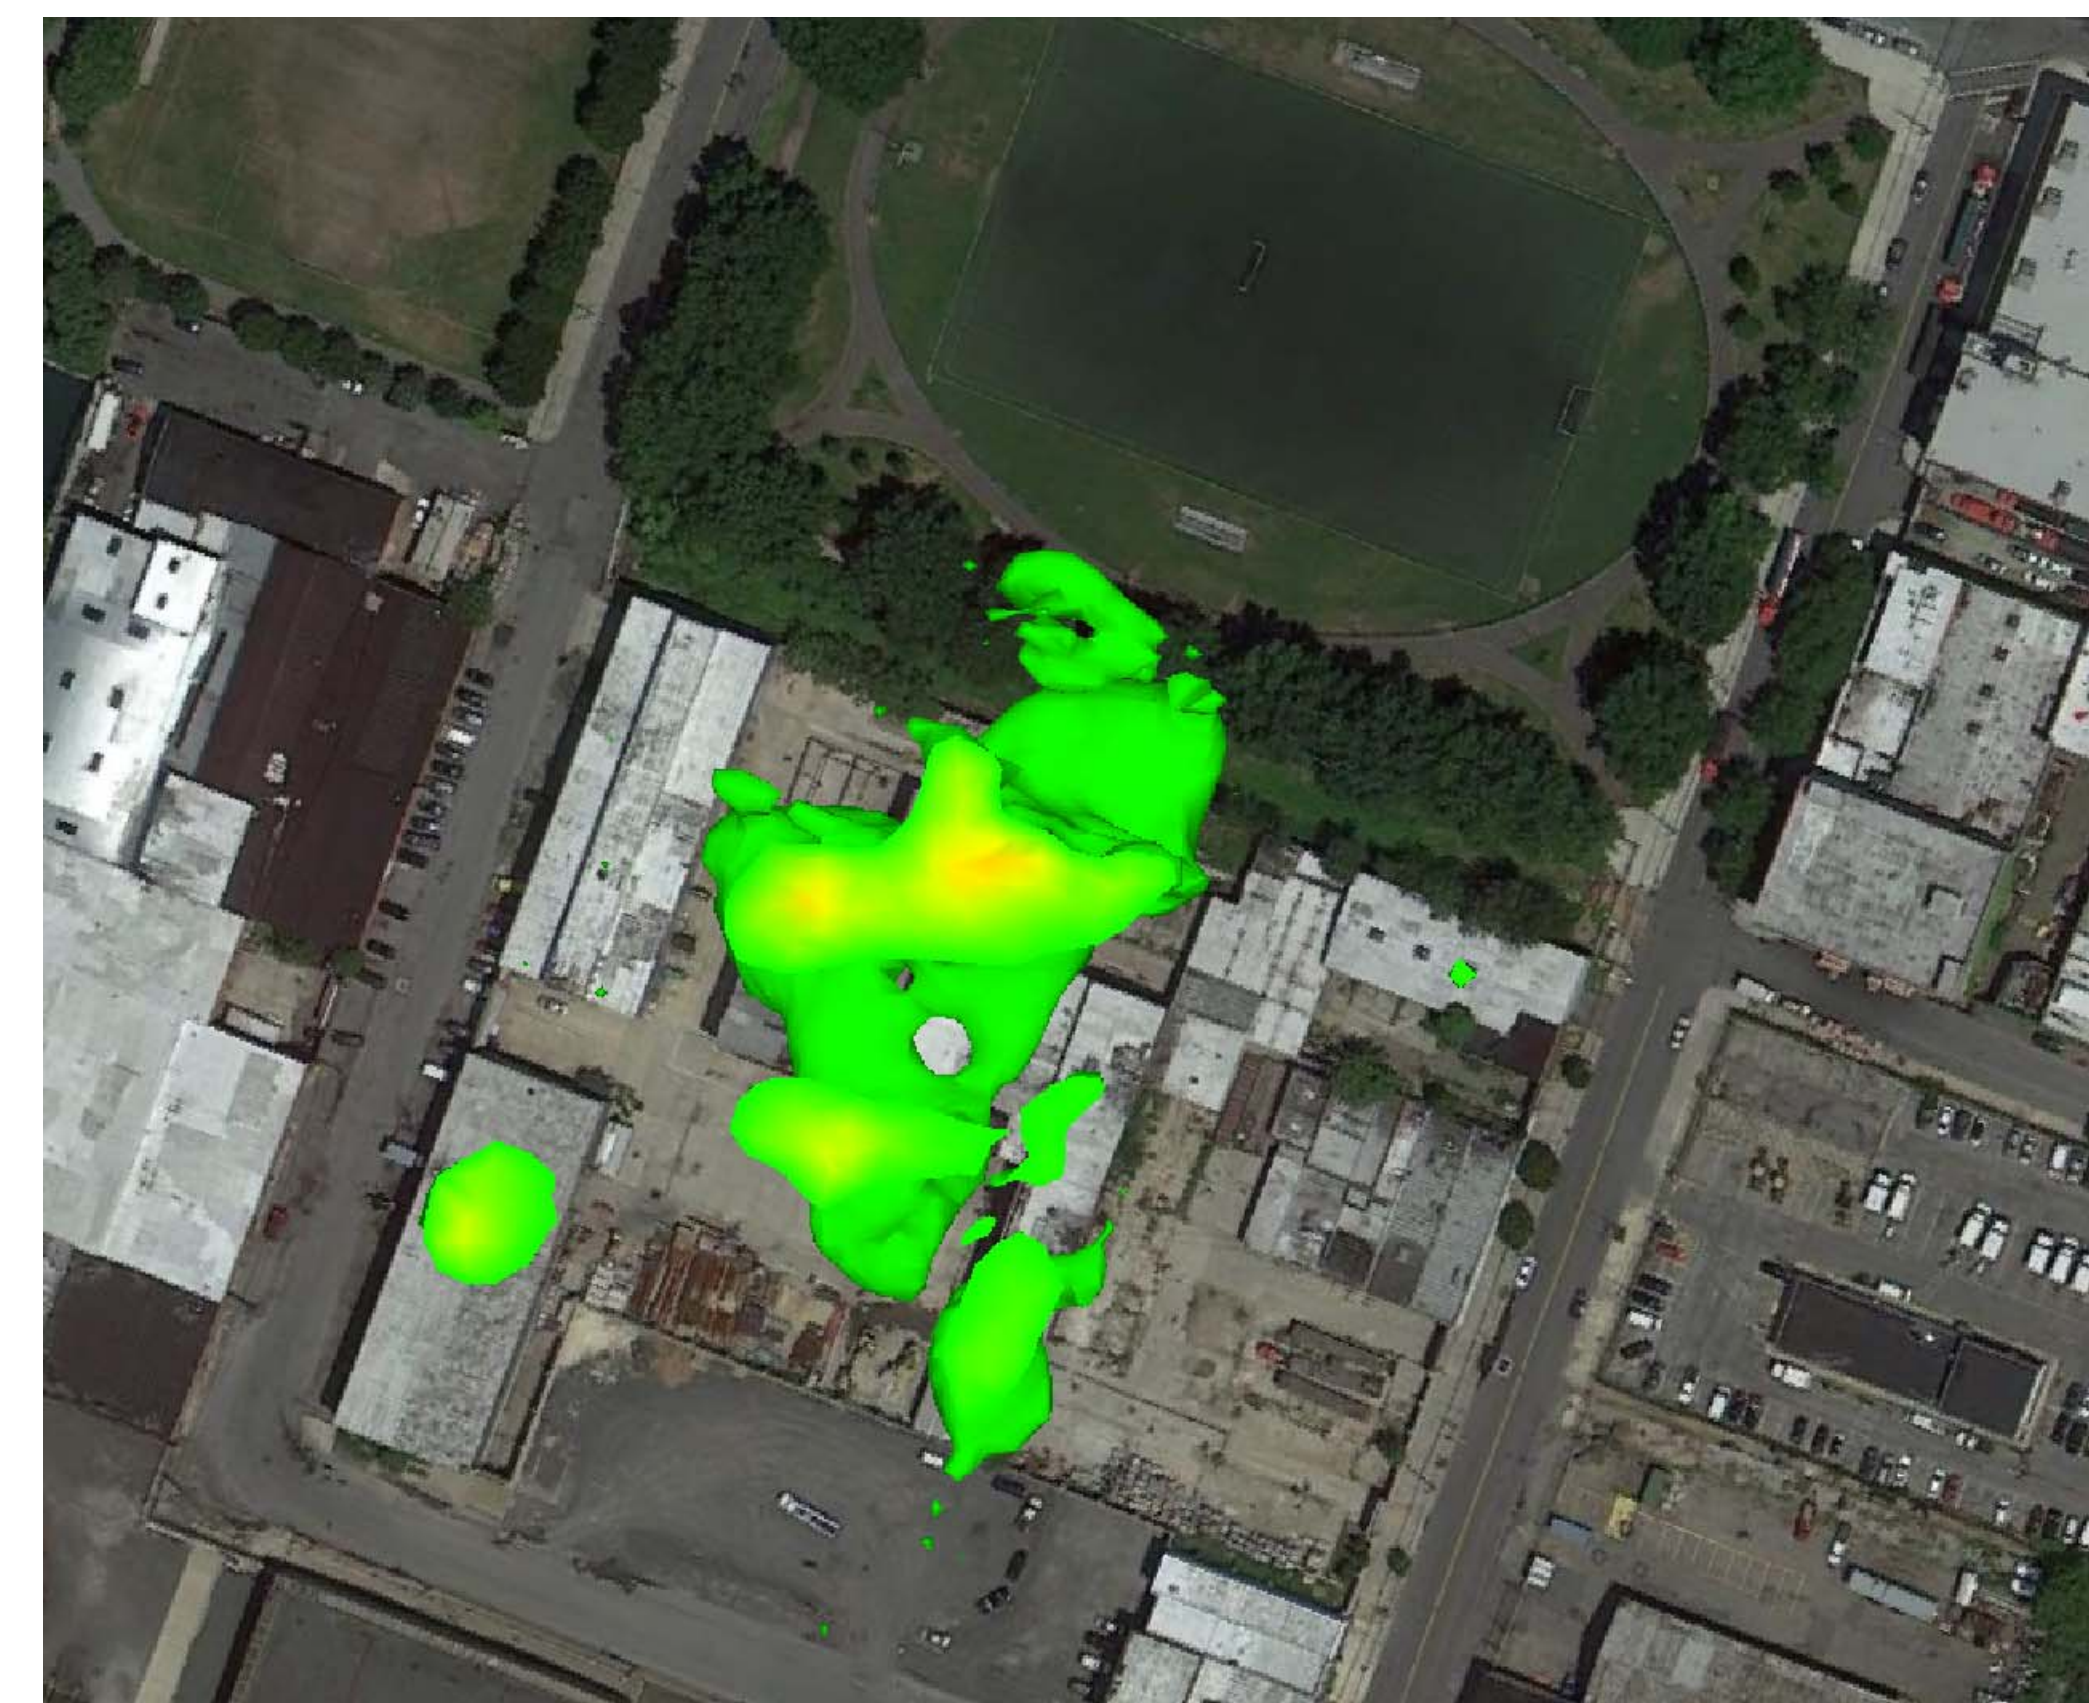
PLAN VIEW SHOWING PCB >1 mg/kg

ORTHOGRAPHIC VIEW FROM SOUTHWEST SHOWING PCBs

ORTHOGRAPHIC VIEW FROM SOUTHEAST SHOWING PCBs

CROSS SECTION LOCATIONS
SCALE: 1"=200'

It should be noted that all of samples containing concentrations above 1 mg/kg were collected from depths greater than 3 feet bgs.
