**Re: Remedial Investigation Report - Final
688-700 Court Street Site, Brooklyn, New York
Amended Order on Consent, Case No.: D2-03811-10-08**

REMEDIAL INVESTIGATION REPORT NYSDEC SITE NO. 224145

Chemtura Corporation
688-700 Court Street
Brooklyn, New York

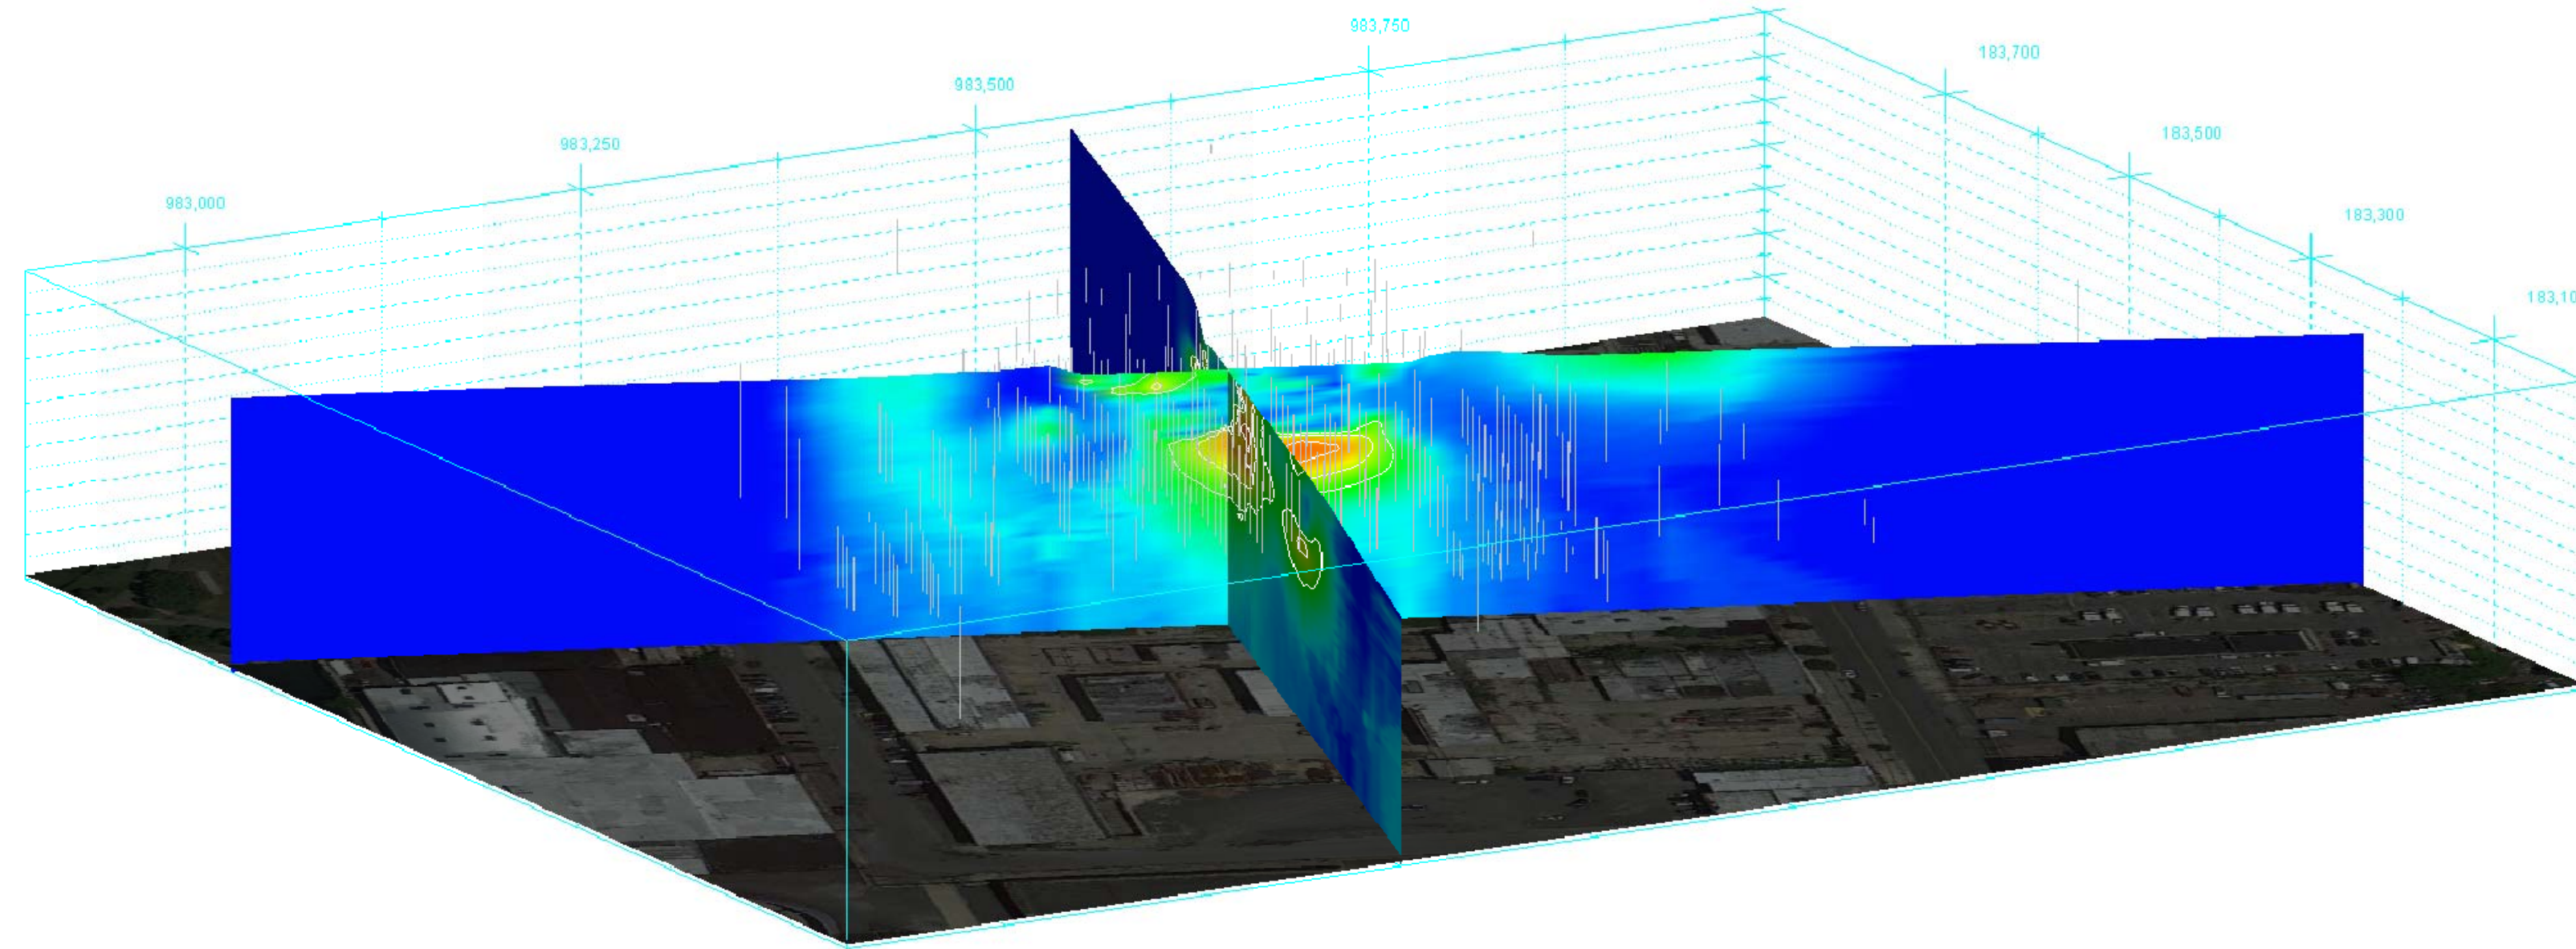
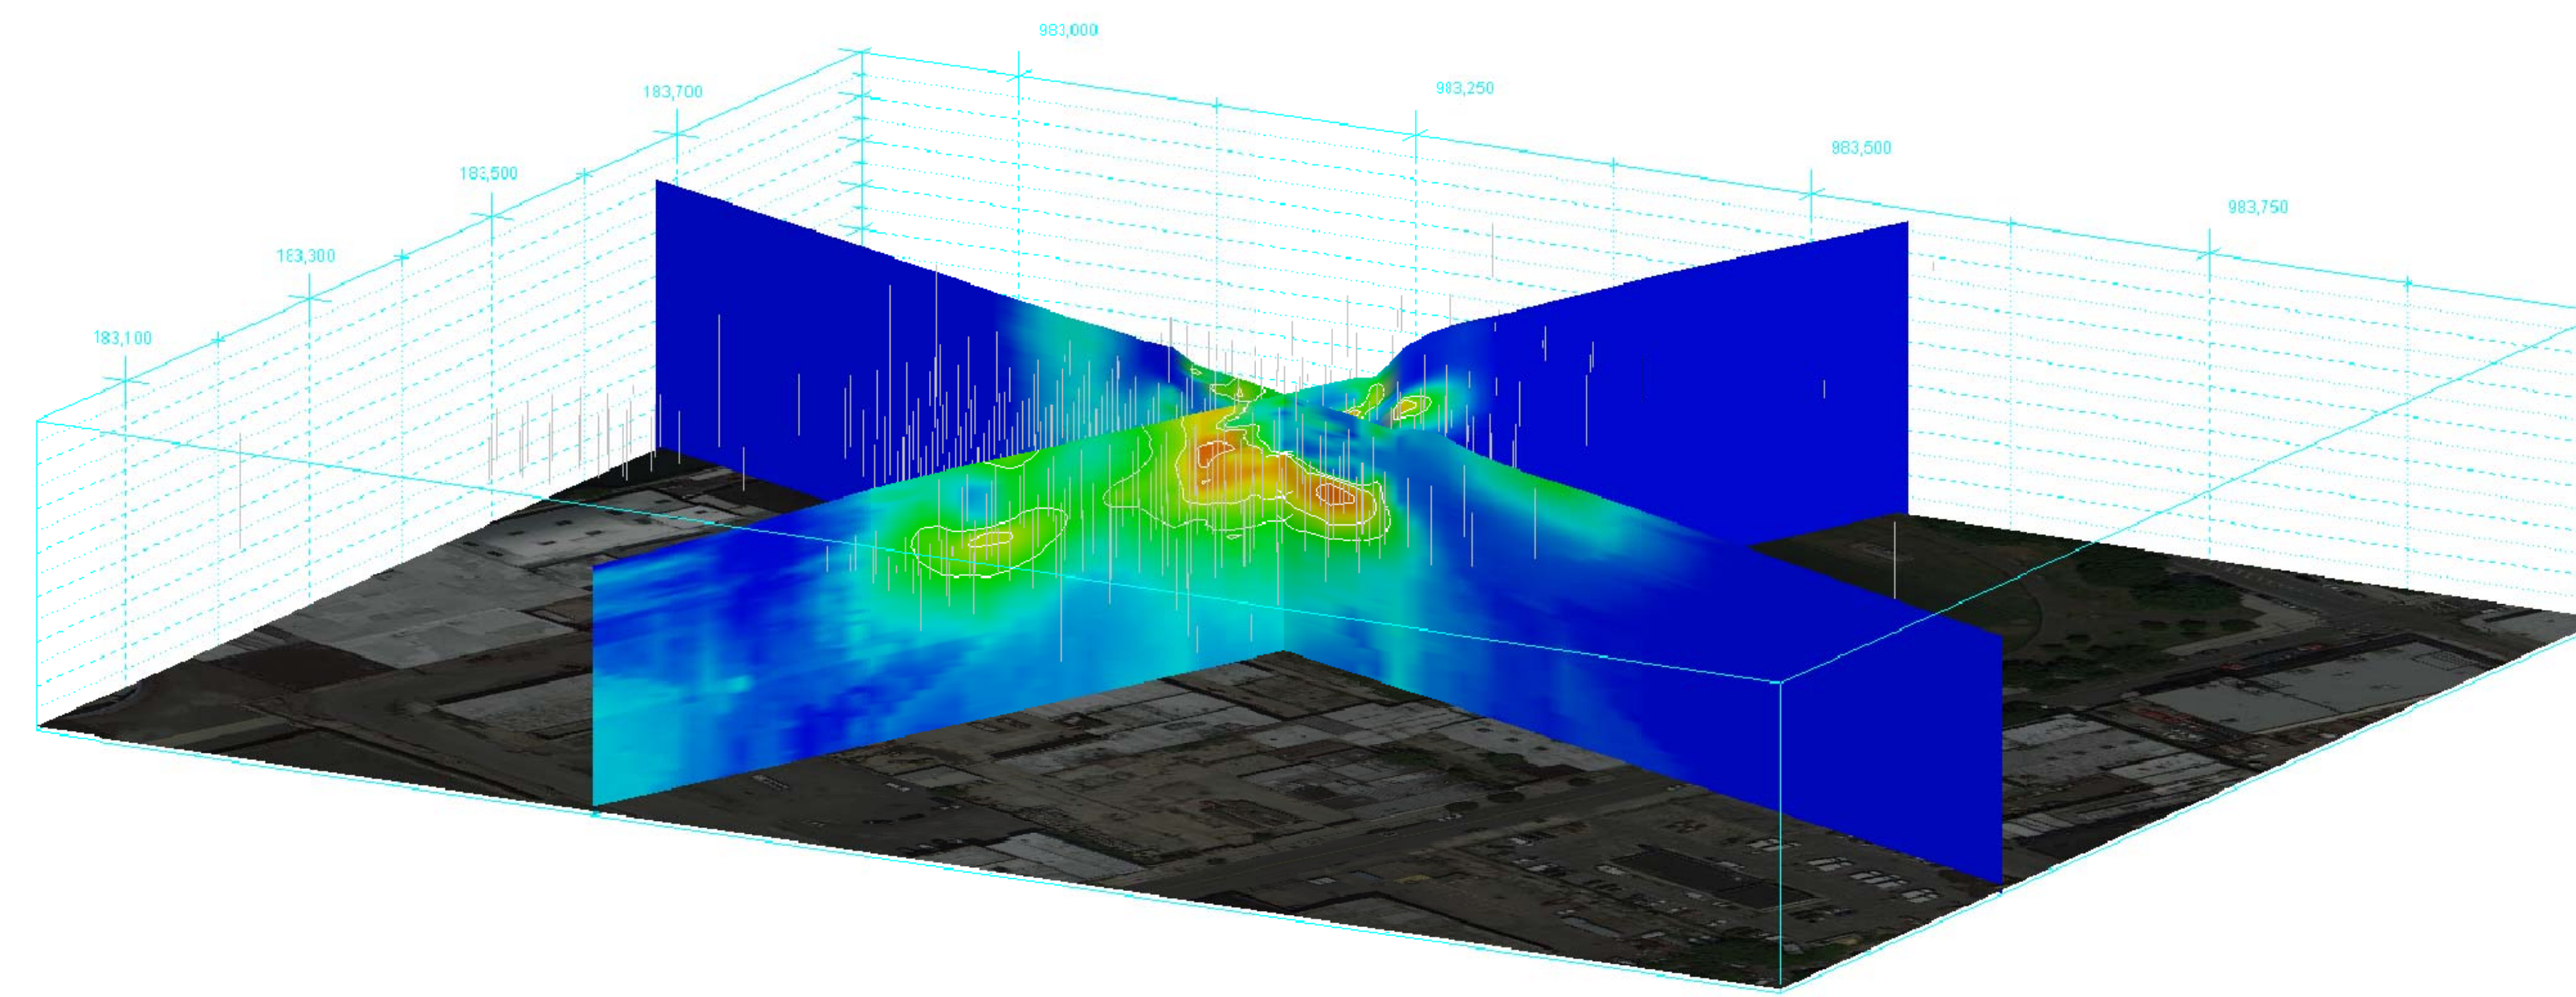
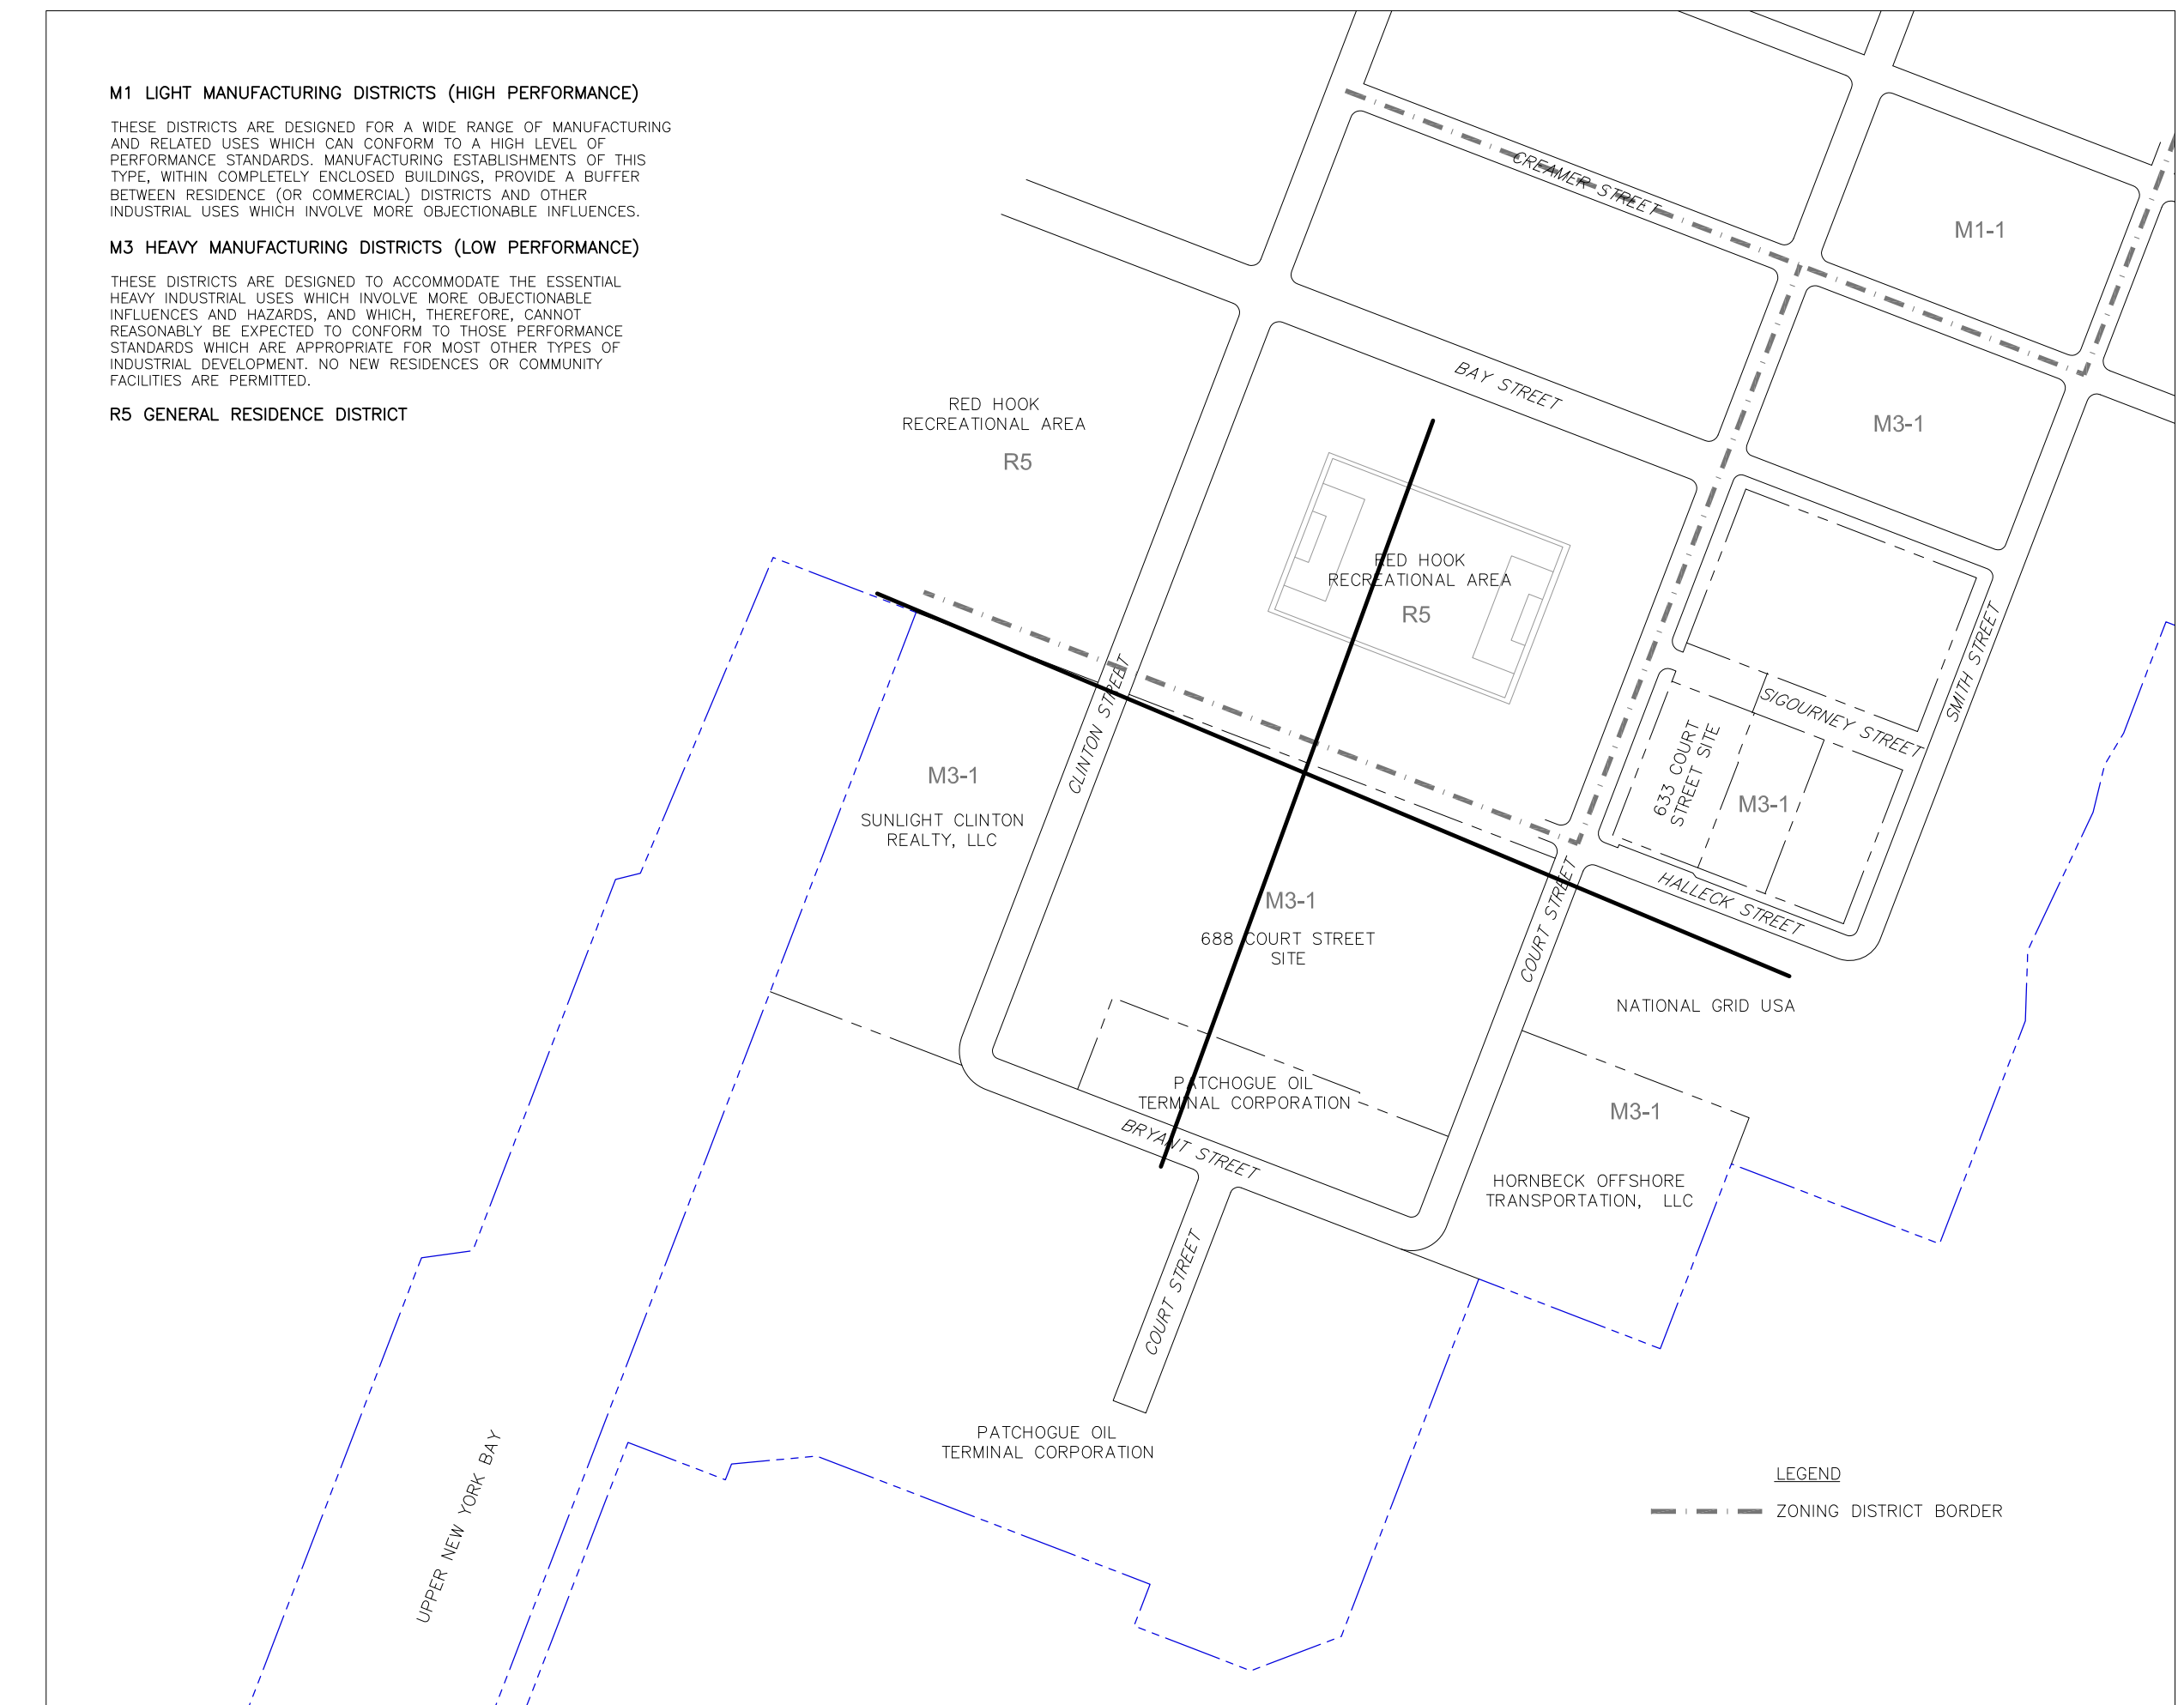
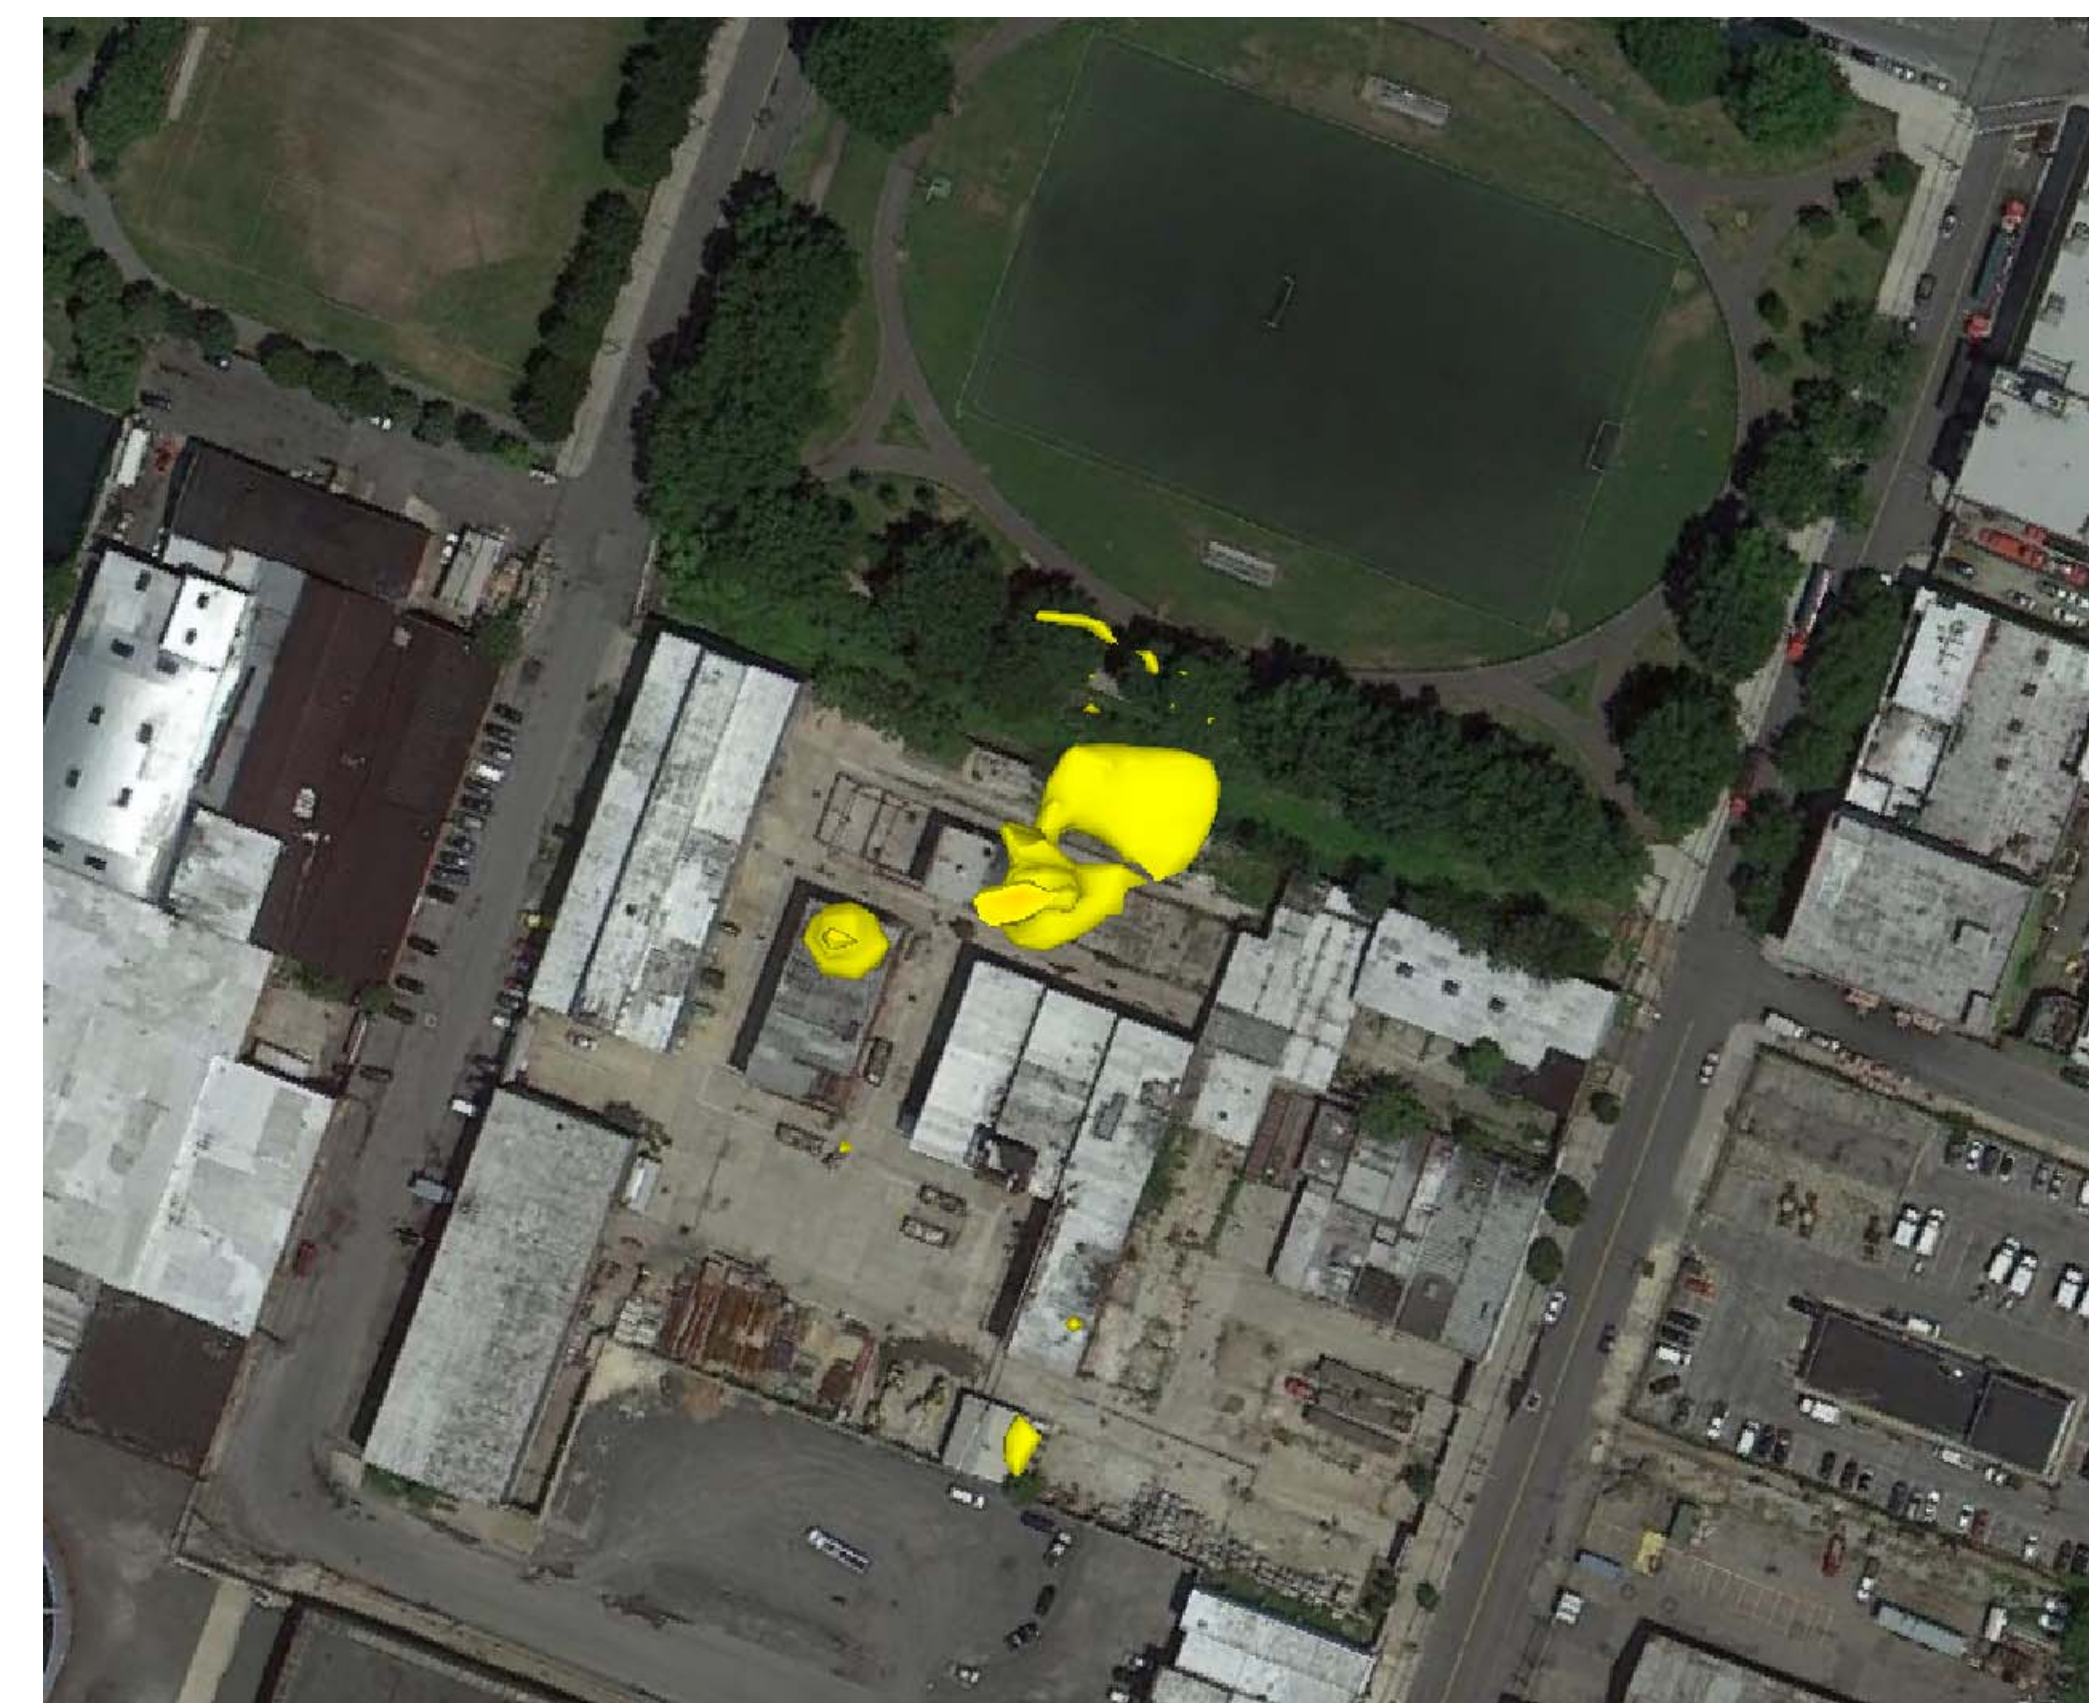
PLAN VIEW SHOWING PCB >25 mg/kg

ORTHOGRAPHIC VIEW FROM SOUTHWEST SHOWING PCBs

ORTHOGRAPHIC VIEW FROM SOUTHEAST SHOWING PCBs

CROSS SECTION LOCATIONS
SCALE: 1"=200'

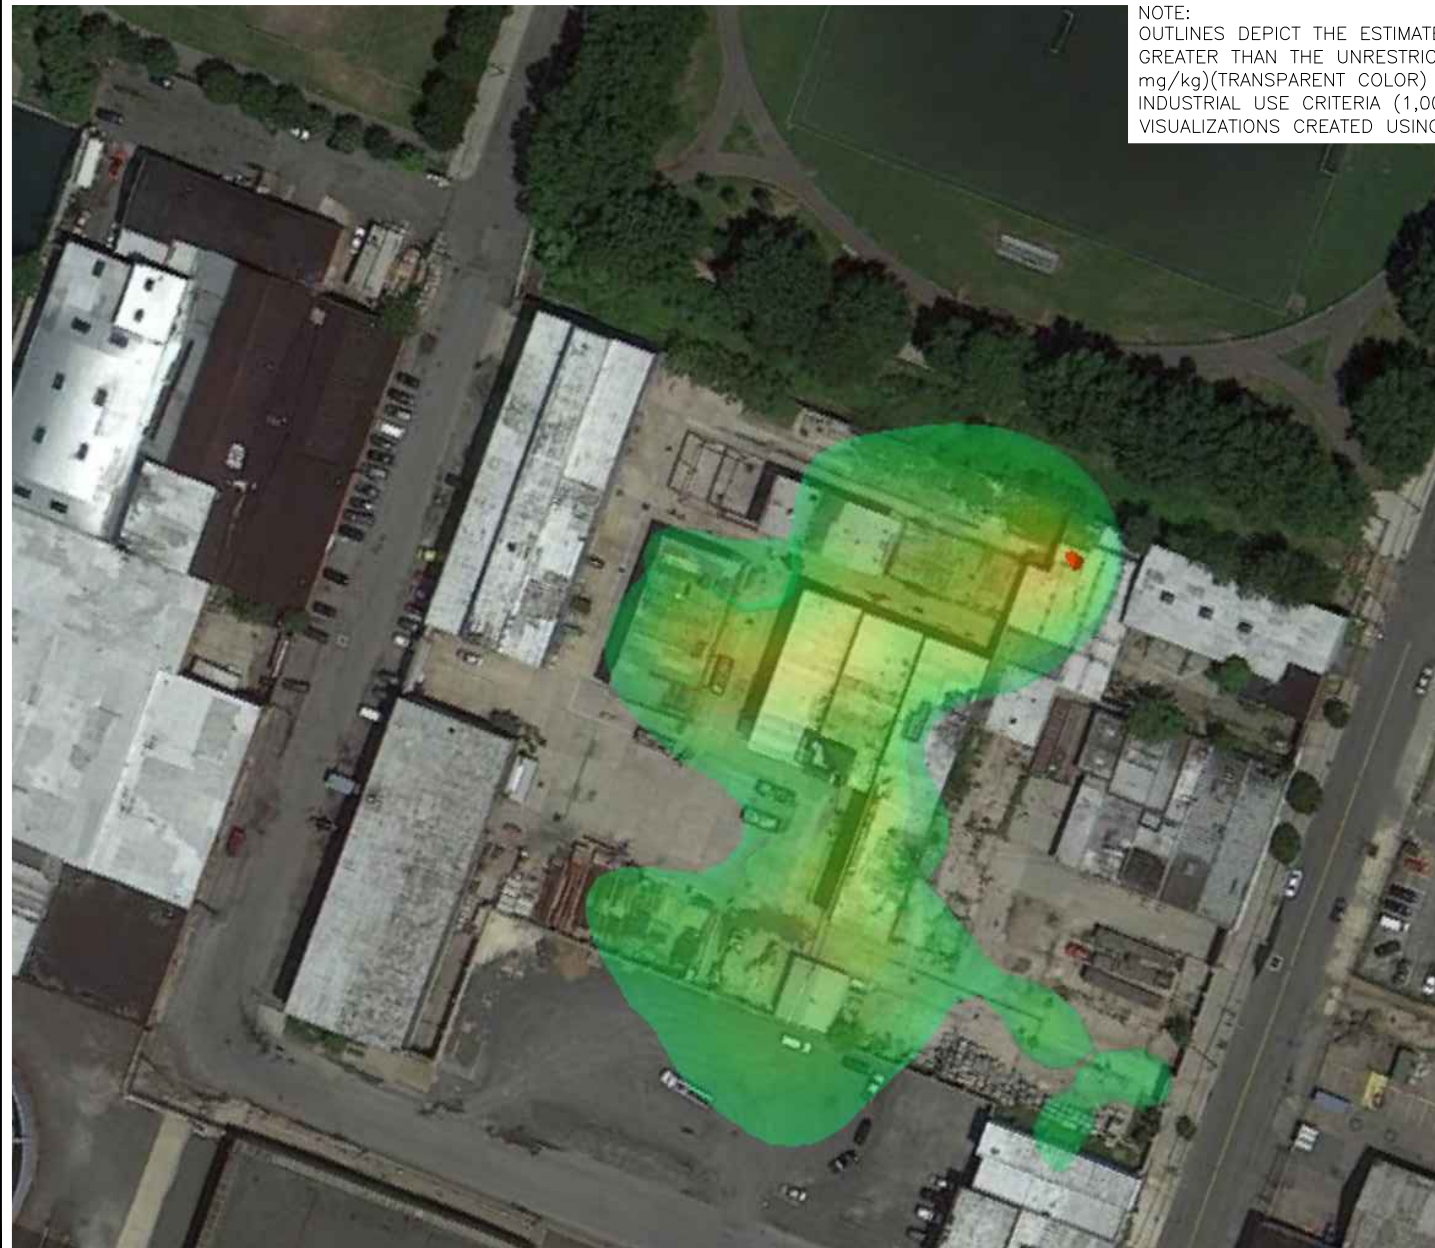
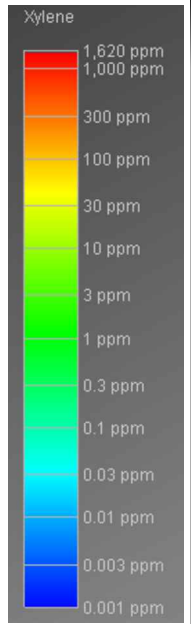
NOTE:
 OUTLINES DEPICT THE ESTIMATED EXTENT OF XYLENES IN SOIL
 GREATER THAN THE UNRESTRICTED USE CRITERIA (0.26
 mg/kg)(TRANSPARENT COLOR) AND GREATER THAN THE
 INDUSTRIAL USE CRITERIA (1,000 mg/kg)(SOLID COLOR).
 VISUALIZATIONS CREATED USING EARTH VISION SOFTWARE (EVS).

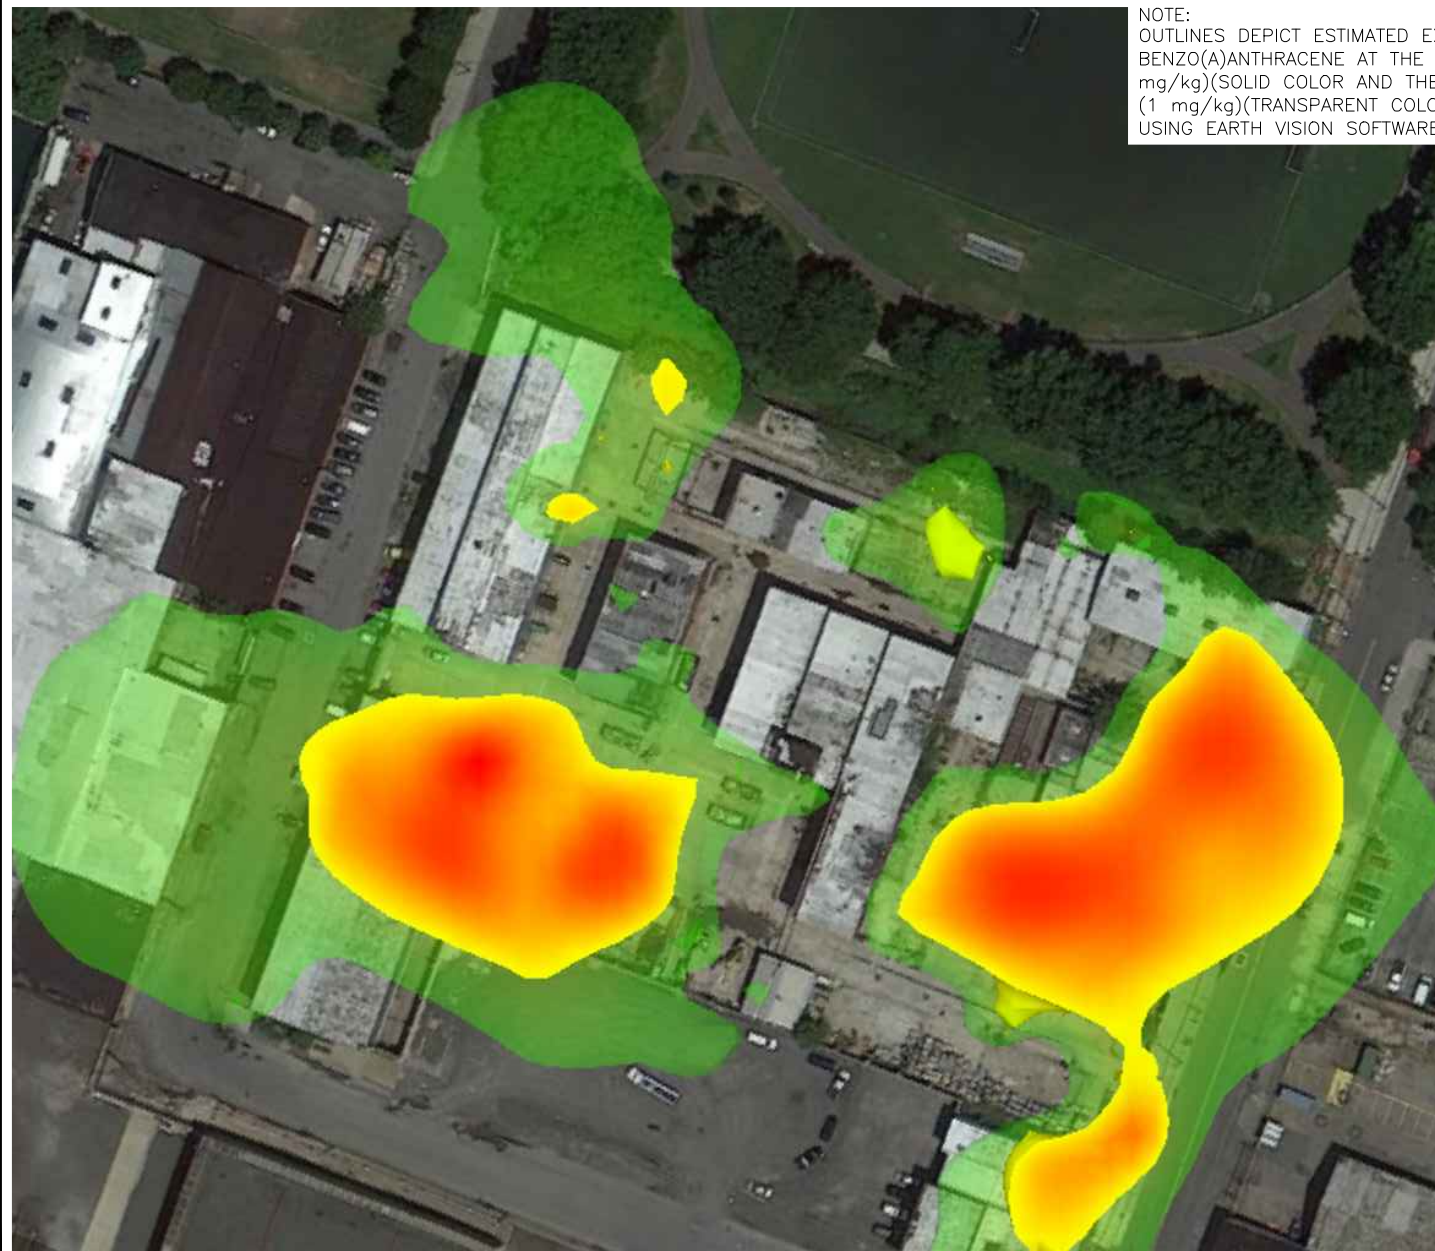
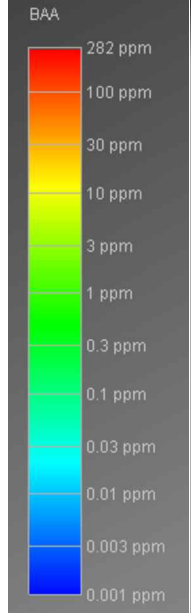
NOTE:
 OUTLINES DEPICT ESTIMATED EXTENT OF SOIL CONTAINING
 BENZO(A)ANTHRACENE AT THE INDUSTRIAL USE CRITERIA (11
 mg/kg)(SOLID COLOR AND THE UNRESTRICTED USE CRITERIA
 (1 mg/kg)(TRANSPARENT COLOR). VISUALIZATIONS CREATED
 USING EARTH VISION SOFTWARE (EVS).

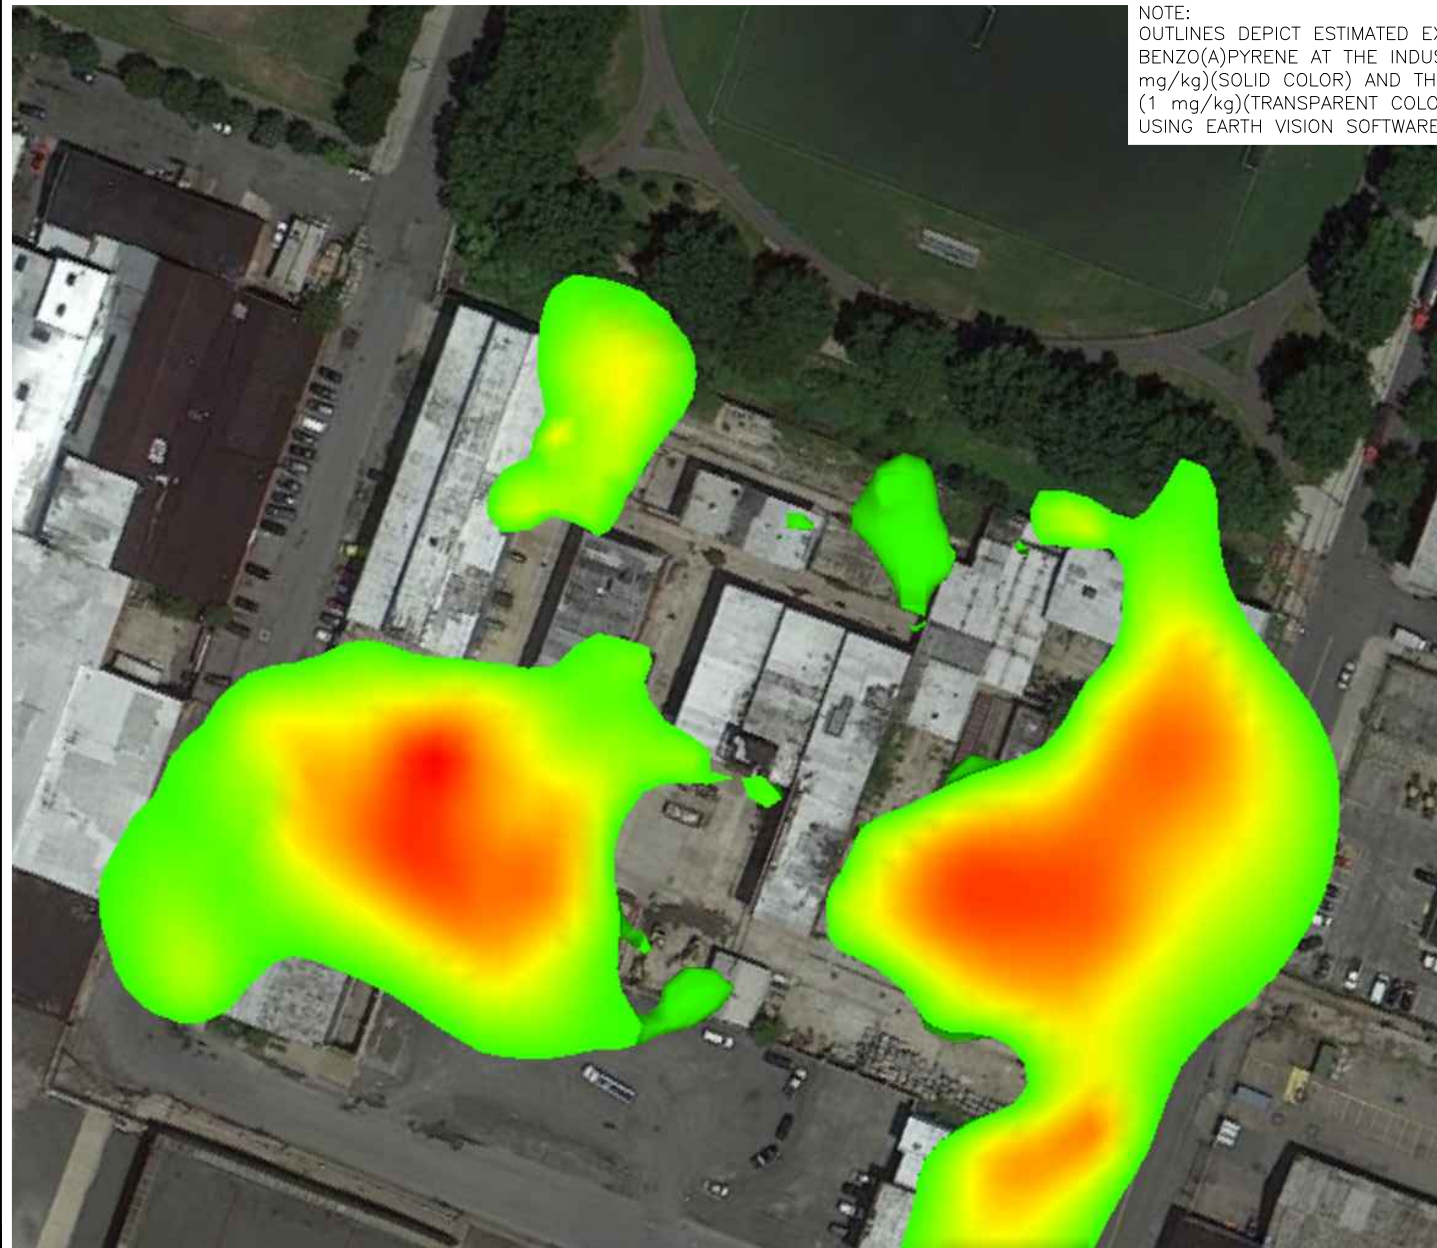
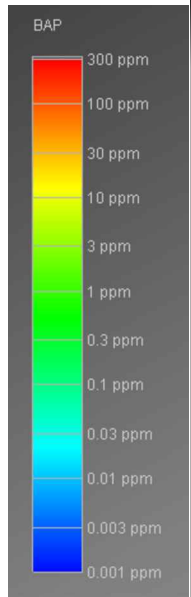
NOTE:
 OUTLINES DEPICT ESTIMATED EXTENT OF SOIL CONTAINING
 BENZO(A)PYRENE AT THE INDUSTRIAL USE CRITERIA (1.1
 mg/kg)(SOLID COLOR) AND THE UNRESTRICTED USE CRITERIA
 (1 mg/kg)(TRANSPARENT COLOR). VISUALIZATIONS CREATED
 USING EARTH VISION SOFTWARE (EVS).

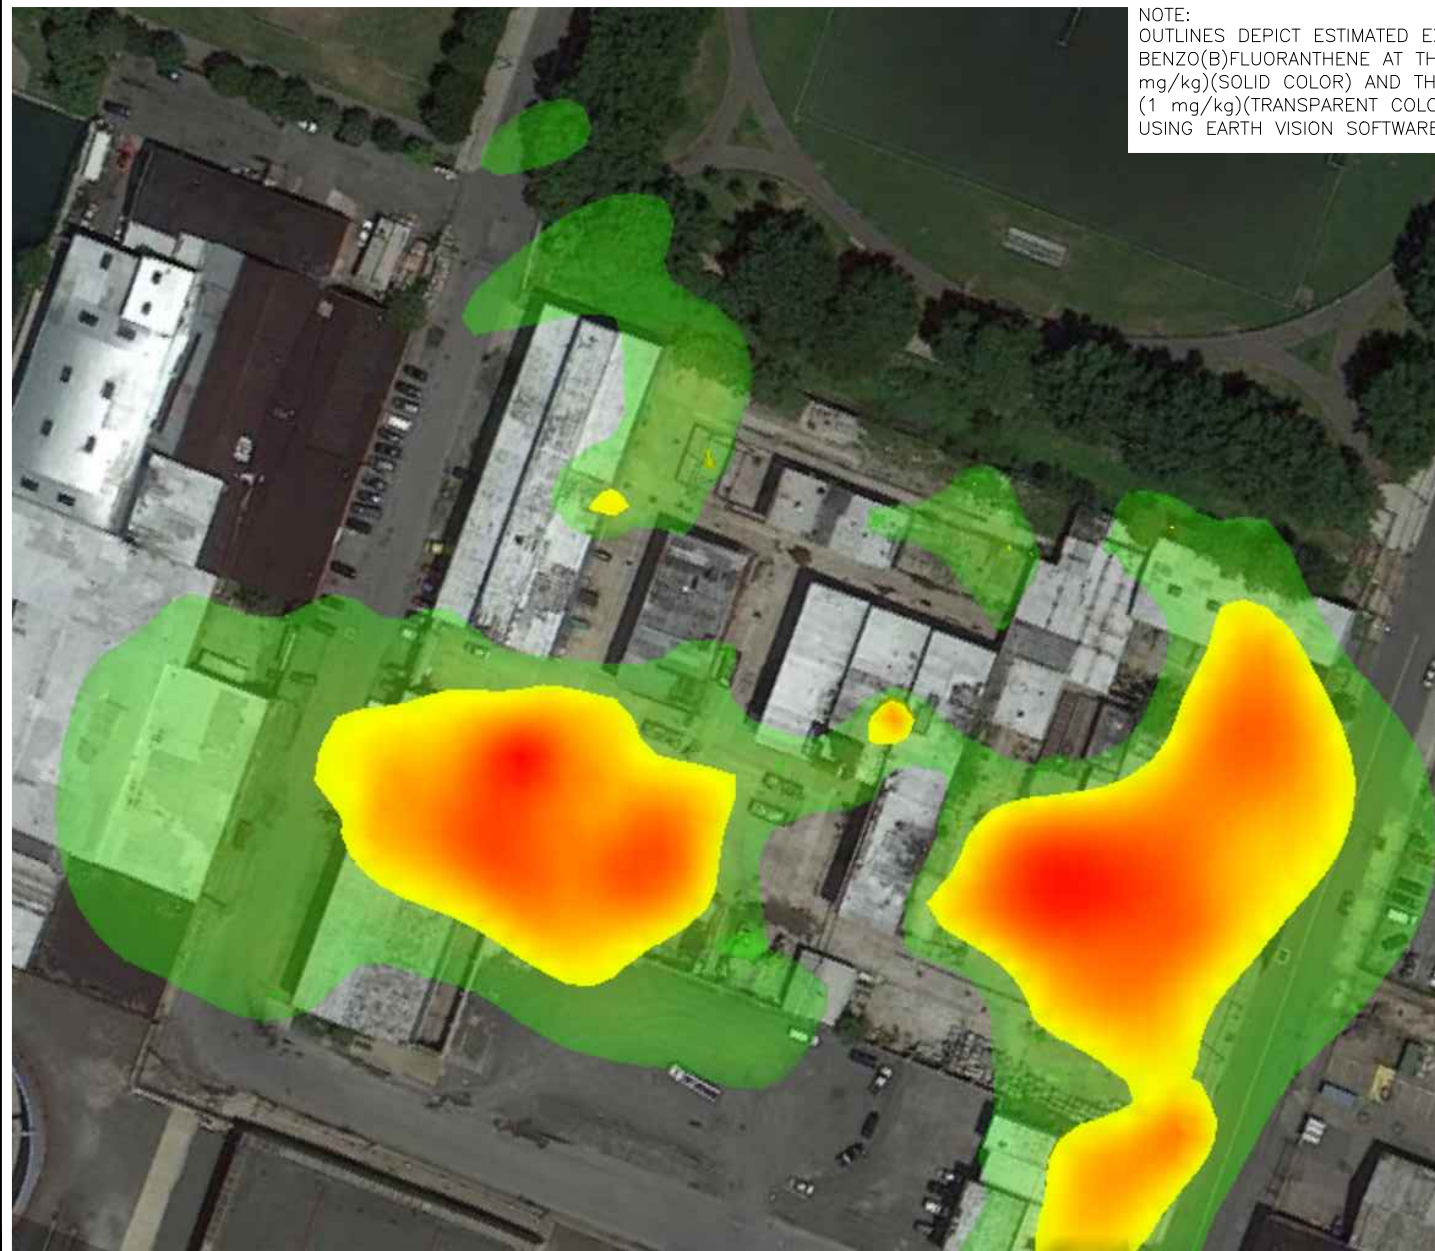
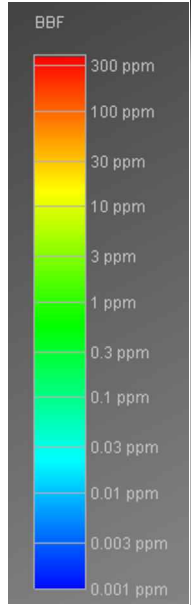
NOTE:
 OUTLINES DEPICT ESTIMATED EXTENT OF SOIL CONTAINING BENZO(B)FLUORANTHENE AT THE INDUSTRIAL USE CRITERIA (11 mg/kg)(SOLID COLOR) AND THE UNRESTRICTED USE CRITERIA (1 mg/kg)(TRANSPARENT COLOR). VISUALIZATIONS CREATED USING EARTH VISION SOFTWARE (EVS).

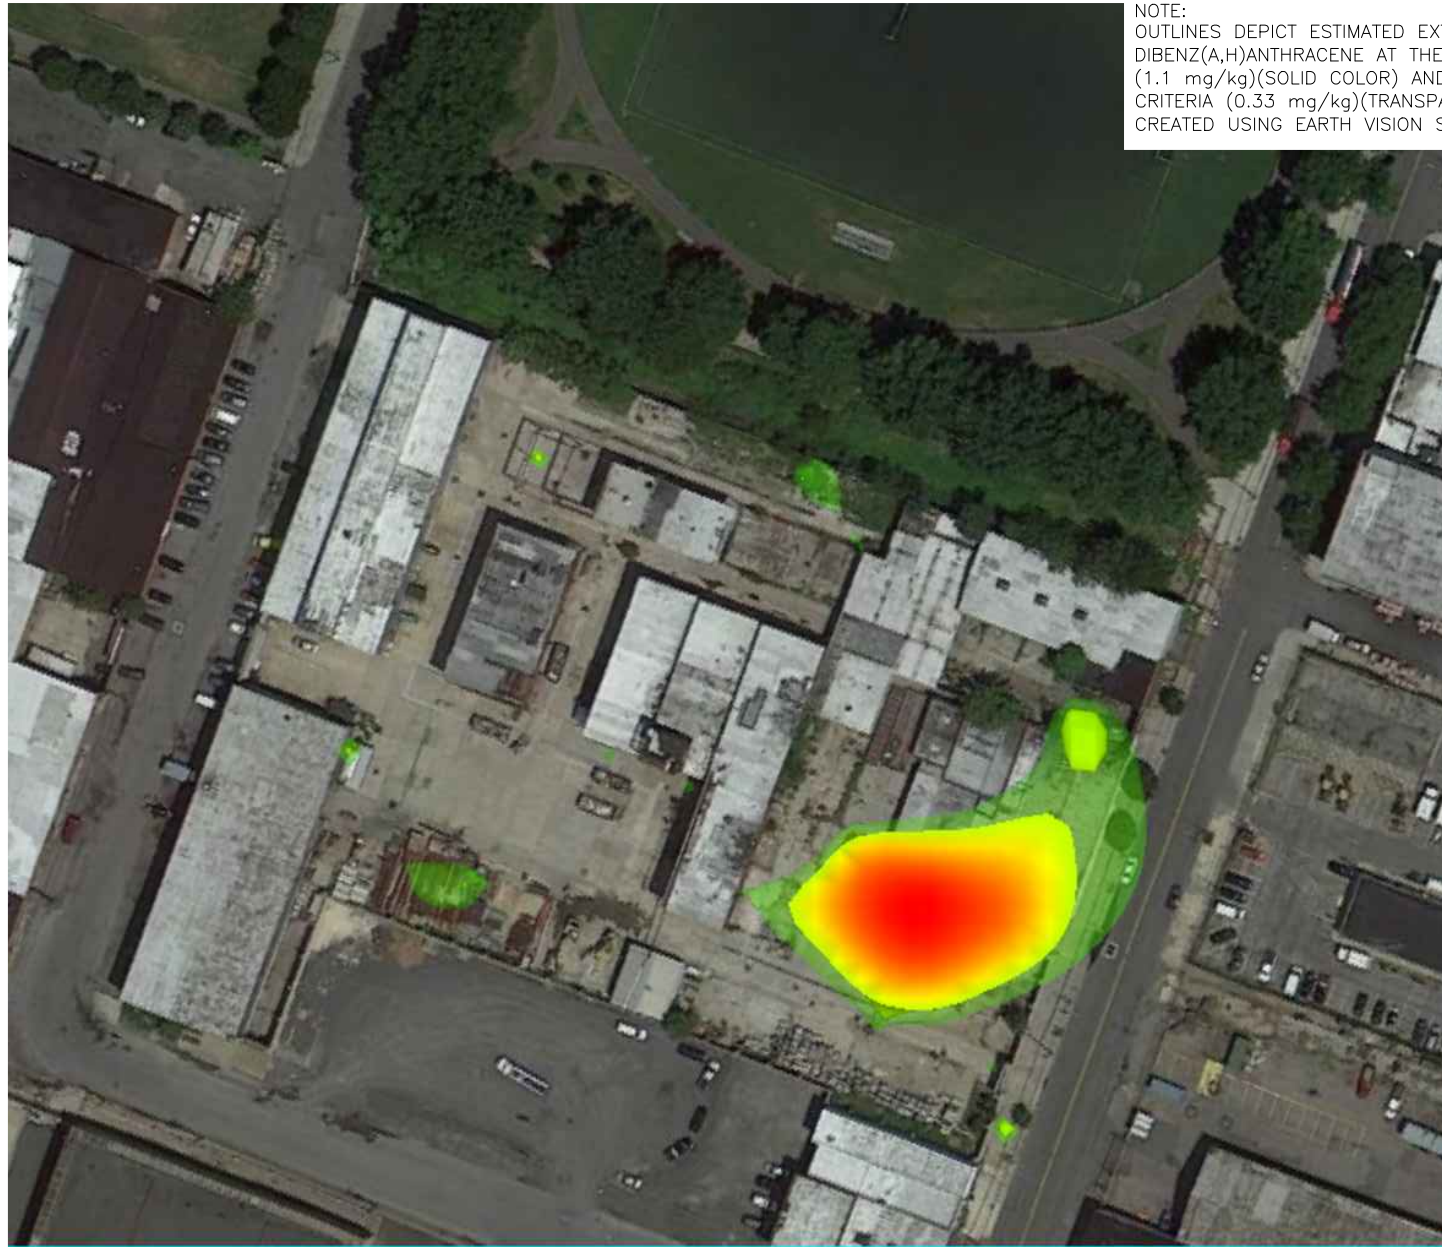
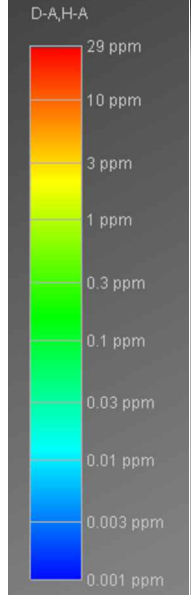
NOTE:
 OUTLINES DEPICT ESTIMATED EXTENT OF SOIL CONTAINING
 DIBENZ(A,H)ANTHRACENE AT THE INDUSTRIAL USE CRITERIA
 (1.1 mg/kg)(SOLID COLOR) AND THE UNRESTRICTED USE
 CRITERIA (0.33 mg/kg)(TRANSPARENT COLOR). VISUALIZATIONS
 CREATED USING EARTH VISION SOFTWARE (EVS).
