**Re: Remedial Investigation Report - Final
688-700 Court Street Site, Brooklyn, New York
Amended Order on Consent, Case No.: D2-03811-10-08**

REMEDIAL INVESTIGATION REPORT NYSDEC SITE NO. 224145

Chemtura Corporation
688-700 Court Street
Brooklyn, New York

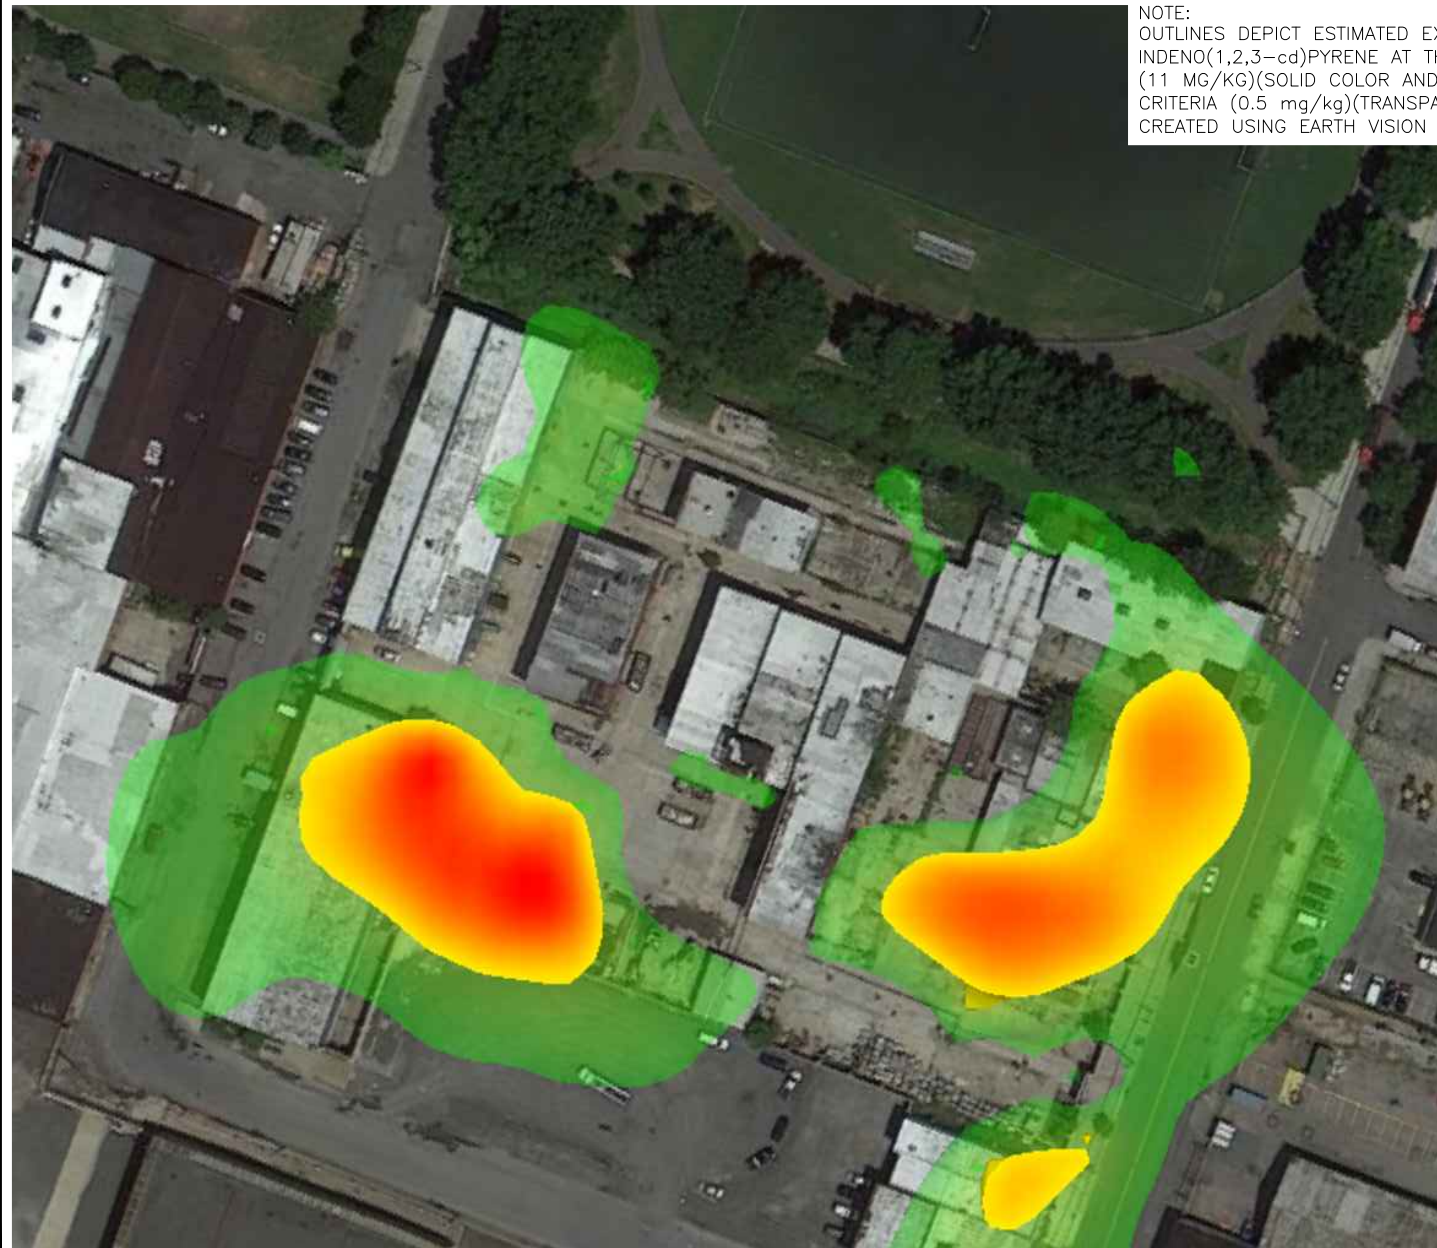
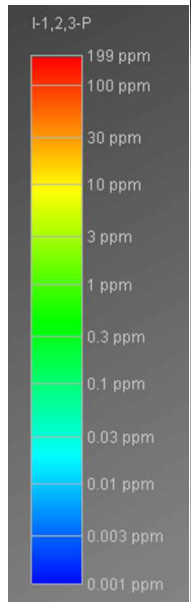
NOTE:
 OUTLINES DEPICT ESTIMATED EXTENT OF SOIL CONTAINING
 INDENO(1,2,3-cd)PYRENE AT THE INDUSTRIAL USE CRITERIA
 (11 MG/KG)(SOLID COLOR AND THE UNRESTRICTED USE
 CRITERIA (0.5 mg/kg)(TRANSPARENT COLOR). VISUALIZATIONS
 CREATED USING EARTH VISION SOFTWARE (EVS).

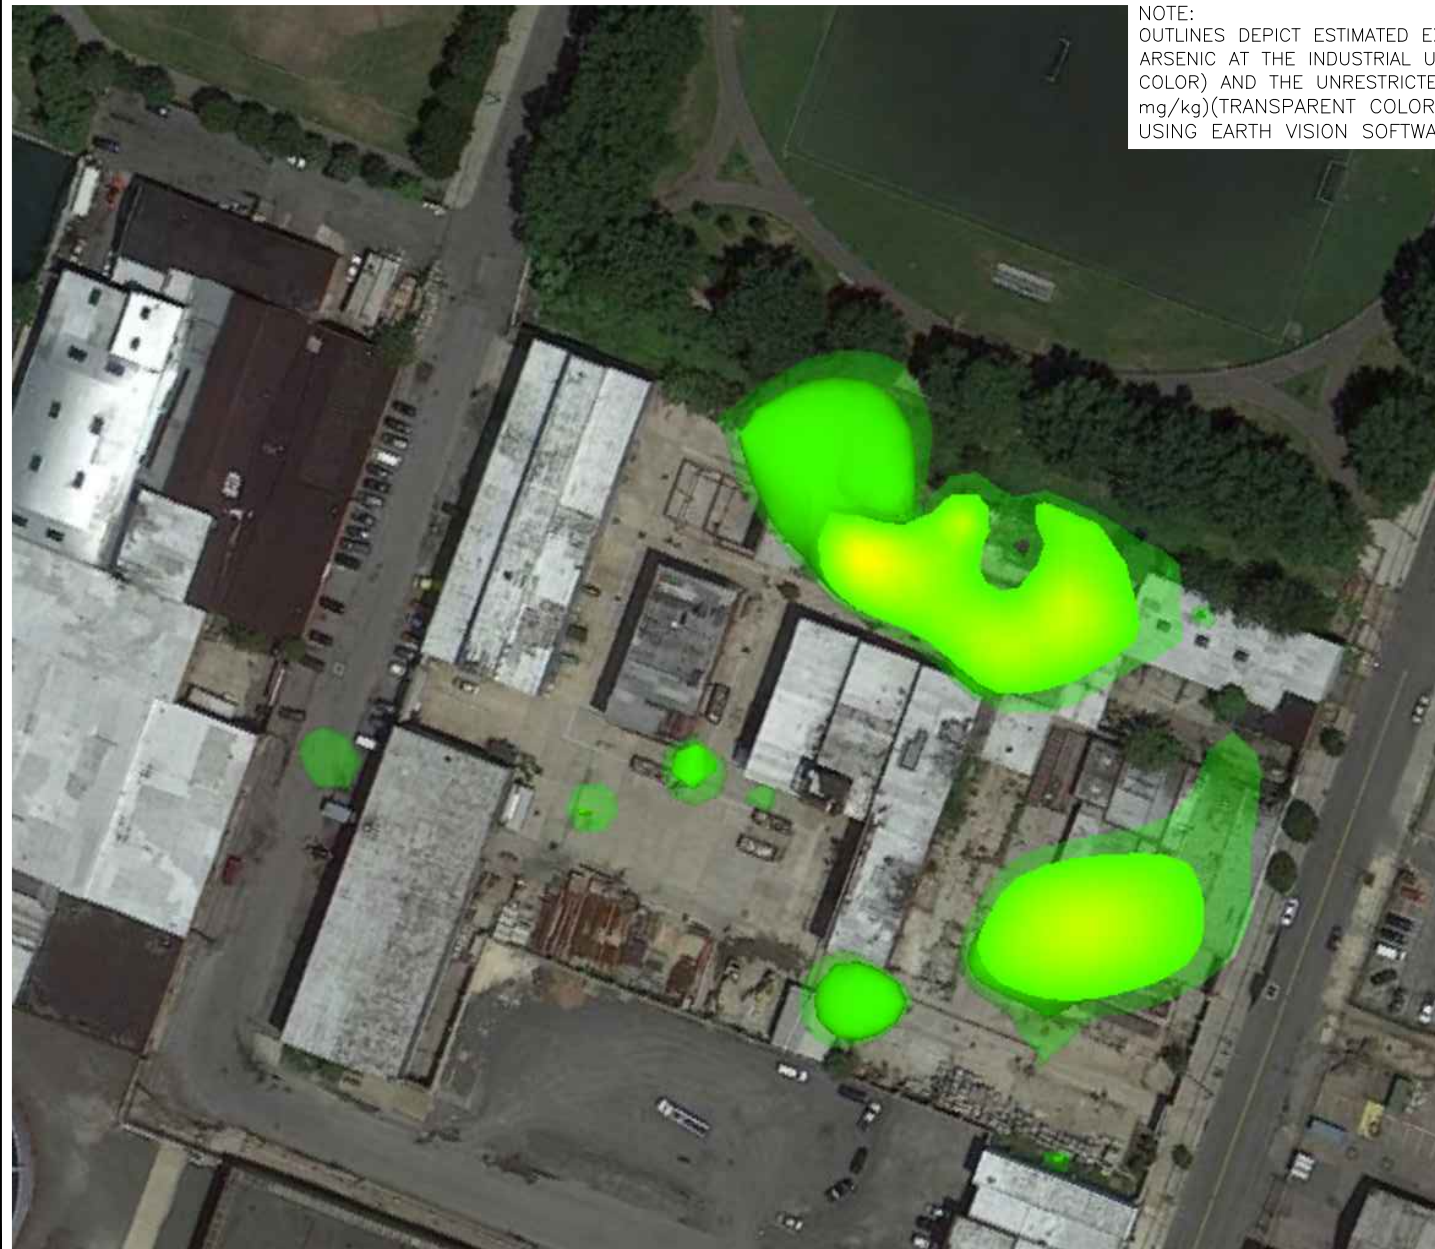
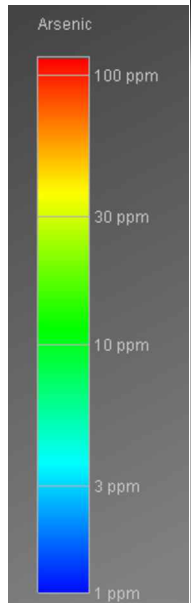
NOTE:
 OUTLINES DEPICT ESTIMATED EXTENT OF SOIL CONTAINING ARSENIC AT THE INDUSTRIAL USE CRITERIA (16 mg/kg)(SOLID COLOR) AND THE UNRESTRICTED USE CRITERIA (13 mg/kg)(TRANSPARENT COLOR). VISUALIZATIONS CREATED USING EARTH VISION SOFTWARE (EVS).

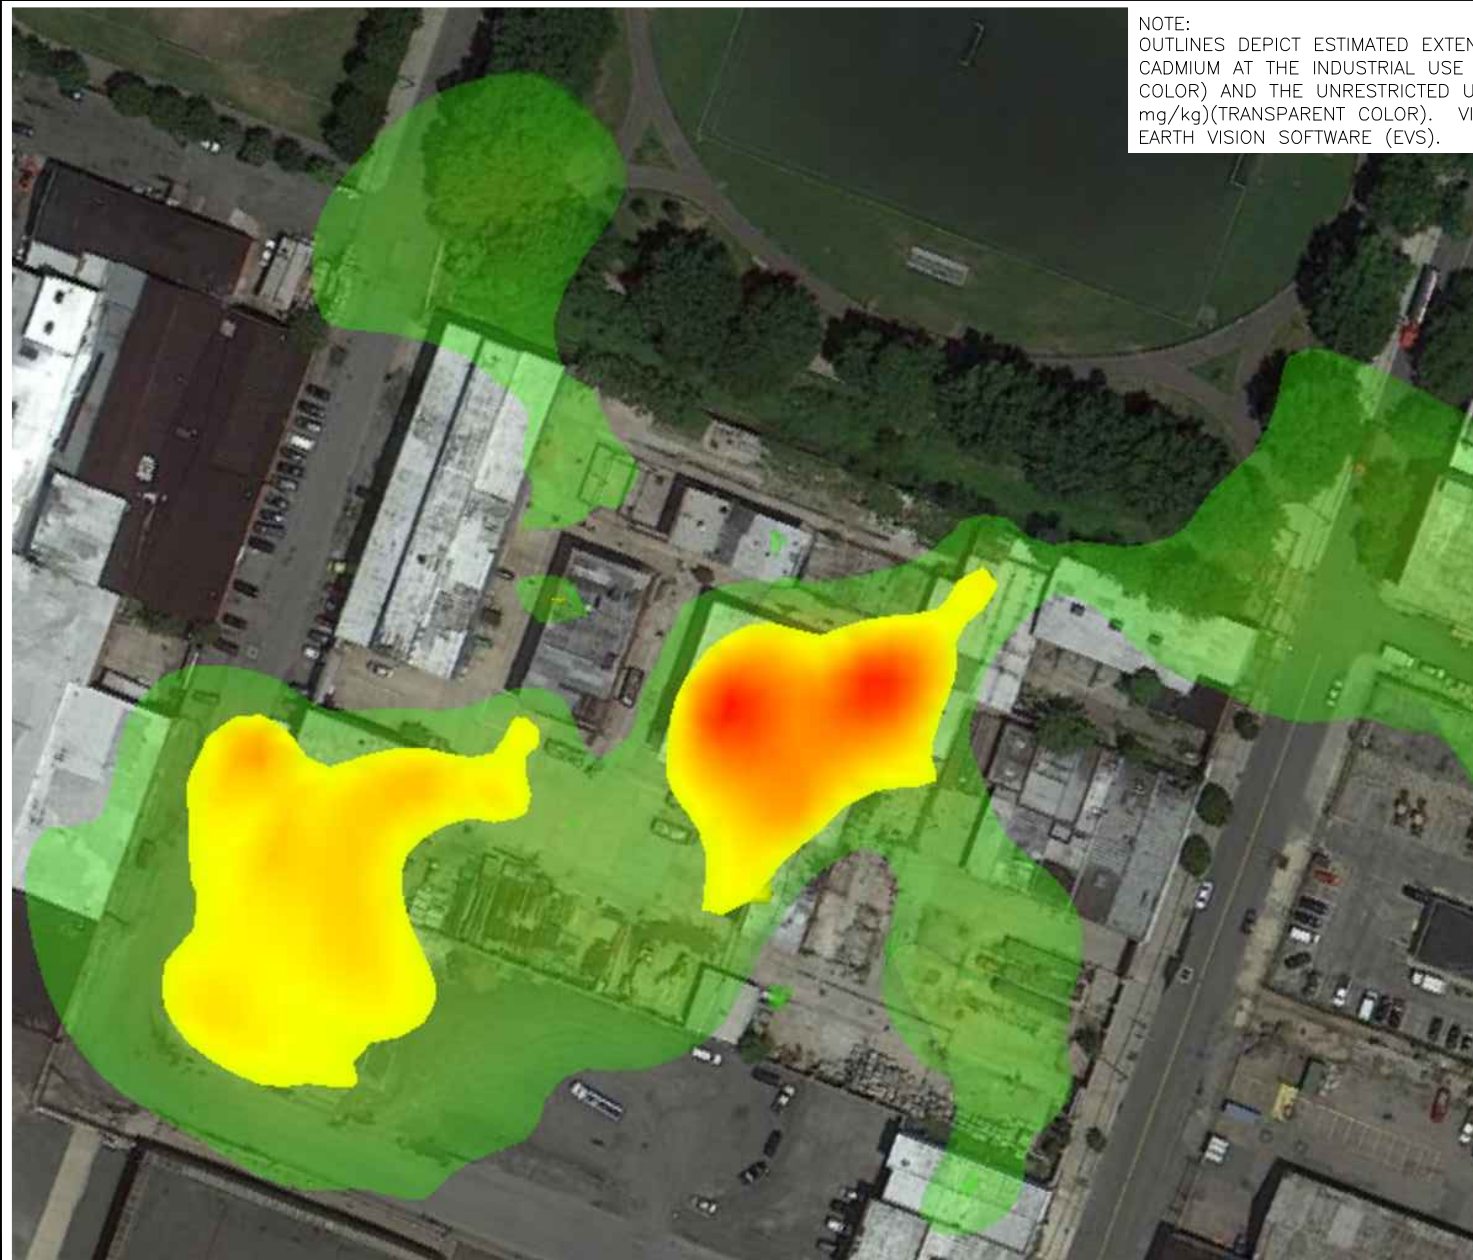
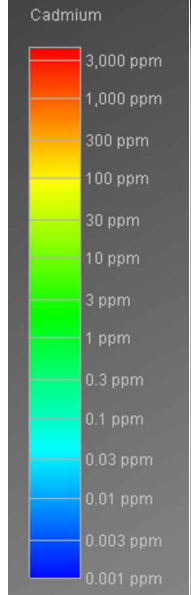
NOTE:
 OUTLINES DEPICT ESTIMATED EXTENT OF SOIL CONTAINING
 CADMIUM AT THE INDUSTRIAL USE CRITERIA (60 mg/kg)(SOLID
 COLOR) AND THE UNRESTRICTED USE CRITERIA (4.3
 mg/kg)(TRANSPARENT COLOR). VISUALIZATIONS CREATED USING
 EARTH VISION SOFTWARE (EVS).

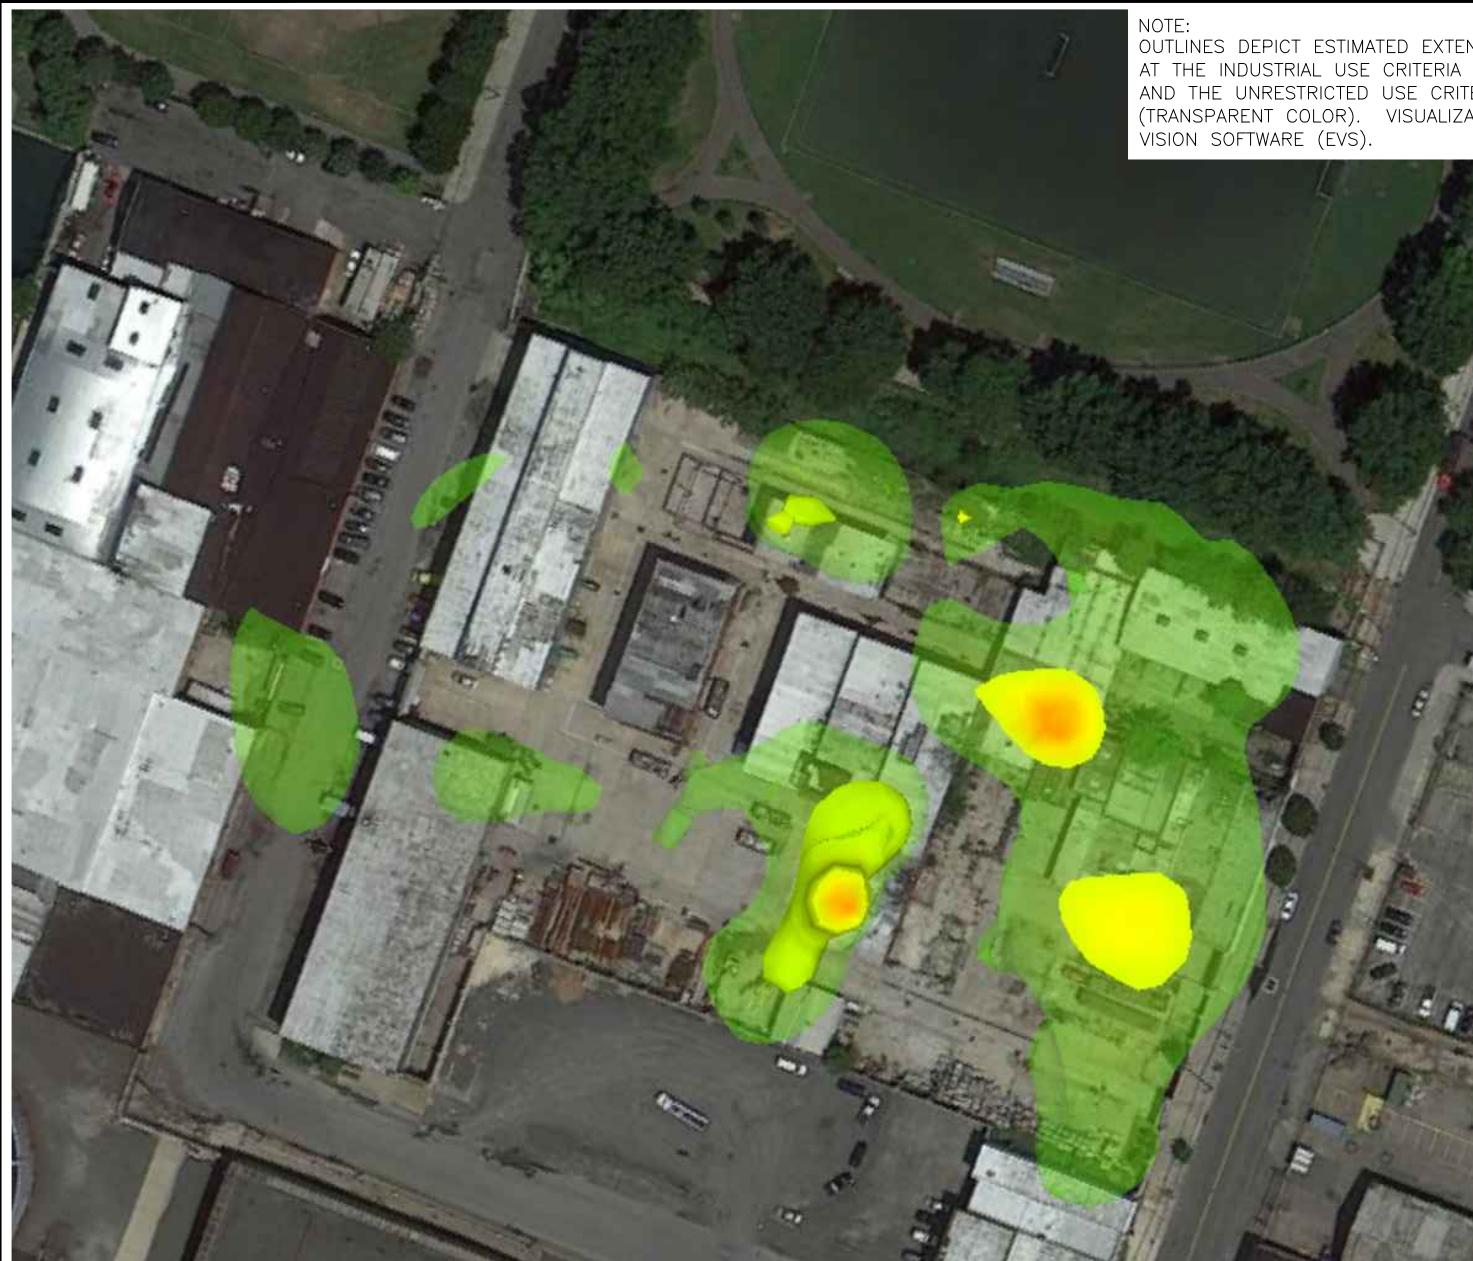
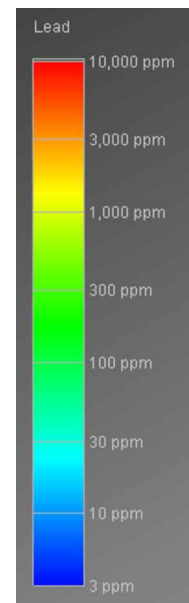
NOTE:
 OUTLINES DEPICT ESTIMATED EXTENT OF SOIL CONTAINING LEAD
 AT THE INDUSTRIAL USE CRITERIA (3,900 mg/kg)(SOLID COLOR)
 AND THE UNRESTRICTED USE CRITERIA (400 mg/kg)
 (TRANSPARENT COLOR). VISUALIZATIONS CREATED USING EARTH
 VISION SOFTWARE (EVS).

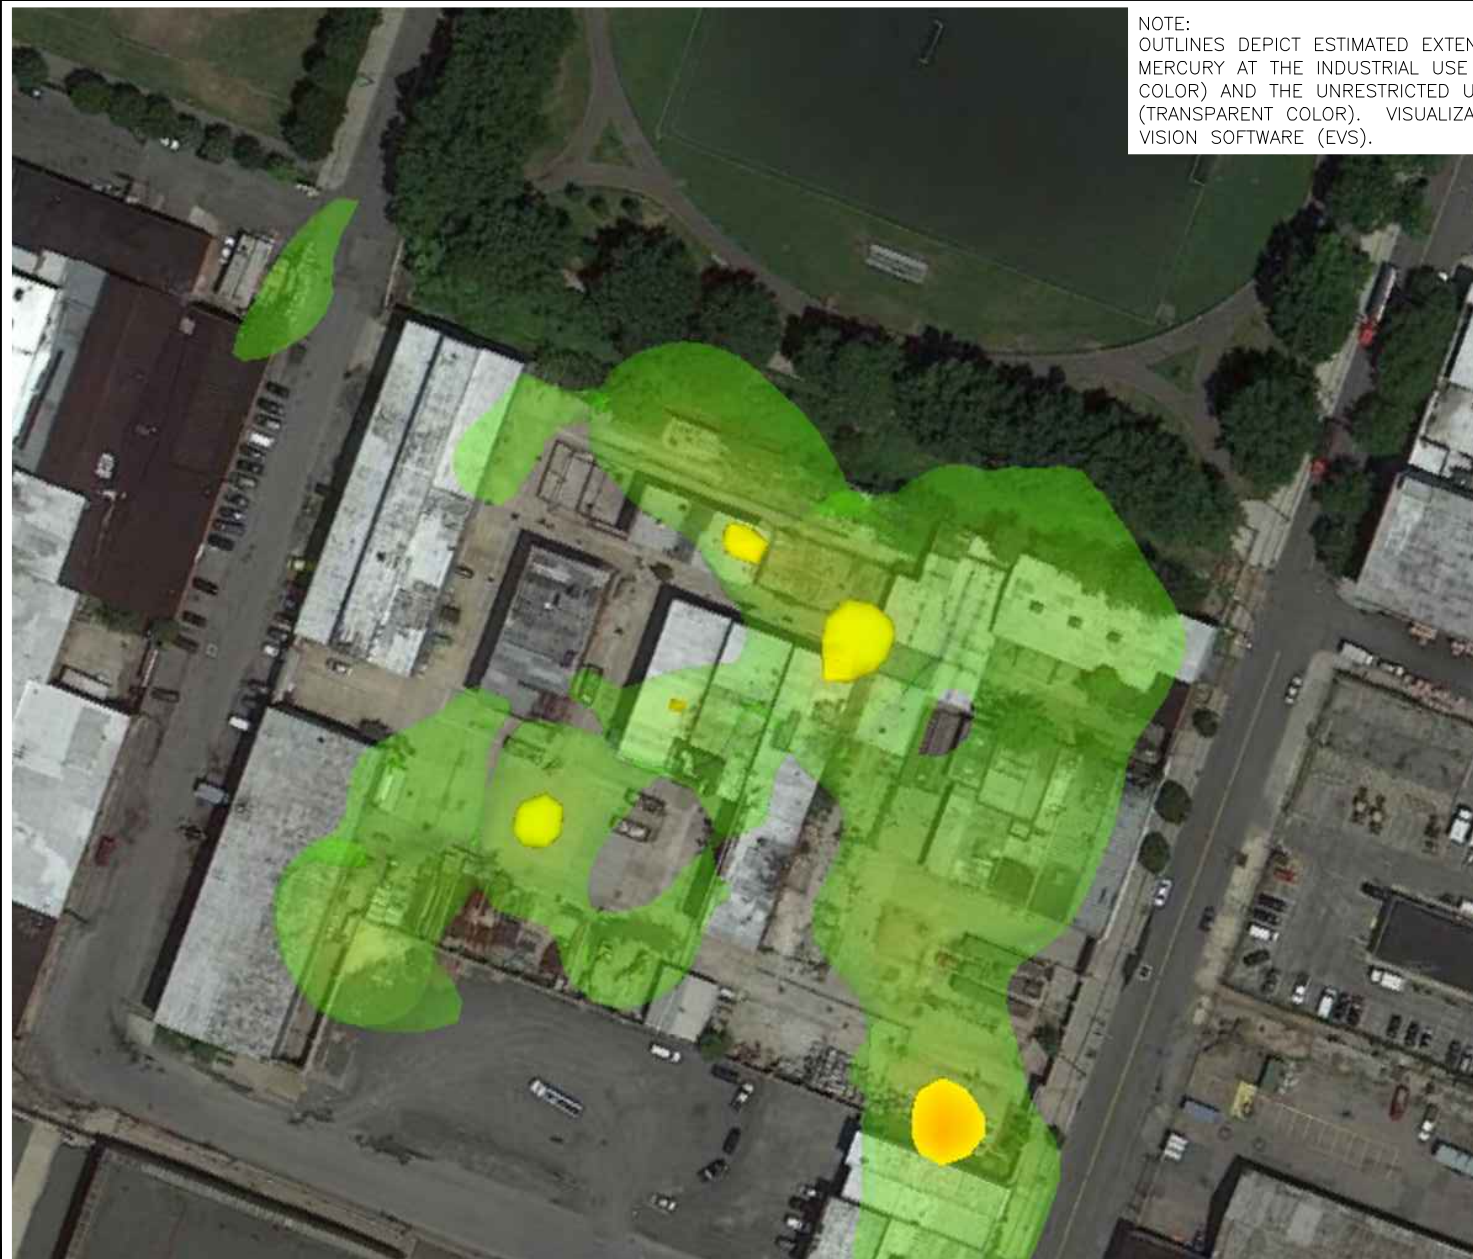
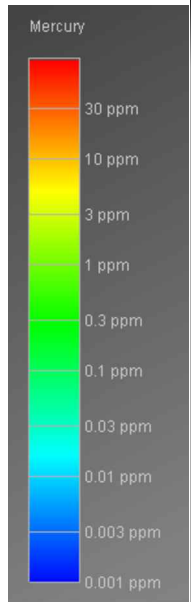
NOTE:
 OUTLINES DEPICT ESTIMATED EXTENT OF SOIL CONTAINING MERCURY AT THE INDUSTRIAL USE CRITERIA (5.7 mg/kg)(SOLID COLOR) AND THE UNRESTRICTED USE CRITERIA (0.81 mg/kg) (TRANSPARENT COLOR). VISUALIZATIONS CREATED USING EARTH VISION SOFTWARE (EVS).

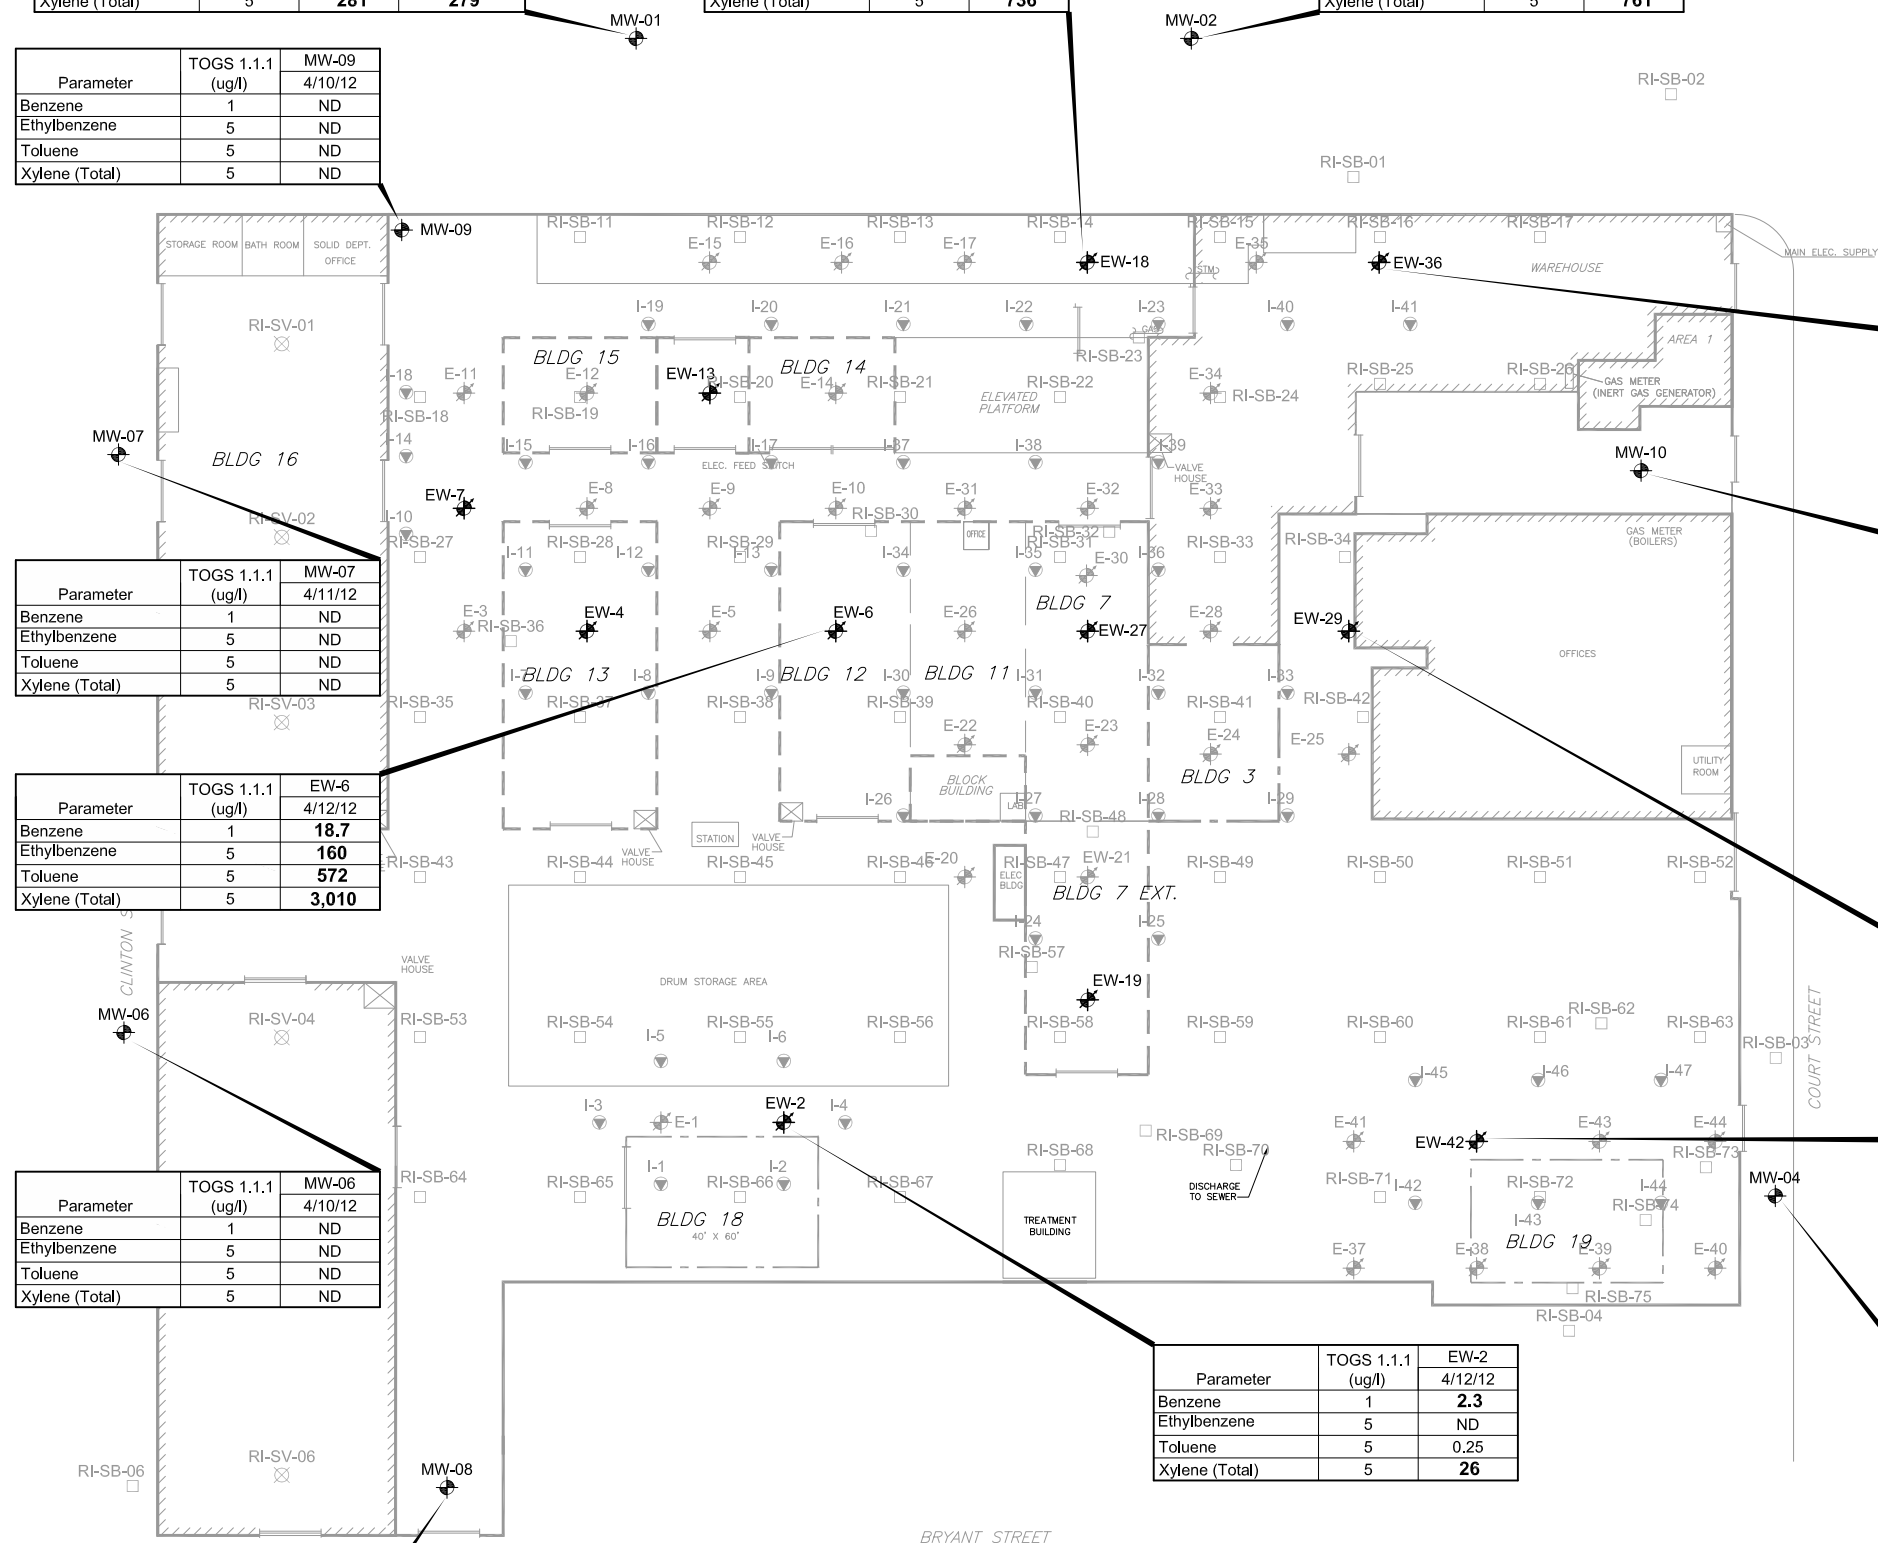
NOTE: GROUNDWATER CONCENTRATIONS ARE COMPARED AGAINST CLASS GA GROUNDWATER STANDARDS OR GUIDANCE VALUES PRESENTED IN "DIVISION OF WATER TECHNICAL AND OPERATIONAL GUIDANCE SERIES (1.1.1), AMBIENT WATER QUALITY STANDARDS AND GUIDANCE VALUES AND GROUNDWATER EFFLUENT LIMITATIONS", DATED JUNE 1998 (TOGS 1.1.1). BOLD FONT INDICATES VALUE EXCEEDS STANDARD OR GUIDANCE VALUE.

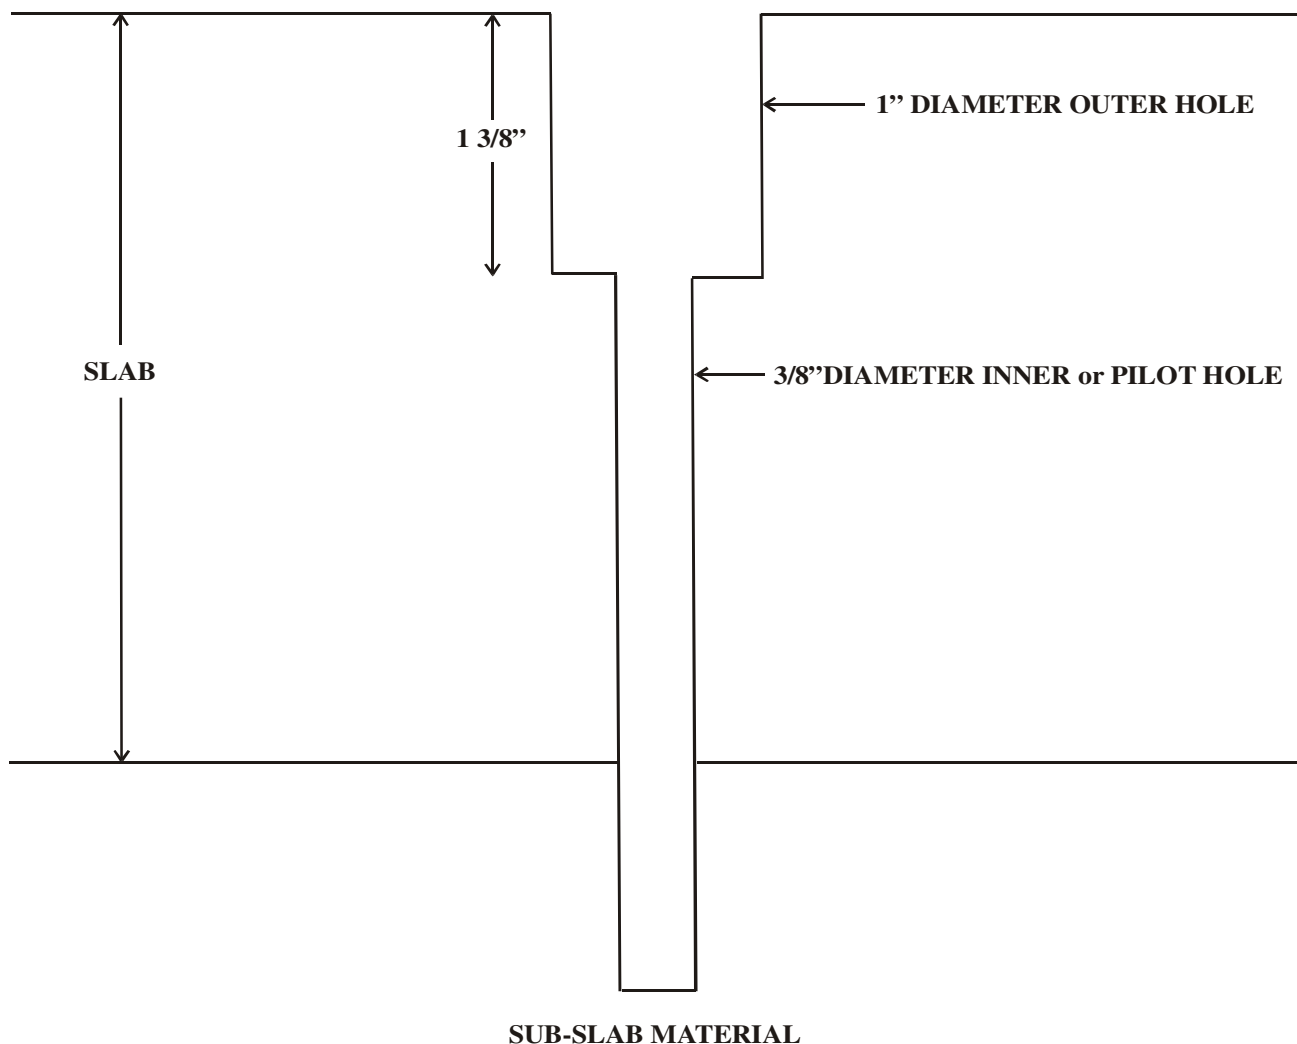
COMPLETED HOLE PRIOR to PROBE INSTALLATION

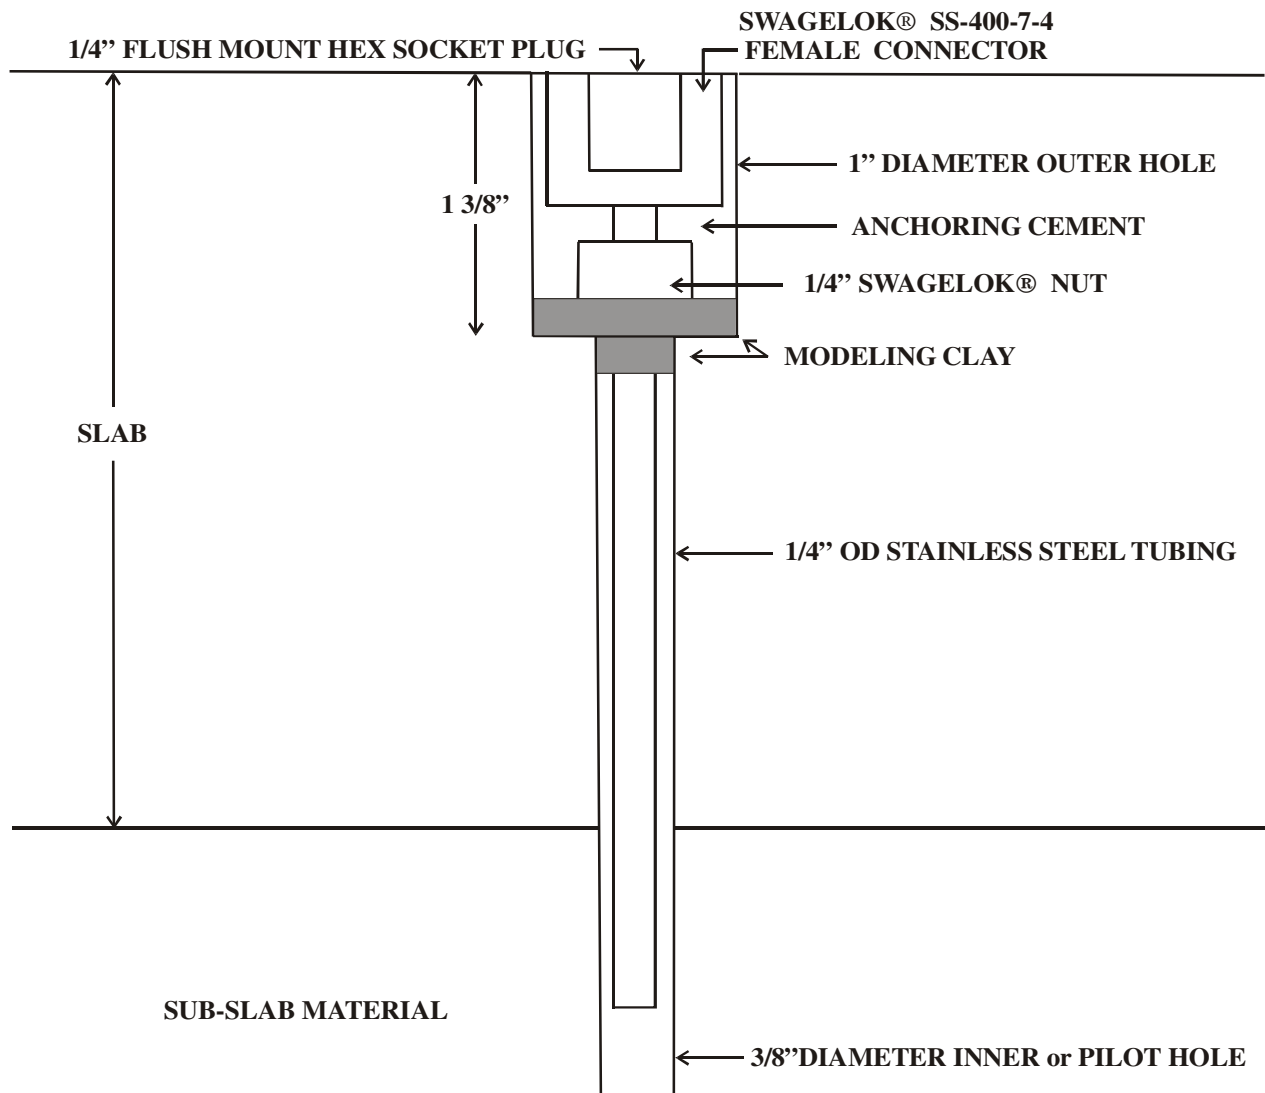
FIGURE 4
SOIL GAS PROBE INSTALLED

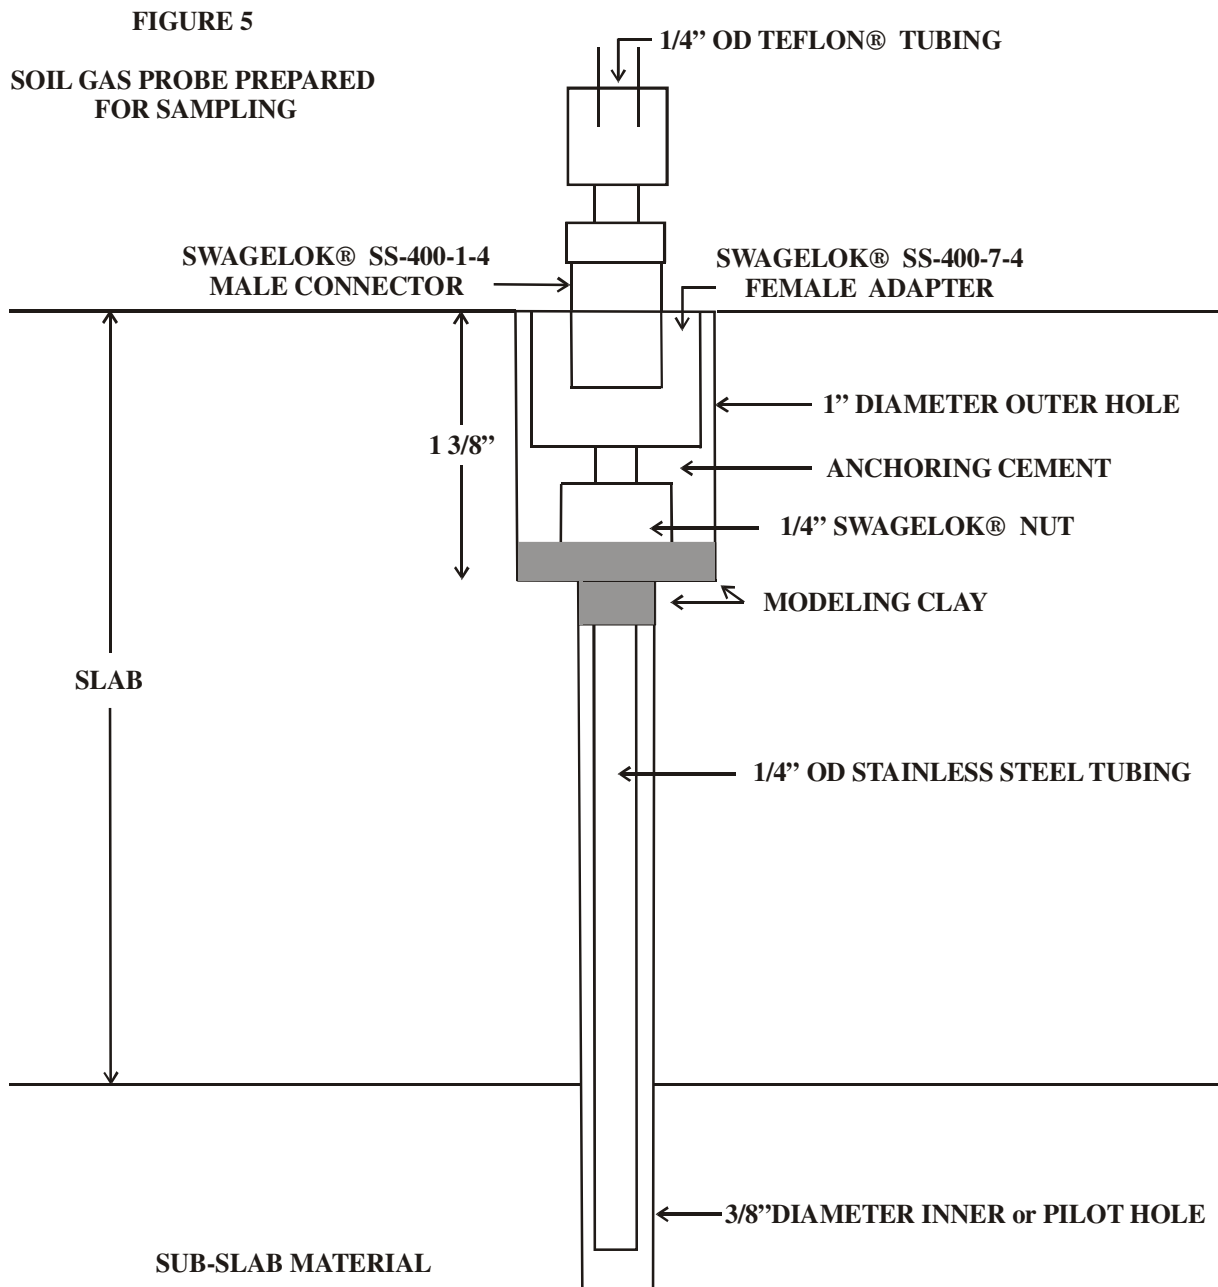
**CONSTRUCTION AND INSTALLATION OF PERMANENT SUB-SLAB
SOIL GAS WELLS**
