Project	Former Port Mobil Terminal –	Report No.	20	
	IRM #1			
NYSDEC Site	#243016	Date	10/18/2024	
Location	4101 Arthur Kill Road	File No.	0208988	
	Staten Island, NY			
Client	NP Staten Island Industrial, LLC	Temperature	44-65°F	
Contractor	Entact, Haley & Aldrich	Wind Direction	NE to SW up to 10 mph	
Weather	Partly Sunny	Personnel on Site	S. Sotomayor,	
			K. O'Connor	
Humidity	76%	Time on Site	6:45 am to 5:00 pm

H&A of New York Engineering and Geology, LLP (Haley & Aldrich) was present to document the implementation of the August 2024 NYSDEC-approved Interim Remedial Measures 1 Work Plan (IRM 1 Work Plan) prepared by Haley & Aldrich for the Former Port Mobil Terminal, located at 4101 Arthur Kill Road, Staten Island, NY. Site Observations are summarized below.

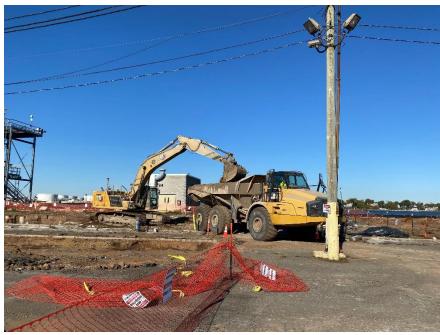
Photo 1: View of rock truck being loaded with soil to be stockpiled and prepped for disposal, in IRM 1
Western Area, Excavation 1, facing west

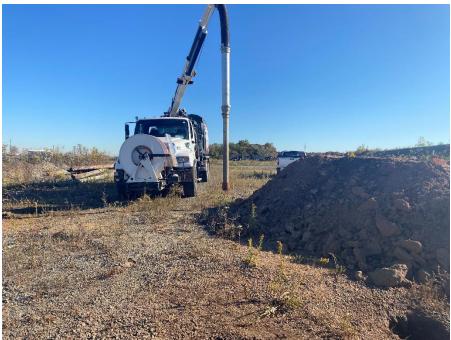
Photo 2: View of pot holing activities using the Hydro-Vac Truck in Excavation 9, IRM 1 Central Area, facing north.

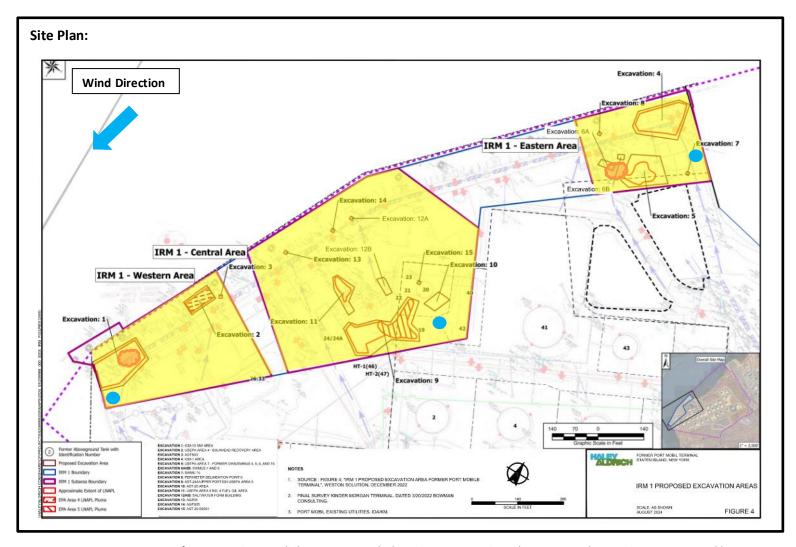
Reference: Interim Remedial Measures 1 Work Plan Figure 7B IRM-1 Central Area Proposed Excavation Area, prepared by Haley & Aldrich of New York, dated May 2024
