RCRA Operation and Maintenance Inspection (OMI), Field Notes
Texaco Research Center, Site No. 3-14-004, Town of Fishkill, Dutchess County
June 20, 2019

The following is a summary of monitoring well inspections performed by William Bennett, PE, NYSDEC on June 20, 2019 at the Texaco Research Center Site (Site No. 314004). All issues identified in notes were addressed as documented in the 1st Half 2019 Semiannual Groundwater Sampling Event Summary Report dated September 2019, prepared by Arcadis.

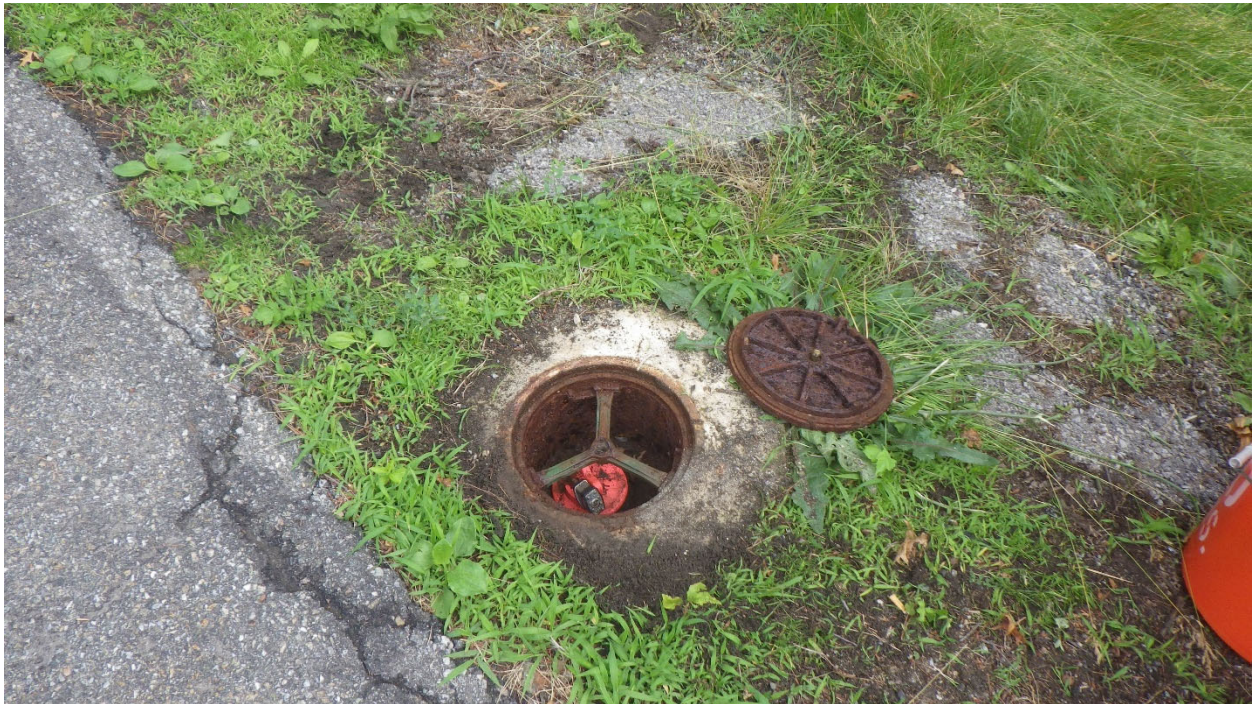
Time 9:32 am, Inspected Monitoring Well **OS-2**

Location: Flush mount along Belvedere Rd

Casing: 4" PVC inner casing, 8-10" outer casing

PID: 0.0 ppm upon opening

Depth to water from TIC 6.10 feet

Total well depth from TIC 15.20 feet

Notes: Monitoring well appears to be in good condition. New lock recommended, $\frac{3}{4}$ " bolt removal allows access.

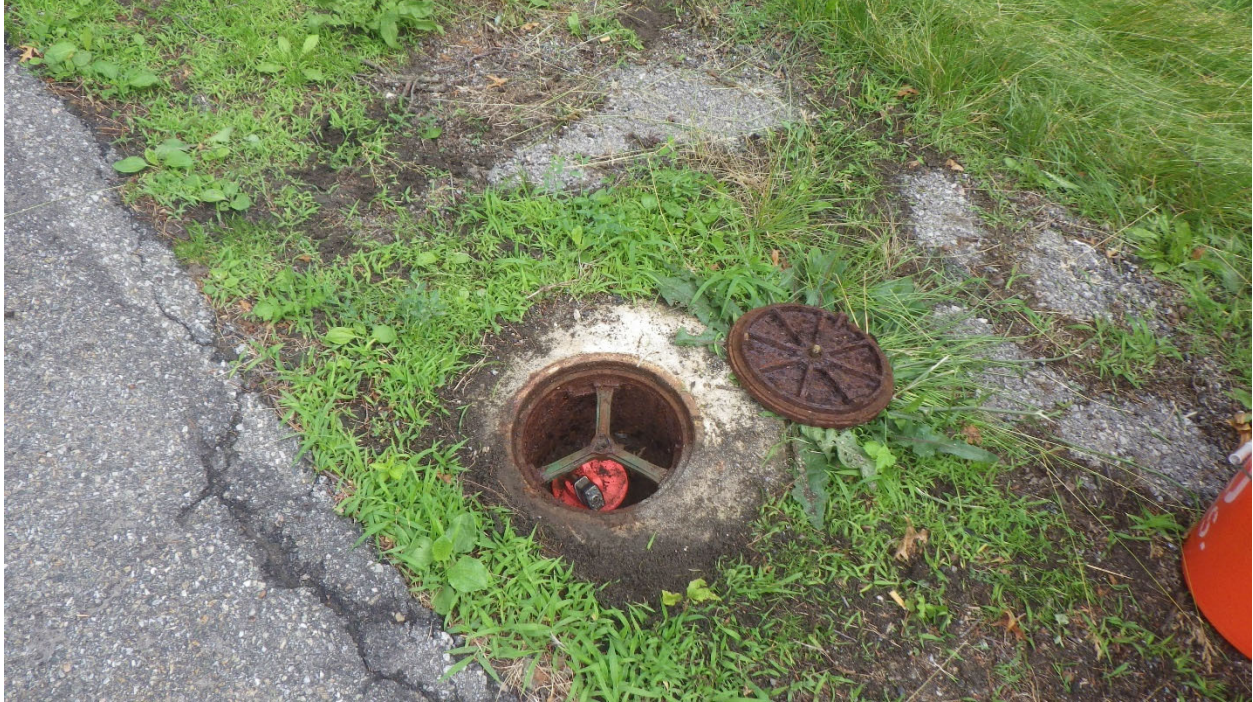
Time 9:40 am, Inspected Monitoring Well **OR-2**

Location: Flush mount to north of OS-2

Casing: 4" PVC inner casing, 8-10" outer casing

PID: 0.0 ppm upon opening

Depth to water from TIC 6.53 feet

Total well depth from TIC 38.74 feet

Notes: Total well depth is shallower than expected, depth probe indicated soft bottom (by 8'); maintenance may be required. New lock recommended, $\frac{3}{4}$ " bolt removal allows access.

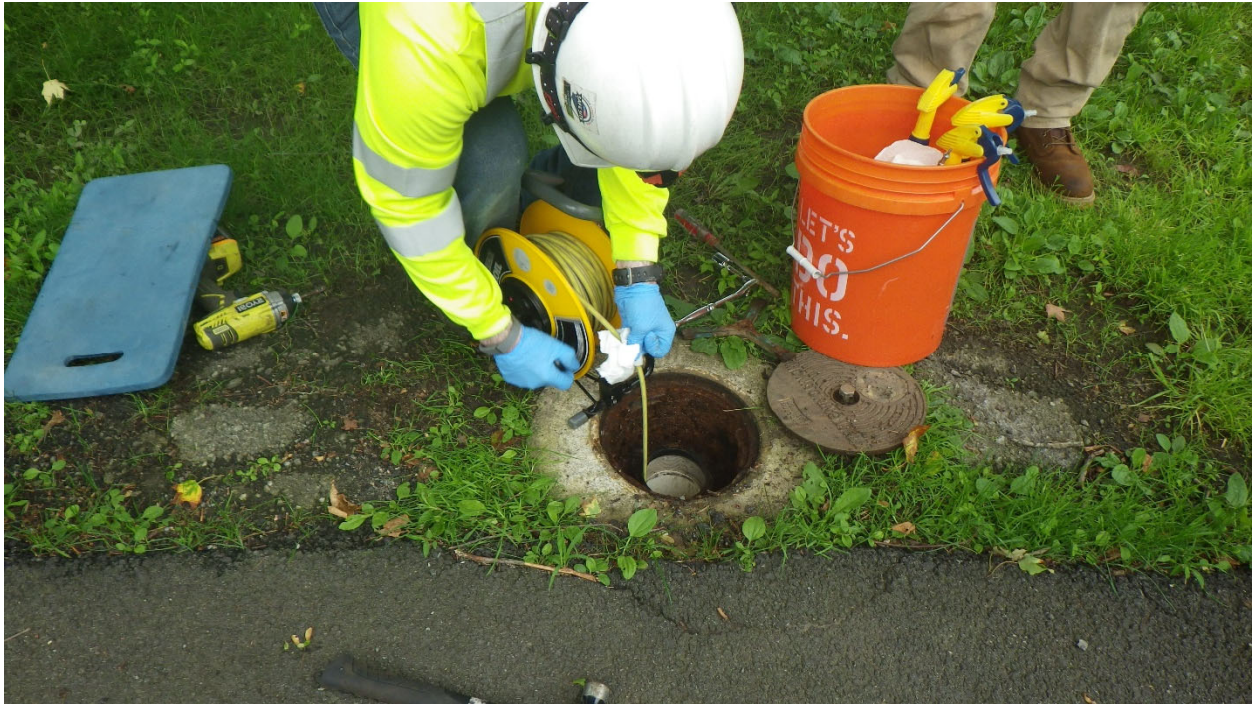
Time 9:58 am, Inspected Monitoring Well OS-3

Location: Flush mount to west of OR-3, southeast corner of Belvedere Rd and May Pl

Casing: 4" PVC inner casing, 8-10" outer casing

PID: 0.0 ppm upon opening

Depth to water from TIC 19.92 feet

Total well depth from TIC 75.54 feet

Notes: Monitoring well appears to be in good condition. New lock recommended, $\frac{3}{4}$ " bolt removal allows access.

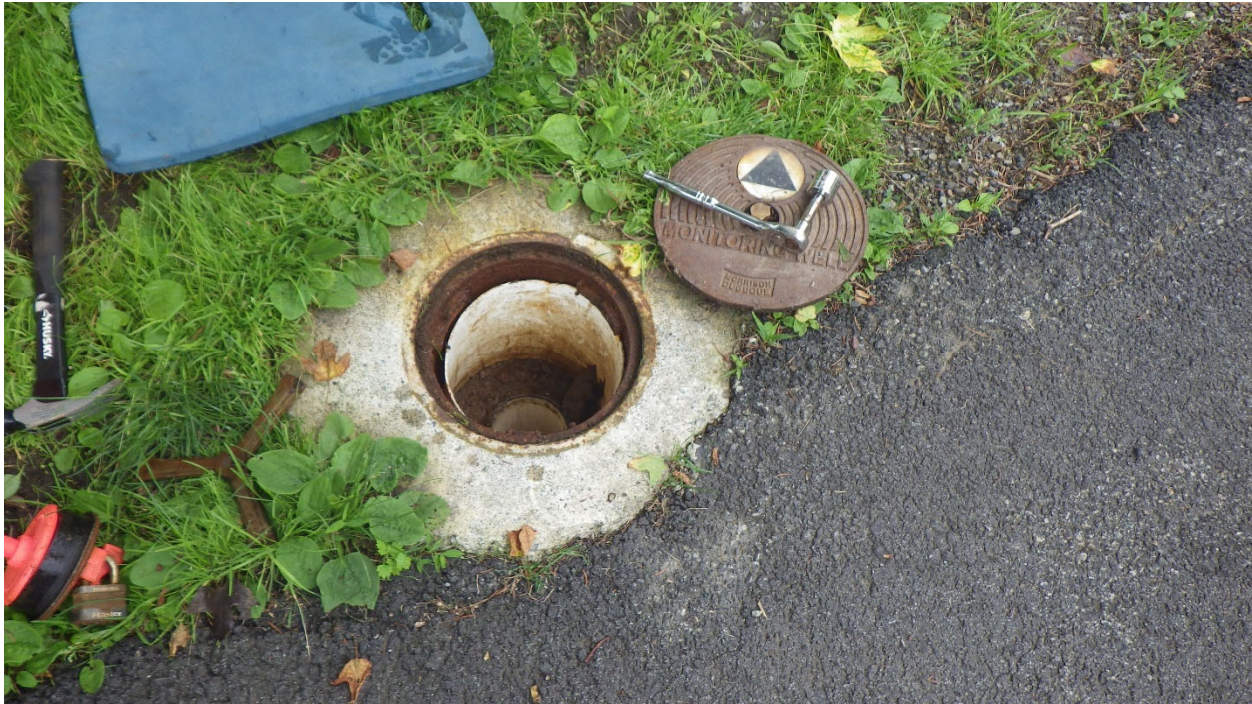
Time 10:05, Inspected Monitoring Well OR-3

Location: Flush mount, to the east of OS-3

Casing: 4" PVC inner casing, 8-10" outer casing

PID: 0.0 ppm upon opening

Depth to water from TIC 3.22 feet

Total well depth from TIC 13.09 feet

Notes: Monitoring well appears to be in good condition. New lock recommended, $\frac{3}{4}$ " bolt removal allows access.

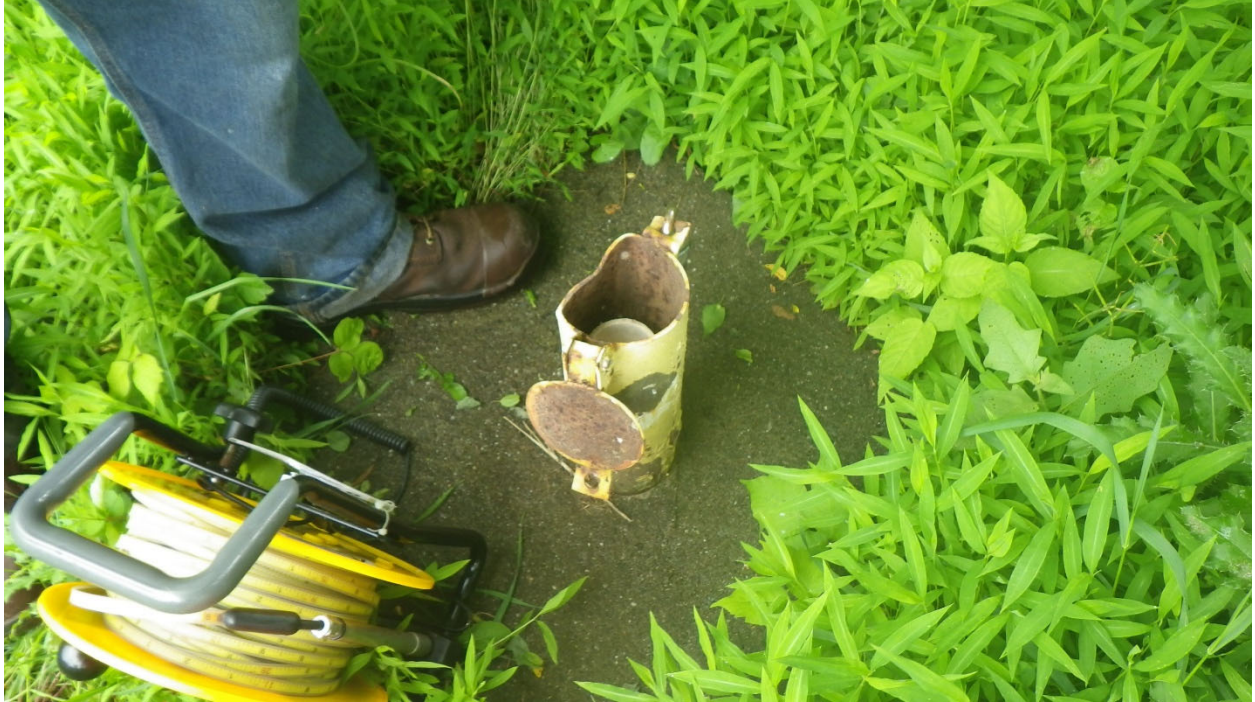
Time 10:25 am, Inspected Monitoring Well **DB-8A**

Location: Stick-up approx. 1 foot, in utility right-of-way to the west of off-site residences

Casing: 4" metal outer casing, 2" PVC inner casing

PID: 0.0 ppm upon opening

Depth to water from TIC 7.13 feet

Total well depth from TIC 16.48 feet

Notes: Monitoring well appears to be in good condition. Monitoring well is secured by lock on outer casing, minor damage to outer casing does no impact use of well.

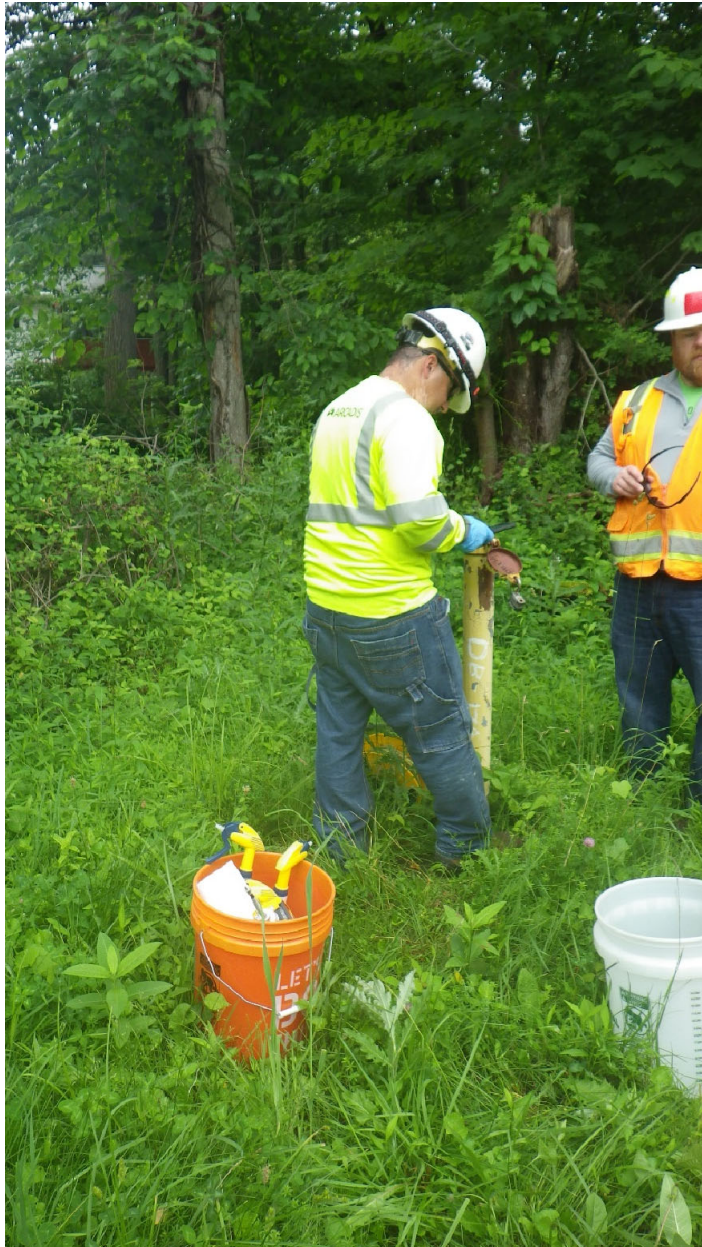
Time 10:30 am, Inspected Monitoring Well **DB-17**

Location: Stick-up approx. 3 feet, in utility right-of-way to the south of DB-8A

Casing: 4" metal outer casing, 2" PVC inner casing

PID: 0.0 ppm upon opening

Depth to water from TOC 8.62 feet

Total well depth from TOC 9.21 feet

Notes: Monitoring well appears to be in good condition. Monitoring well is secured by lock on outer casing. Well has little water, which may make sampling difficult.

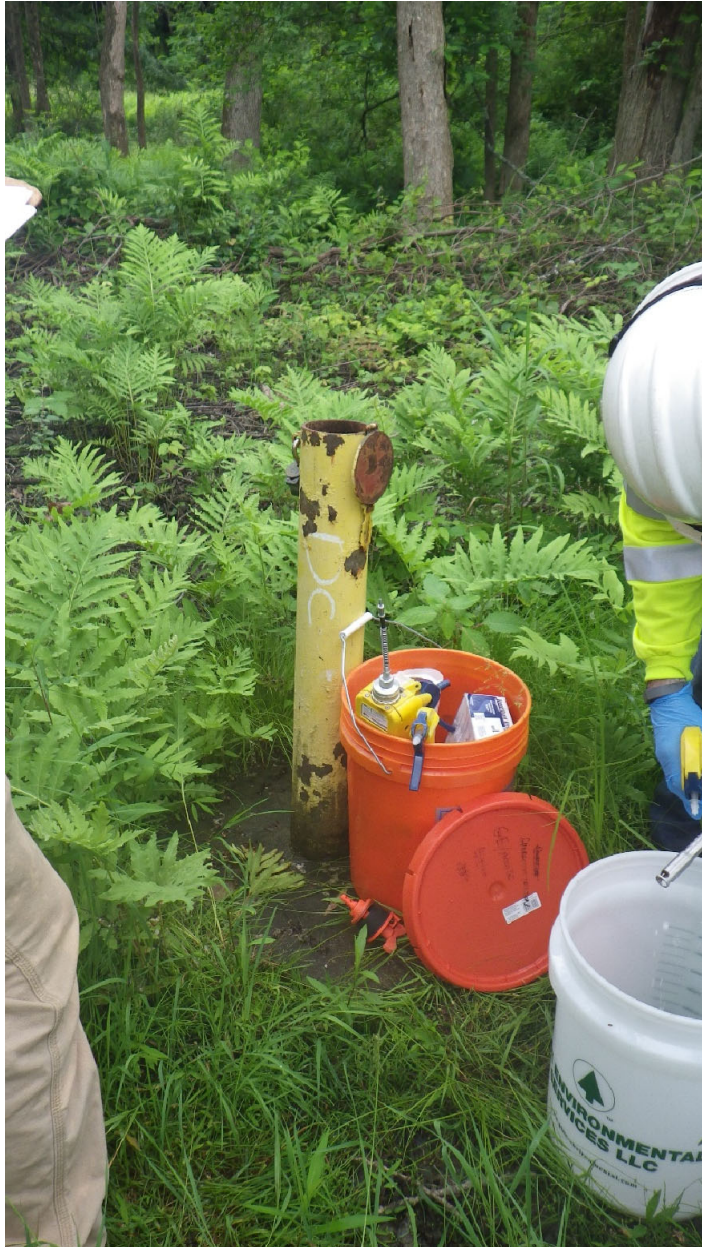
Time 10:43 am, Inspected Monitoring Well DC-1

Location: Stick-up approx. 3 feet, located to the east of DC-2

Casing: 6" metal outer casing, 2" PVC inner casing

PID: 0.0 ppm upon opening

Depth to water from TOC 2.54 feet

Total well depth from TOC 4.98 feet

Notes: Ants were observed within the outer casing. Total well depth is shallower than expected, depth probe indicated soft bottom (by 10 feet); maintenance may be required. Monitoring well is secured by lock on outer casing.

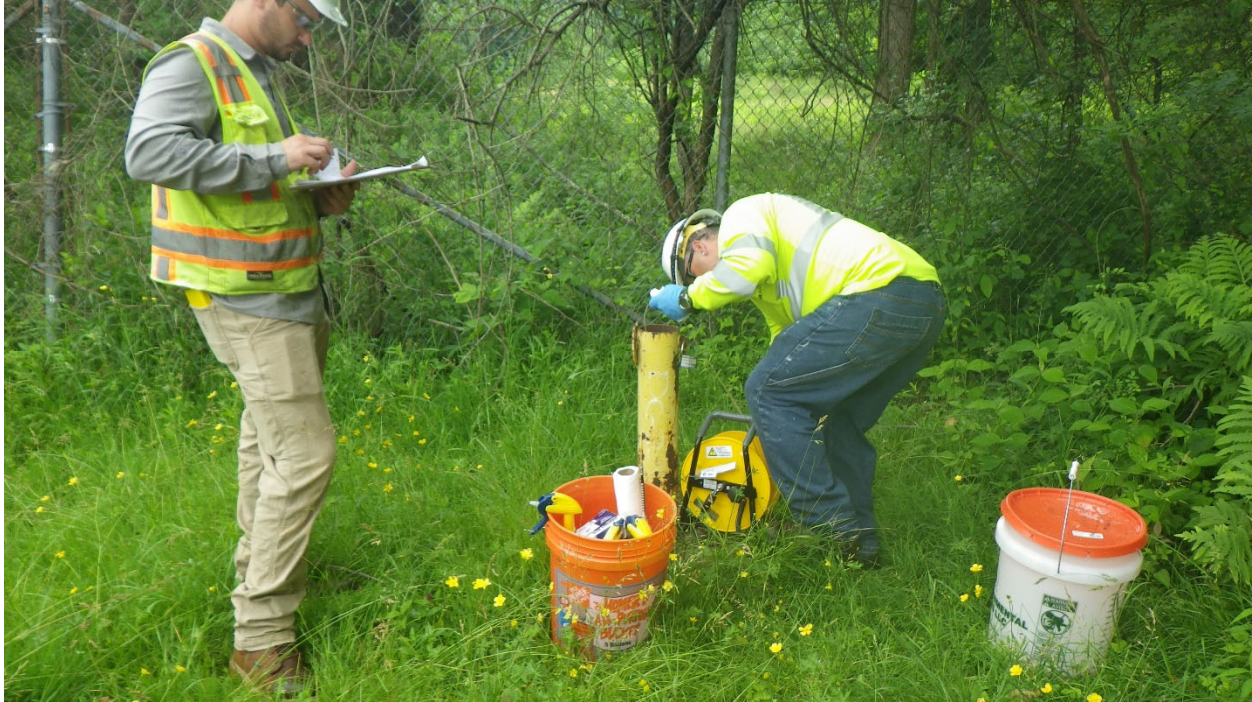
Time 10:50 am, Inspection Monitoring Well **DC-2**

Location: Stick-up approx. 3 feet, located to the west of DC-1

Casing: 6" metal outer casing, 2" PVC inner casing

PID: 0.0 ppm upon opening

Depth to water from TOC 2.61 feet

Total well depth from TOC 13.72 feet

Notes: Issue with monitoring well lock, no catch on outer casing. Total well depth is shallower than expected, depth probe indicted soft bottom (by 4 feet); maintenance may be required.
