**From:** [Dean Chartrand](#)  
**To:** [Czuhanich, Alex G \(DEC\)](#)  
**Cc:** [Jayne Ulrich](#)  
**Subject:** RE: East Fishkill SWMU Closures  
**Date:** Friday, April 08, 2016 2:35:08 PM  
**Attachments:** [report.hw314054.2015-12-18.SWM closure report\\_multiple SWMUs 21.pdf](#)  
[ARCADIS\\_MLC EOL SWMU Closure Certification Report to GF\\_12.18.15\\_Final w Figures\\_R-040616.pdf](#)

TMAH and other industrial wastewater lift tanks, waste transfer piping, and holding tanks had been identified by IBM as SWMUs, prior to initiation of the Project, in accordance with Permit Module II of IBM's 6NYCRR Part 373 Hazardous Waste Management Permit. A preliminary list of the active SWMUs within the Project area was included as Table 1 in the Plan. The active SWMU list was to be evaluated to confirm which SWMUs would be closed as part of the Project. This Certification Letter includes a final updated version of Table 1 listing only the SWMUs that were managed and closed during the Project.

I, Frederick J. Kirschenheiter, P.E., as a licensed Professional Engineer in the State of New York, hereby certify that the Solid Waste Management Units (SWMUs) identified in Table 1 of this letter

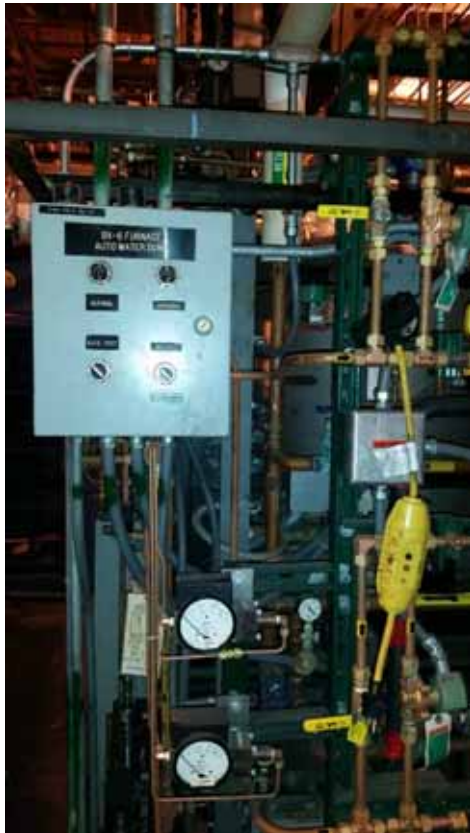
## Pre-Removal

MLC Packaging End of Life Project SWMU Removal Documentation  
SWMU# 286 – Industrial Wastewater  
9x-6 Furnace stainless steel de-saturator waste tank  
Area 16 at L47-N47, Index No. 2015001.1 – Clean Verified 4/20/15

| UNIT ID # | DESCRIPTION | LOCATION | STATUS | GW<br>REMEDIATION<br>AREA?* | RCRA STATUS | SWMU<br>UNITS | DESCRIPTION (TANK, SUMP, CONTAINMENT, SYSTEM; SIZE;<br>CONTENT) | SWMU Checklist<br>Index Number |
|---|---|---|---|---|---|---|---|---|
| 286 | Industrial Wastewater | B/338 (Inside),<br>L47-N47 | <b>Removed<br/>Component<br/>at Tool</b> | B/330 AOC | No Further Action * | 0 | 9x-6 Furnace stainless steel de-saturator waste tank , (approximately 100 gal.)/ lift station in tool, pumped carbon effluent. <b>Removed 4/20/15</b> | 20150001.1 |

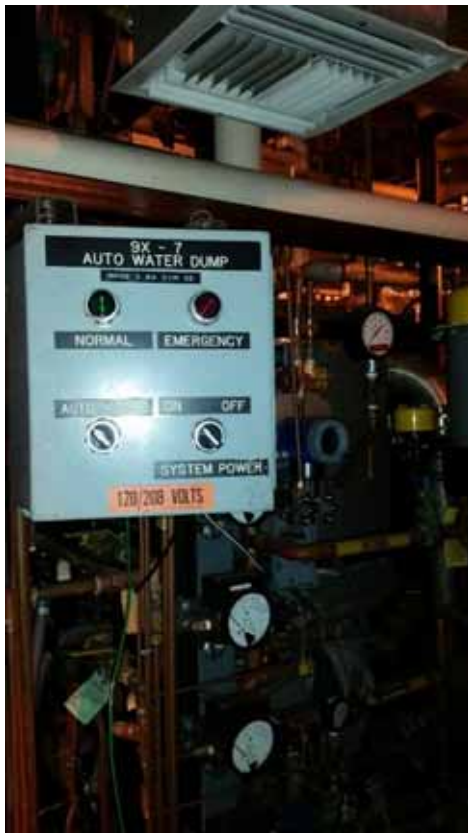
## Pre-Removal

MLC Packaging End of Life Project SWMU Removal Documentation  
SWMU# 286 – Industrial Wastewater  
9x-7 Furnace stainless steel de-saturator waste tank Area 16 at L47-N47, Index No.  
2015001.2 – Clean Verified 4/20/15

| UNIT ID # | DESCRIPTION | LOCATION | STATUS | GW<br>REMEDIATION<br>AREA?* | RCRA STATUS | SWMU<br>UNITS | DESCRIPTION (TANK, SUMP, CONTAINMENT, SYSTEM; SIZE;<br>CONTENT) | SWMU Checklist<br>Index Number |
|---|---|---|---|---|---|---|---|---|
| 286 | Industrial Wastewater | B/338 (Inside),<br>L47-N47 | <b>Removed<br/>Component<br/>at Tool</b> | B/330 AOC | No Further Action * | 0 | 9x-7 Furnace stainless steel de-saturator waste tank , (approximately 100 gal.)/ lift station in tool, pumped carbon effluent. <b>Removed 4/20/15</b> | 20150001.2 |

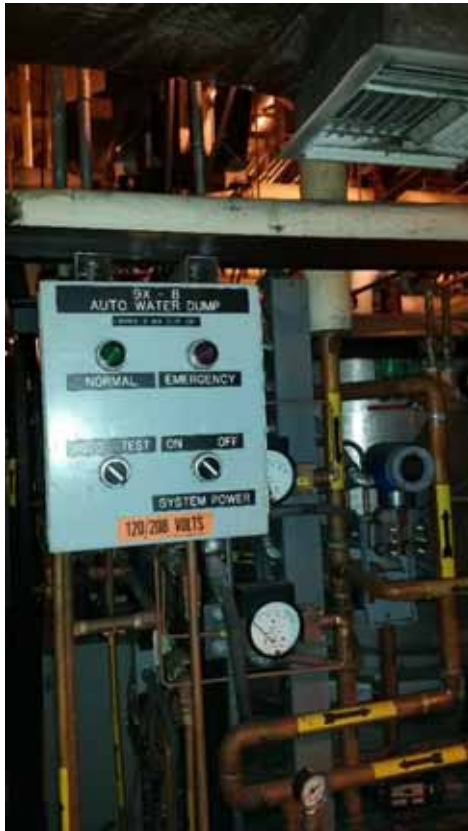
## Pre-Removal

MLC Packaging End of Life Project SWMU Removal Documentation  
SWMU# 286 – Industrial Wastewater  
9x-8 Furnace stainless steel de-saturator waste tank  
Area 16 at L47-N47, Index No. 2015001.3 – Clean Verified 4/20/15

| UNIT ID # | DESCRIPTION | LOCATION | STATUS | GW<br>REMEDIATION<br>AREA?* | RCRA STATUS | SWMU<br>UNITS | DESCRIPTION (TANK, SUMP, CONTAINMENT, SYSTEM; SIZE;<br>CONTENT) | SWMU Checklist<br>Index Number |
|---|---|---|---|---|---|---|---|---|
| 286 | Industrial Wastewater | B/338 (Inside),<br>L47-N47 | <b>Removed<br/>Component<br/>at Tool</b> | B/330 AOC | No Further Action * | 0 | 9x-8 Furnace stainless steel de-saturator waste tank , (approximately 100 gal.)/ lift station in tool, pumped carbon effluent. <b>Removed 4/20/15</b> | 20150001.3 |

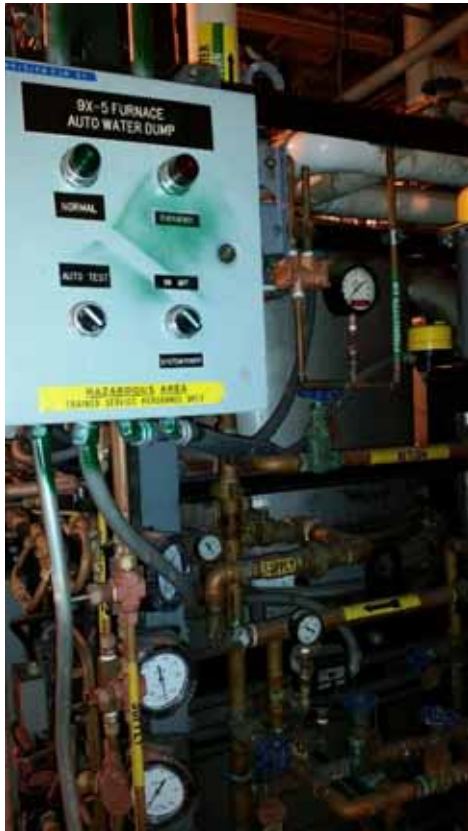
## Pre-Removal

MLC Packaging End of Life Project SWMU Removal Documentation  
SWMU# 286 – Industrial Wastewater  
9x-5 Furnace stainless steel de-saturator waste tank  
Area 16 at L47-N47, Index No. 2015001.4 – Clean Verified 4/20/15

| UNIT ID # | DESCRIPTION | LOCATION | STATUS | GW<br>REMEDIATION<br>AREA?* | RCRA STATUS | SWMU<br>UNITS | DESCRIPTION (TANK, SUMP, CONTAINMENT, SYSTEM; SIZE;<br>CONTENT) | SWMU Checklist<br>Index Number |
|---|---|---|---|---|---|---|---|---|
| 286 | Industrial Wastewater | B/338 (Inside),<br>L47-N47 | <b>Removed<br/>Component<br/>at Tool</b> | B/330 AOC | No Further Action * | 0 | 9x-5 Furnace stainless steel de-saturator waste tank , (approximately 100 gal.)/ lift station in tool, pumped carbon effluent. <b>Removed 4/20/15</b> | 20150001.4 |

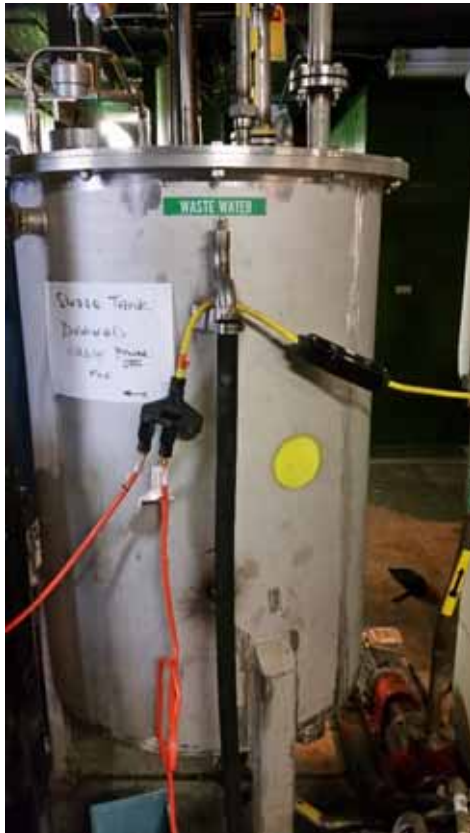
## Pre-Removal

MLC Packaging End of Life Project SWMU Removal Documentation  
SWMU# 286 – Industrial Wastewater  
Binder water tank/lift station, pumped carbon effluent to Tank 286  
Area 16 at N48, Index No. 2015001.5 – Clean Verified 6/02/15

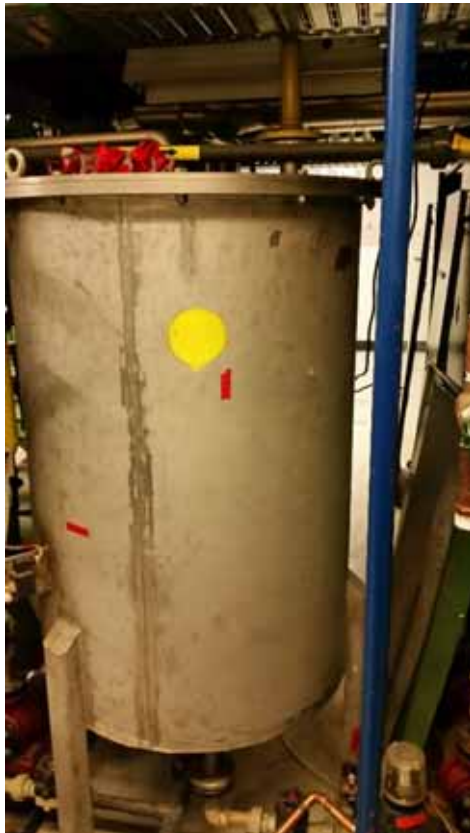
**Pre-Removal**

MLC Packaging End of Life Project SWMU Removal Documentation  
SWMU# 287 – Industrial Wastewater  
Pfeiffer 5-4 furnace industrial waste tank/lift station Area 14.1 at S-35 Index No.  
2015002.4 – Clean Verified 5/26/15

| UNIT ID # | DESCRIPTION | LOCATION | STATUS | GW<br>REMEDIA<br>TION<br>AREA?* | RCRA STATUS | SWMU<br>UNITS | DESCRIPTION (TANK, SUMP, CONTAINMENT, SYSTEM; SIZE;<br>CONTENT) | SWMU Checklist<br>Index Number |
|---|---|---|---|---|---|---|---|---|
| 287 | Industrial Wastewater | B/330C<br>(Inside), S/35 | <b>Removed<br/>Component<br/>at Tool</b> | B/330 AOC | No Further Action * | 0 | Pfeiffer 5-4 furnace industrial waste tank/lift station, 100 gal. (approximate) stainless steel. Part of Hex# 14.1.3 <b>Removed 5/26/15</b> | 20150002.4 |

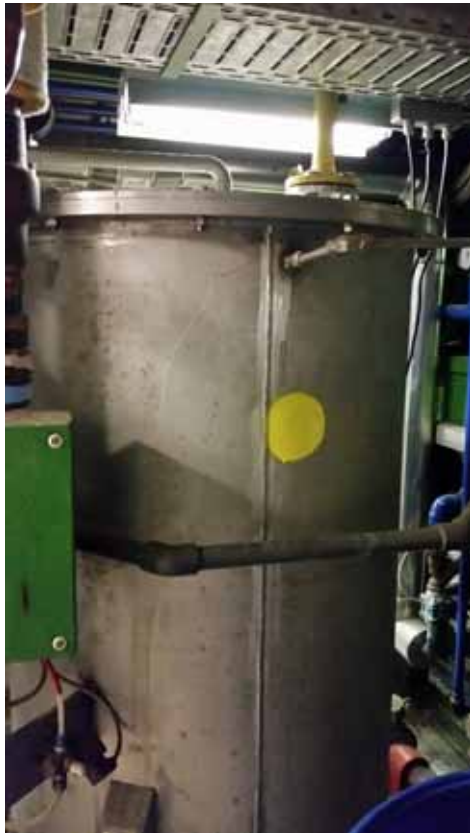
**Pre-Removal**

MLC Packaging End of Life Project SWMU Removal Documentation  
SWMU# 287 – Industrial Wastewater  
Pfeiffer 5-5 furnace industrial waste tank/lift  
Area 14.1 at R-38 Index No. 2015002.5 – Clean Verified 5/26/15

| UNIT ID # | DESCRIPTION | LOCATION | STATUS | GW<br>REMEDIA<br>TION<br>AREA?* | RCRA STATUS | SWMU<br>UNITS | DESCRIPTION (TANK, SUMP, CONTAINMENT, SYSTEM; SIZE;<br>CONTENT) | SWMU Checklist<br>Index Number |
|---|---|---|---|---|---|---|---|---|
| 287 | Industrial Wastewater | B/330C<br>(Inside), R/38 | <b>Removed<br/>Component<br/>at Tool</b> | B/330 AOC | No Further Action * | 0 | Pfeiffer 5-5 furnace industrial waste tank/lift station, 100 gal. (approximate) stainless steel. Part of Hex# 14.1.4 <b>Removed 5/26/15</b> | 20150002.5 |

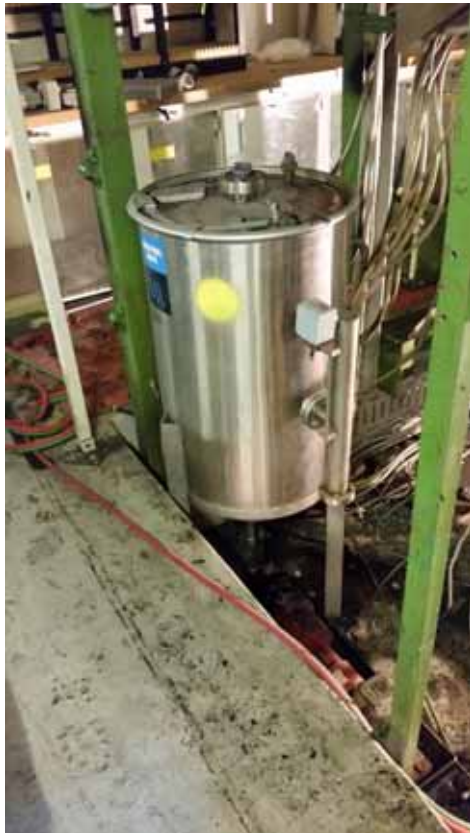
**Pre-Removal**

MLC Packaging End of Life Project SWMU Removal Documentation  
SWMU# 287 – Industrial Wastewater  
Pfeiffer C furnace industrial waste tank/lift station  
Area 14.2 at M-37 Index No. 2015002.6 – Clean Verified 5/26/15

| UNIT ID # | DESCRIPTION | LOCATION | STATUS | GW<br>REMEDIA<br>TION<br>AREA?* | RCRA STATUS | SWMU<br>UNITS | DESCRIPTION (TANK, SUMP, CONTAINMENT, SYSTEM; SIZE;<br>CONTENT) | SWMU Checklist<br>Index Number |
|---|---|---|---|---|---|---|---|---|
| 287 | Industrial Wastewater | B/330C<br>(Inside), M/37 | <b>Removed<br/>Component<br/>at Tool</b> | B/330 AOC | No Further Action * | 0 | Pfeiffer C furnace industrial waste tank/lift station, 60 gal. (approximate) stainless steel. Part of Hex# 14.2.2 <b>Removed 5/26/15</b> | 20150002.6 |

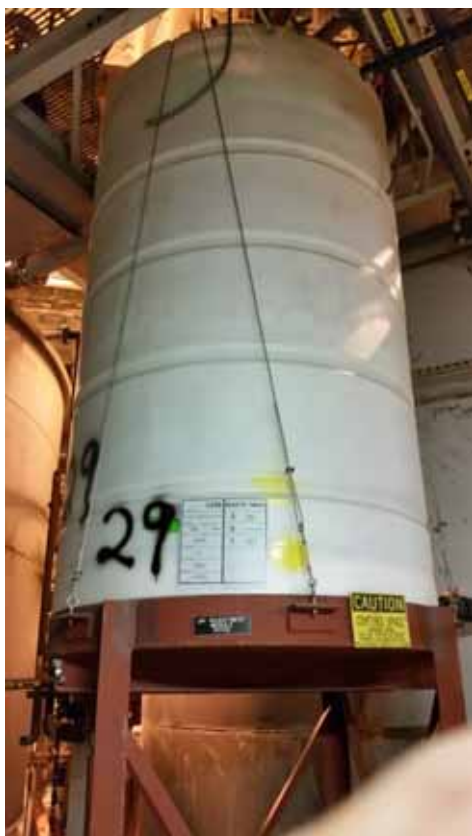
## Tank Pre-Removal

MLC Packaging End of Life Project SWMU Removal Documentation  
SWMU #3356 - Waste TMAH  
Waste TMAH, pH Adjustment Module R1700, CS3356  
Area 15.1 at Q-44, Index No. 20150006 - Clean Verified 7/13/15

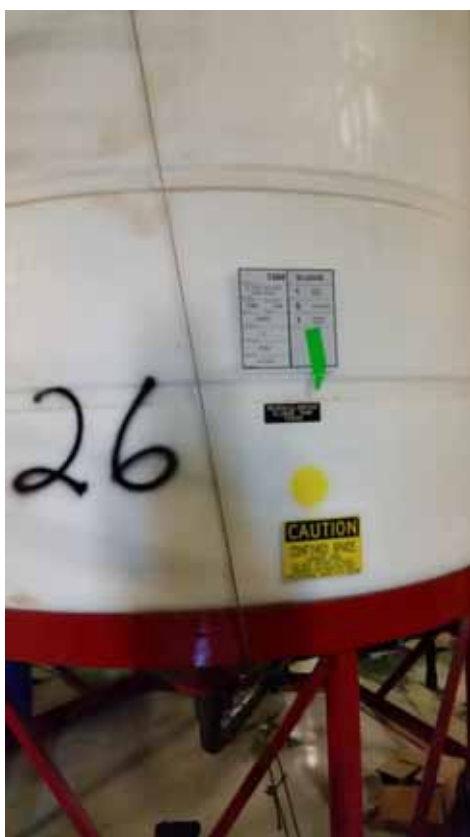
## Tank Pre-Removal

MLC Packaging End of Life Project SWMU Removal Documentation  
SWMU #3360 - TMAH Wastewater  
Sludge Holding Tank R2500, Regen/Clarifier Sludge Tank T2500, CS3360  
Area 15.1 at S-42, Index No. 20150009 - Clean Verified 6/22/15

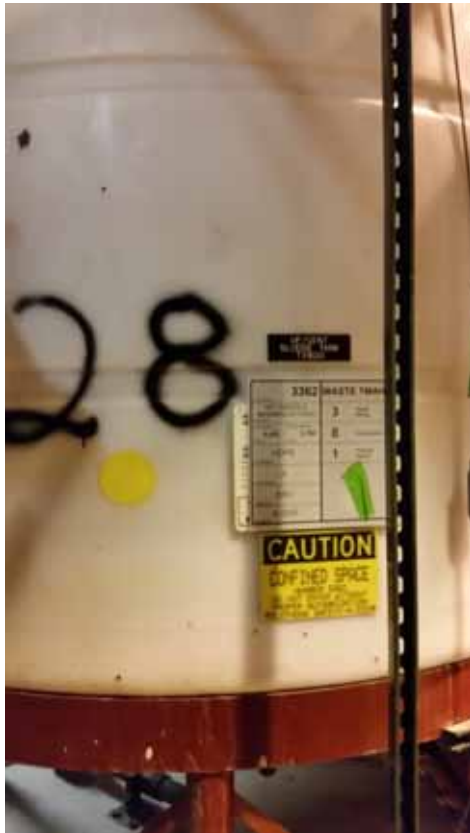
## Tank Pre-Removal

MLC Packaging End of Life Project SWMU Removal Documentation  
SWMU #3362 – Waste TMAH  
MTL Waste & Membralox T-2800, CS3362  
Area 15.1 at S-43, Index No. 20150011 - Clean Verified 6/16/15

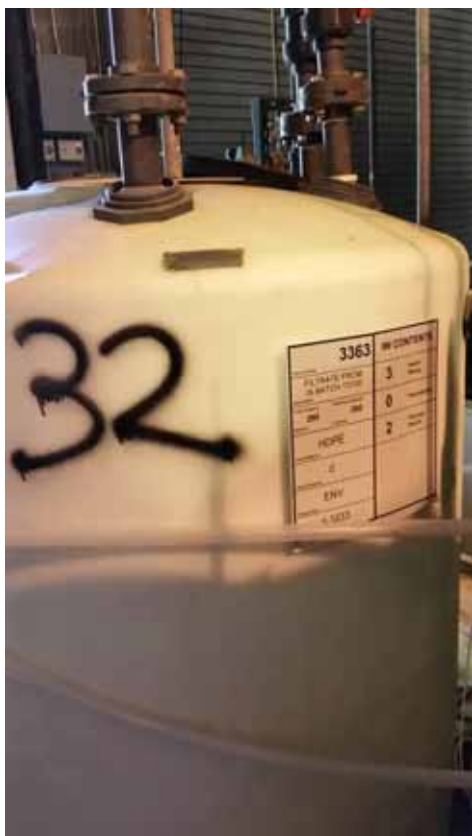
## Tank Pre-Removal

MLC Packaging End of Life Project SWMU Removal Documentation  
SWMU #3363 - TMAH Wastewater  
IW Contents Filtrate Tank T-3100  
Area 15.1 at V-44, Index No. 20150012 - Clean Verified 6/10/15

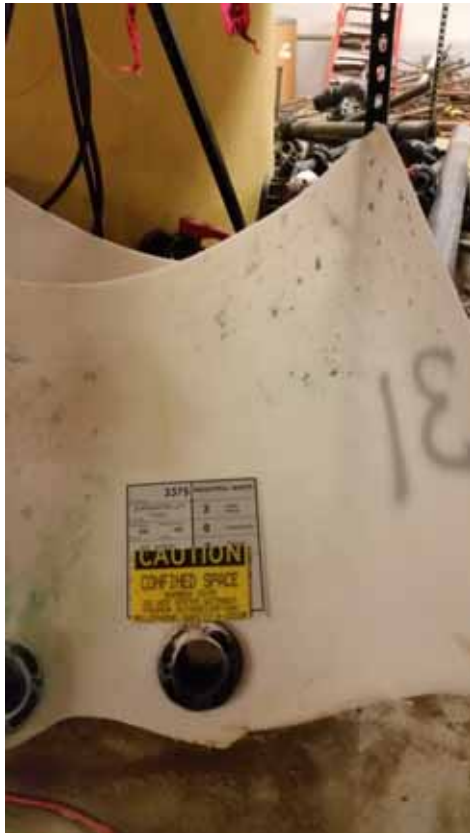
## Tank Pre-Removal

MLC Packaging End of Life Project SWMU Removal Documentation  
SWMU #3375 – Waste TMAH  
Supernatant Lift Tank T3000, CS3375  
Area 15.1 at S-42, Index No. 20150015 - Clean Verified 6/10/15

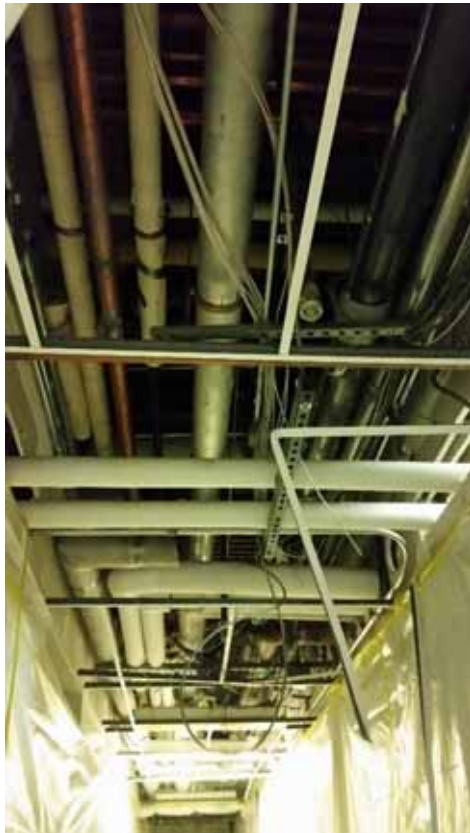
**Pre-removal TMAH Pipe above the ceiling in hallway of B 330D**

**TMAH Pipe abandoned in place above ceiling between AY27-AZ29 in B 330D (approx. 60 ft.)**

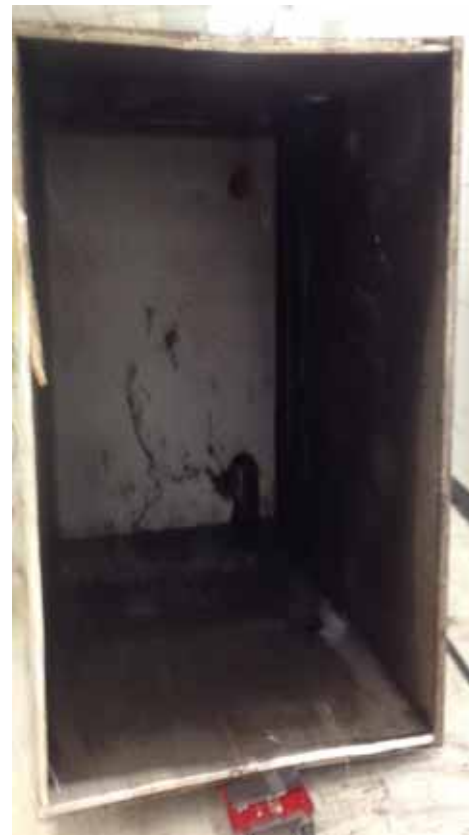
MLC Packaging End of Life Project SWMU Removal Documentation  
SWMU B/330-TMAH - Waste TMAH Transfer Piping  
Core 21D, Waste TMAH Sump/Lift Station Pit and Trench in Area 2 CS3403 & CS3404  
Index No. 20150032.4 - Clean Verified 5/7/15

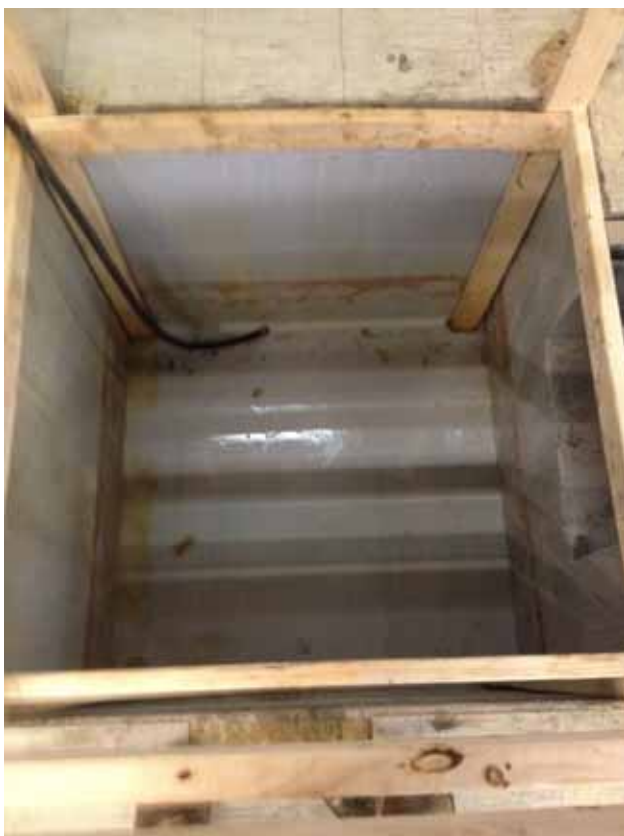
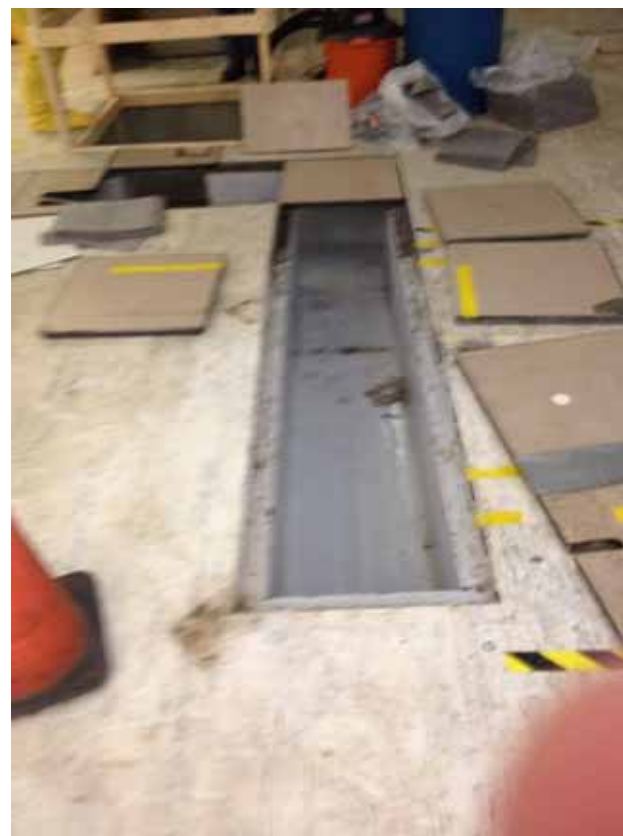
MLC Packaging End of Life Project SWMU Removal Documentation  
SWMU B/330-TMAH - Waste TMAH Transfer Piping  
Core 2C, Waste TMAH Sump/Lift Station Pit and Trench in Area 9 CS0469  
Index No. 20150032.16 - Clean Verified 5/21/15

**Cleaned Lift Station Pit**

**Cleaned Trench**

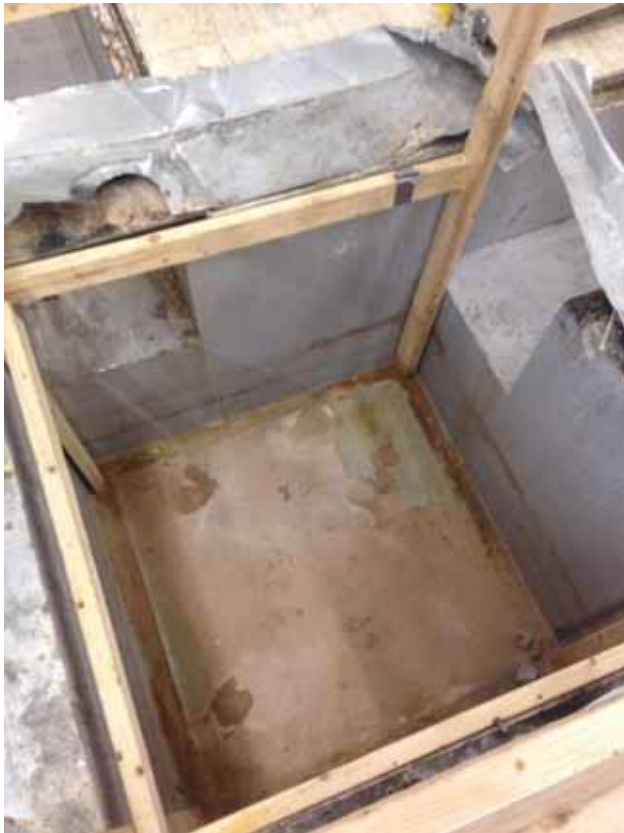
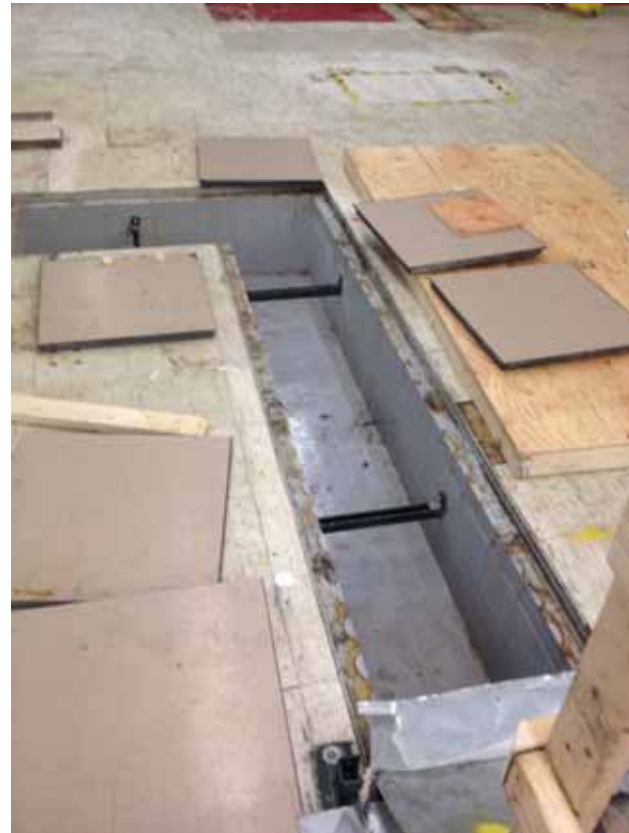
MLC Packaging End of Life Project SWMU Removal Documentation  
SWMU B/330-TMAH - Waste TMAH Transfer Piping  
Core 1C, Waste TMAH Sump/Lift Station Pit and Trench in Area 9 CS0470  
Index No. 20150032.17 - Clean Verified 5/21/15

**Cleaned Lift Station Pit**

**Cleaned Trench**

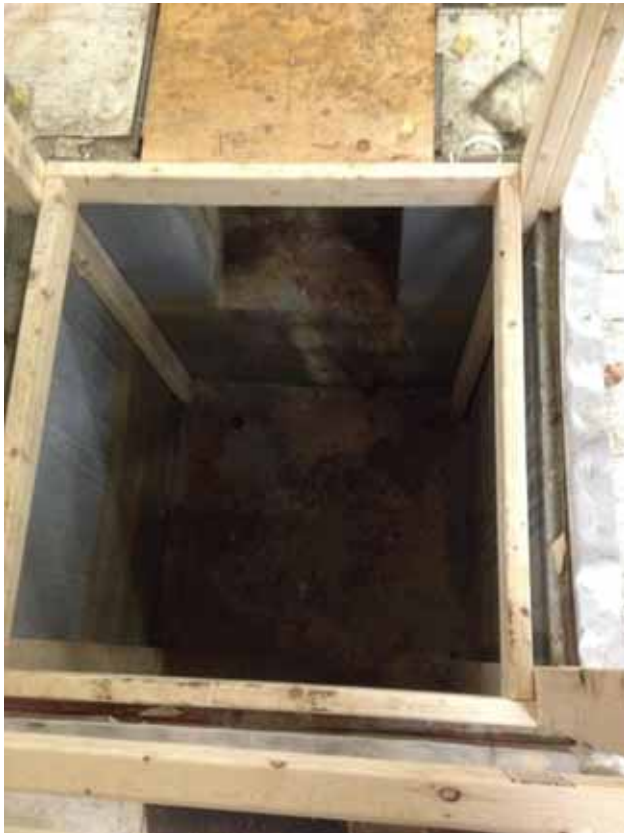
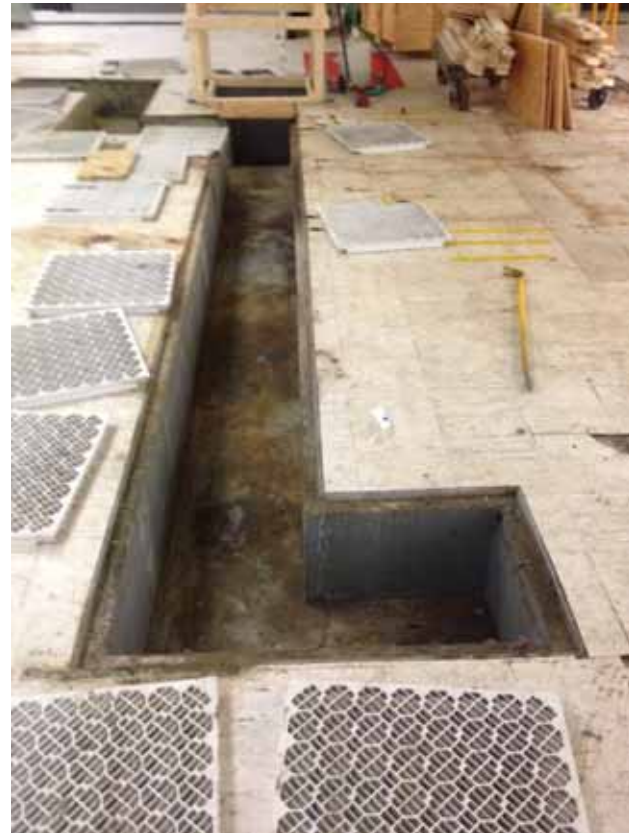
MLC Packaging End of Life Project SWMU Removal Documentation  
SWMU B/330-TMAH - Waste TMAH Transfer Piping  
Core 6C, Waste TMAH Sump/Lift Station Pit and Trench in Area 9 CS0474  
Index No. 20150032.18 - Clean Verified 5/28/15

## Cleaned Lift Station Pit

## Cleaned Trench

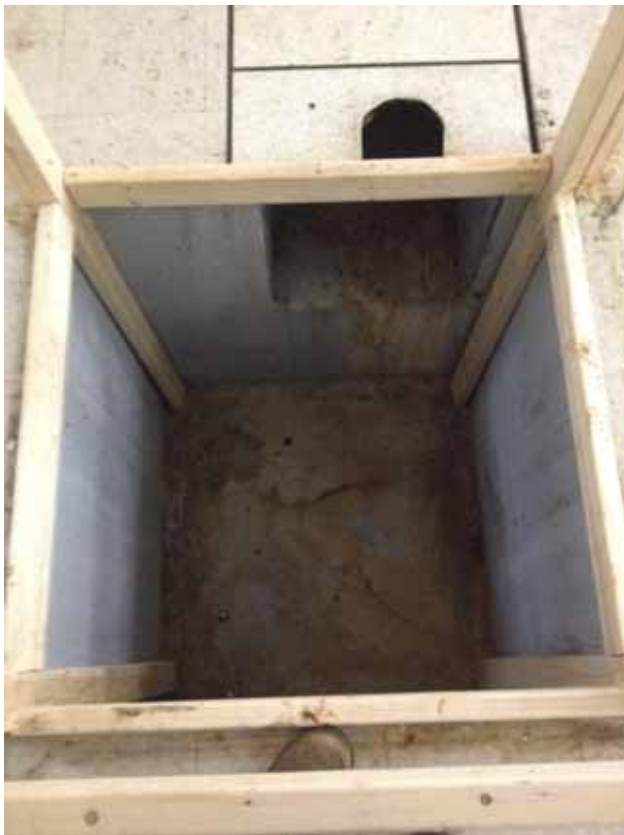
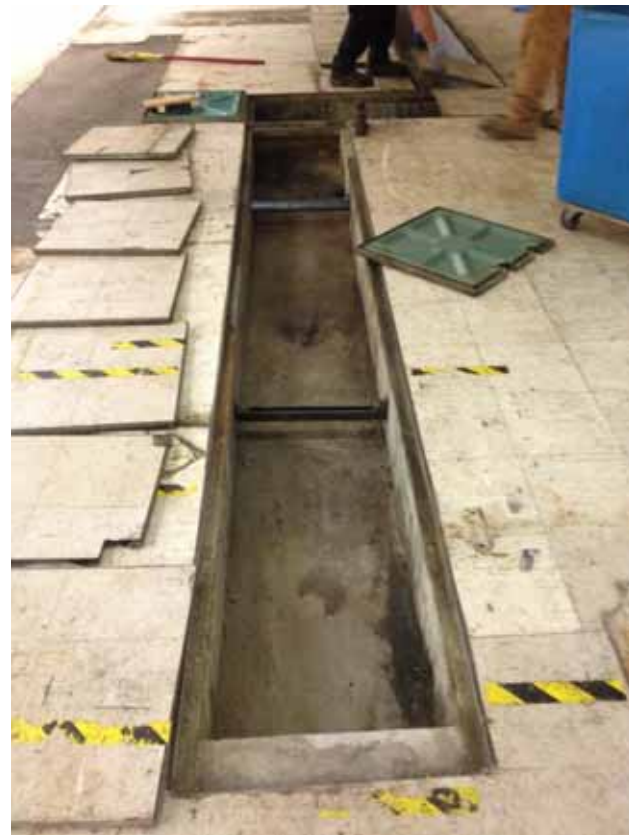
MLC Packaging End of Life Project SWMU Removal Documentation  
SWMU B/330-TMAH - Waste TMAH Transfer Piping  
Core 4C, Waste TMAH Sump/Lift Station Pit and Trench in Area 9 (Unlabeled)  
Index No. 20150032.19 - Clean Verified 5/28/15

**Cleaned Lift Station Pit**

**Cleaned Trench**

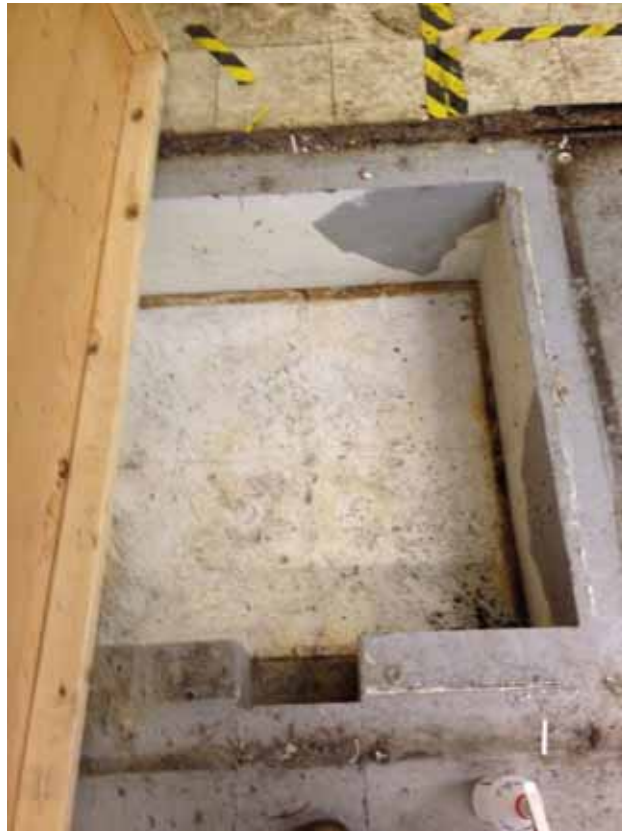
## **Cleaned Lift Station Pit**

MLC Packaging End of Life Project SWMU Removal Documentation  
SWMU B/330-TMAH - Waste TMAH Transfer Piping  
Proceco Hex# 9.8, Sump/Lift Station for TMAH Degreaser #3 in Area 9  
Index No. 20150032.21 - Clean Removal Verified 5/28/15

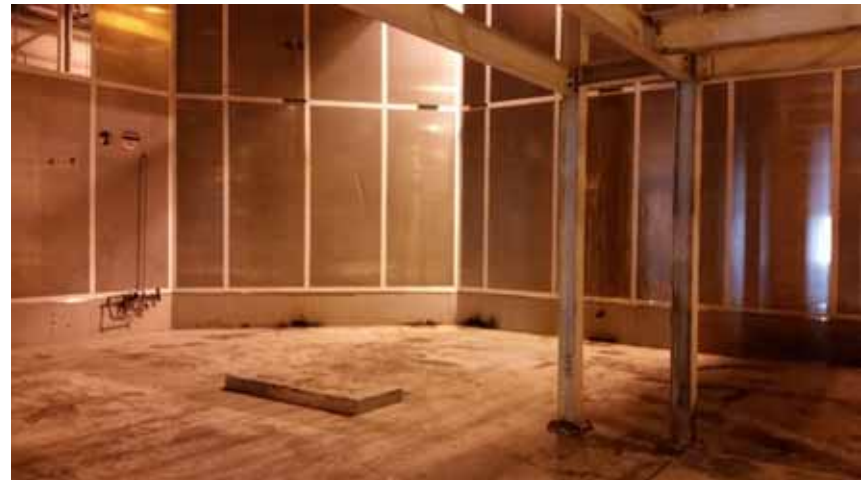
## After Removal

MLC Packaging End of Life Project SWMU Removal Documentation  
SWMU B/338-TMAH - Waste TMAH Transfer Piping  
Includes all TMAH and TMAH waste transfer piping in B/338 and B/339  
Area 15.2, Index No. 20150033 - Clean Removal Verified 8/6/15
