**BUILDING 330C SWMU REMOVAL:
CERTIFICATION OF SWMU CLOSURE**

**IPARK 84
FORMER IBM EAST FISHKILL FACILITY**

OCTOBER 2019

Re: iPark 84, Former IBM East Fishkill Facility
Building 330C SWMU Removal
Certification of SWMU Closure

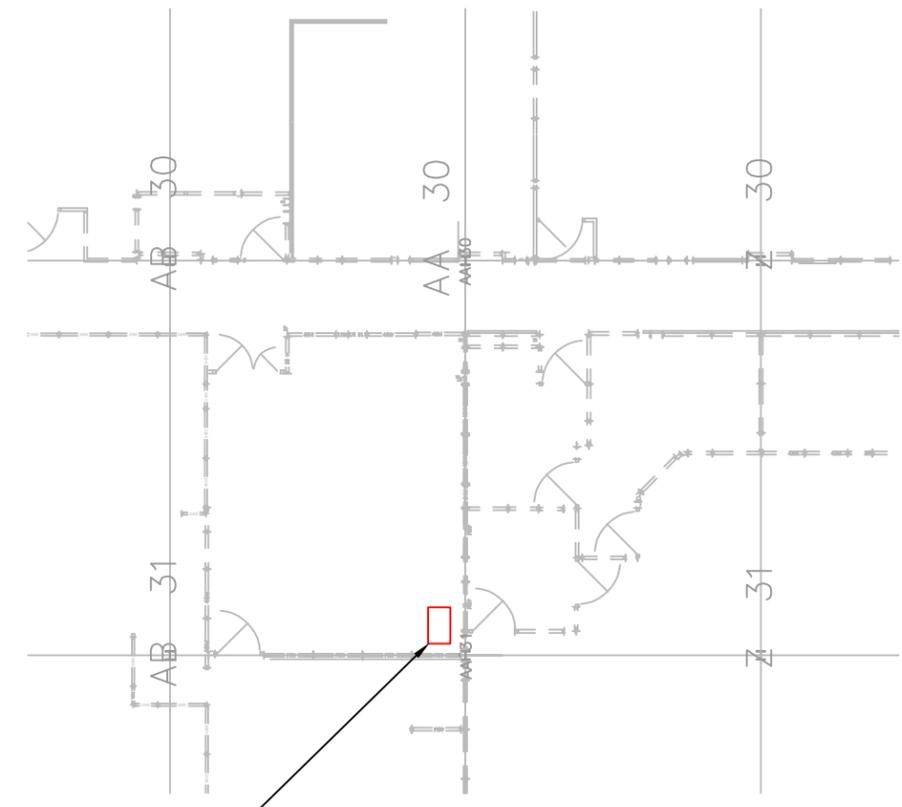
BUILDING 330C SWMU REMOVAL
(COLUMN AREA AB-Z; 30-31)
SCALE 1" = 15'-0"

B/330C LS IW
ACID SWMU (ECOL 2255)

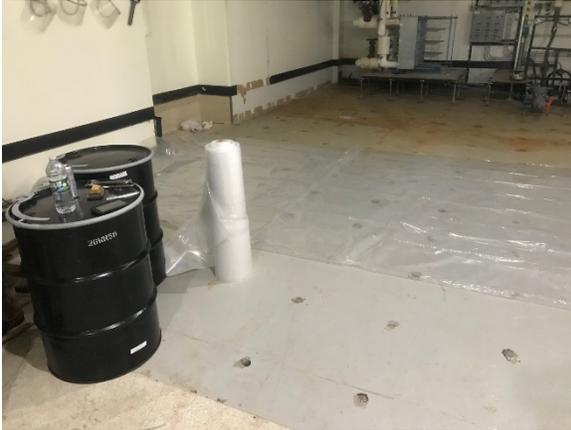
Photograph #1

Setting up Decontamination Area

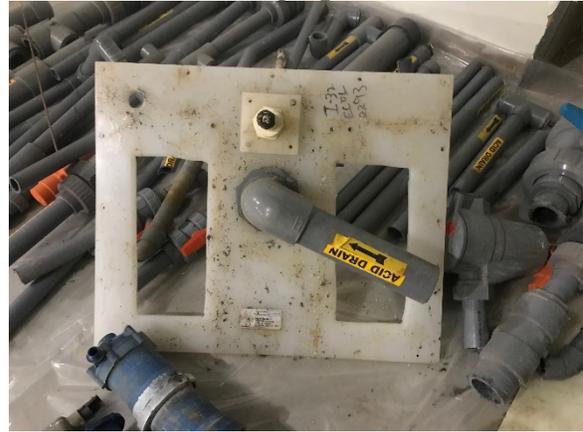
Photograph #2

Acid Lift Station After Removal, Prior to Cleaning

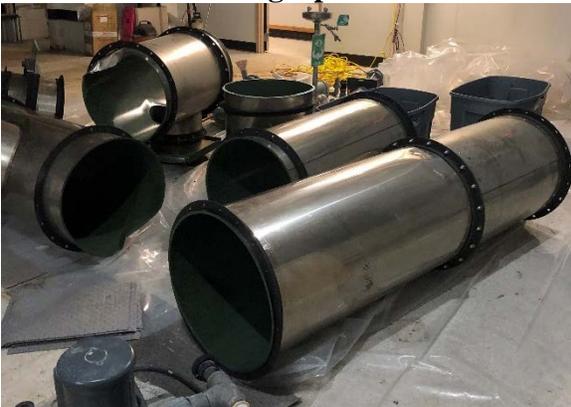
Photograph #3

Removed Portions of Exhaust Duct Piping Staged for Disposal

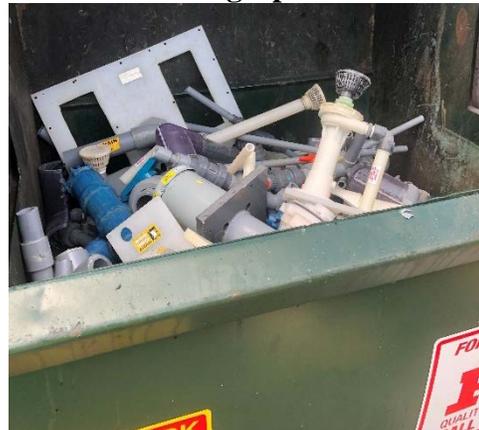
Photograph #4

Cleaned and Cleared Components in Container for Disposal

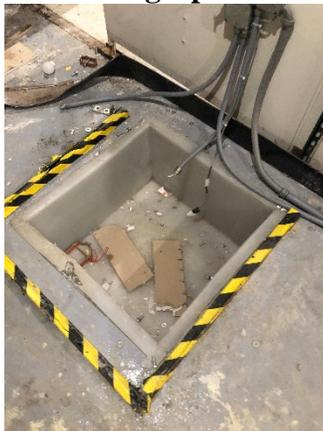
Photograph #5

Secondary Containment Sump Prior to Cleaning

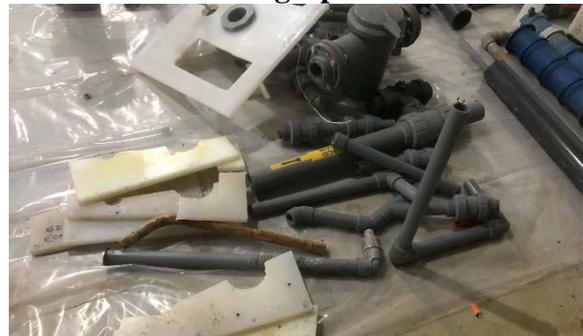
Photograph #6

Acid Lift Station After Removal, Prior to Cleaning

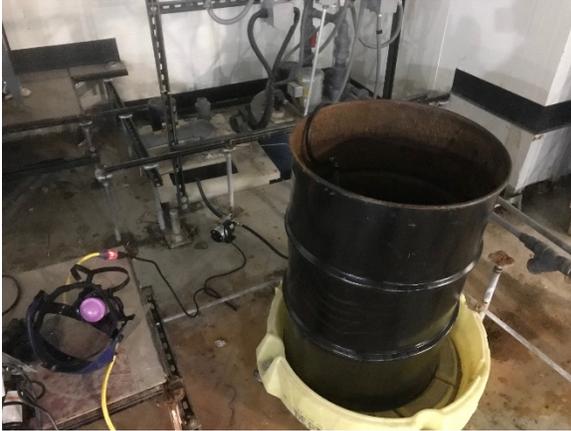
Photograph #7

Liquids Being Transferred From Lift Station Into Drum for Later Disposal

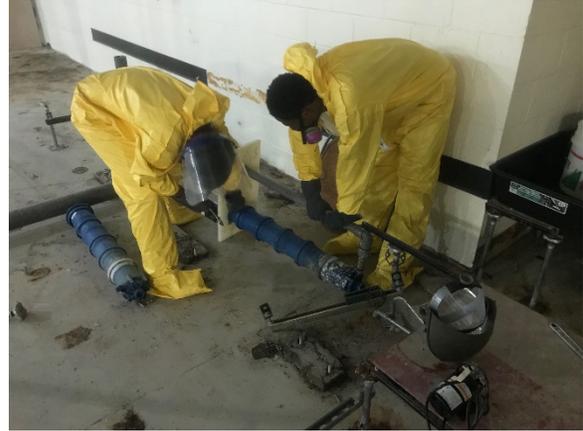
Photograph #8

Workers Disconnecting Piping Sections

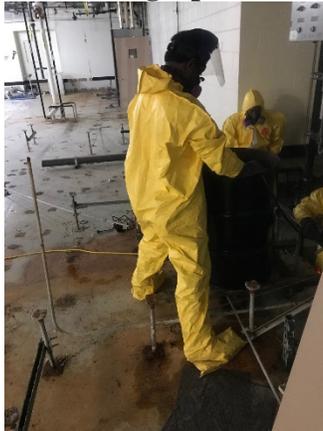
Photograph #9

Workers Disconnecting SWMU Components

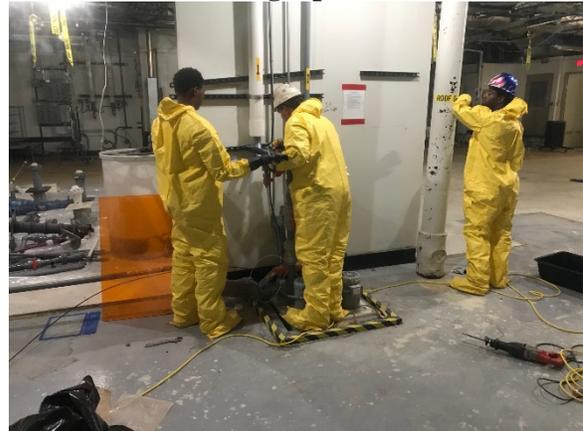
Photograph #10

Worker Removing Supports from SWMU

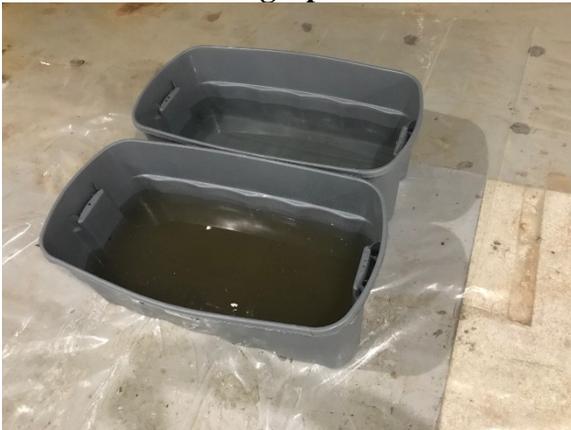
Photograph #11

Designated Rinsing Bins for Pipe Sections

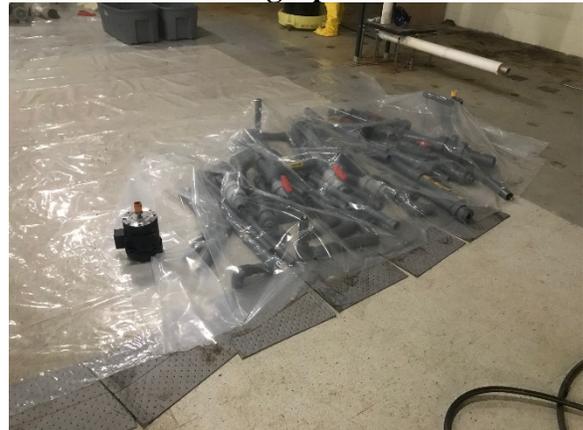
Photograph #12

Decontaminated Piping Sections Slated for Disposal
