NYSDEC**Remedial Bureau C****Division of Environmental Remediation****Site: Goshen MGP****Phase:****Site No.: 336046****Contractor PM: Rob Drabot****NYSDEC PM: Sarah Saucier P.E.****Construction Manager: Arcadis****Project Engineers: Jason Golubski****Remedial Contractor: Abscope****Air Monitoring: Arcadis****Health & Safety: Triangle Safety****Weather Conditions**

Summary of Events:

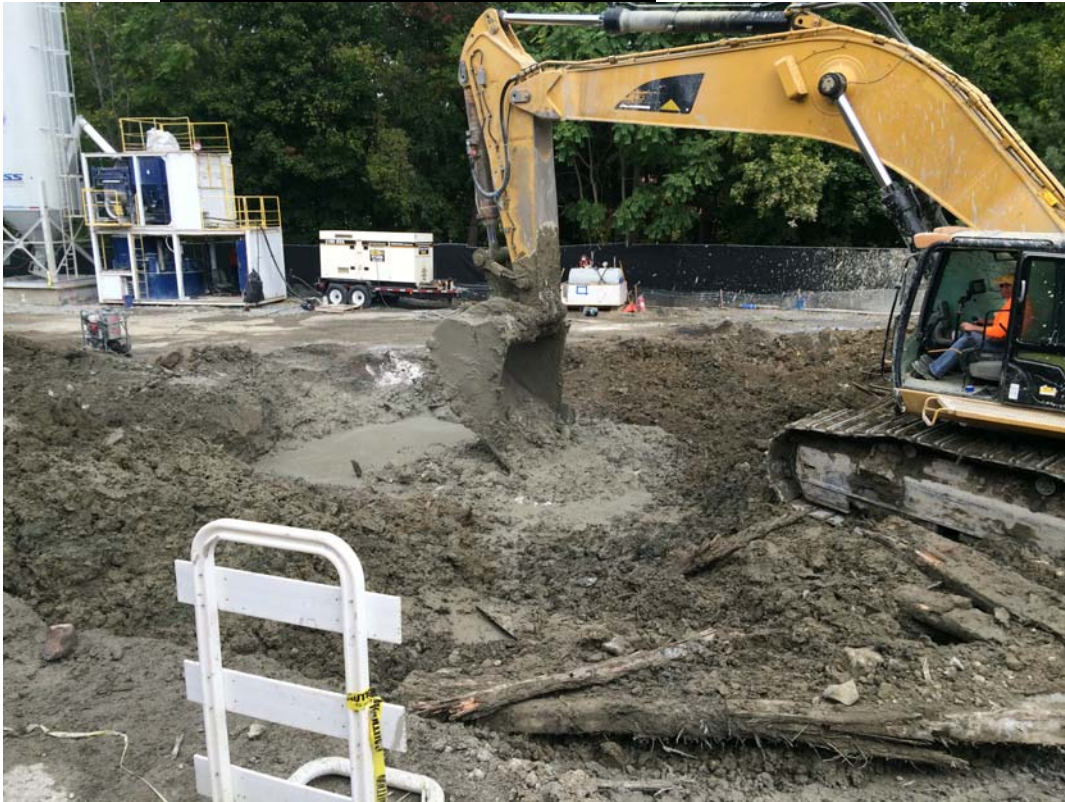
- Some wastewater from the frac tank was added to the ISS swell pile. CKD was mixed with the swell and the swell was prepped for loadout to Seneca Meadows.

Mixing ISS swell with CKD for offsite disposal

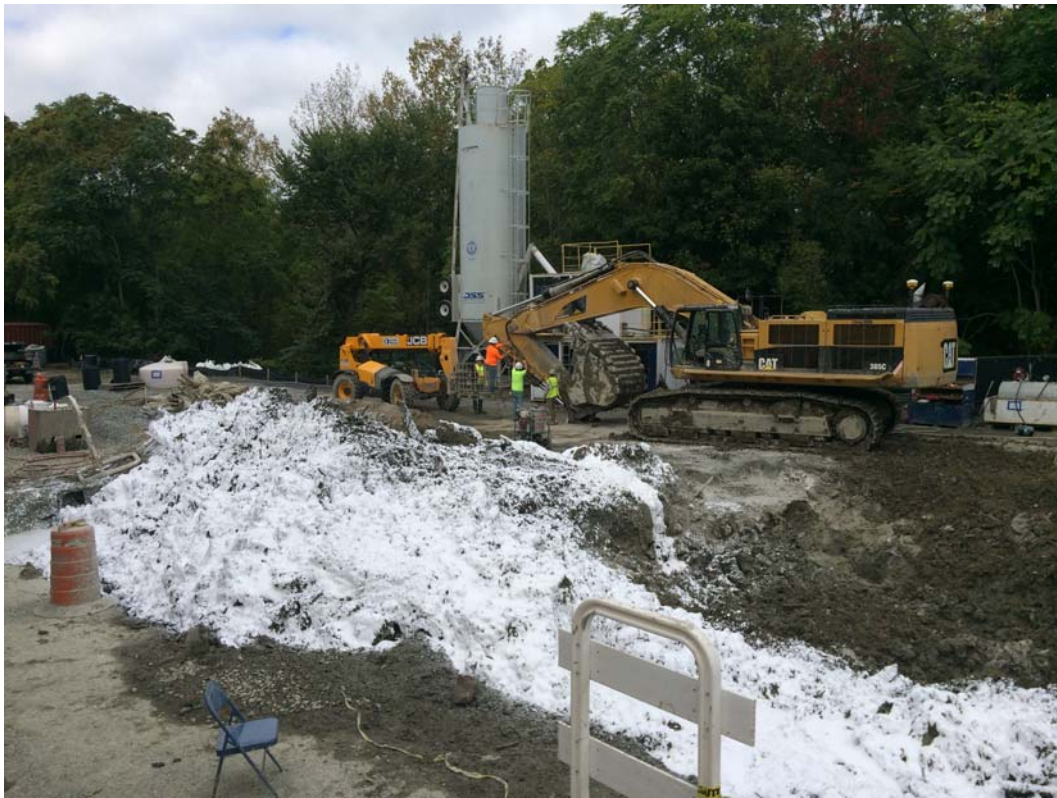
- Abscope performed ISS this date in ISS Area 2, southwest corner, Cell 2K. Abscope used a Cat 385C tracked excavator to mix ISS. The GPS on the excavator broke during ISS mixing of Cell 2J.

- GPS unit fixed at 13:45 and Abscope because remixing Cell 2J in order to get shots of the bottom. Abscope then moved on to mix Cell 2K.
- Slurry Engineering, Inc. ran the grout batch plant.

Contractor fixing GPS unit on excavator

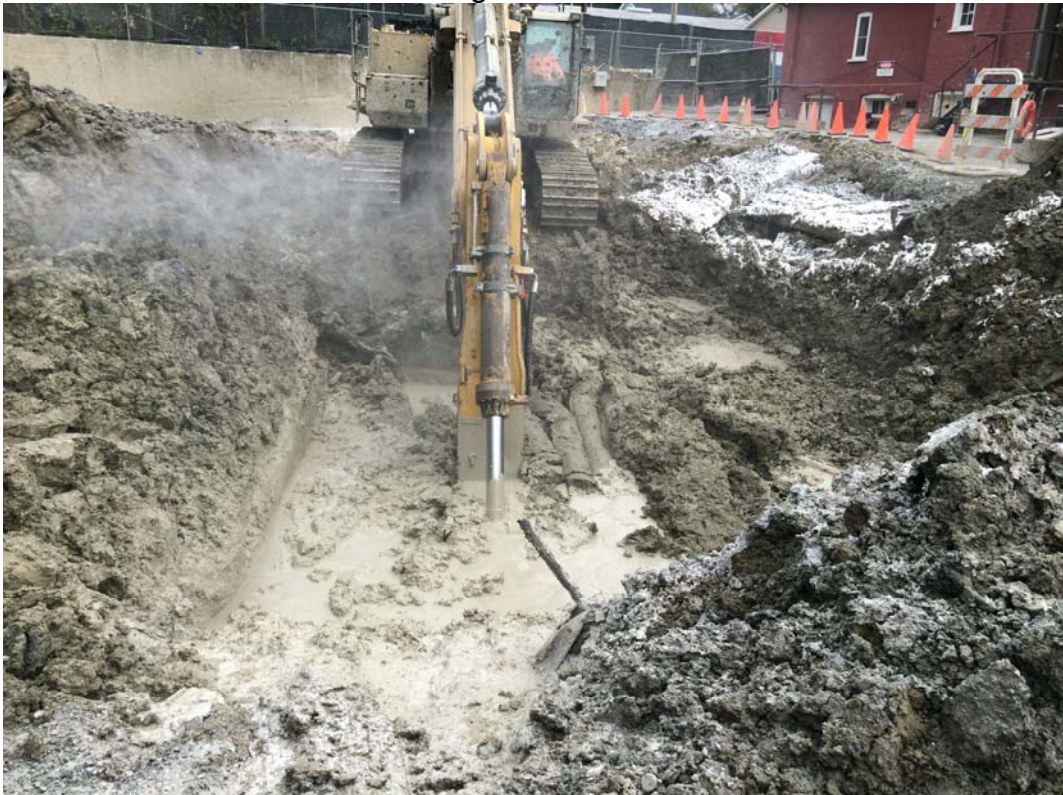
ISS Mixing on Cell 2K
