Mitigation System Installation Record

System Information	Site No: 3-60-009
System ID: 360009-BVM1	Site Name: Bedford Wells - Hunting Ridge
Owner Name:	X Owner Occupied
System Address: 420 Old Post Road	Talanhana
City: Bedford Zip:	10506 Alt. Telephone:
Contractor Information	
Installer Name: Chris Homicz	Company: Aztech Technologies, Inc
Telephone: 518-885-5383	
Building Conditions Building Type: Strip	Mall
Slab Integrity: O Poor	Average
Slab Penetrations: Sump Describe:	Floor drain Perimeter drain Other
No slab penetrations.	
Observed Water: Describe:	○ Damp ○ Sump only ○ Standing
No water observed.	
System Installation	
Installation Type: Sub-Slab Depressurization (A	ctive) Date Installed: Jul 6, 2009
Slab Thickess (inches): >5 in.	
Subslab Material: Gravel	Subslab Moisture: Damp
Number of Suction Points: 1	Number of Fans Installed: 1
🔀 Fan #1 Operating	Fan #2 Operating Fan #3 Operating
Fan Model No(s): GAST R5125-2	
Fan Serial No(s):	
Final U-Tube Levels: -59.00"

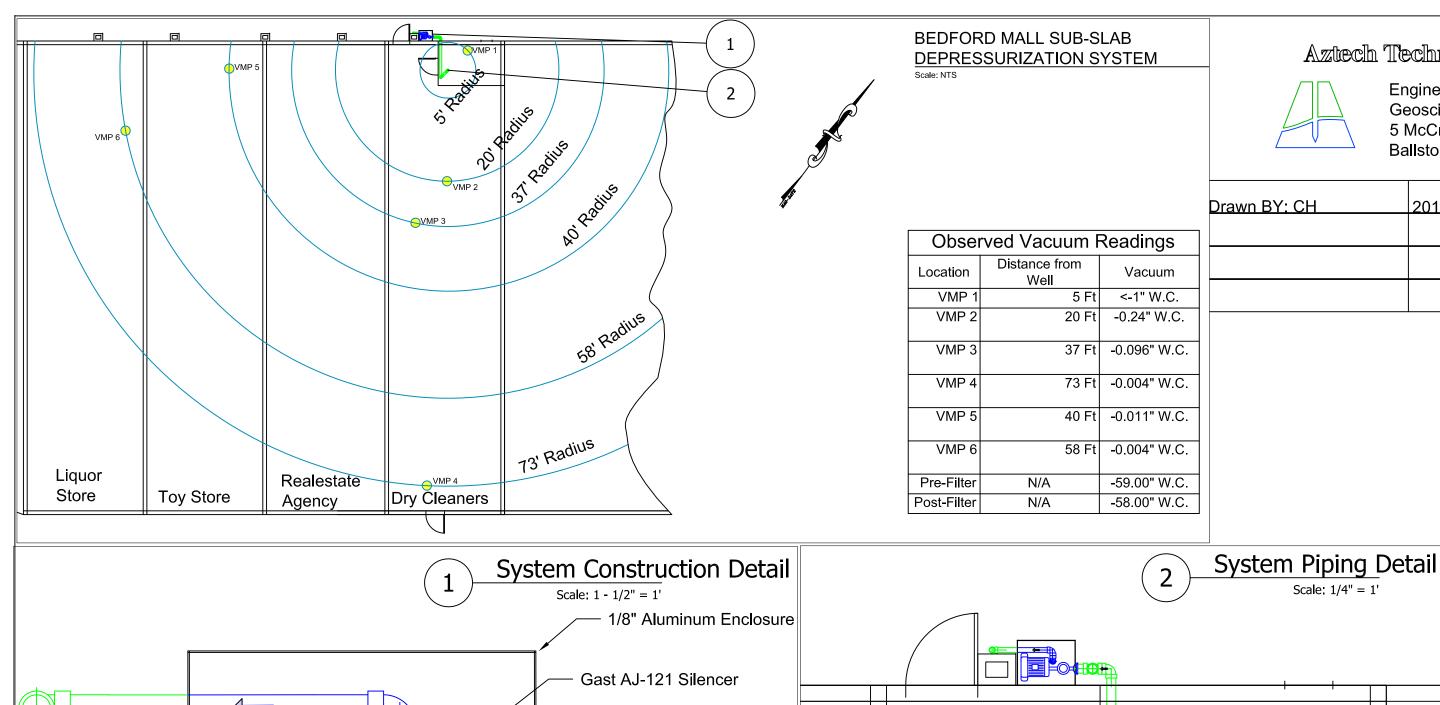
System Sketch (indicate notable features, location of extraction points, and communication test holes)
NORTH

Location	Reading/Result	Dist. From Suction Point (ft)	Passed?
#1	-1.0"	5'	X
#2	-0.24"	20'	X
#3	-0.011"	40'	X
#5	-0.004"	58'	X
#6	-0.004"	73'	X
