# **PROPOSED REMEDIAL ACTION PLAN BICC CABLES**

**Yonkers, Westchester County, New York  
Site No. 360051**

Division of Environmental Remediation  
New York State Department of Environmental Conservation

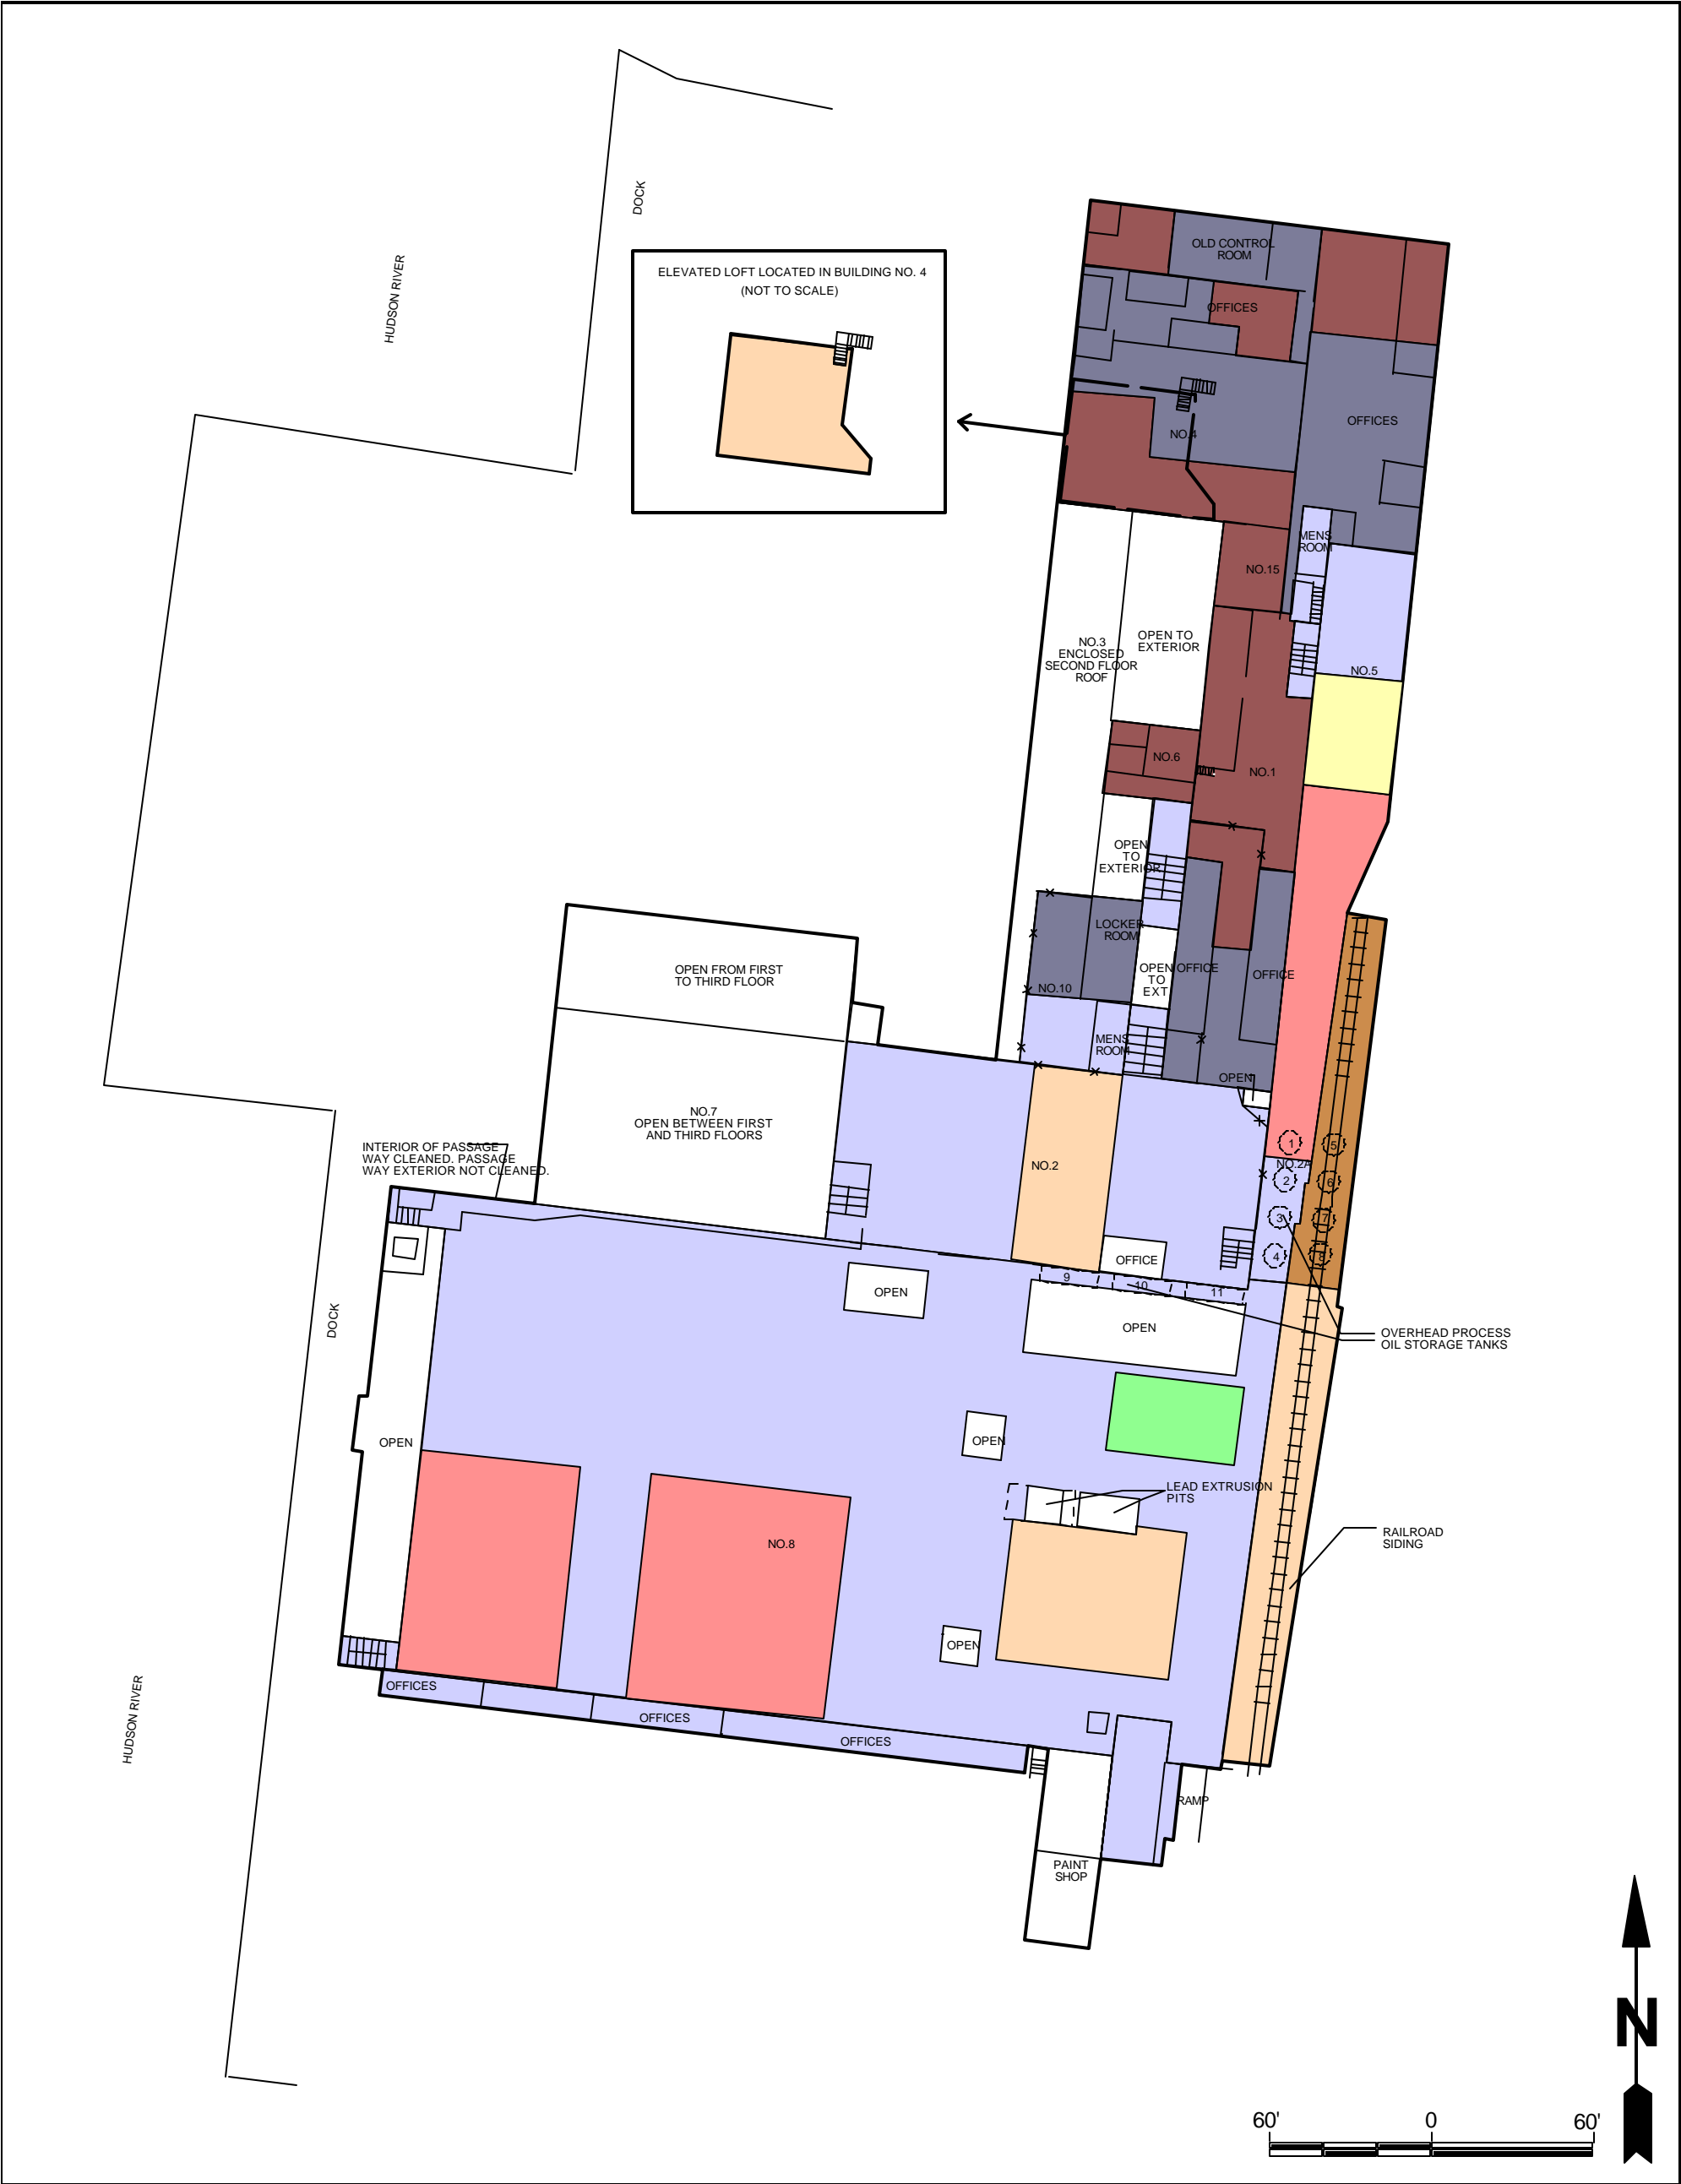
<div><div></div><div>EXTENT OF SURFICIAL ACCUMULATION/SURFICIAL IMPACTS ON CONCRETE BUILDING MATERIAL LESS THAN THE SURFACE SCGs IN POST CLEAN SAMPLES [50,385 SF (EXCLUDES STAIRWELLS)]</div></div> <div><div></div><div>EXTENT OF IMPACTED BULK CONCRETE BUILDING MATERIAL WITH SURFICIAL IMPACTS FOR LEAD AND/OR PCBs GREATER THAN THE SCGs TO A MAXIMUM OF 1/16-INCH (9,745 SF)</div></div> <div><div></div><div>EXTENT OF IMPACTED BULK CONCRETE BUILDING MATERIAL WITH PCBs GREATER THAN THE SCGs TO A MAXIMUM OF 1/2-INCH (1,345 SF)</div></div> <div><div></div><div>EXTENT OF IMPACTED BULK CONCRETE BUILDING MATERIAL WITH PCBs GREATER THAN THE SCGs TO A MAXIMUM OF 1-INCH (1,370 SF)</div></div> <div><div></div><div>EXTENT OF IMPACTED BULK CONCRETE BUILDING MATERIAL WITH PCBs GREATER THAN THE SCGs DEEPER THAN 1-INCH (14,100 SF)</div></div>		<div><div></div><div>EXTENT OF SURFICIAL ACCUMULATION/SURFICIAL IMPACTS ON WOOD BUILDING MATERIAL (13,650 SF)</div></div> <div><div></div><div>EXTENT OF IMPACTED BULK WOOD BUILDING MATERIAL (11,340 SF)</div></div> <div><div></div><div>EXTENT OF CONCRETE SLAB REMOVAL TO FACILITATE SOIL EXCAVATION</div></div>		<div>NOTES:</div> <div>PCB - POLYCHLORINATED BIPHENYL</div> <div>CONCRETE SLABS IN THE PAINT SHOP WILL BE ADDRESSED WITH THE SOIL/FILL REMEDIAL ALTERNATIVES</div>		<div>Title:</div> <div>EXTENT OF IMPACTED BUILDING MATERIAL ON THE SECOND FLOOR</div> <div>PROPOSED REMEDIAL ACTION PLAN</div> <div>Prepared For:</div> <div>BICC CABLES CORPORATION YONKERS, NEW YORK</div> <div><div><div>ROUX</div><div>ROUX ASSOCIATES INC Environmental Consulting &amp; Management</div></div><div><div>Compiled by: RSK</div><div>Prepared by: RSK</div><div>Project Mgr: JEP</div><div>File No: 1B0130814.WOR</div></div><div><div>Date: 10/8/2004</div><div>Scale: SHOWN</div><div>Office: NY</div><div>Project: 62401Y</div></div><div>FIGURE</div><div>14</div></div>

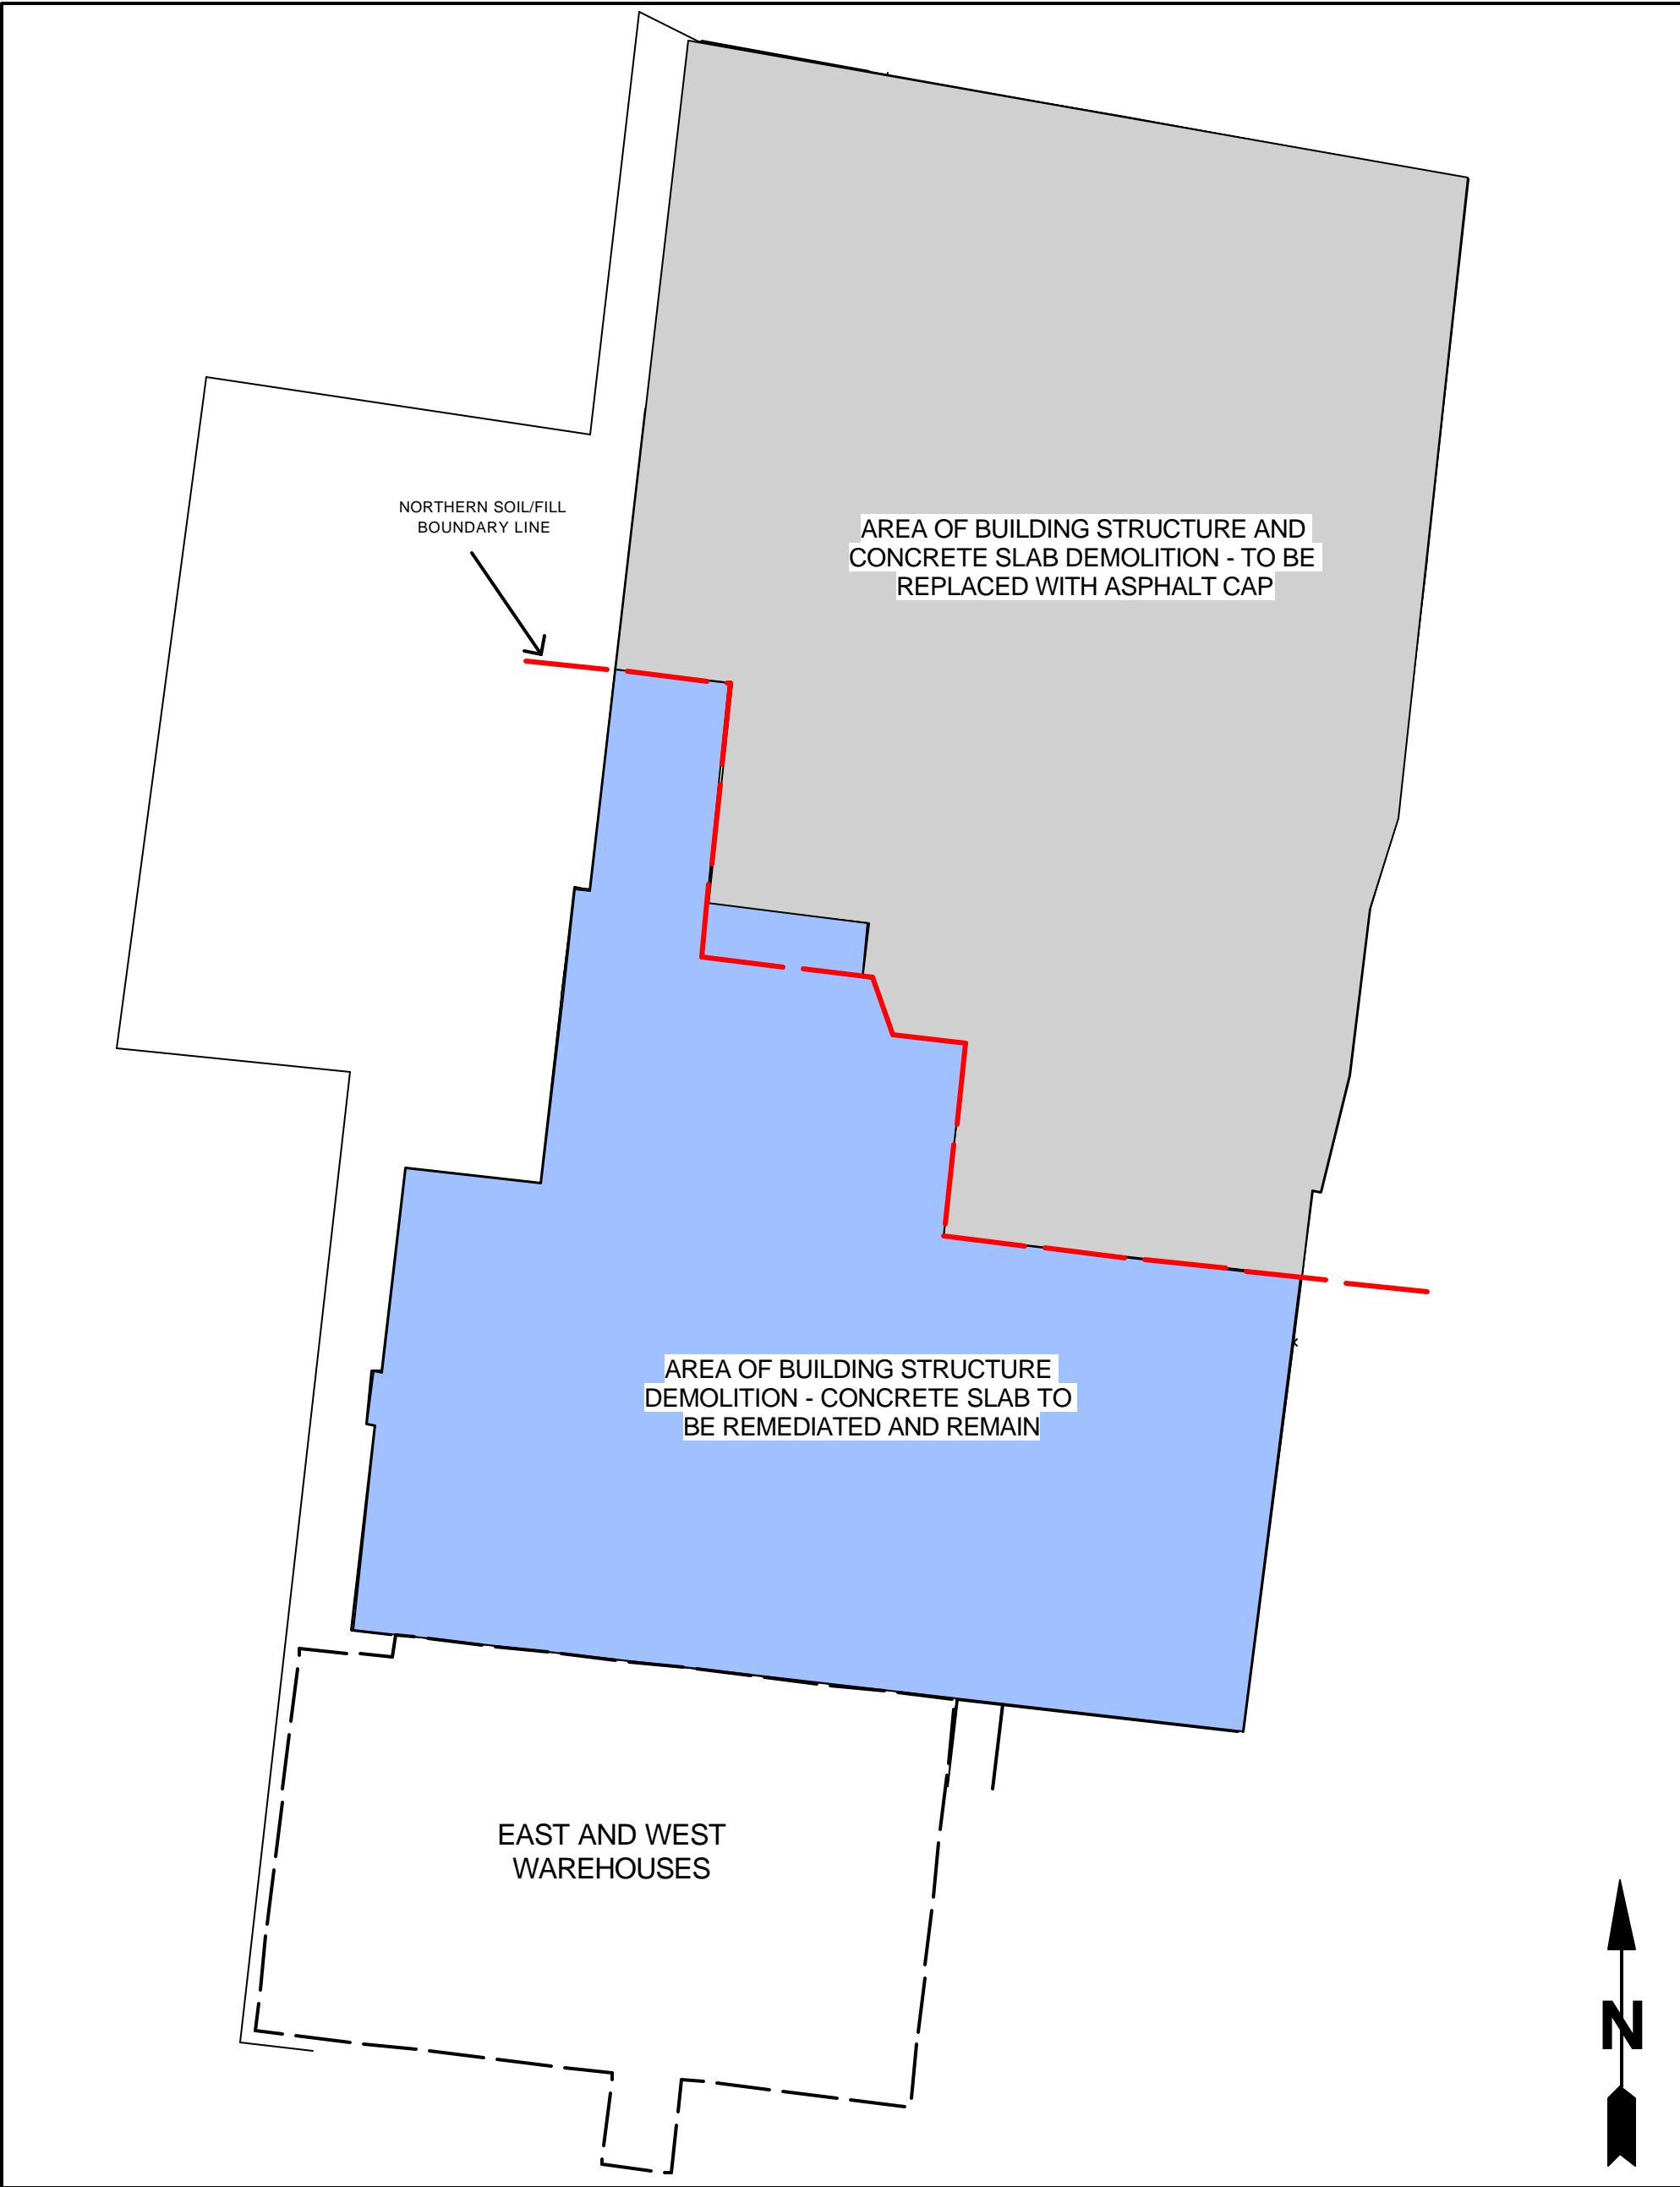
EXTENT OF BUILDING STRUCTURE AND CONCRETE SLAB DEMOLITION - SLAB TO BE REPLACED WITH ASPHALT CAP
-

Alternative I4 would entail demolition of all the Site buildings to address the impacted building materials. This does not include the East and West Warehouses, Paint Shop and guardhouse because, as discussed above, the East and West Warehouses, Paint Shop and guardhouse are addressed in the soil/fill alternatives. Under this alternative, all buildings located north of Buildings 7, 8 and 9 and constructed on soil/fill would be removed, including the concrete slab on grade. The concrete slab on grade would be replaced with asphalt to provide a cover for the Below Building historic fill (see Figure 18). The second, third and fourth floors of the southern buildings constructed on timber support piles (Building Nos. 7, 8, and 9) would be removed. The first floor concrete slab supported by the timber piles would remain in place (see Figure 18). This slab would be treated to meet the surface and bulk SCGs. Areas of the remaining concrete slab that exceed the bulk SCG would be subject to either concrete micro-removal or bulk removal, as needed. The remaining floor slab would be treated to meet the surface SCGs. Peeling and chipping lead-based paint on building surfaces would be removed prior to building demolition. All known ACM would be removed and disposed prior to demolition activities.
