# **SITE MANAGEMENT PLAN**

Site Management Activities  
Northeastern Industrial Park AOC 1 and 7  
C02NY000203  
Former Schenectady Army Depot  
Guilderland, New York

**Revision 1, December 2018**

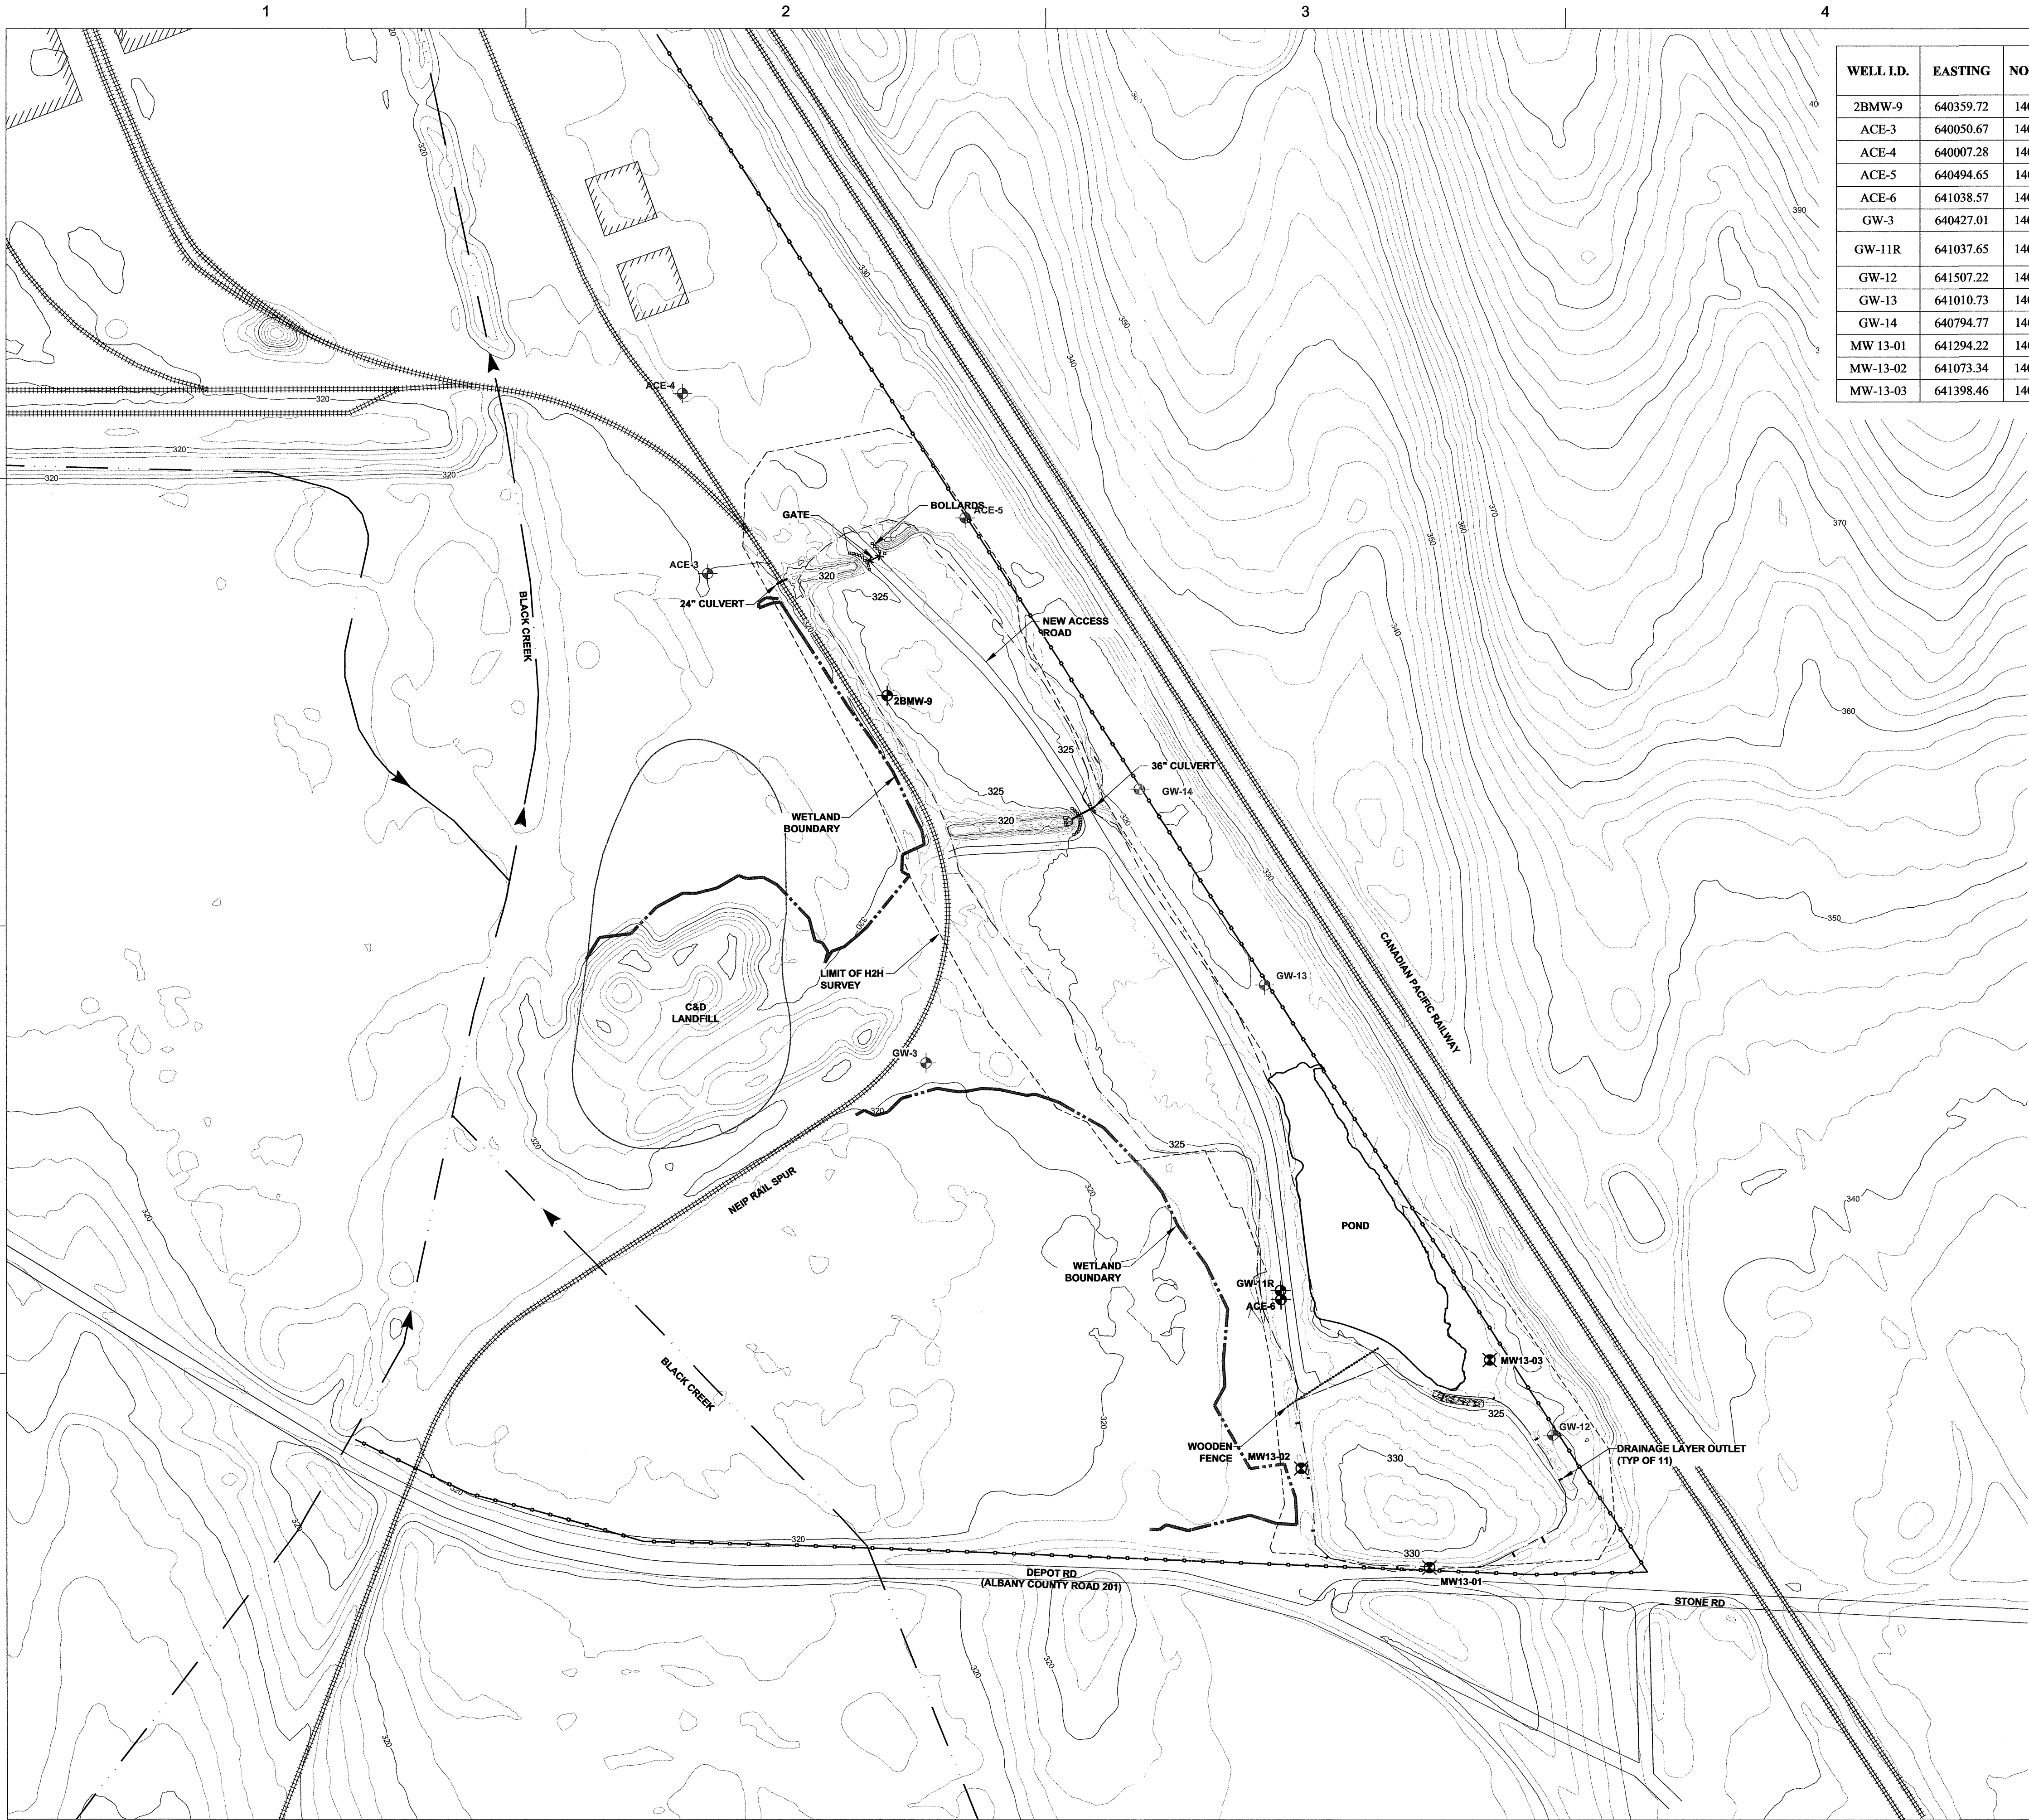
SHEET  
IDENTIFICATION  
C-1  
SHEET 2 OF 9

SITE PLAN
