RE: Ground Water Pump and Containment
System Decommissioning Report
David Axelrod Institute Site (Site No.: 401031)
ERM Project No.: EC190.00

PHOTOGRAPHIC LOG
DAVID AXELROD INSTITUTE FACILITY
ALBANY, NEW YORK
NYSDEC SITE NUMBER 401031
ERM PROJECT NUMBER EC190.00

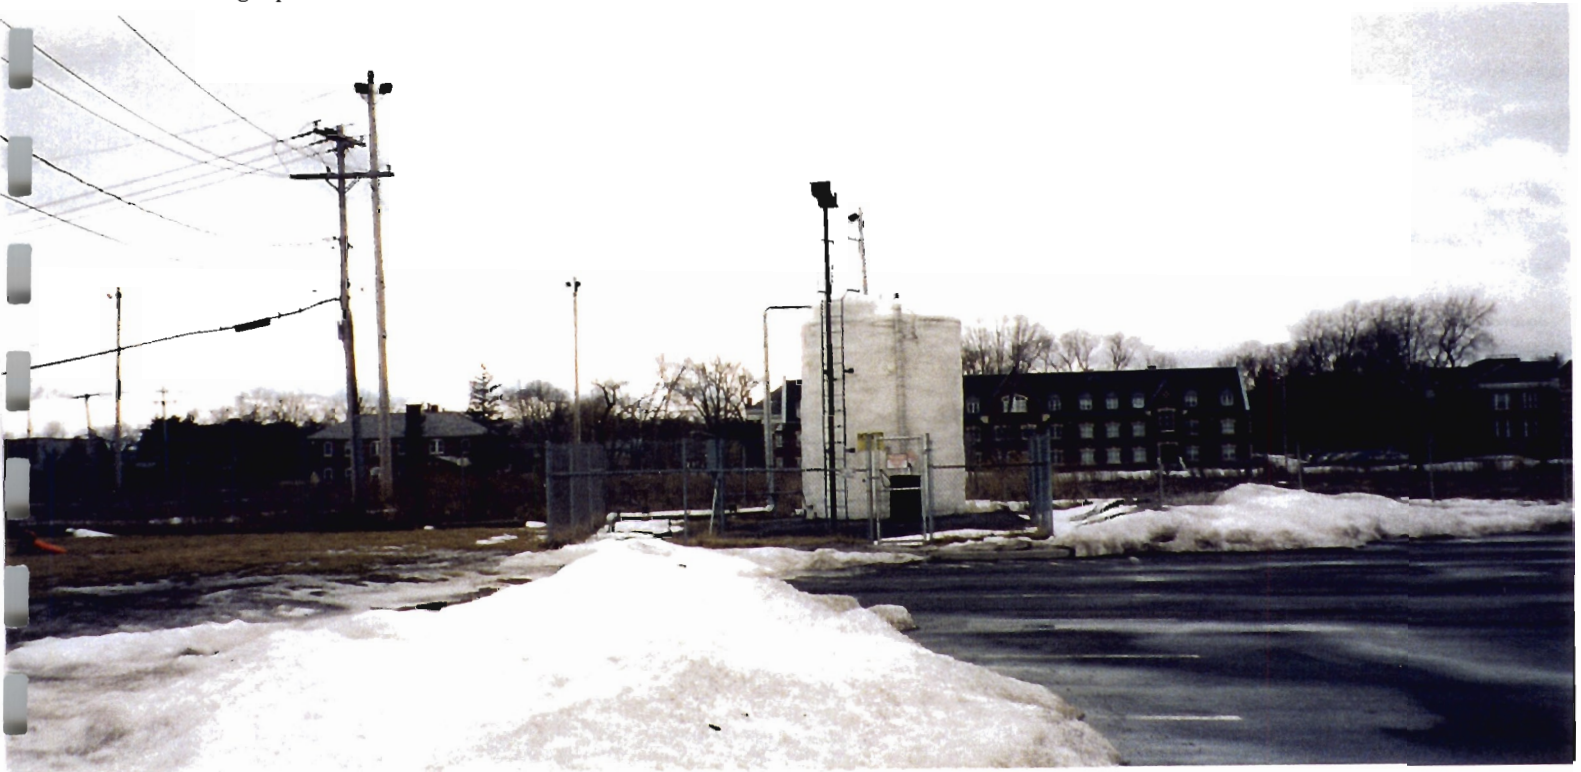
Photograph #01 - Ground water pump and containment system located at the Southwest corner of the David Axelrod Institute Facility parking lot.

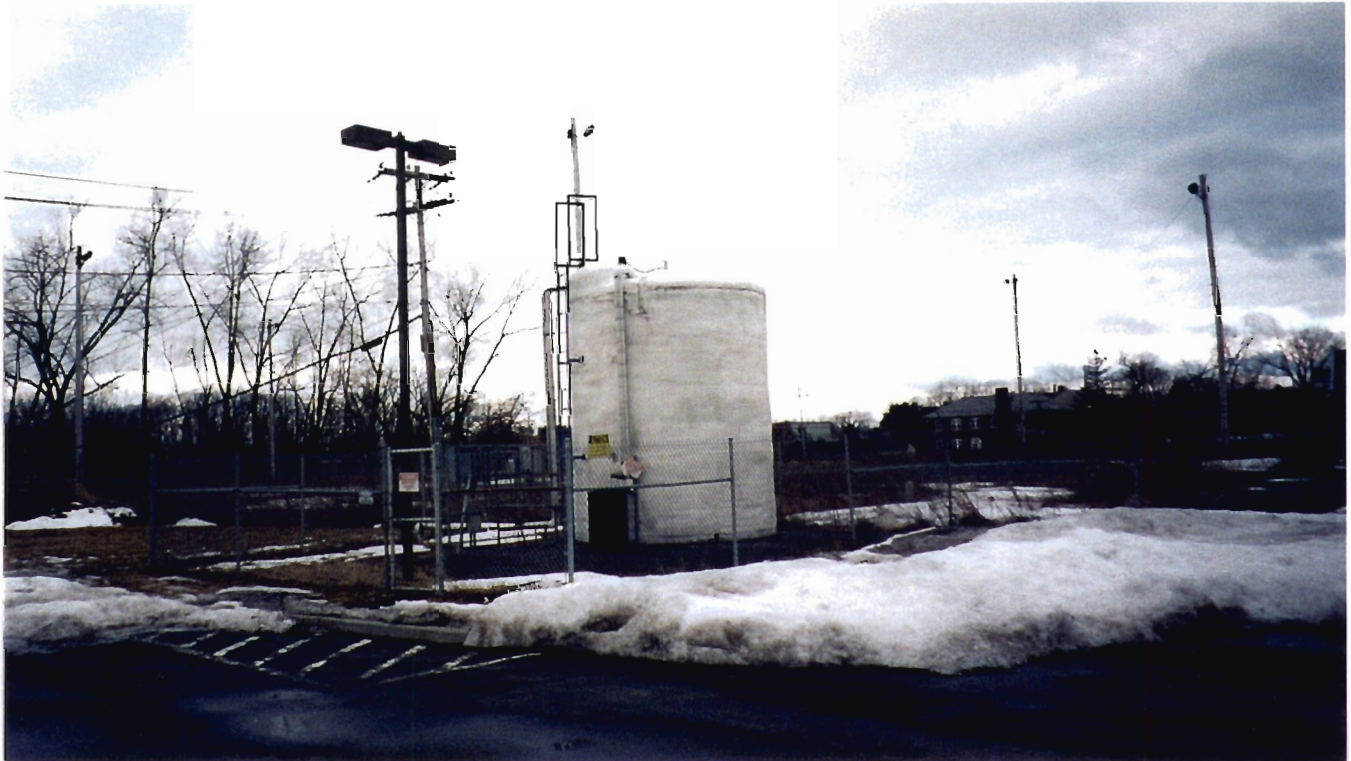
Photograph #03 - View of the pump and containment system towards the southwest.

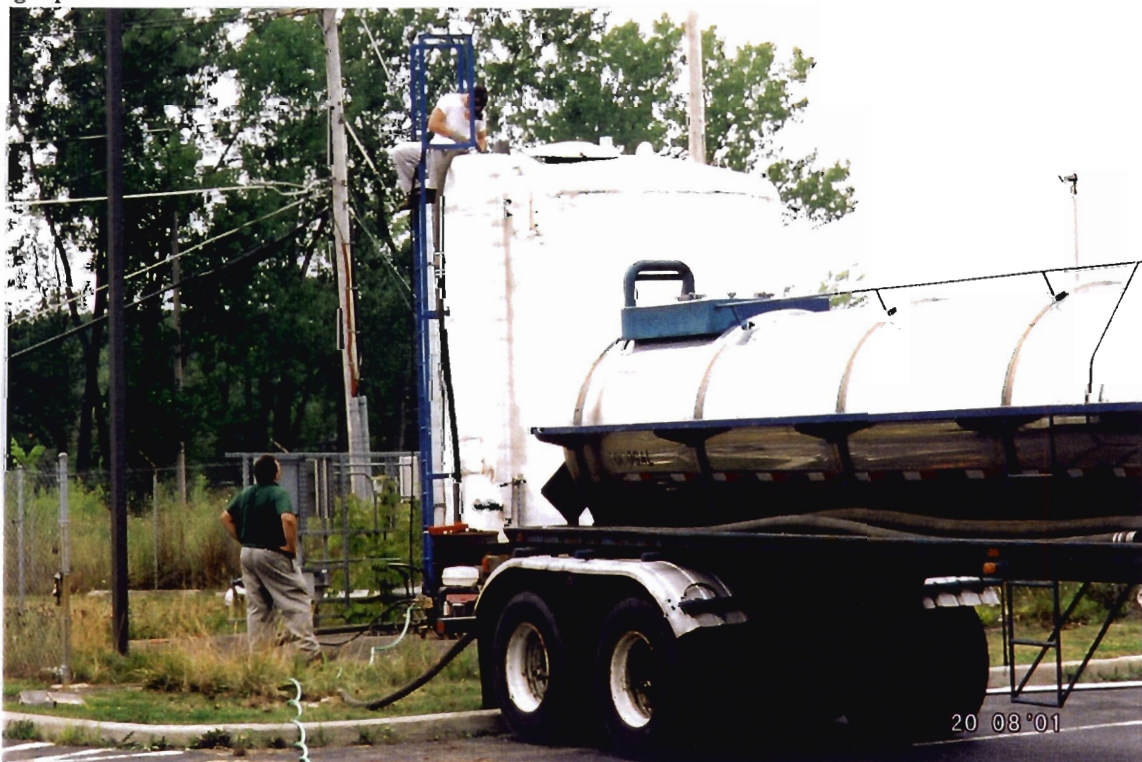
Photograph #04 - Steam cleaning the containment tank. Tanker truck vacuuming liquids from steam cleaning process.

On 20 August 2001 ECOR removed from service and steam cleaned the 5,000-gallon dual containment polypropylene storage tank. The tank was accessed through a man-way located at the top of the tank.

Decontamination water was vacuumed out from the bottom of the tank into a Tonawanda Tank Transport Service, Inc. tanker truck. A hole was cut into the side of the containment tank near the bottom in order to steam clean the sludge and decontamination water into an area where the sludge and water could be easily vacuumed out by the tanker truck. One gallon of Simple Green™ detergent was mixed with and sprayed through steam cleaner to thoroughly spray down and clean the sidewalls and bottom of the containment tank. The steam cleaning process generated approximately 700 gallons of wastewater.

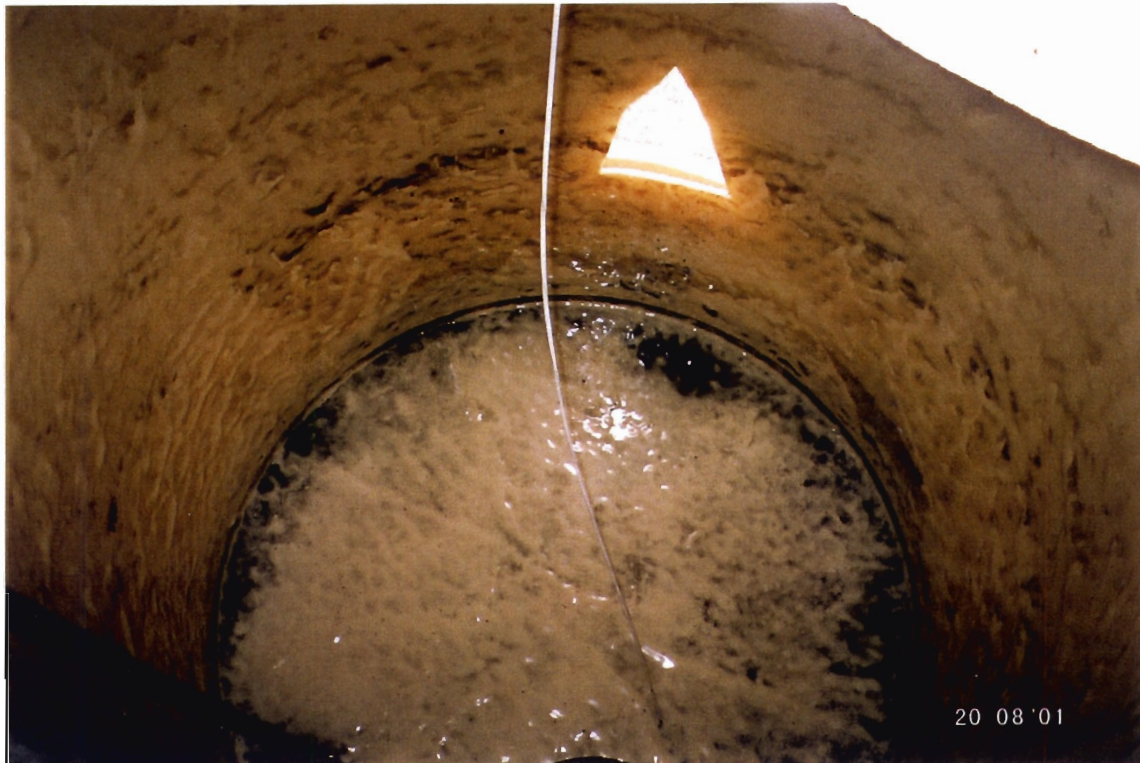
Photograph #05 - Inside view of the containment tank (from the top of the tank) near the end of steam cleaning process.

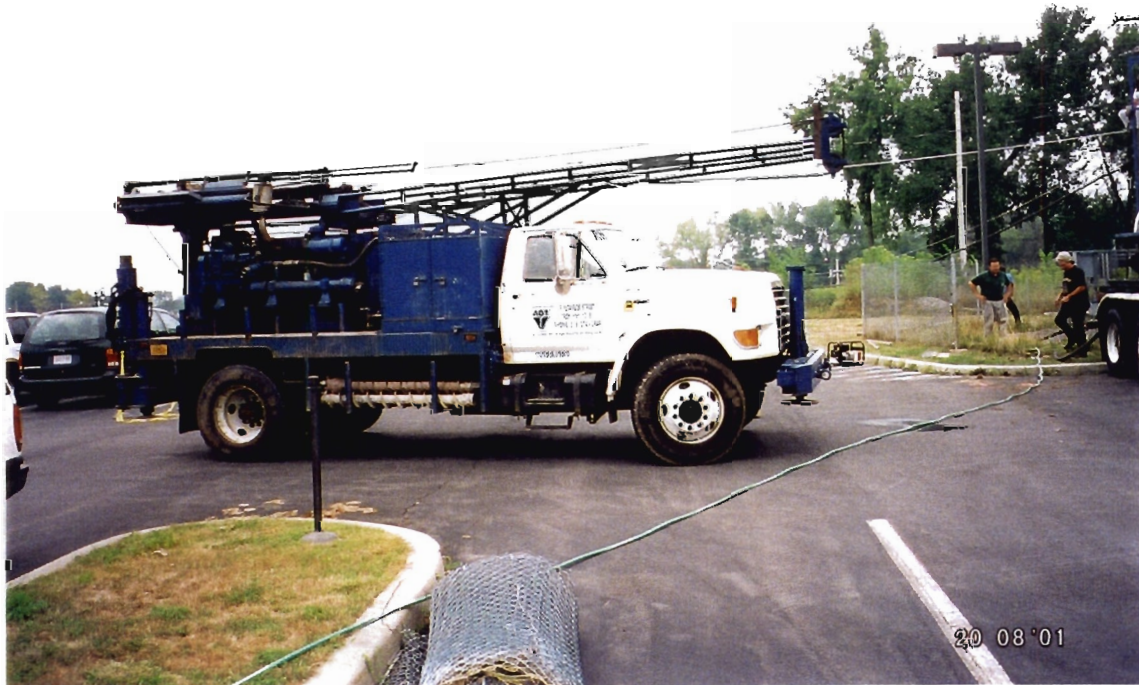
Photograph #06 - Aquifer Drilling and Testing's drill rig used for the monitoring well abandonments.

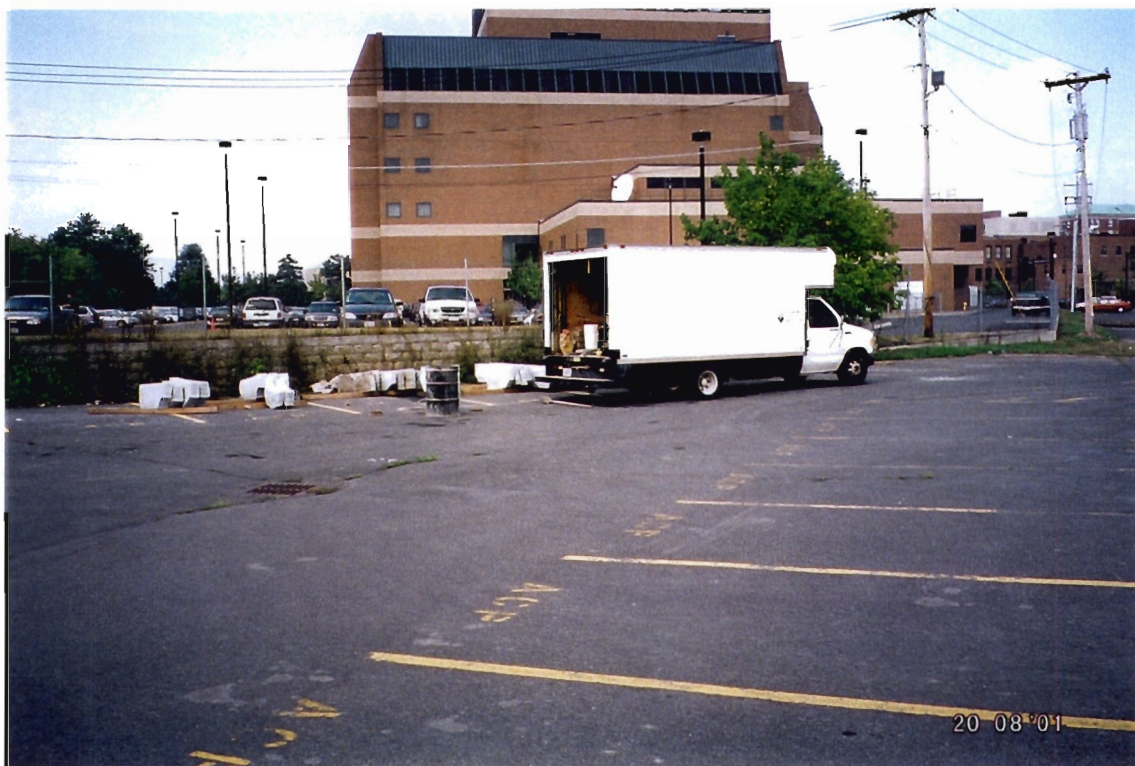
Photograph #07 - Aquifer Drilling and Testing's support vehicle used for the monitoring well abandonments.

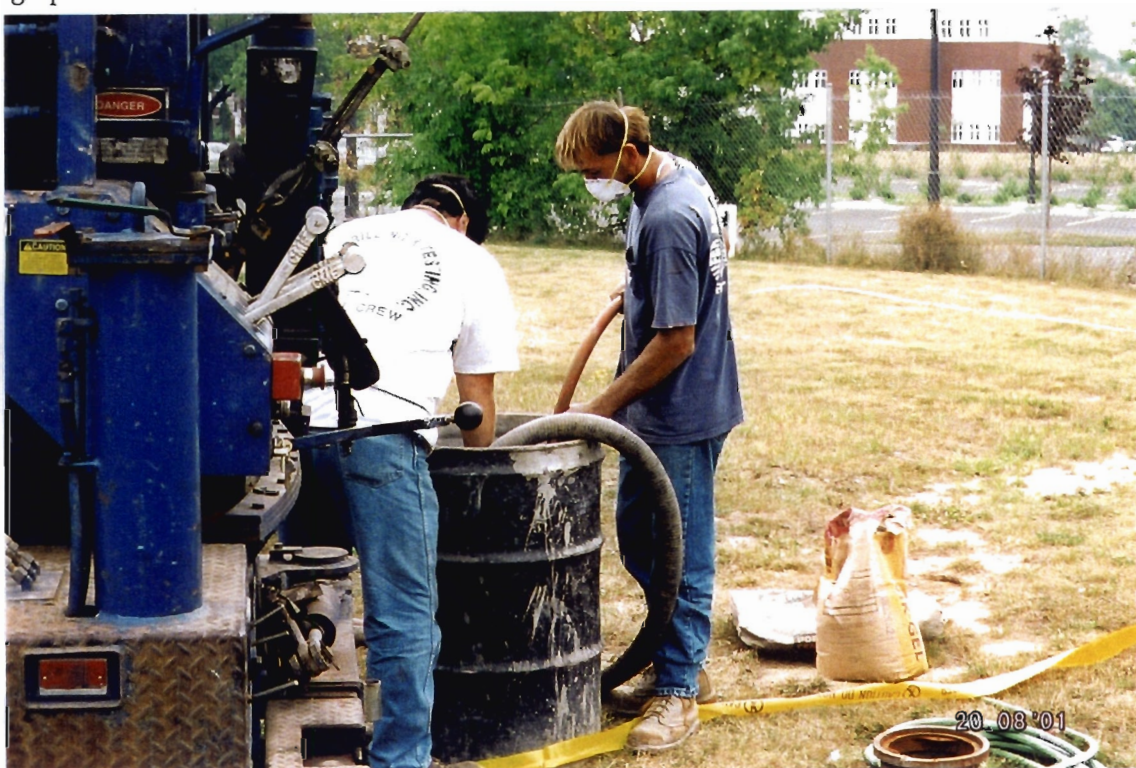
Photograph #08 - Mixing of the bentonite grout slurry used to decommission the monitoring wells.

The protective curb boxes and guard pipes were removed from the ground and placed in the metal recycling pile. The monitoring wells were grouted in place using a Portland cement/bentonite grout mixture to preclude a pathway for future contamination of the deep saturated zone. Monitoring wells MW-1M, MW-3S, MW-6S, MW-9S and MW-9M were not located at the site and are believed to have been either paved over or permanently destroyed during site construction activities. Monitoring well MW-3M was located with the protective guard pipe cut off and the casing filled with miscellaneous soils, gravel and debris. A cement/bentonite grout mixture was placed over the destroyed

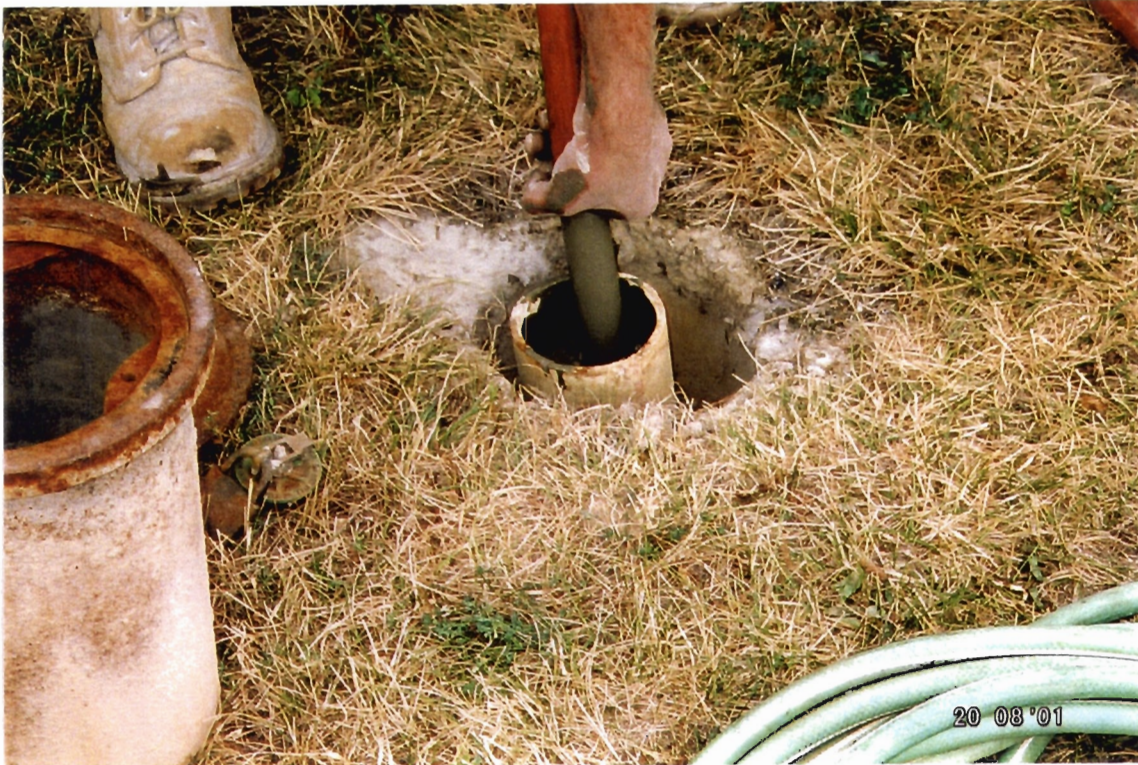
Photograph #09 - Pumping of the bentonite grout slurry into monitoring well MW-7D.

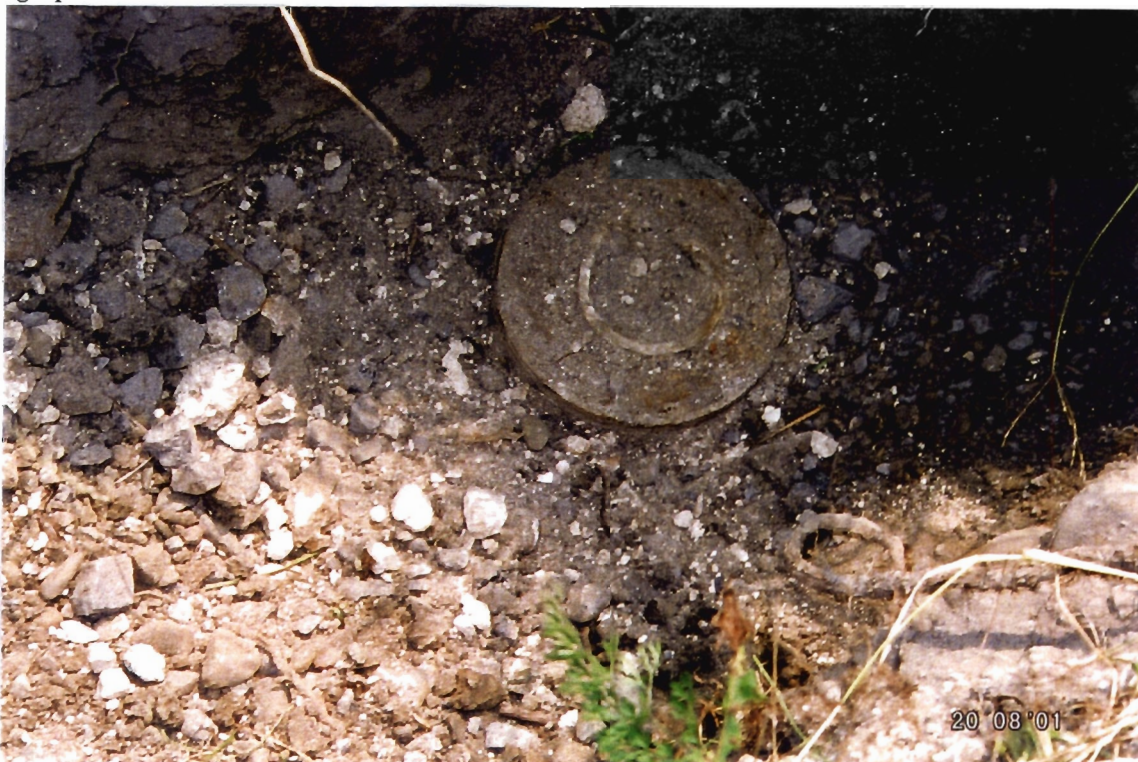
Photograph #10 - Monitoring well MW-3M found buried approximately one and a half feet below grade. The protective guard-pipe was found sheared off and the well was filled with soil and gravel.

monitoring well MW-3M. The recovery well was cut off below grade and capped with a J type plug for future accessibility. A schematic plan showing the locations of the decommissioned monitoring wells, the monitoring wells that were not located and the shallow monitoring wells that were left in place is detailed in Figure 2, Appendix A, attached.

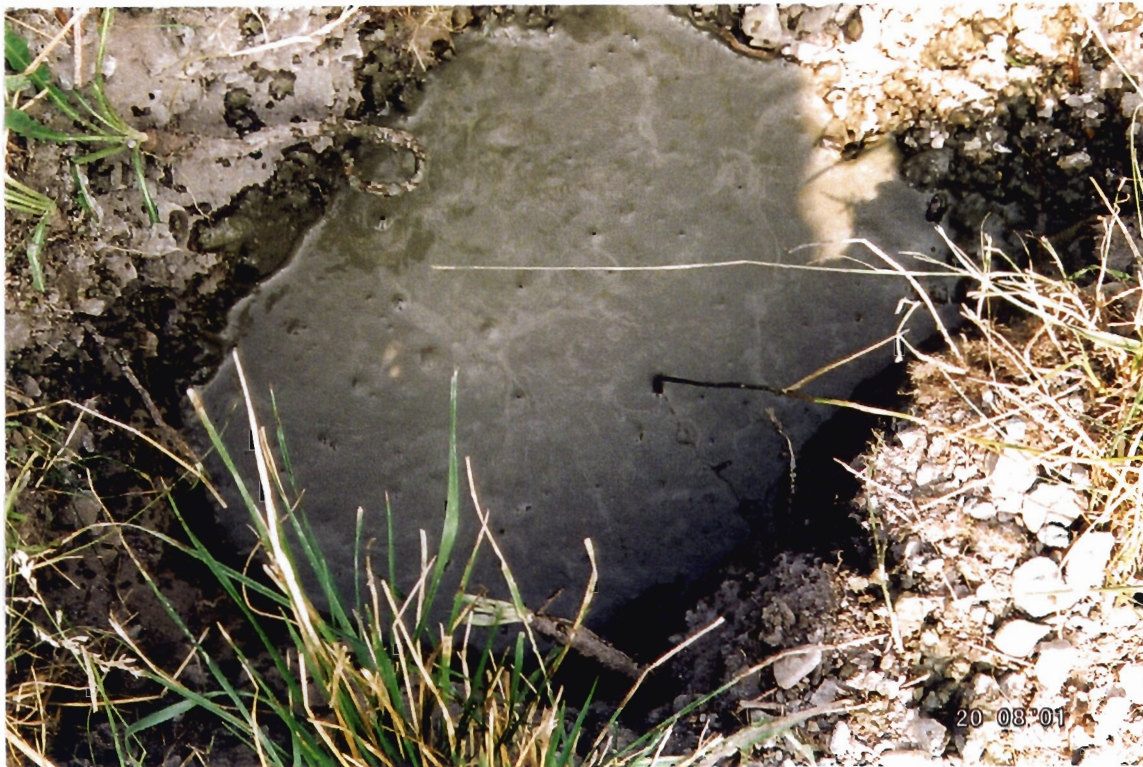
Photograph #11 - A bentonite slurry was placed over monitoring well MW-3M.

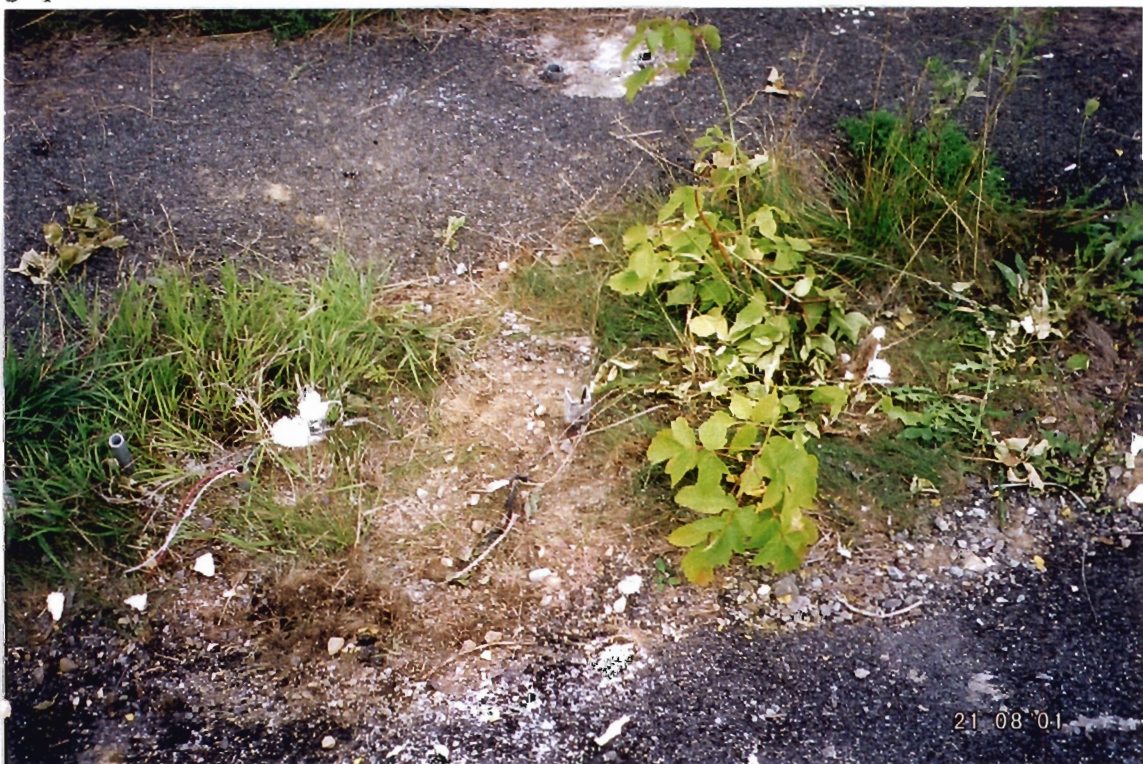
Photograph #12 - View of electrical conduits cut to grade and capped with foam insulation.

ERM and ECOR met with Mr. Bill Stone the NYSDOH facility maintenance manager to locate the electrical breakers for the pump and containment system within the NYSDOH facility. Mr. Stone indicated the breakers servicing power to the system were set to the off position. Mr. Stone indicated that he would have one of the facility's electrician remove the breakers from the service panel and secure the system feed wires. ECOR cut the electrical service wires on the outside system breaker panel. The wires were tapped to a pull string and pulled from the electrical service junction box approximately two feet below grade into the rigid conduits. The rigid conduits were then cut at grade and filled with foam insulation so that the pull string was exposed allowing for access of electrical service at the site in the future, if required.

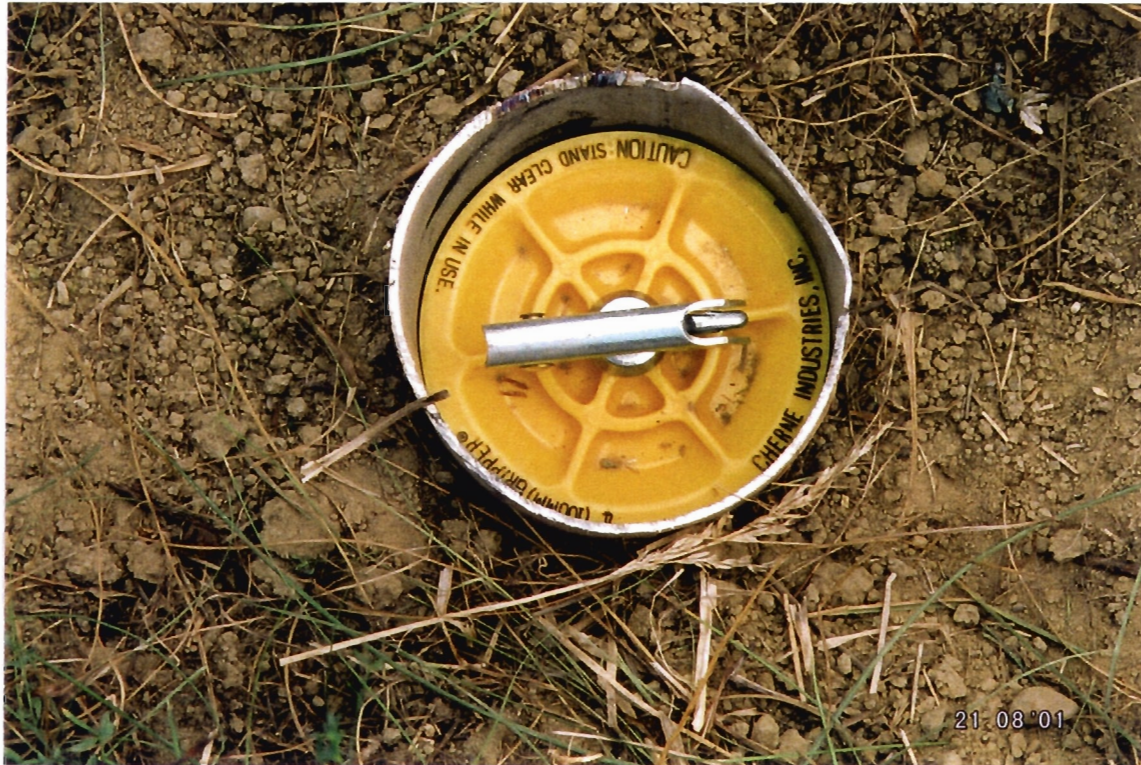
Photograph #13 - View of recovery well cut six inches below grade and capped with J-plug.

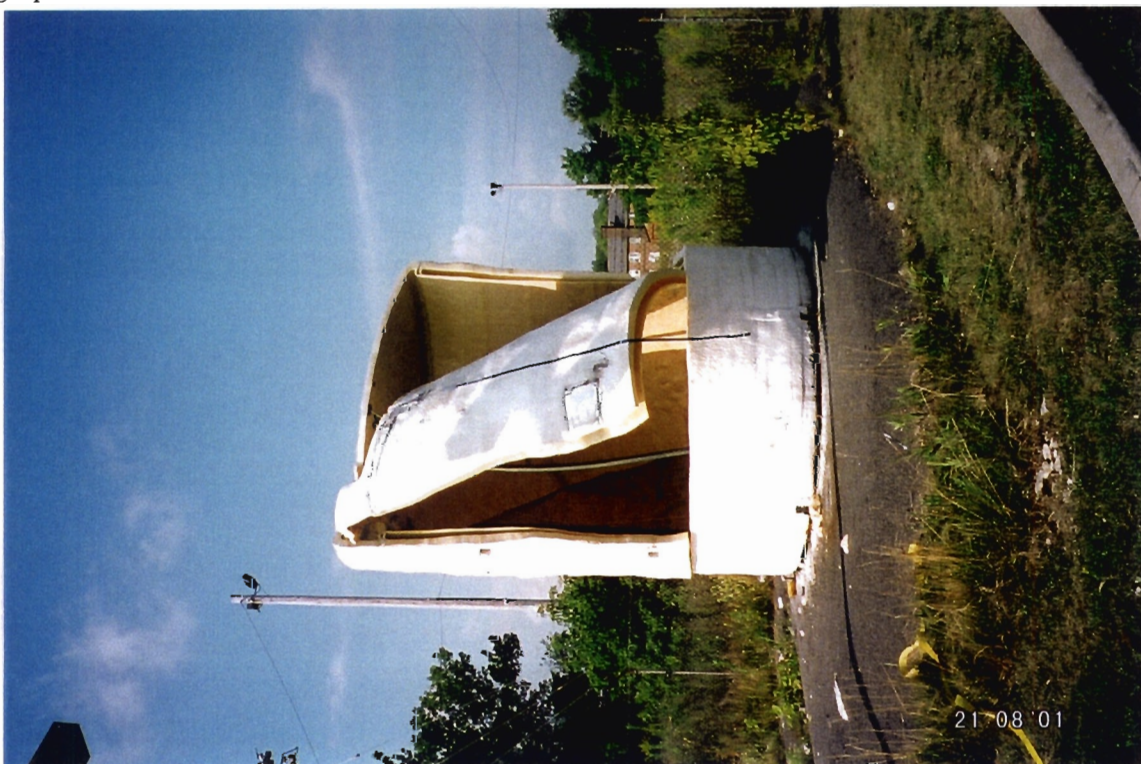
Photograph #14 - Containment tank cut in thirds (top of picture on left side of page).

On 21 August 2001 ECOR cut the 5,000-gallon containment tank into thirds using electric saws. The tank thirds were then cut into smaller pieces and placed in a roll-off container for disposal. The bolts that secured the tank to the tank-pad were all cut at grade.

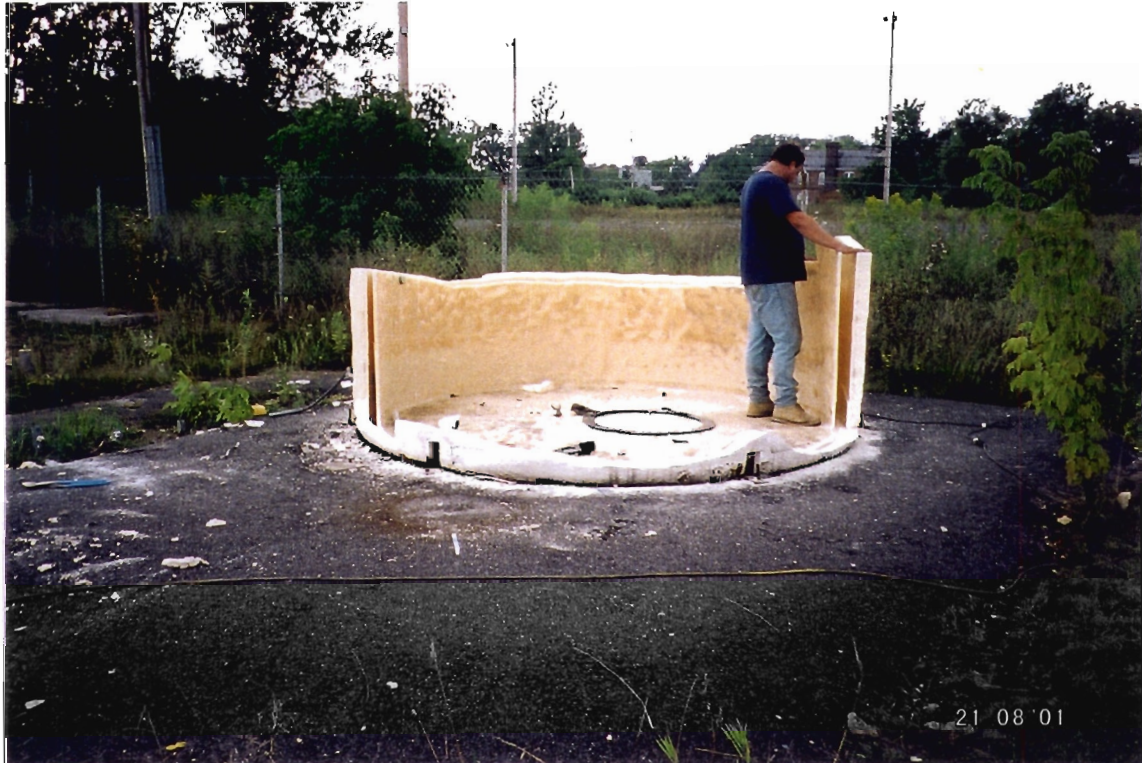
Photograph #15 - Bottom third of containment tank being cut up for disposal.

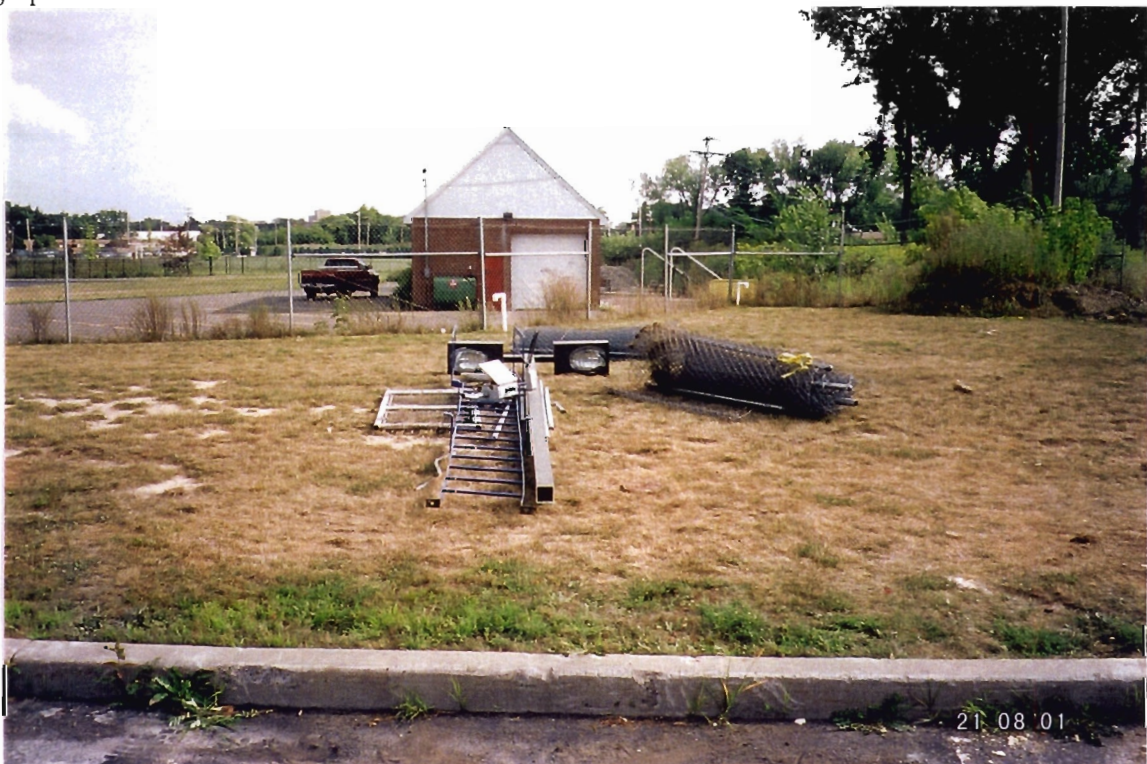
Photograph #16 - Metal scraps from fence, light pole and control panels staged for recycling.

and containment system. The chain link fence was detached from the fence posts, rolled up and staged for metal recycling. The fence posts and electrical panel racks were also cut at grade and staged for metal recycling.

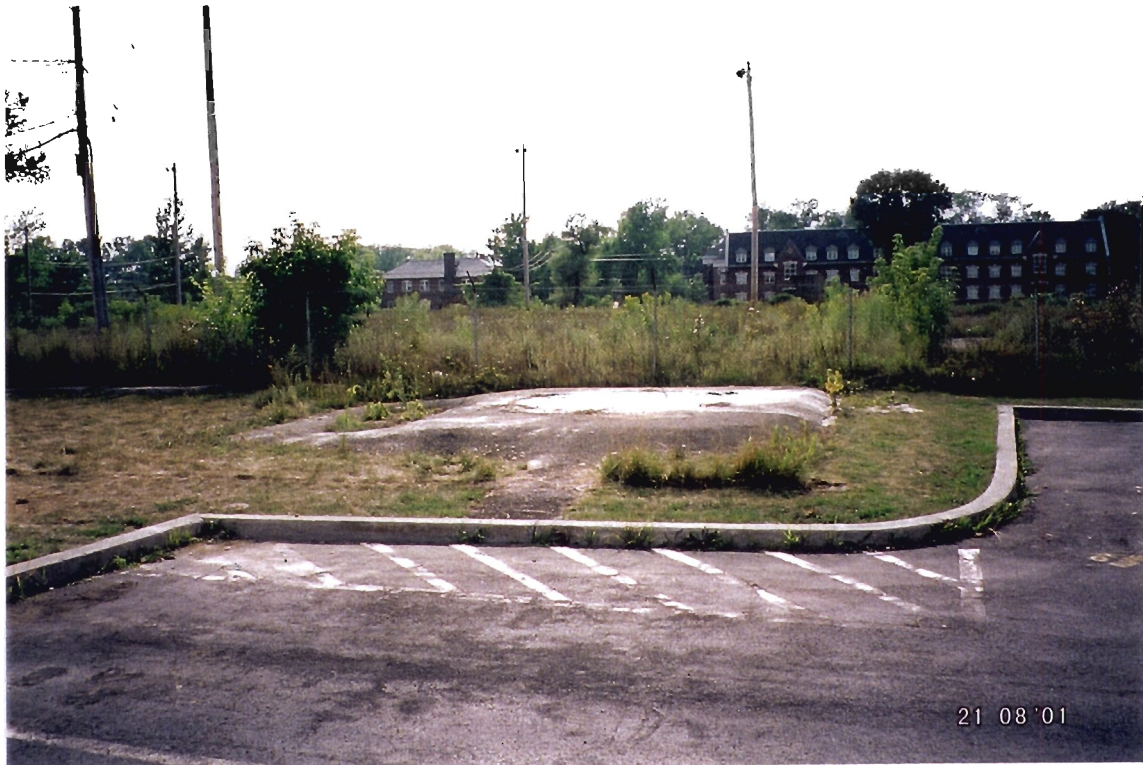
Photograph #17 - Tank pad area.

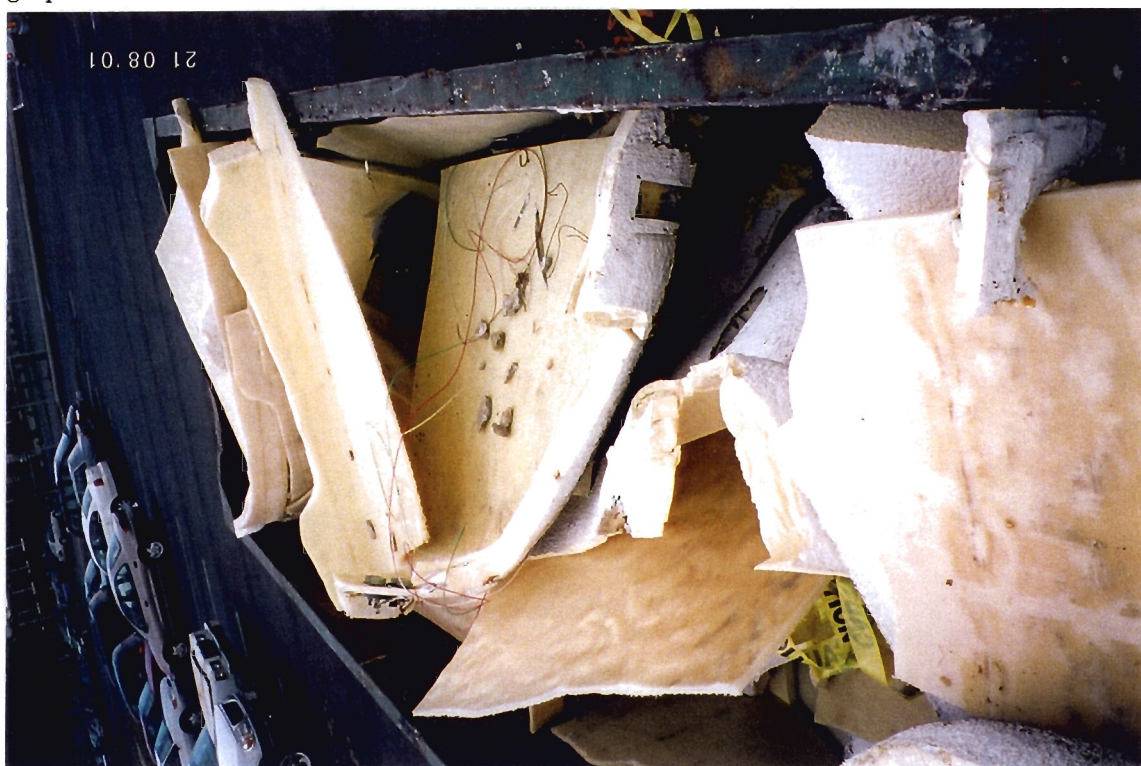
Photograph #18 - Roll-off dumpster with cleaned cut containment tank and associated debris (top of picture on left side of page).

Waste generated during the dismantling of the ground water pump and containment system was separated into waste water, scrap demolition and metal recycling. Approximately 4.06 tons (973 gallons) of residual tank water, steam cleaner decontamination water and sludge were vacuumed from the containment tank by Tonawanda Tank Transport Service, Inc. and transported to CECOS International for recycling and disposal. The waste manifests are attached in Appendix C. Metal generated from the system dismantling was staged for recycling. The decontaminated polypropylene dual containment tank and associated piping along with miscellaneous ancillary system components were staged in a roll-off dumpster for appropriate disposal.

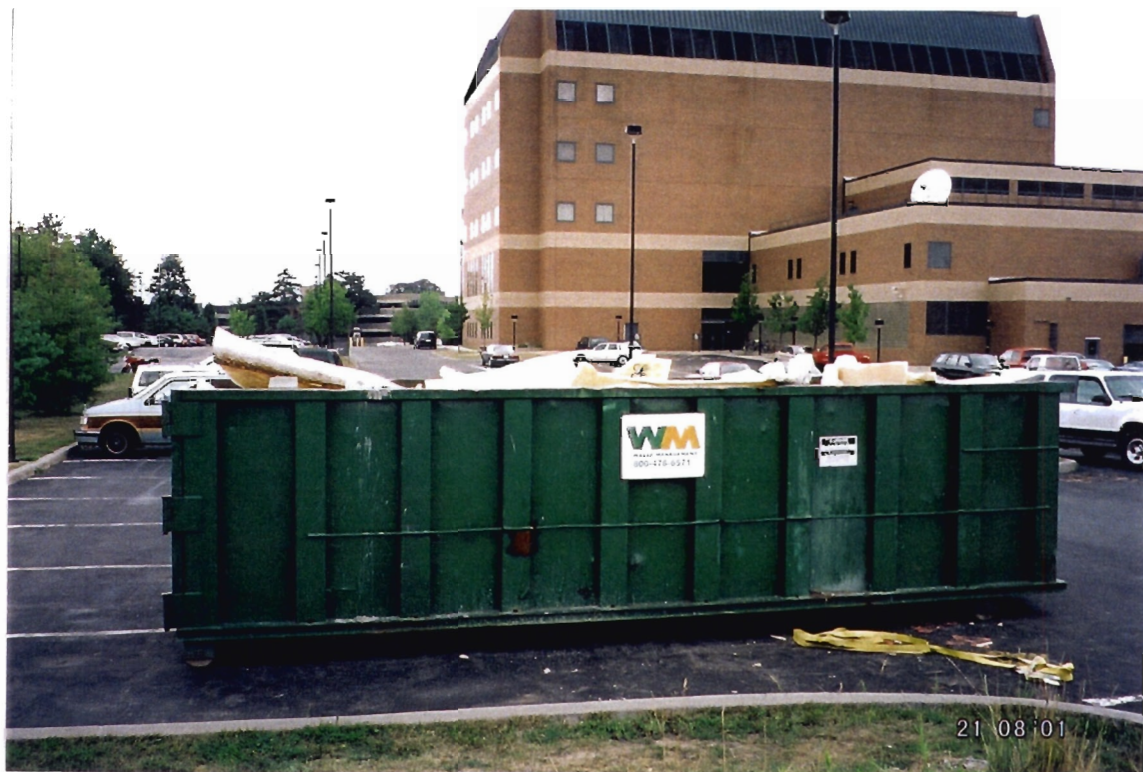
Photograph #19 - View of filled roll-off dumpster.

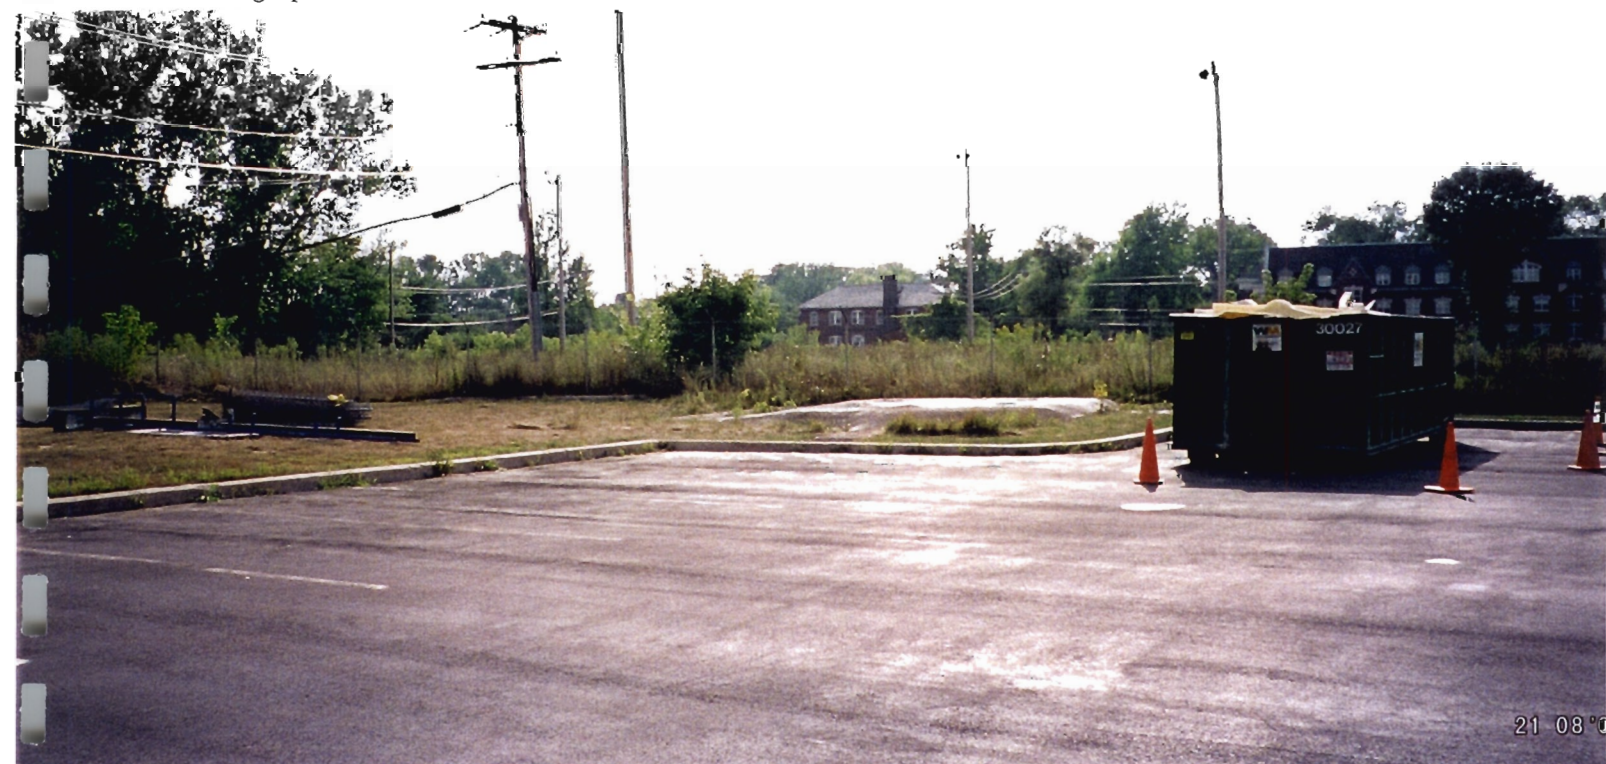
Photograph #20 - View of decommissioned pump and containment system area.

The remedial system is effectively decommissioned. The utilities have been removed and capped. The system components have been destroyed and specific monitoring wells have been decommissioned.
