## DAILY FIELD ACTIVITY REPORT

| <b>PROJECT</b> | <b>Former Bouchard Junkyard</b> | <b>WEATHER</b> | <b>TIME</b> | <b>TEMP.</b> | <b>PRECIP.</b> | <b>WIND (MPH)</b> | <b>WIND (DIR)</b> |
| <b>LOCATION</b> | <b>Town of New Lebanon, NY</b> | <b>M. Cloudy</b> | <b>0630</b> | <b>60-65 F</b> | <b>None</b> | <b>0-5</b> | <b>W-SW</b> |

**PROJECT NO. 2605**

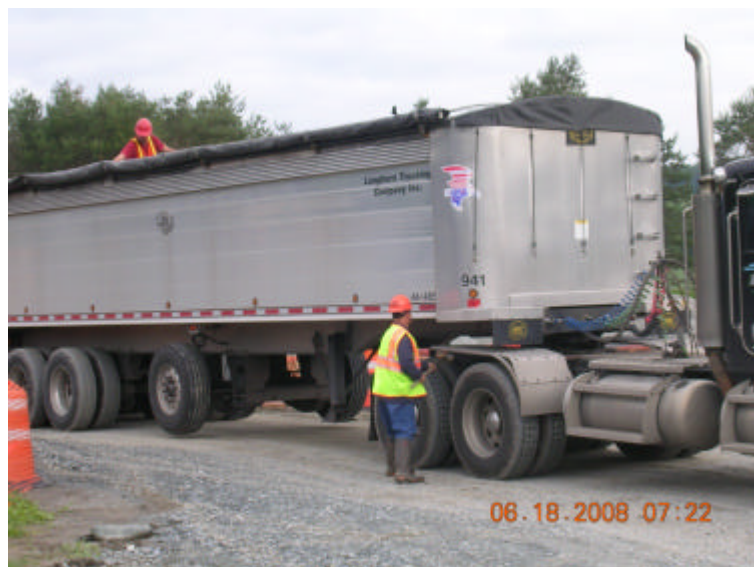
**DSCN3632.JPG**

| PHOTO | DATE | TIME | DESCRIPTION |
|---|---|---|---|
| DSCN 3632 | 6/18/2008 | 0722 | View of DAC loading an 18-wheel waste hauling truck with non-TSCA PCB contaminated soil using a Kawasaki 80ZV Front Loader and dry brushing of truck tires at the western side of Area 4 looking NW. |

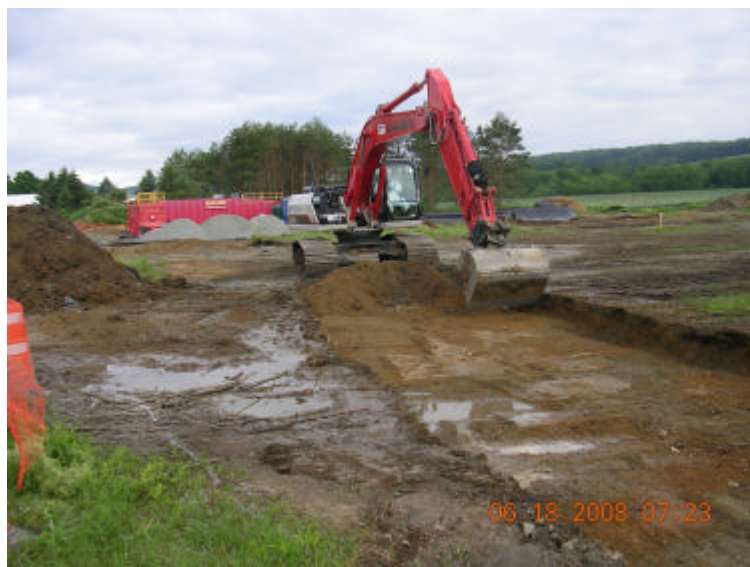
**DSCN3633.JPG**

| PHOTO | DATE | TIME | DESCRIPTION |
|---|---|---|---|
| DSCN 3633 | 6/18/2008 | 0723 | Remedial excavation activities within Grid M-10 in Area 3 utilizing a Link-Belt 240 Trackhoe; Non-TSCA soil was transported using a Terex End Dump TA30 to the non-TSCA stockpile in Area 2; View of Area 3 looking W-NW. |

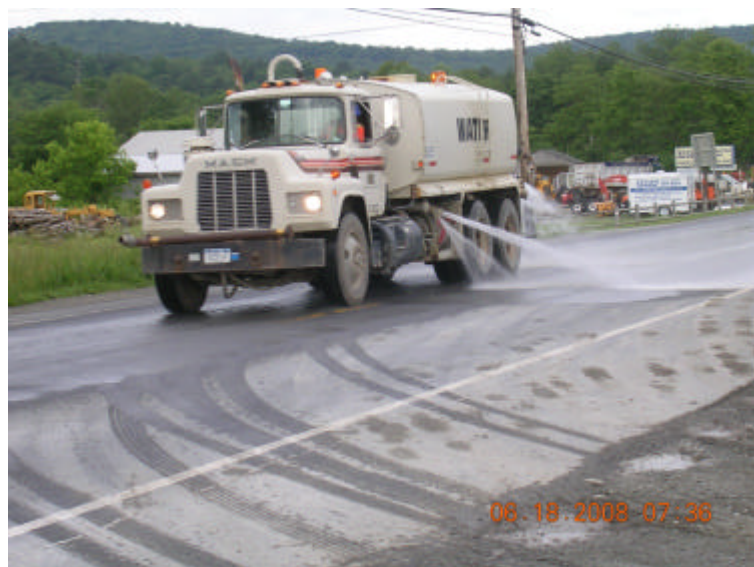
**DSCN3634.JPG**

| PHOTO | DATE | TIME | DESCRIPTION |
|---|---|---|---|
| DSCN 3634 | 6/18/2008 | 0736 | Cleaning of muddy tire tracks in progress onto Route 20 road surface at entrance to driveway to Building 666 using Water Truck; View of Route 20 looking SW. |

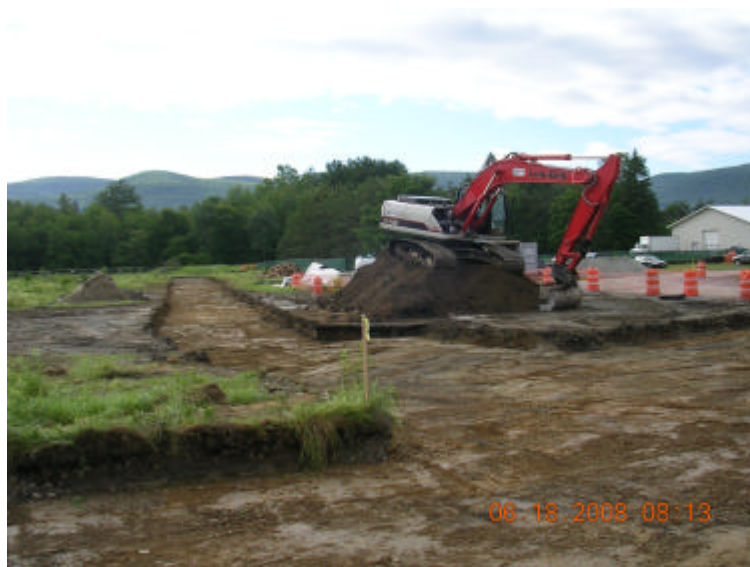
**DSCN3635.JPG**

| PHOTO | DATE | TIME | DESCRIPTION |
|---|---|---|---|
| DSCN 3635 | 6/18/2008 | 0813 | View of remedial excavation across the southern part of Area 3; RCRA TSCA soil was excavated from the northern part of Grid I-10 utilizing a Link-Belt 240 Trackhoe and stockpiled on like-material on the southern portion of the grid; View of Area 3 looking E down access road. |

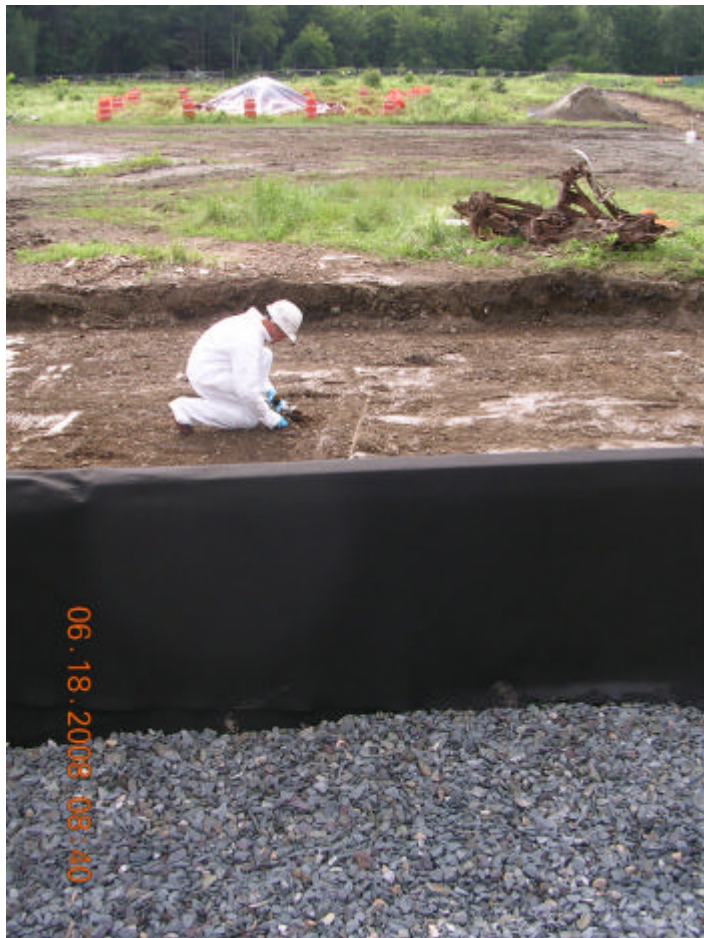
**DSCN3639.JPG**

| PHOTO | DATE | TIME | DESCRIPTION |
|---|---|---|---|
| DSCN 3639 | 6/18/2008 | 0840 | Collection of bottom soil sample at 1 ft bgs near the center of grid EP-H11; Area 1 looking SE. |

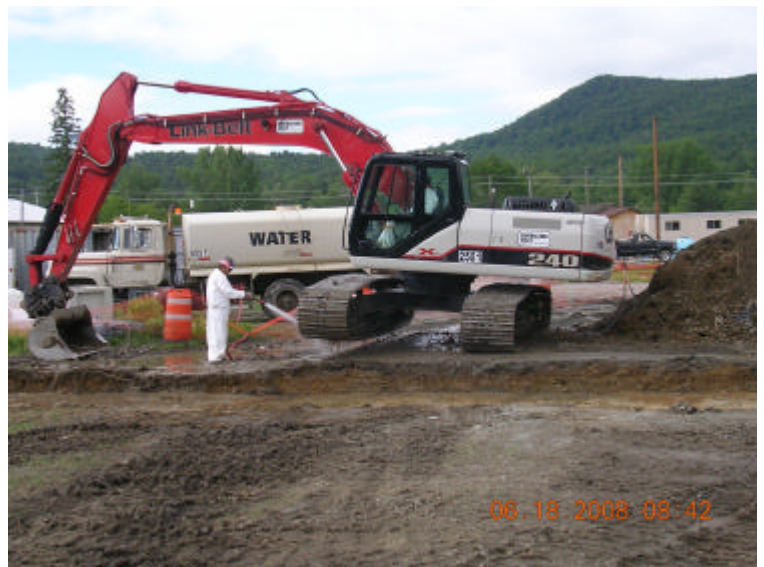
**DSCN3640.JPG**

| PHOTO | DATE | TIME | DESCRIPTION |
|---|---|---|---|
| DSCN 3640 | 6/18/2008 | 0842 | Cleaning of excavator tracks in progress using water truck looking South. |

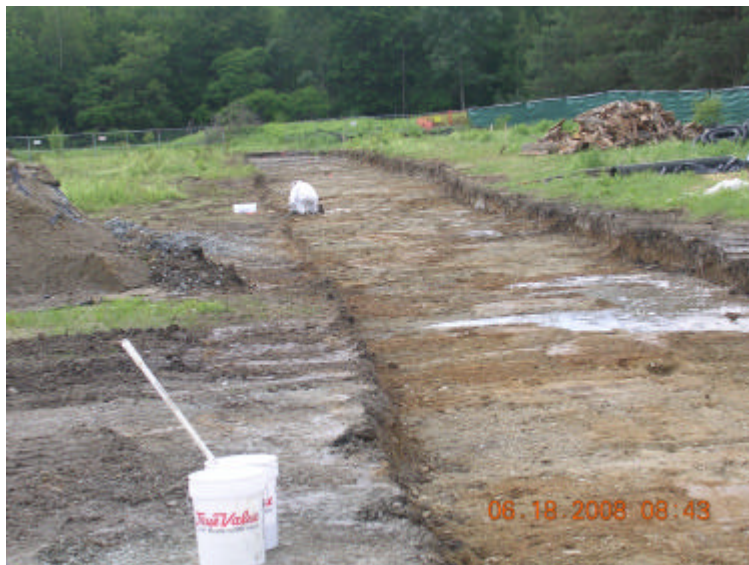
**DSCN3641.JPG**

| PHOTO | DATE | TIME | DESCRIPTION |
|---|---|---|---|
| DSCN 3641 | 6/18/2008 | 0843 | Collection of bottom soil sample at 1 ft bgs near the center of grid EP-L10; Area 1 looking SE. |

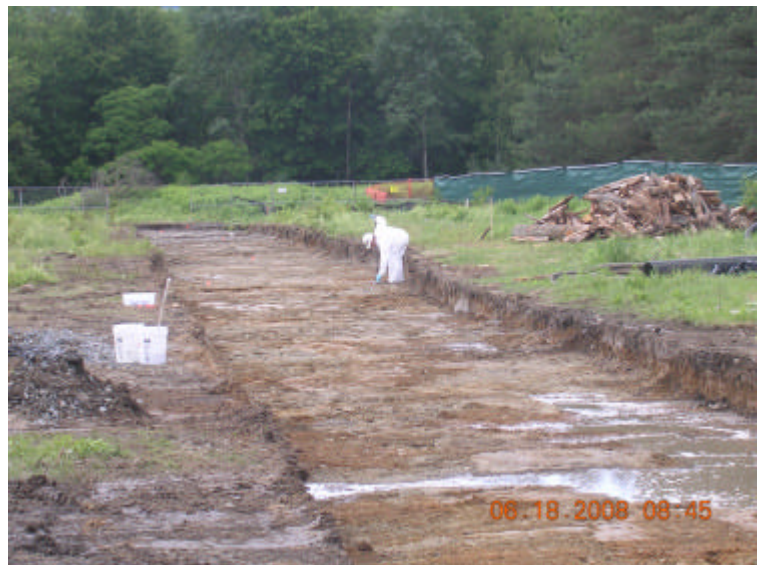
**DSCN3642.JPG**

| PHOTO | DATE | TIME | DESCRIPTION |
|---|---|---|---|
| DSCN 3642 | 6/18/2008 | 0845 | Collection of bottom soil sample at 1 ft bgs at the SE corner of grid EP-L9; Area 1 looking N-NW. |

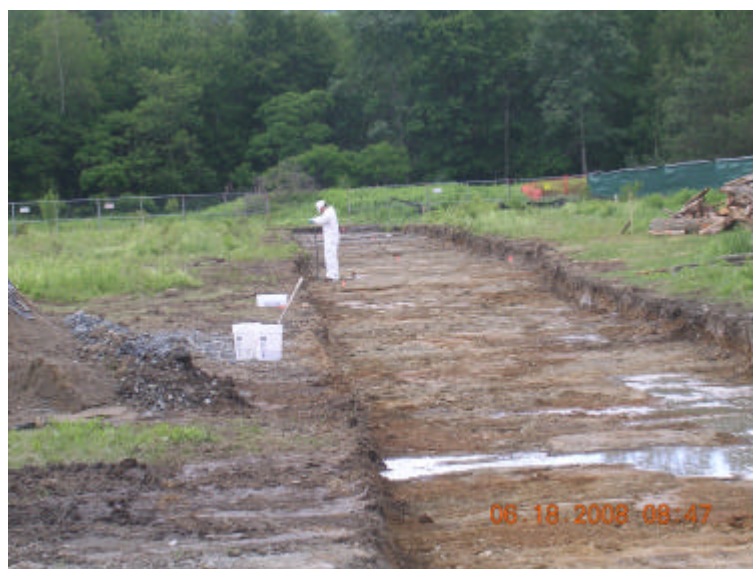
**DSCN3643.JPG**

| PHOTO | DATE | TIME | DESCRIPTION |
|---|---|---|---|
| DSCN 3643 | 6/18/2008 | 0847 | Collection of bottom soil sample at 1 ft bgs near the center of grid EP-N10; Area 1 looking SE. |

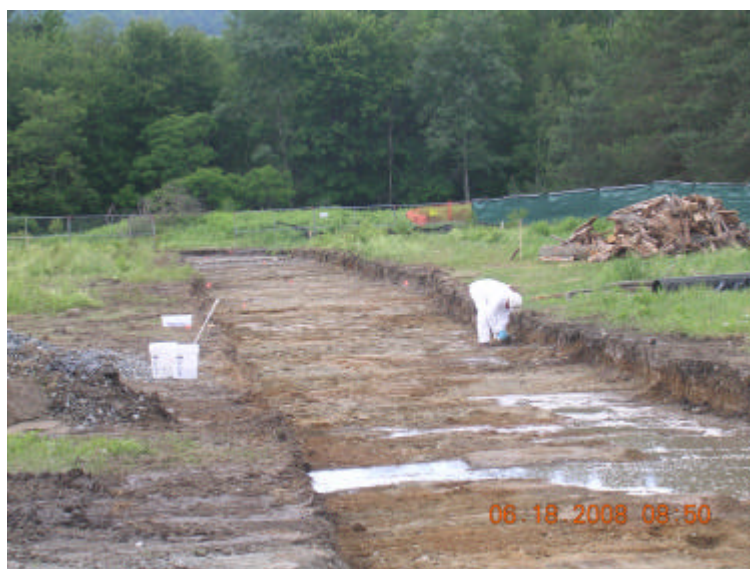
**DSCN3644.JPG**

| PHOTO | DATE | TIME | DESCRIPTION |
|---|---|---|---|
| DSCN 3644 | 6/18/2008 | 0850 | Collection of bottom soil sample at 1 ft bgs at the SE corner of grid EP-K9; Area 1 looking N-NW. |

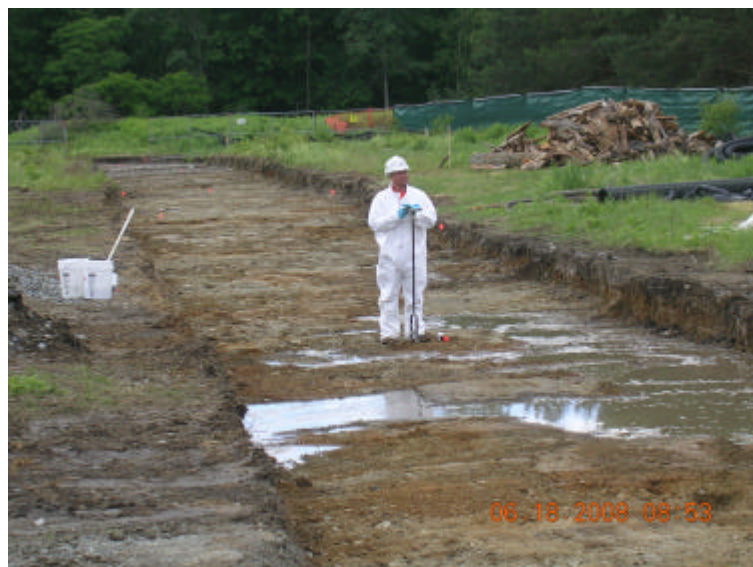
**DSCN3645.JPG**

| PHOTO | DATE | TIME | DESCRIPTION |
|---|---|---|---|
| DSCN 3645 | 6/18/2008 | 0853 | Collection of bottom soil sample at 1 ft bgs near the center of grid EP-K10; Area 1 looking SE. |

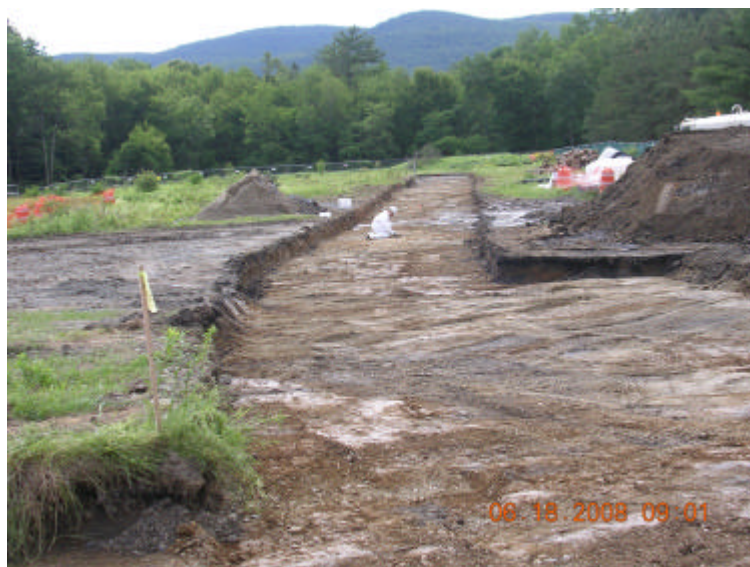
**DSCN3646.JPG**

| PHOTO | DATE | TIME | DESCRIPTION |
|---|---|---|---|
| DSCN 3646 | 6/18/2008 | 0901 | Collection of bottom soil sample at 1 ft bgs near the center of grid EP-J10; Area 1 looking SE. |

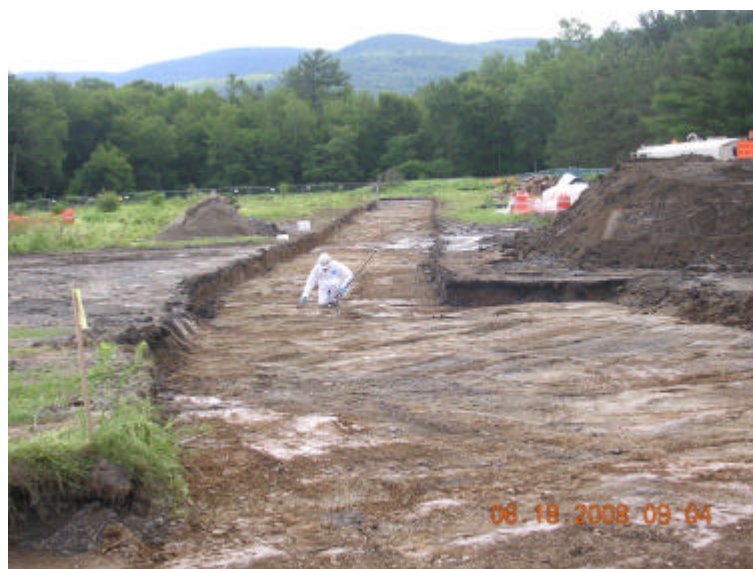
**DSCN3647.JPG**

| PHOTO | DATE | TIME | DESCRIPTION |
|---|---|---|---|
| DSCN 3647 | 6/18/2008 | 0904 | Collection of bottom soil sample at 1 ft bgs at the SE corner of grid EP-I10; Area 1 looking N-NW. |

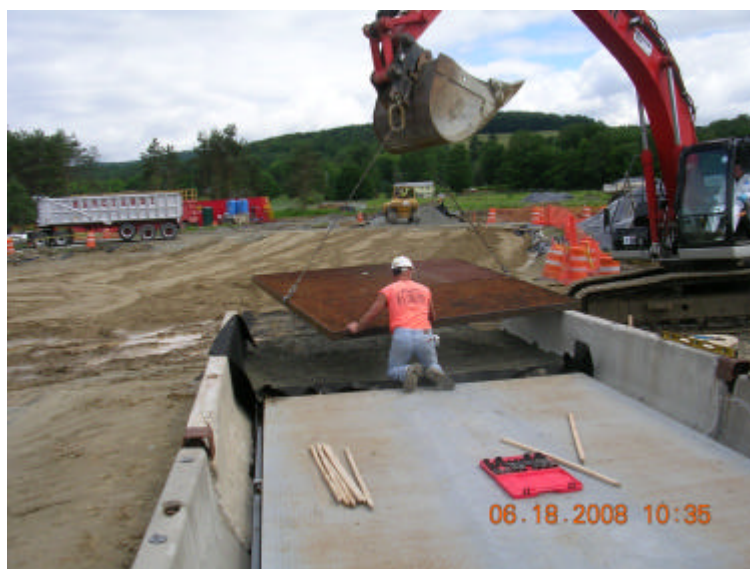
**DSCN3650.JPG**

| PHOTO | DATE | TIME | DESCRIPTION |
|---|---|---|---|
| DSCN 3650 | 6/18/2008 | 1035 | Construction of north ramp of truck weigh scale in progress; DAC lowered a drainage grate into place using a Link-Belt 240 Trackhoe; View of Area 9 looking N-NW. |

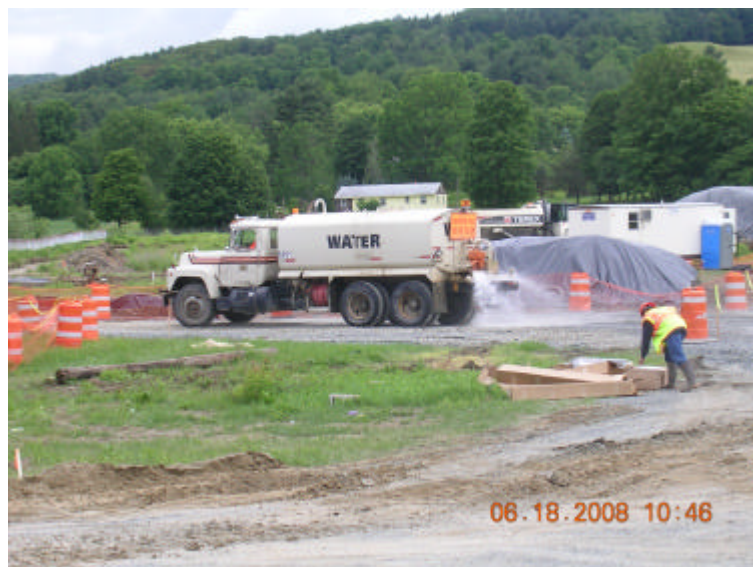
**DSCN3651.JPG**

| PHOTO | DATE | TIME | DESCRIPTION |
|---|---|---|---|
| DSCN 3651 | 6/18/2008 | 1046 | Dust suppression in progress using a Water Truck onto ground surface in Area 3/9 looking N. |

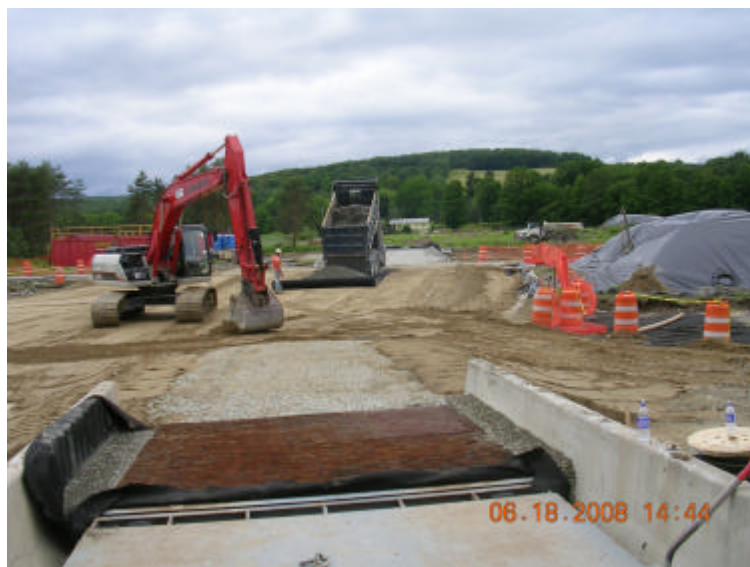
**DSCN3660.JPG**

| PHOTO | DATE | TIME | DESCRIPTION |
|---|---|---|---|
| DSCN 3660 | 6/18/2008 | 1444 | View of completed north ramp of truck weigh scale (i.e. material placed, graded, and compacted) in Area 9 looking N-NW. |

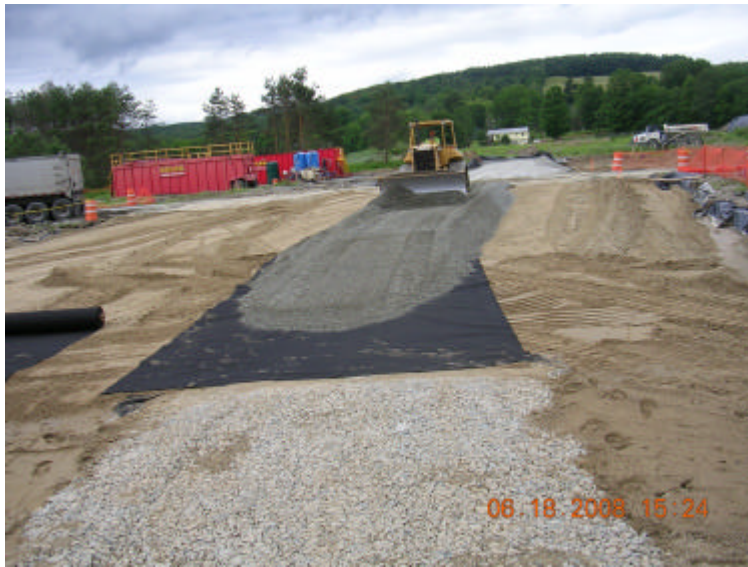
**DSCN3664.JPG**

| PHOTO | DATE | TIME | DESCRIPTION |
|---|---|---|---|
| DSCN 3664 | 6/18/2008 | 1524 | Construction of access road in progress between north ramp of truck weigh scale (foreground) and decontamination pad (background); View of Area 3/9 looking N-NW. |

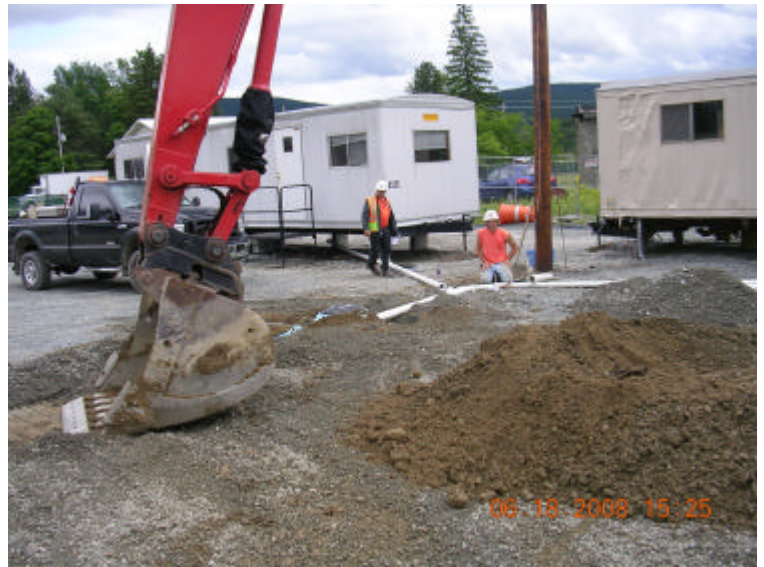
**DSCN3665.JPG**

| PHOTO | DATE | TIME | DESCRIPTION |
|---|---|---|---|
| DSCN 3665 | 6/18/2008 | 1525 | View of nearly completed temporary septic system for project trailers in Area 9 looking SE. |
