## DAILY FIELD ACTIVITY REPORT

| PROJECT | Former Bouchard Junkyard | WEATHER | TIME | TEMP. | PRECIP. | WIND (MPH) | WIND (DIR) |
| LOCATION | Town of New Lebanon, NY | Overcast | 0715 | 70 F | Rain | Calm | N/A |

**PHOTOGRAPHIC LOG**  
**July 23, 2008**  
**D&B JOB NO. 2605**  
**FORMER BOUCHARD JUNKYARD SITE**  
**TOWN OF NEW LEBANON, NEW YORK**

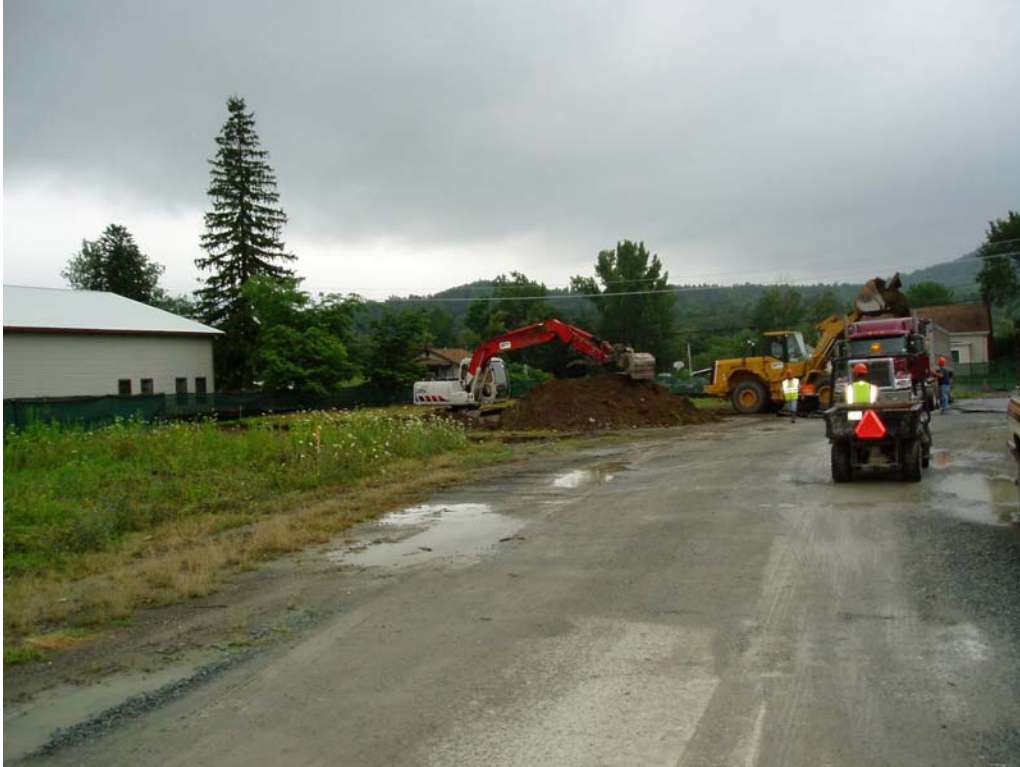
P7230001.JPG

| PHOTO | DATE | TIME | DESCRIPTION |
|---|---|---|---|
| P7 230001 | 7/23/2008 | 7:42 | View to southeast showing remedial excavation at south side of Area 9 (grid stations L-2, L-3) |

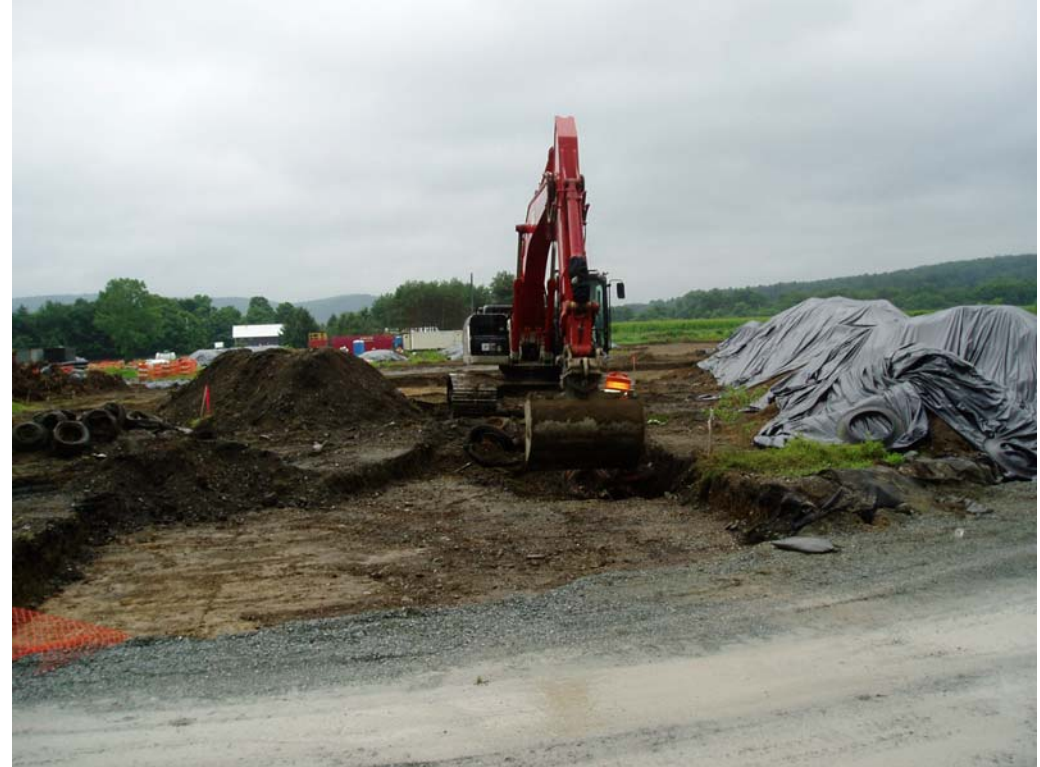
P7230002.JPG

| PHOTO | DATE | TIME | DESCRIPTION |
|---|---|---|---|
| P7 230002 | 7/23/2008 | 7:46 | View to west showing remedial excavation at southeast corner of Area 3 (grid station P-10) |

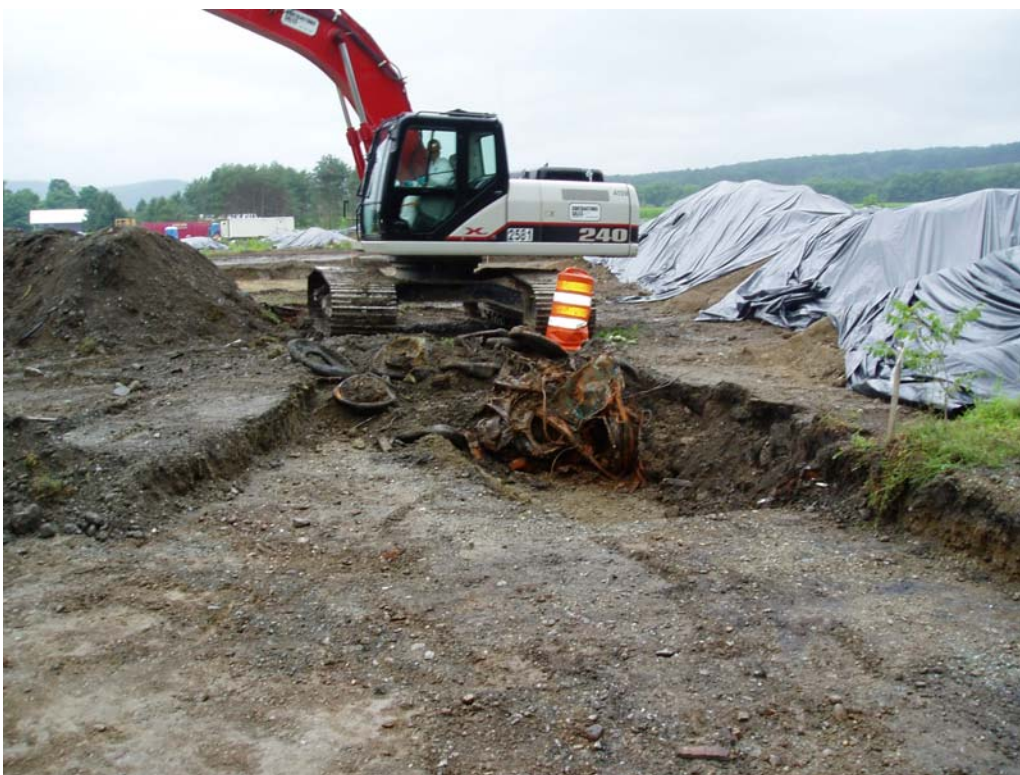
P7230003.JPG

| PHOTO | DATE | TIME | DESCRIPTION |
|---|---|---|---|
| P7 230003 | 7/23/2008 | 7:47 | View to west showing misc. metal and tire debris encountered during remedial excavation at southeast corner of Area 3 (grid station P-10) |

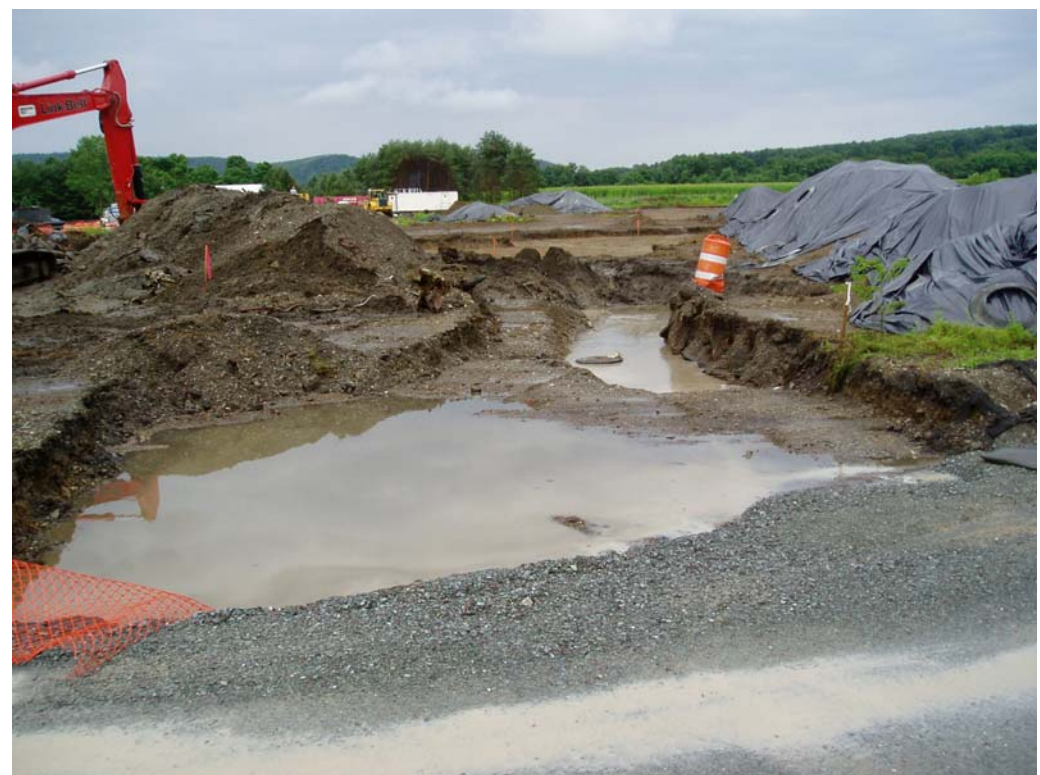
P7230004.JPG

| PHOTO | DATE | TIME | DESCRIPTION |
|---|---|---|---|
| P7 230004 | 7/23/2008 | 9:51 | View to west showing standing water at southeast corner of Area 3 (grid stations P-10, Q-10) |

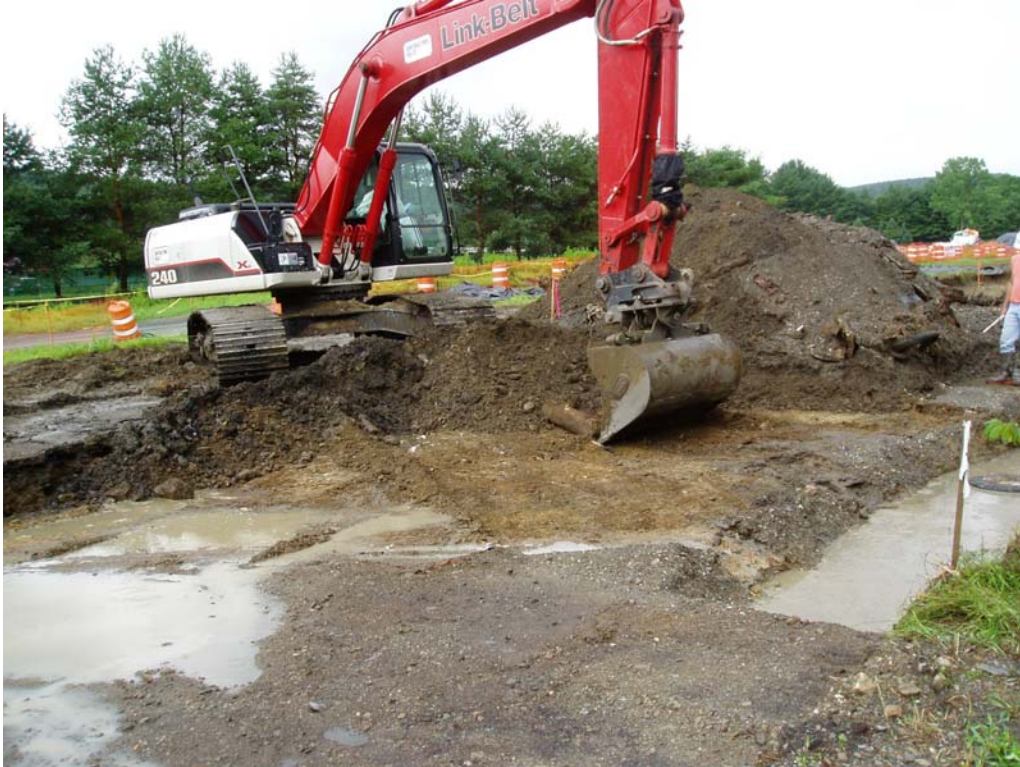
P7230005.JPG

| PHOTO | DATE | TIME | DESCRIPTION |
|---|---|---|---|
| P7 230005 | 7/23/2008 | 10:04 | View to southwest showing remedial excavation at southeast corner of Area 3 (grid station P-10) |

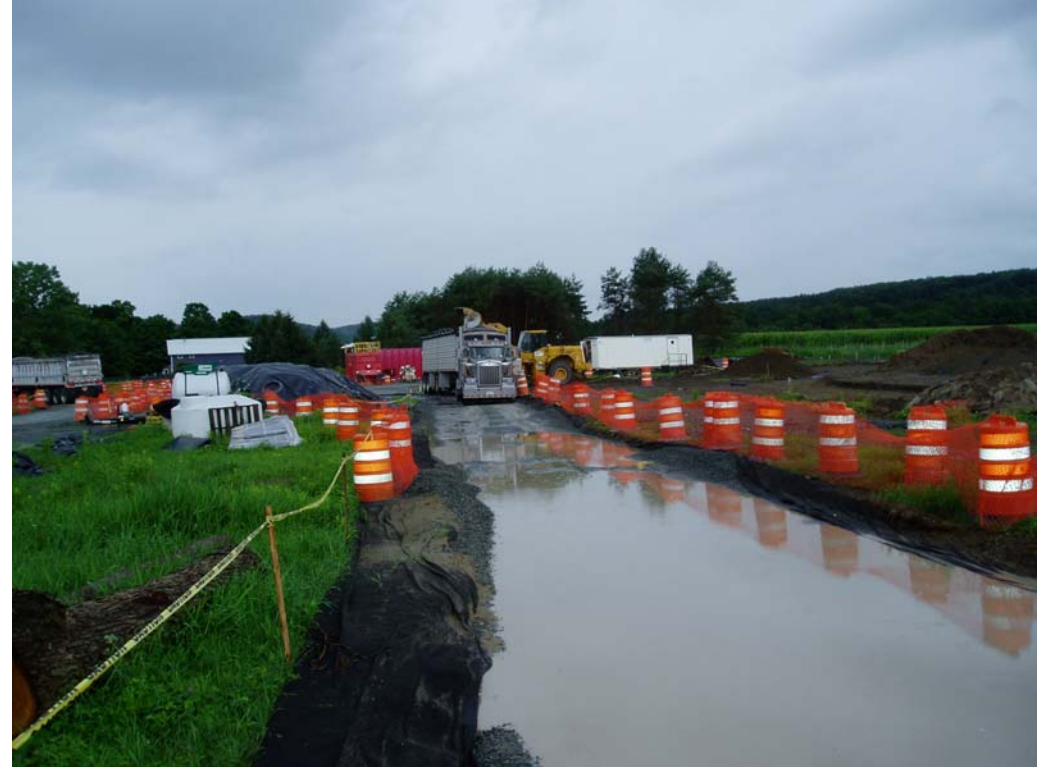
P7230006.JPG

| PHOTO | DATE | TIME | DESCRIPTION |
|---|---|---|---|
| P7 230006 | 7/23/2008 | 10:15 | View to west showing front end loader loading non-TSCA PCB contaminated soil into truck at south side of Area 3 for off-site disposal |

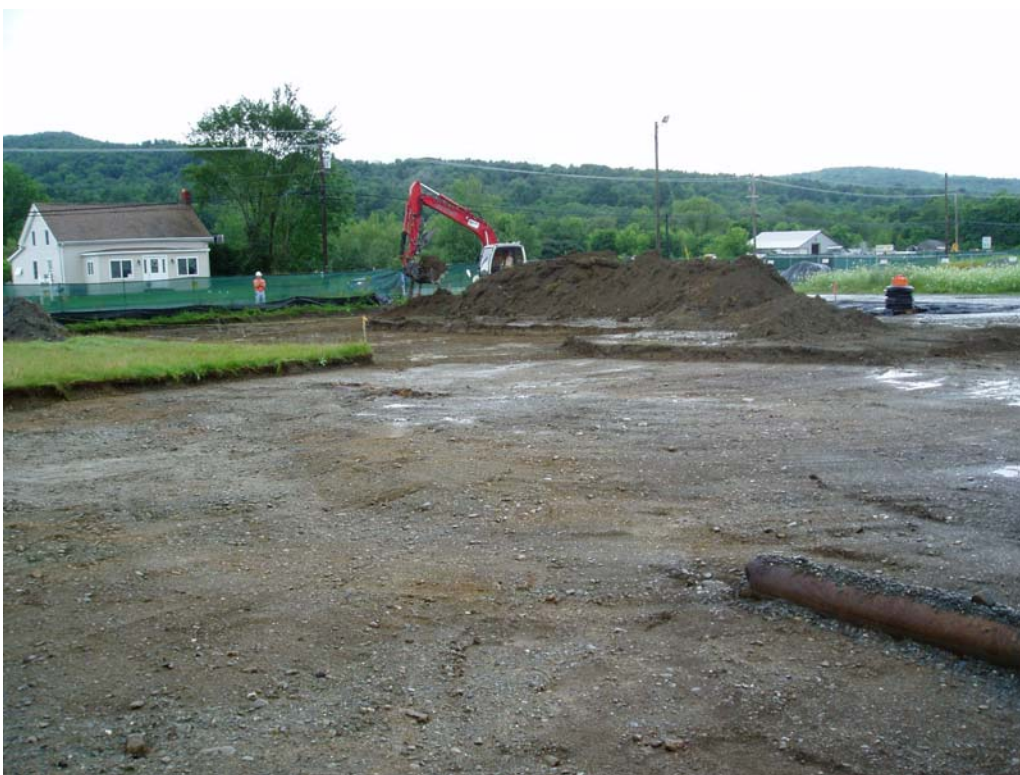
P7230007.JPG

| PHOTO | DATE | TIME | DESCRIPTION |
|---|---|---|---|
| P7 230007 | 7/23/2008 | 11:30 | View to southwest showing remedial excavation extending into grid station K-1 at south side of Area 9 (adjacent Rt. 20) |

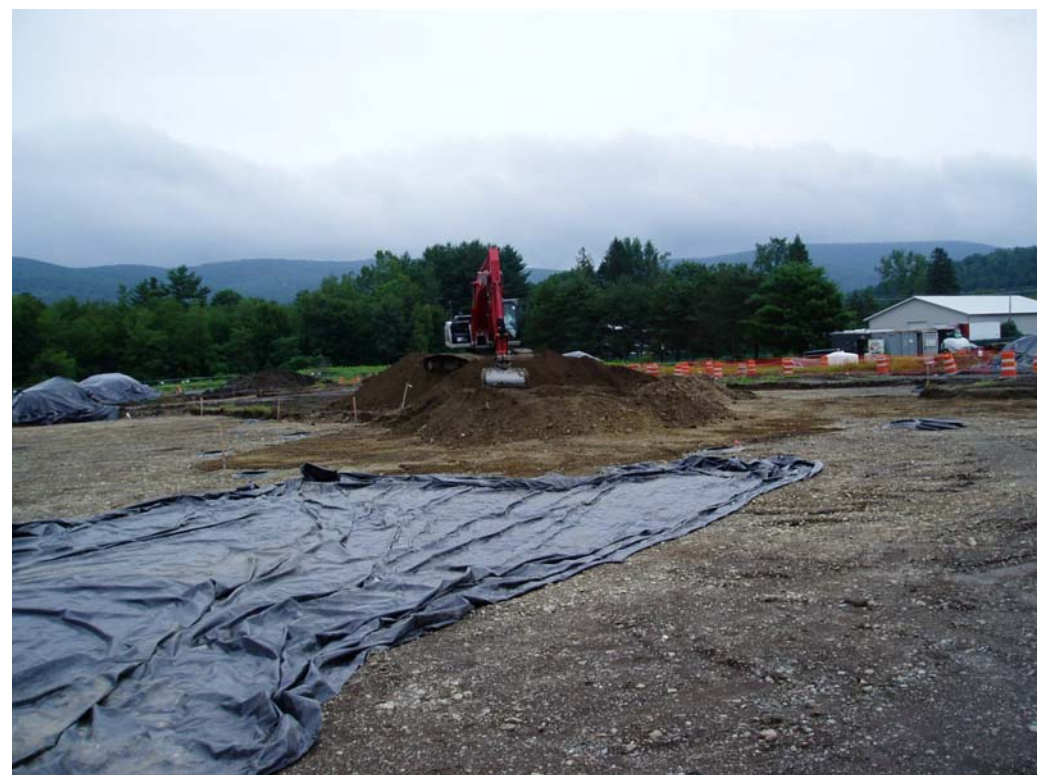
P7230008.JPG

| PHOTO | DATE | TIME | DESCRIPTION |
|---|---|---|---|
| P7 230008 | 7/23/2008 | 14:03 | View to southeast showing remedial excavation at north side of Area 3 (grid station I-12) |

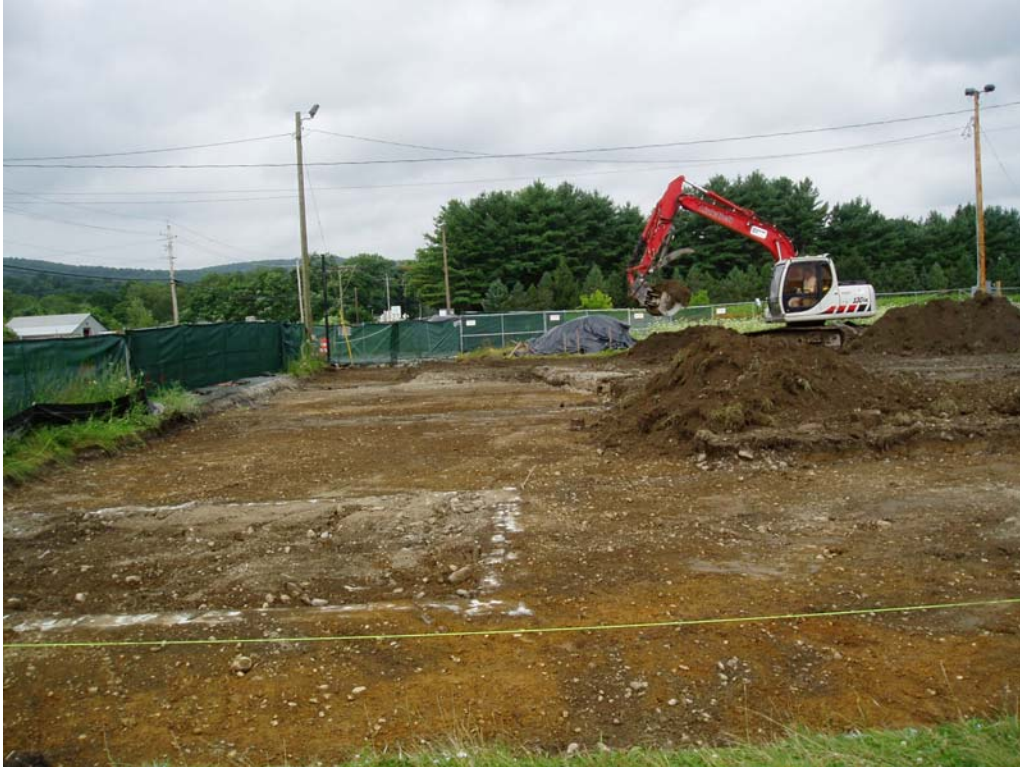
P7230009.JPG

| PHOTO | DATE | TIME | DESCRIPTION |
|---|---|---|---|
| P7 230009 | 7/23/2008 | 14:55 | View to west showing remedial excavation at south side of Area 9 (grid station J-1) |

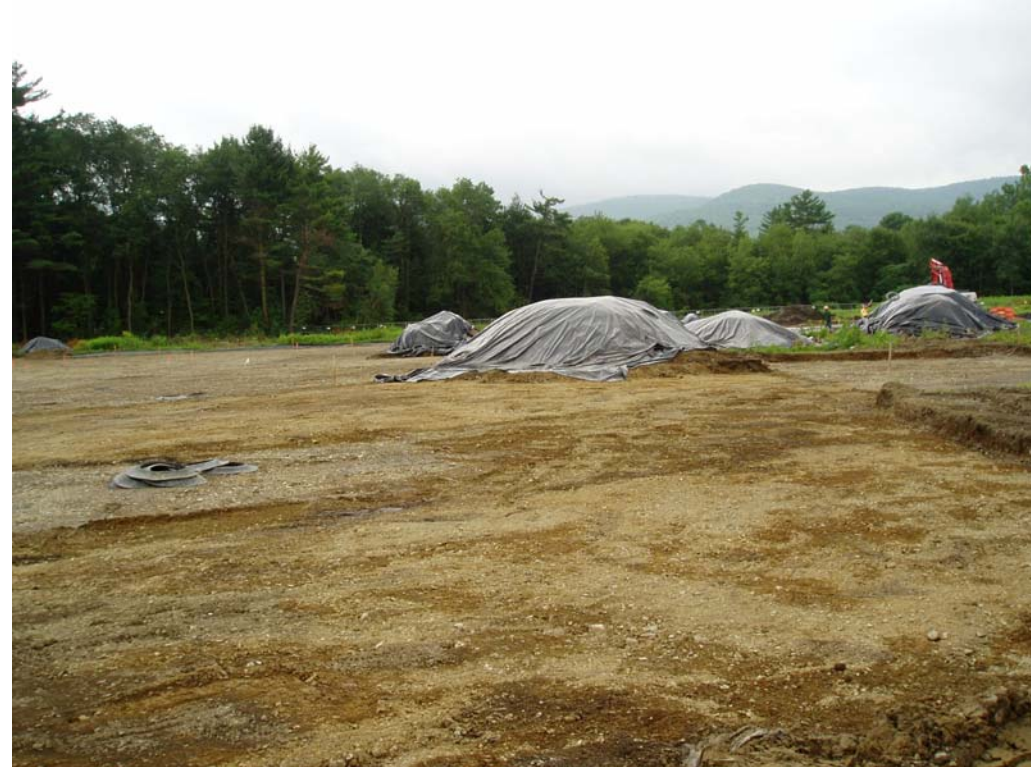
P7230010.JPG

| PHOTO | DATE | TIME | DESCRIPTION |
|---|---|---|---|
| P7 230010 | 7/23/2008 | 15:56 | View to east showing stockpiles of excavated PCB contaminated soil covered with poly sheeting after work completed for the day (Area 3) |

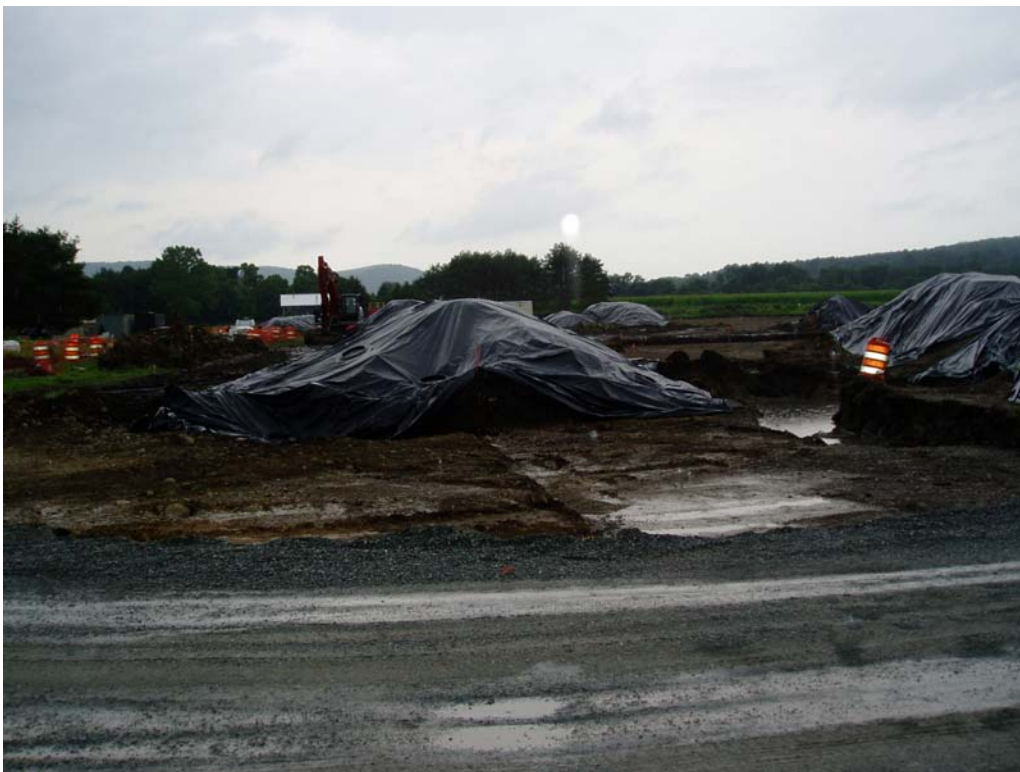
P7230011.JPG

| PHOTO | DATE | TIME | DESCRIPTION |
|---|---|---|---|
| P7 230011 | 7/23/2008 | 16:07 | View to west showing grid stations P-10, Q-10 after remedial excavation completed for the day (SE corner Area 3/West side Area 8) |

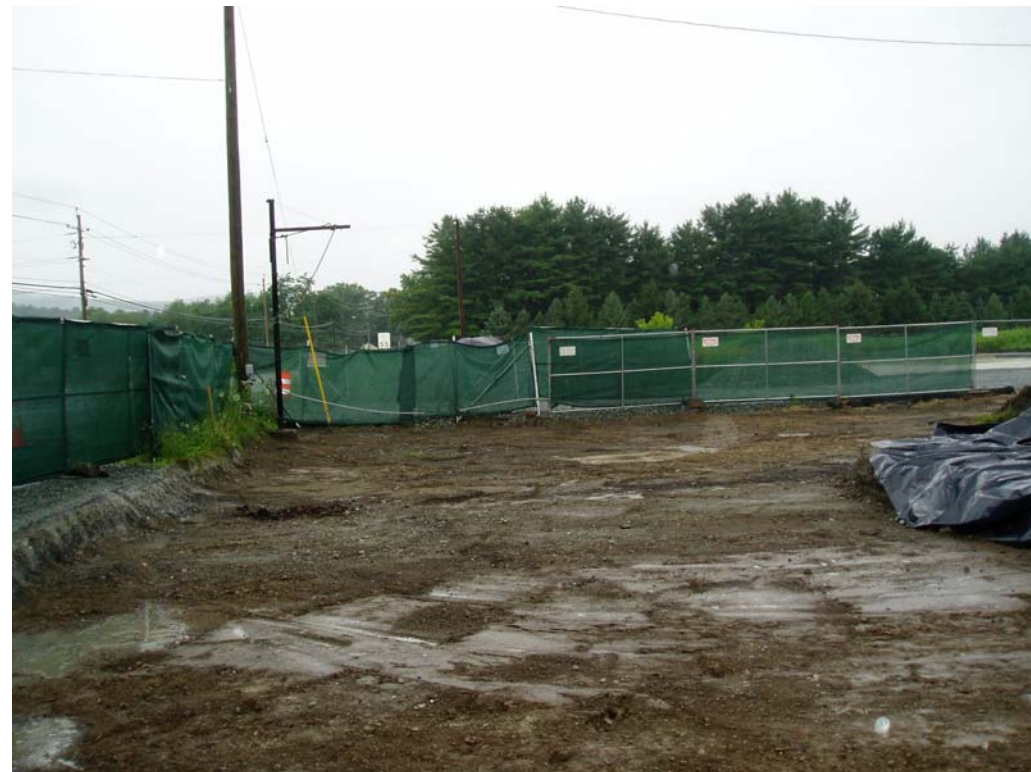
P7230012.JPG

| PHOTO | DATE | TIME | DESCRIPTION |
|---|---|---|---|
| P7 230012 | 7/23/2008 | 16:36 | View to west showing south side of Area 9 after remedial excavation completed for the day (grid stations J-1, K-1) |

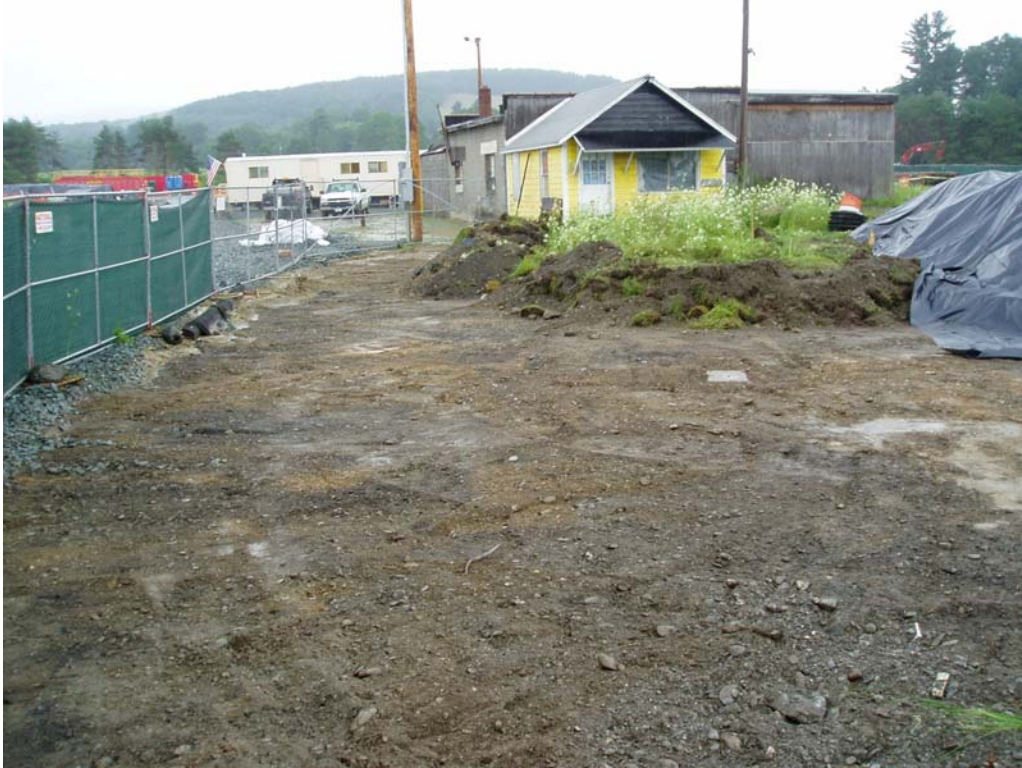
P7230013.JPG

| PHOTO | DATE | TIME | DESCRIPTION |
|---|---|---|---|
| P7 230013 | 7/23/2008 | 16:36 | View to north showing south side of Area 9 after remedial excavation completed for the day (grid stations J-1, J-2) |
