**PROJECT NO. 2605**

## DAILY FIELD ACTIVITY REPORT

| <b>PROJECT</b> | <b>Former Bouchard Junkyard</b> | <b>WEATHER</b> | <b>TIME</b> | <b>TEMP.</b> | <b>PRECIP.</b> | <b>WIND (MPH)</b> | <b>WIND (DIR)</b> |
| <b>LOCATION</b> | <b>Town of New Lebanon, NY</b> | <b>Sunny</b> | <b>0700</b> | <b>65-70 F</b> | <b>None</b> | <b>0-10 Gusts to 20</b> | <b>NW</b> |

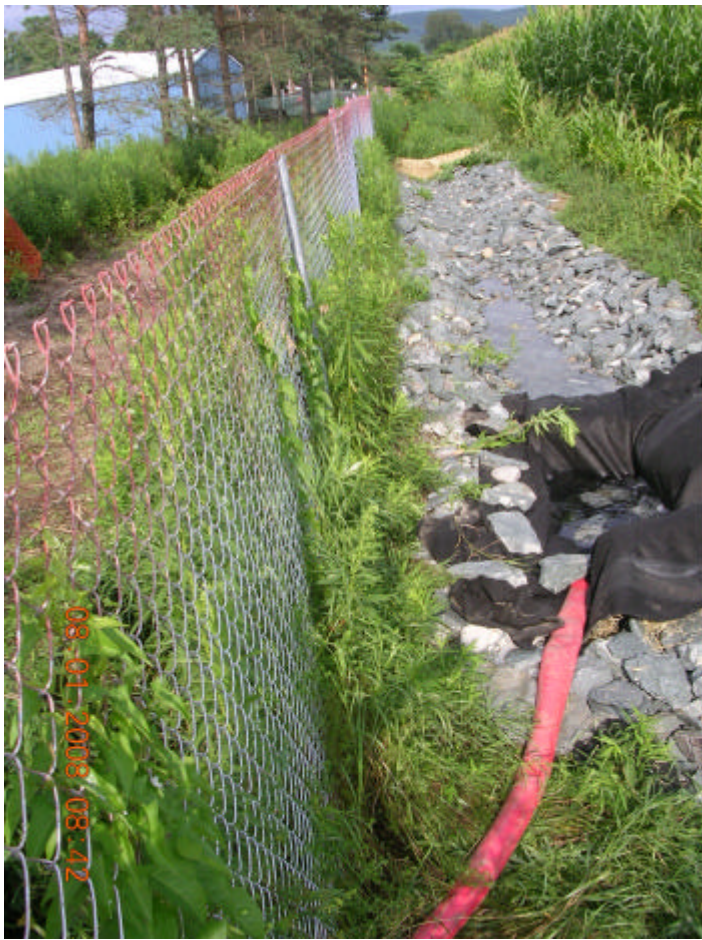
**DSCN4415.JPG**

| PHOTO | DATE | TIME | DESCRIPTION |
|---|---|---|---|
| DSCN 4415 | 8/1/08 | 0842 | View of gravity draining of approximately 18,000 gallons of treated water from the tertiary Frac tank on the wastewater treatment pad to the improved drainage swale along the northern boundary of Area 4 approximately 30 minutes after commencing discharge; The draining water did not exceed the maximum flow rate of 100 gpm during the discharge event; Overland flow of discharged water was minimal, since surface runoff infiltrated entirely into the subsurface less than 50 feet from the discharge point; View of northern boundary of Area 4 looking W. |

2. Prior to departure from site, D.A. Collins secured the PCB-contaminated soil stockpiles in Areas 3, 4, 8, and 9 with 6 mil polyethylene sheeting;
3. Upon permission granted by NYSDEC, D.A. Collins gravity drained approximately 18,000 gallons of treated water from the tertiary Frac tank on the wastewater treatment pad to the improved drainage swale along the northern boundary of Area 4. The draining water did not exceed the maximum flow rate of 100 gpm during the discharge event. Overland flow of discharged water was minimal, since surface runoff infiltrated entirely into the subsurface less than 50 feet from the discharge point;

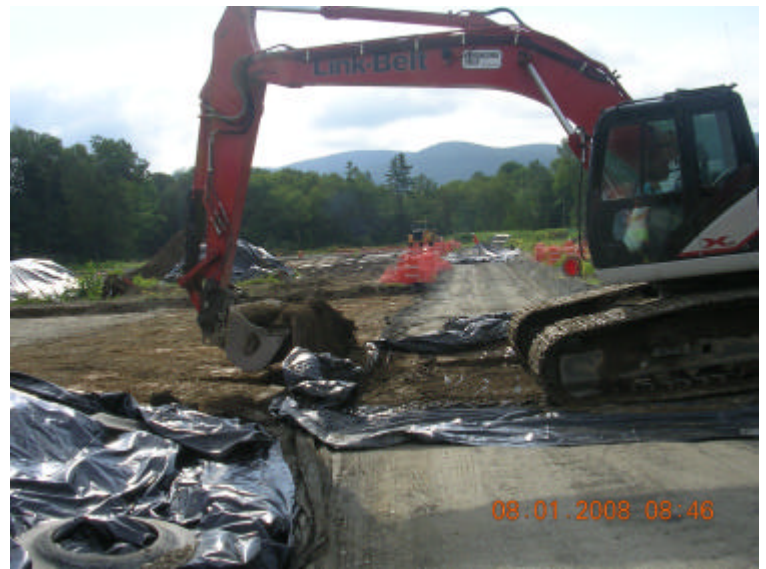
**DSCN4417.JPG**

| PHOTO | DATE | TIME | DESCRIPTION |
|---|---|---|---|
| DSCN 4417 | 8/1/08 | 0846 | Remedial excavation activities within RCRA-TSCA Grid I-10 in Area 3 utilizing a Link-Belt 240 Trackhoe; RCRA-TSCA soil was stockpiled on like-material in a centralized location in order to facilitate loading of trucks from the truck access road; View of Area 3 looking E. |

2. D.A. Collins excavated approximately 504 yd<sup>3</sup> of PCB-contaminated soil using Link-Belt 240 and Link-Belt 130 LX Trackhoes from Areas 2 and 8 within non-TSCA grids O-14 through O-16 and P-14 through P-16 (400 yd<sup>3</sup>) and from Area 3 within RCRA-TSCA grids I-10 and J-10 (104 yd<sup>3</sup>). The excavated non-TSCA soils were either consolidated onto like-kind material for future load out or directly loaded onto waste hauling trucks, while the RCRA-TSCA soils were consolidated onto like-kind material for future load out only.

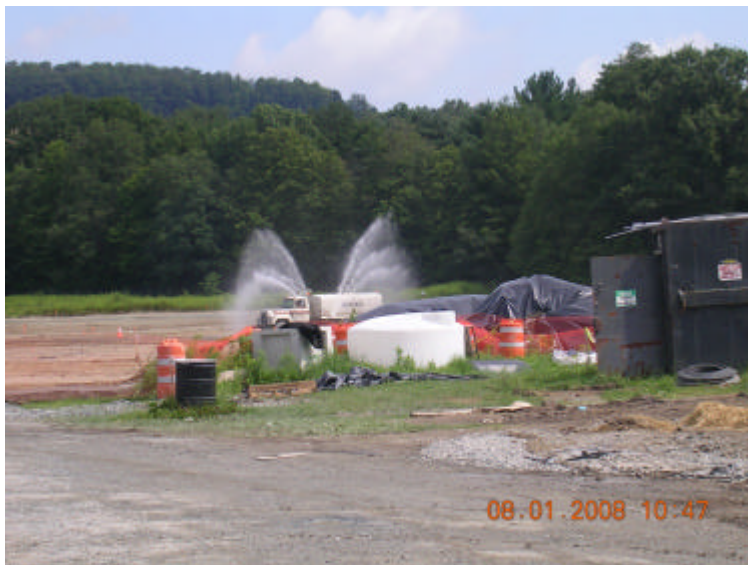
**DSCN4421.JPG**

| PHOTO | DATE | TIME | DESCRIPTION |
|---|---|---|---|
| DSCN 4421 | 8/1/08 | 1047 | View of dust suppression onto remedial excavation areas in Areas 2 and 3 looking NNE. |

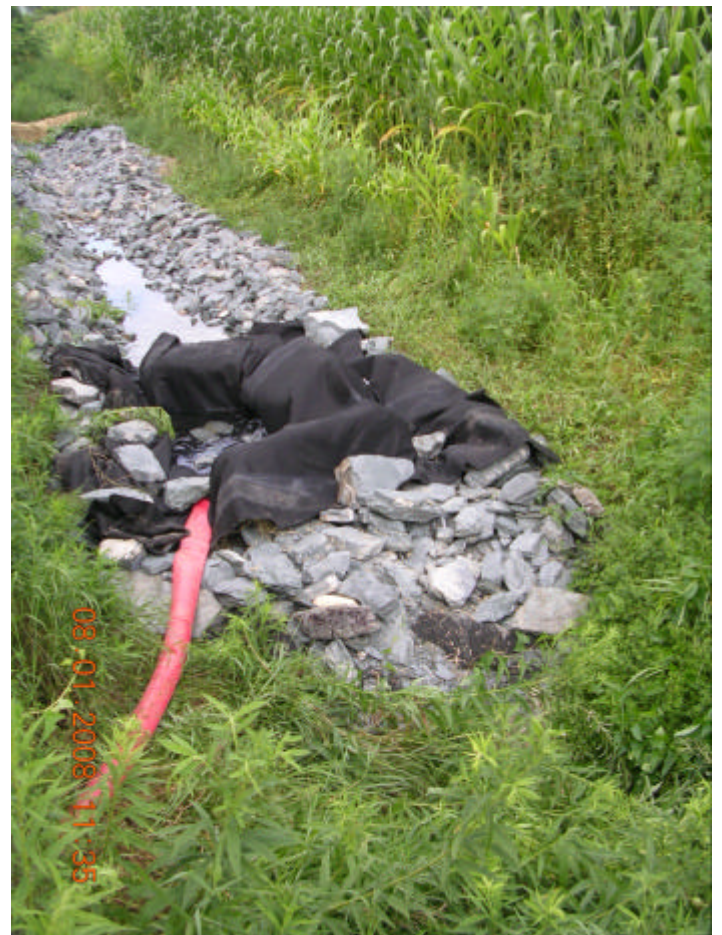
**DSCN4427.JPG**

| PHOTO | DATE | TIME | DESCRIPTION |
|---|---|---|---|
| DSCN 4427 | 8/1/08 | 1135 | View of continued gravity draining from the tertiary Frac tank on the wastewater treatment pad to the improved drainage swale along the northern boundary of Area 4 approximately 3.5 hours after commencing discharge; The draining water did not exceed the maximum flow rate of 100 gpm during the discharge event; Surface runoff is still infiltrating into the subsurface less than 50 feet from the discharge point; View of northern boundary of Area 4 looking W. |

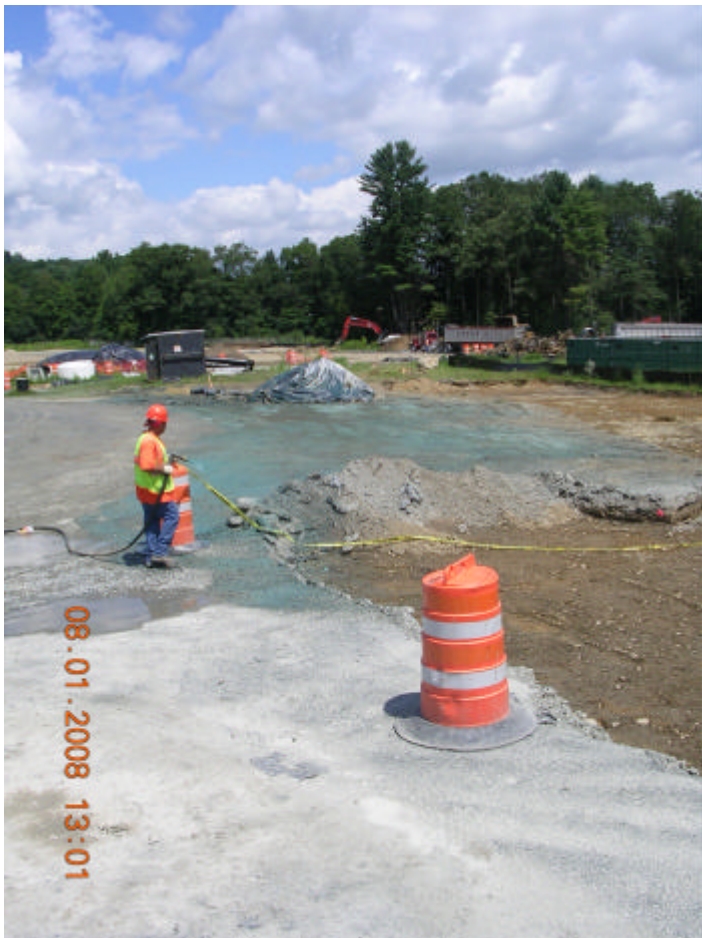
**DSCN4430.JPG**

| PHOTO | DATE | TIME | DESCRIPTION |
|---|---|---|---|
| DSCN 4430 | 8/1/08 | 1301 | View of hydroseeding activities in progress within remedial excavation areas and along the side of the truck access road to keep the dust down across the site; Area 9 looking NE. |

4. As a dust suppression technique over the weekend, D.A. Collins applied approximately 1,000 gallons of hydroseed mulch with tackifier to the ground surface within remedial excavations across a majority of Areas 1, 2, 3, and 9 and along the truck access road using a MS Sprayer Model HS500 Hydro-Seeding Unit Trailer. Some areas have had tackifier applied at least once or twice;

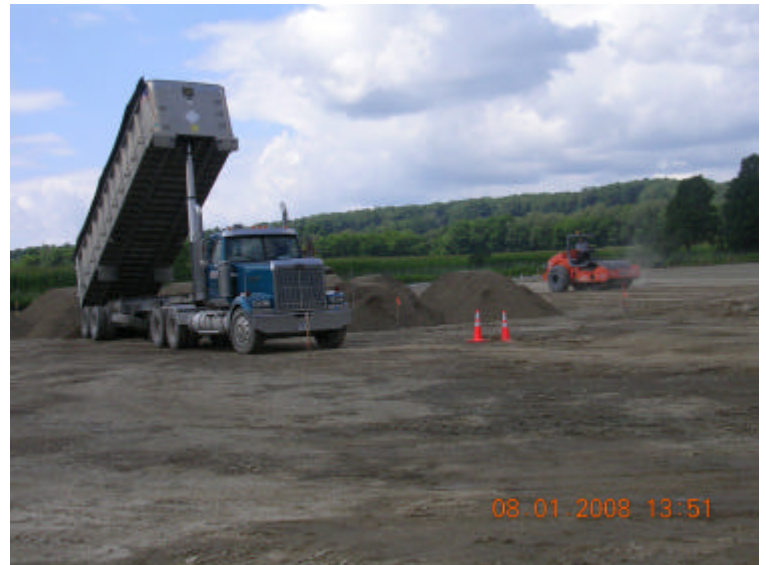
**DSCN4436.JPG**

| PHOTO | DATE | TIME | DESCRIPTION |
|---|---|---|---|
| DSCN 4436 | 8/1/08 | 1351 | View of multiple simultaneous activities in progress; Mangiardi Trucking delivered a load of common fill sand and dumped it in Area 3; DAC used a Hamm 2593 Vibratory Compaction Roller to compact common fill sand placed by a bulldozer in Area 2; View from Areas 2 and 3 looking NW. |

1. Mangiardi Trucking (subcontractor to Troy Sand and Gravel) delivered 504 yd<sup>3</sup> of common fill sand and dumped the sand in stockpiles in south-central Area 2. D.A. Collins placed, graded, and compacted approximately 868 yd<sup>3</sup> of common fill sand in Area 2 using the Kawasaki 80ZV Front Loader, Caterpillar 6465 Bull Dozer, and Hamm 2593 Vibratory Compaction Roller.

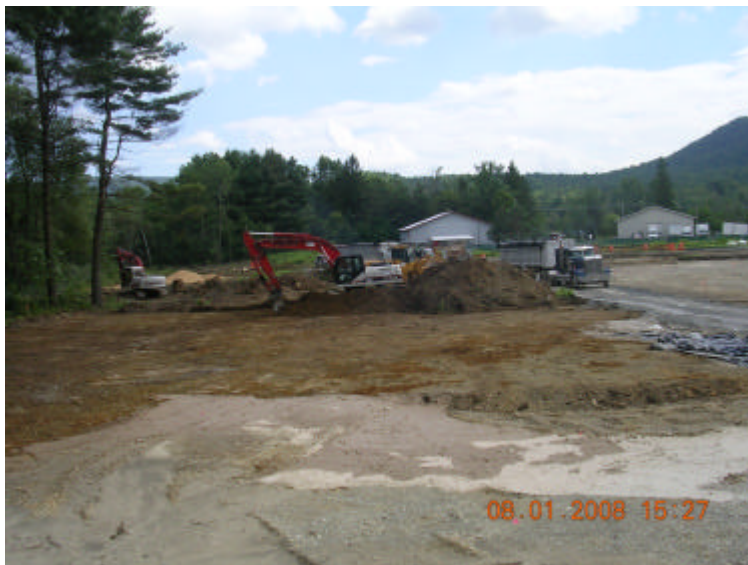
**DSCN4437.JPG**

| PHOTO | DATE | TIME | DESCRIPTION |
|---|---|---|---|
| DSCN 4437 | 8/1/08 | 1527 | View of multiple simultaneous activities in progress; Remedial excavation activities in the foreground within Grids O-15 and P-15 in Area 8 utilizing a Link-Belt 240 Trackhoe; Non-TSCA soil was stockpiled on like-material in a centralized location in order to facilitate loading of trucks from the truck access road; Komatsu 80ZV Frontloader is loading a waste hauling truck at the right side of the photo; Link-Belt 130 LX Trackhoe is clearing tree stumps from the proposed remedial excavation area within grid Q-14; Area 8 looking SSE. |
