DAILY FIELD ACTIVITY REPORT

PROJECT	Former Bouchard Junkyard	WEATHER	TIME	TEMP.	PRECIP.	WIND (MPH)	WIND (DIR)
LOCATION	Town of New Lebanon, NY	Overcast	0730	60-65 F	None	0-10	W
ATTACHMENTS	Photo Log and Photos	M. Cloudy	1700	70-75 F	Few T-storms Heavy at Times	5-10 Gusts 15-20	NW

PHOTOGRAPHIC LOG
August 12, 2008
D&B JOB NO. 2605
FORMER BOUCHARD JUNKYARD SITE
TOWN OF NEW LEBANON, NEW YORK

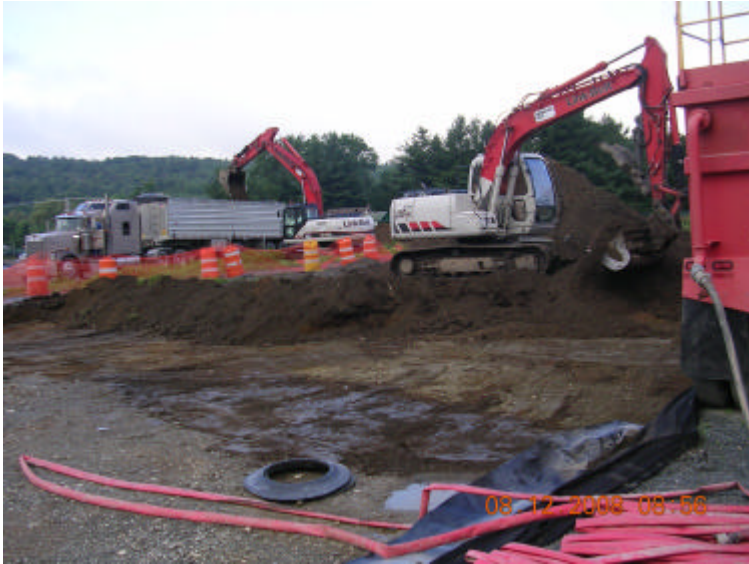
DSCN4653.JPG

PHOTO	DATE	TIME	DESCRIPTION
DSCN 4653	8/12/2008	0856	Multiple simultaneous activities in progress; Remedial excavation of non-TSCA grid D-10 to 1.5 ft bgs utilizing a Link-Belt 130 LX Trackhoe at right foreground; Link-Belt 240 Trackhoe loads TSCA soil derived from TSCA grid 9 in the distant background; Area 4 looking SW.
DSCN 4656	8/12/2008	1014	View of D.A. Collins grinding down a tree stump at the residential property at Area 7 utilizing a Vermeer SC802 Tree Stump Grinder; Area 7 looking ESE.
DSCN 4657	8/12/2008	1110	Multiple simultaneous activities in progress; Remedial excavation of non-TSCA grid C-10 to 1 ft bgs utilizing a Link-Belt 130 LX Trackhoe at right; Kawasaki 80ZV Front Loader loading an 18-wheel waste hauling truck with non-TSCA soil from grid C-10 at left; Link-Belt 240 Trackhoe excavates non-TSCA soil derived from the west-central boundary of Area 4 in the distant background; Area 4 looking SW.

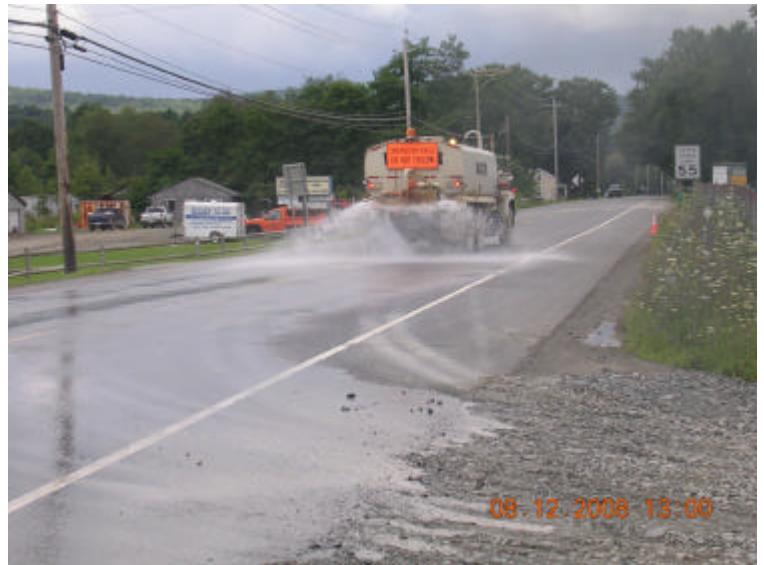
DSCN4662.JPG

DSCN 4662	8/12/2008	1300	Accumulations of mud tracked onto the Route 20 roadway were promptly washed off the road surface utilizing a Mack 6051 Water Truck; View of Route 20 looking WSW.
DSCN 4670	8/12/2008	1603	Remedial excavation of TSCA soil from grid B-11 (waste characterization sampling grid 49) to 1 ft bgs at the NW corner Area 4 utilizing a Link-Belt 240 Trackhoe looking S.
DSCN 4671	8/12/2008	1604	Remedial excavation of non-TSCA grid C-10 to 1 ft bgs in Area 4 utilizing a Link-Belt 130 LX Trackhoe looking SE; Kawasaki 80ZV Front Loader loading an 18-wheel waste hauling truck with non-TSCA soil in the background.
