VRI-RIVERVIEW FACILITY
Schenectady, New York

2001 SOIL QUALITY DATA
NYSDEC TAGM EXCEEDANCES

Project Manager: J.K.P.	Reviewed By:	Date: JULY 2002
Scale: 1"=100'	Project No: 18631-50	Report No: 006
		Drawing No: PLAN 2

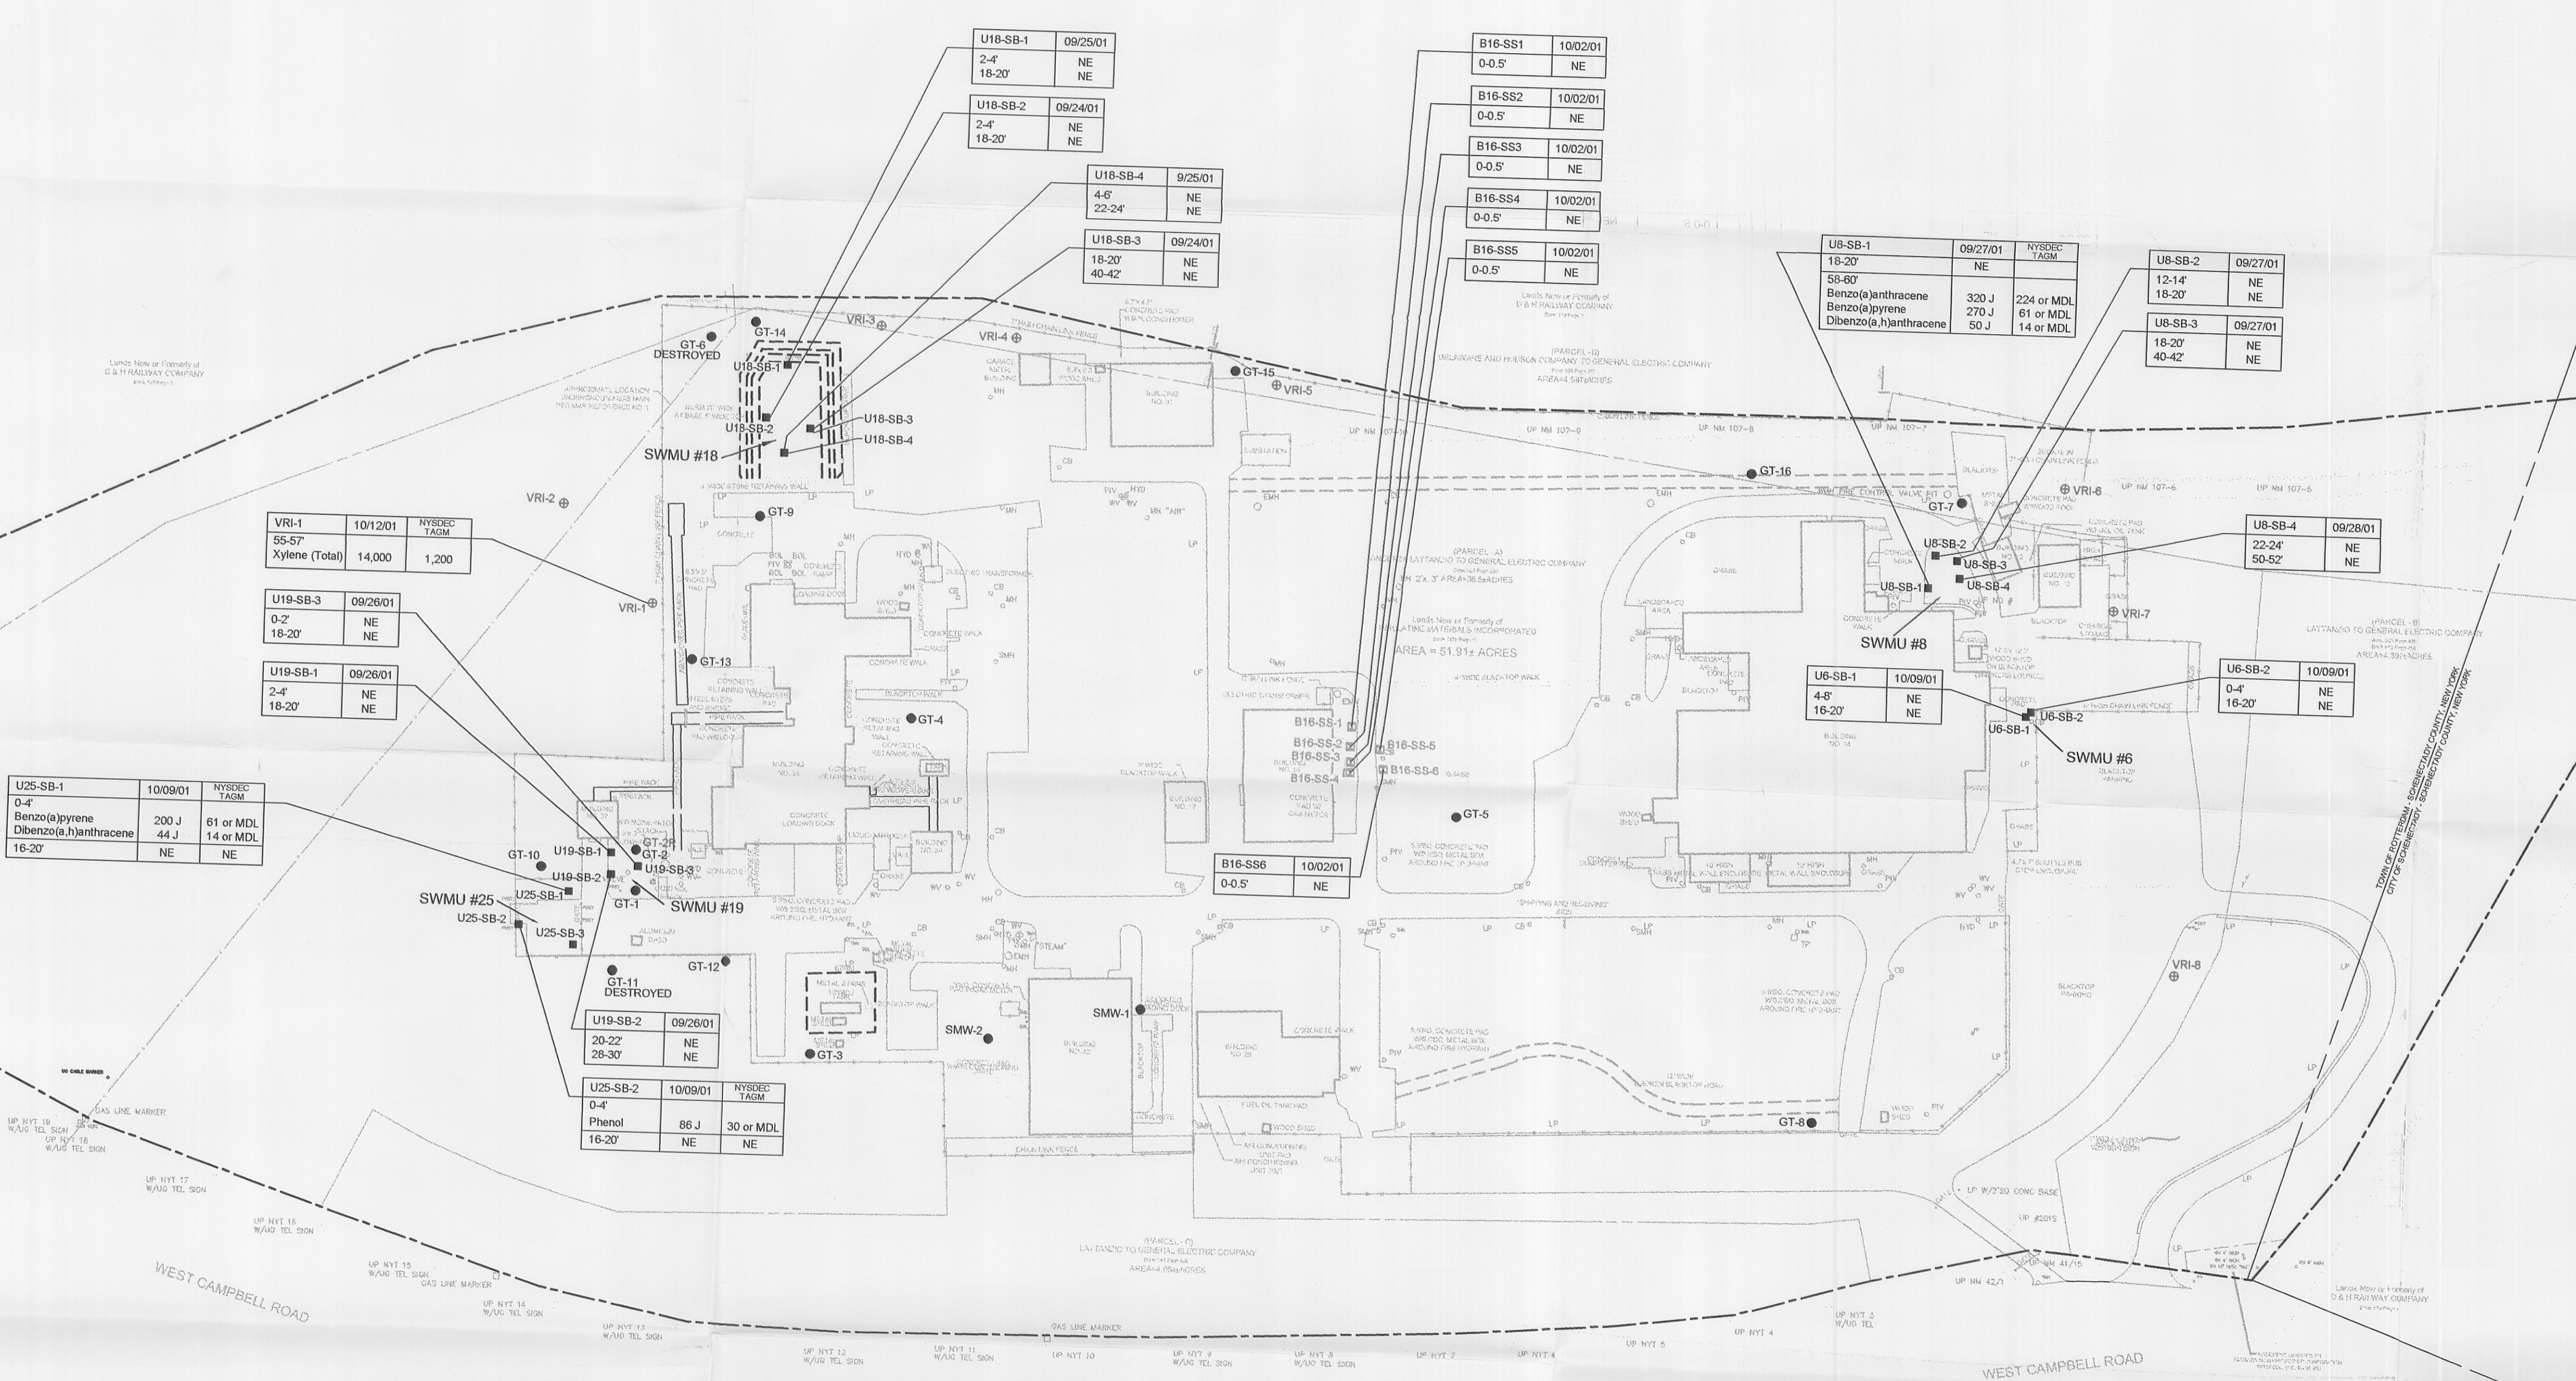
LOCATION ID	SAMPLE DATE	NYSDEC TAGM #4046 CRITERIA EXCEEDANCES (pp/kg)
U6-SB-1	09/27/01	224 or MDL
B16-SS-1	09/27/01	61 or MDL
B16-SS-1	09/27/01	14 or MDL
