# **FINAL REMEDIATION REPORT**

## **34 Freeman's Bridge Road Site Site # 4-47-028 Soil Remediation Project**

**November 2006 – October 2007**

**March 2008**

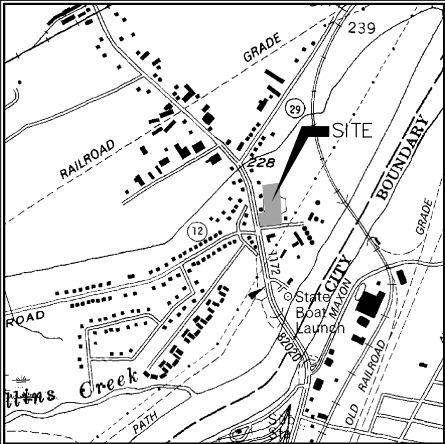
FIGURE 2

The Site is bordered on the east by Canadian Pacific Railway property, and Mohawk Asphalt Emulsions, Inc.; on the north by Warner Creek, designated as a Class C tributary to the Mohawk River (Class A); on the west by private properties and Freeman's Bridge Road; and on the south by private property. Residential and commercial properties exist to the north and west of the Site, with the nearest residential dwelling located approximately 450 feet west. The Mohawk River is approximately 500 feet east of the main part of the Site. This information is presented on the Site pre-excavation topographic map, (Figure 2).

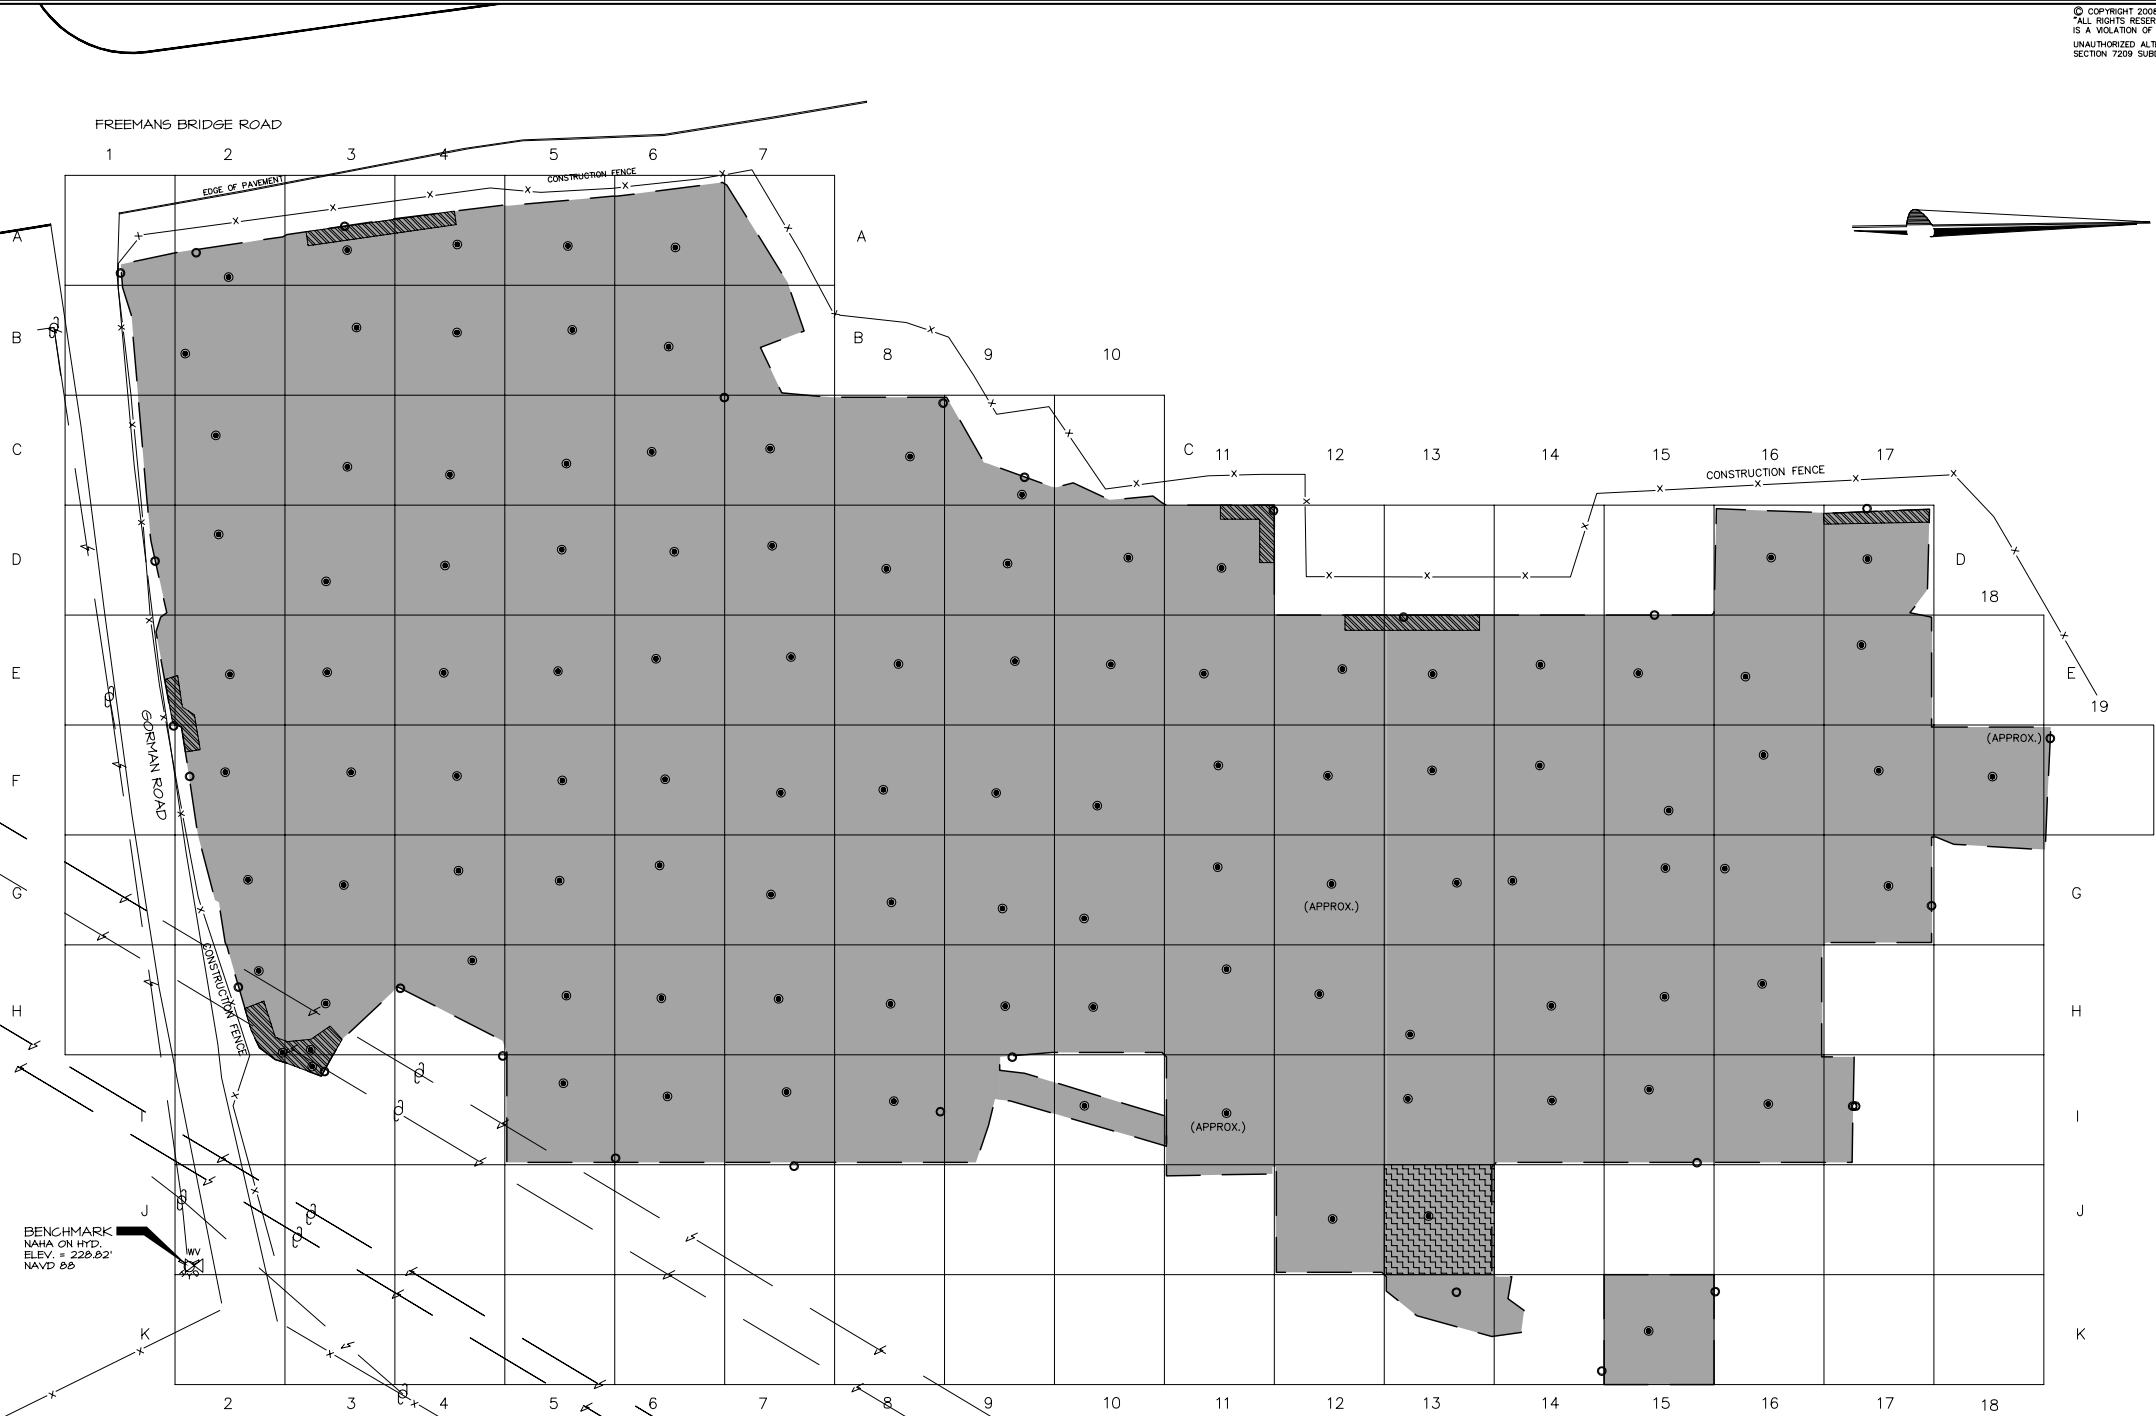
PROJECT NO.  
30670  
DRAWING NAME  
30670.DWG  
DRAWING NO.  
FIGURE 6

- BOTTOM SAMPLE
- SIDEWALL SAMPLE
- EXCAVATED AREA
- FENCE
- EDGE OF PAVEMENT
- RAILROAD
- FIRE HYDRANT
- SIDEWALL FAILURE
- BOTTOM FAILURE

SCALE	1" = 40'	DATE	BY	REVISIONS:
DATE	08/28/2007	1	LIB	UPDATED GRID SAMPLES
DRAWN BY	LIB	2	LIB	UPDATED GRID SAMPLES AND CHANGE PAGE NUMBER
CHECKED	ERG	3	LIB	UPDATED GRID SAMPLES
APPROVED	ERG			
TITLE	VERIFICATION SOIL SAMPLE LOCATIONS MAP

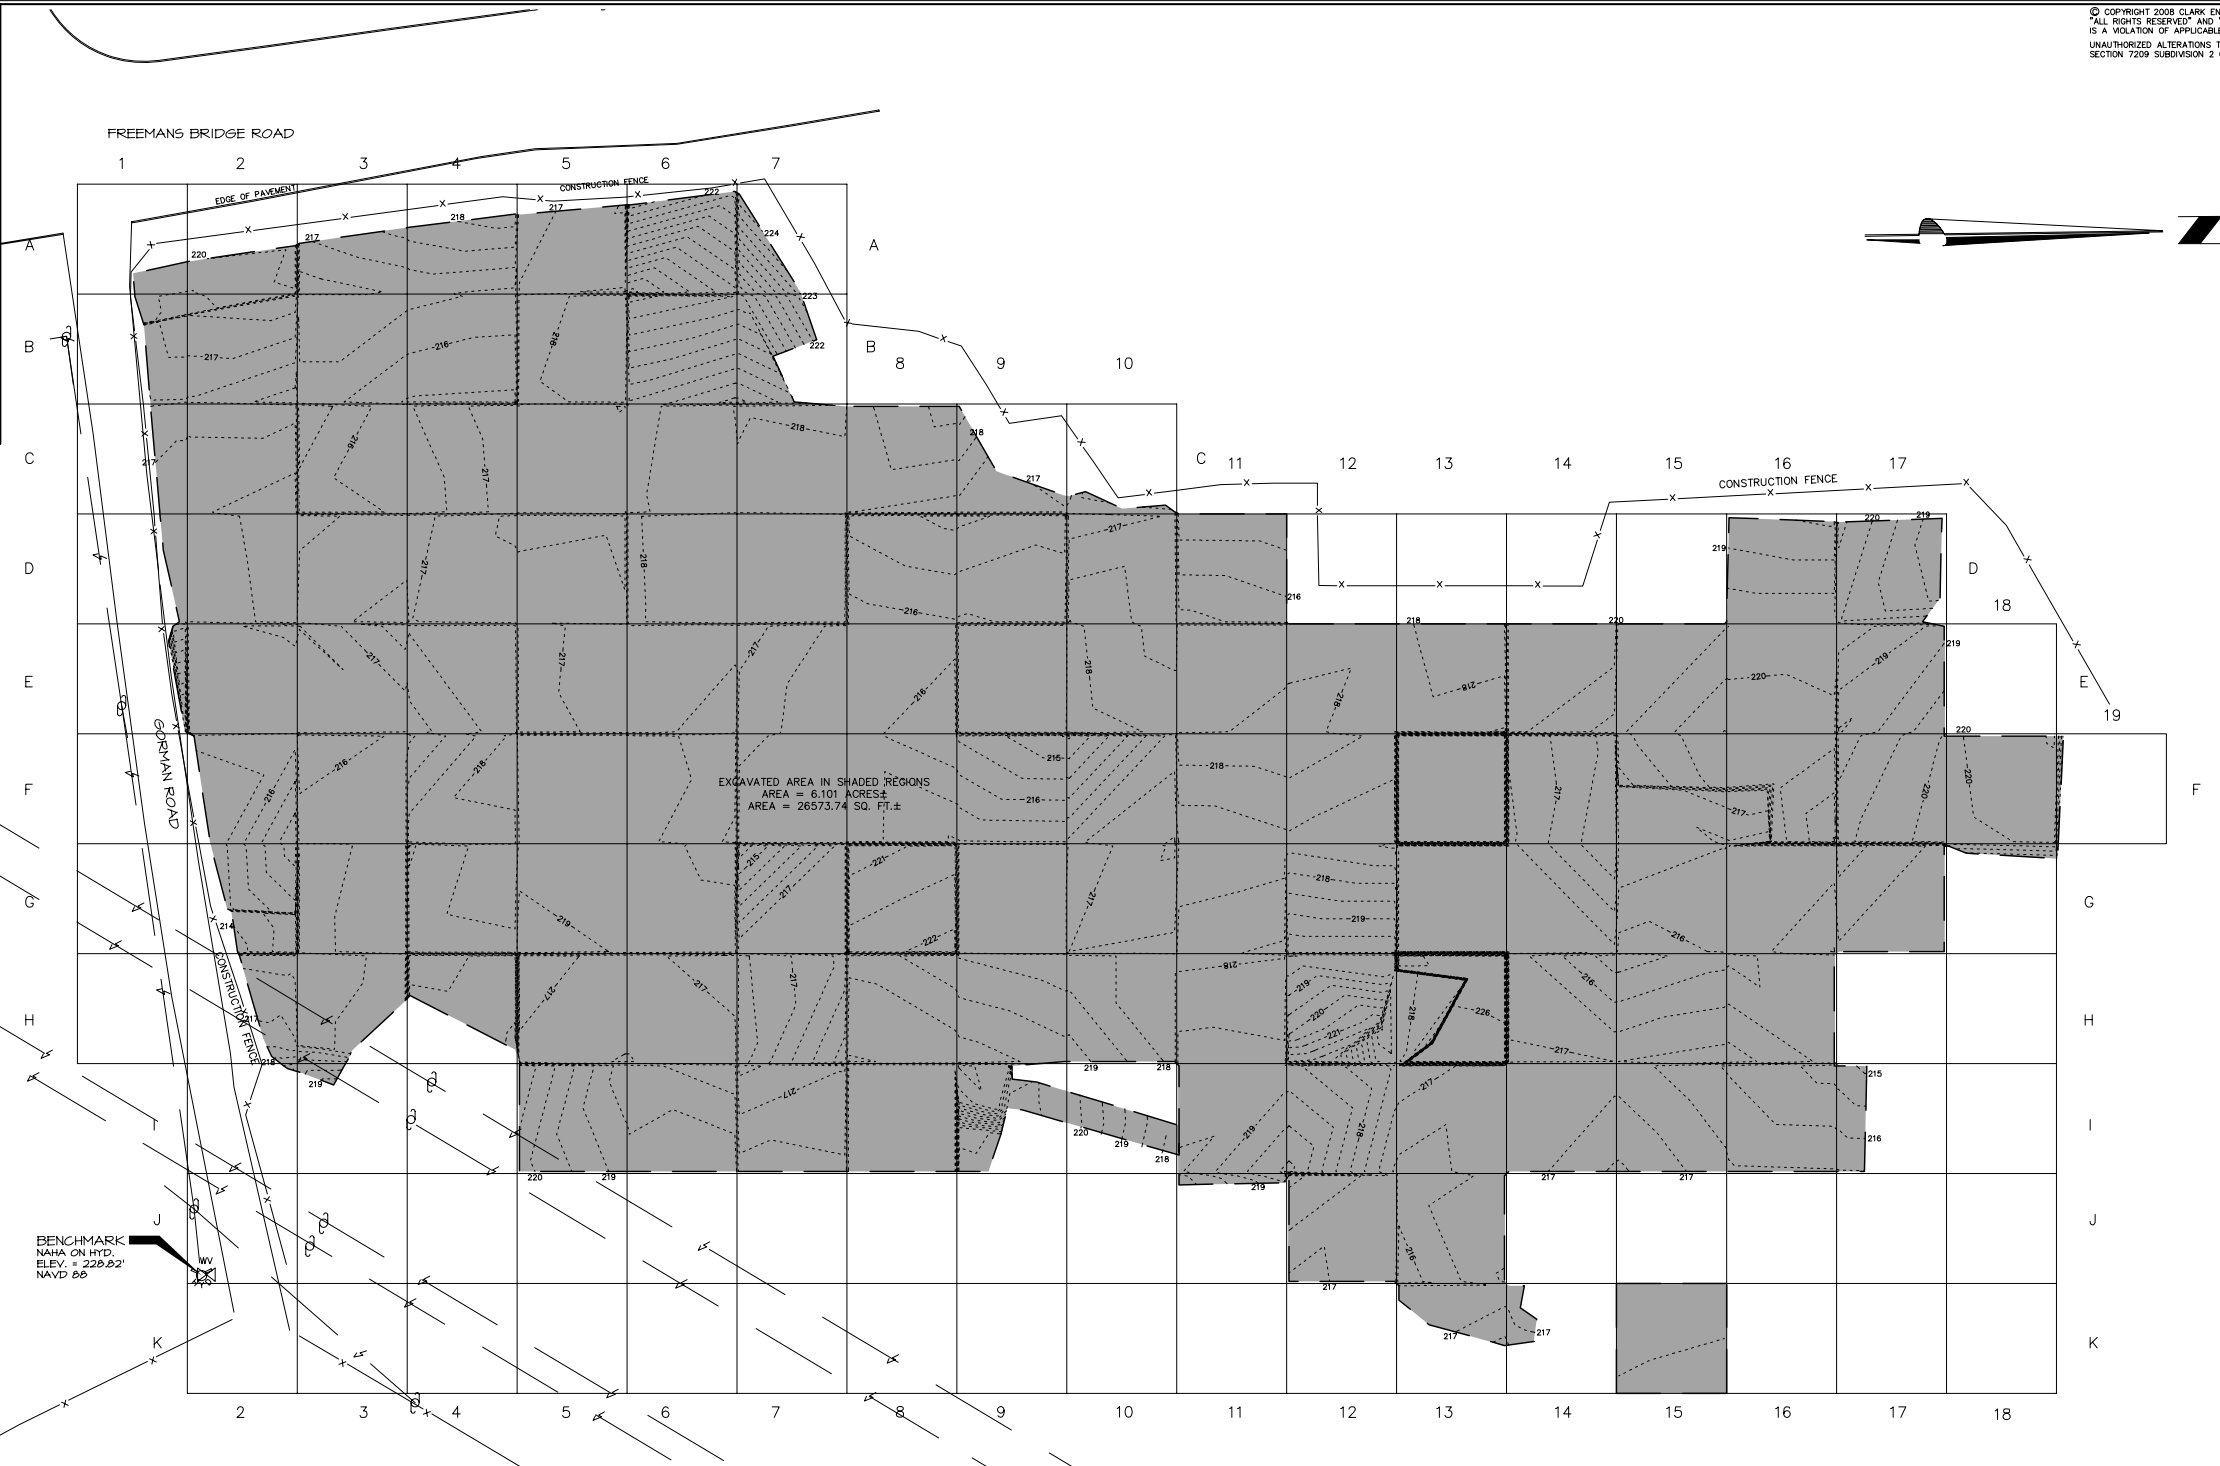
EXCAVATED AREA IN SHADED REGIONS  
AREA = 6.101 ACRES±  
AREA = 26573.74 SQ. FT.±

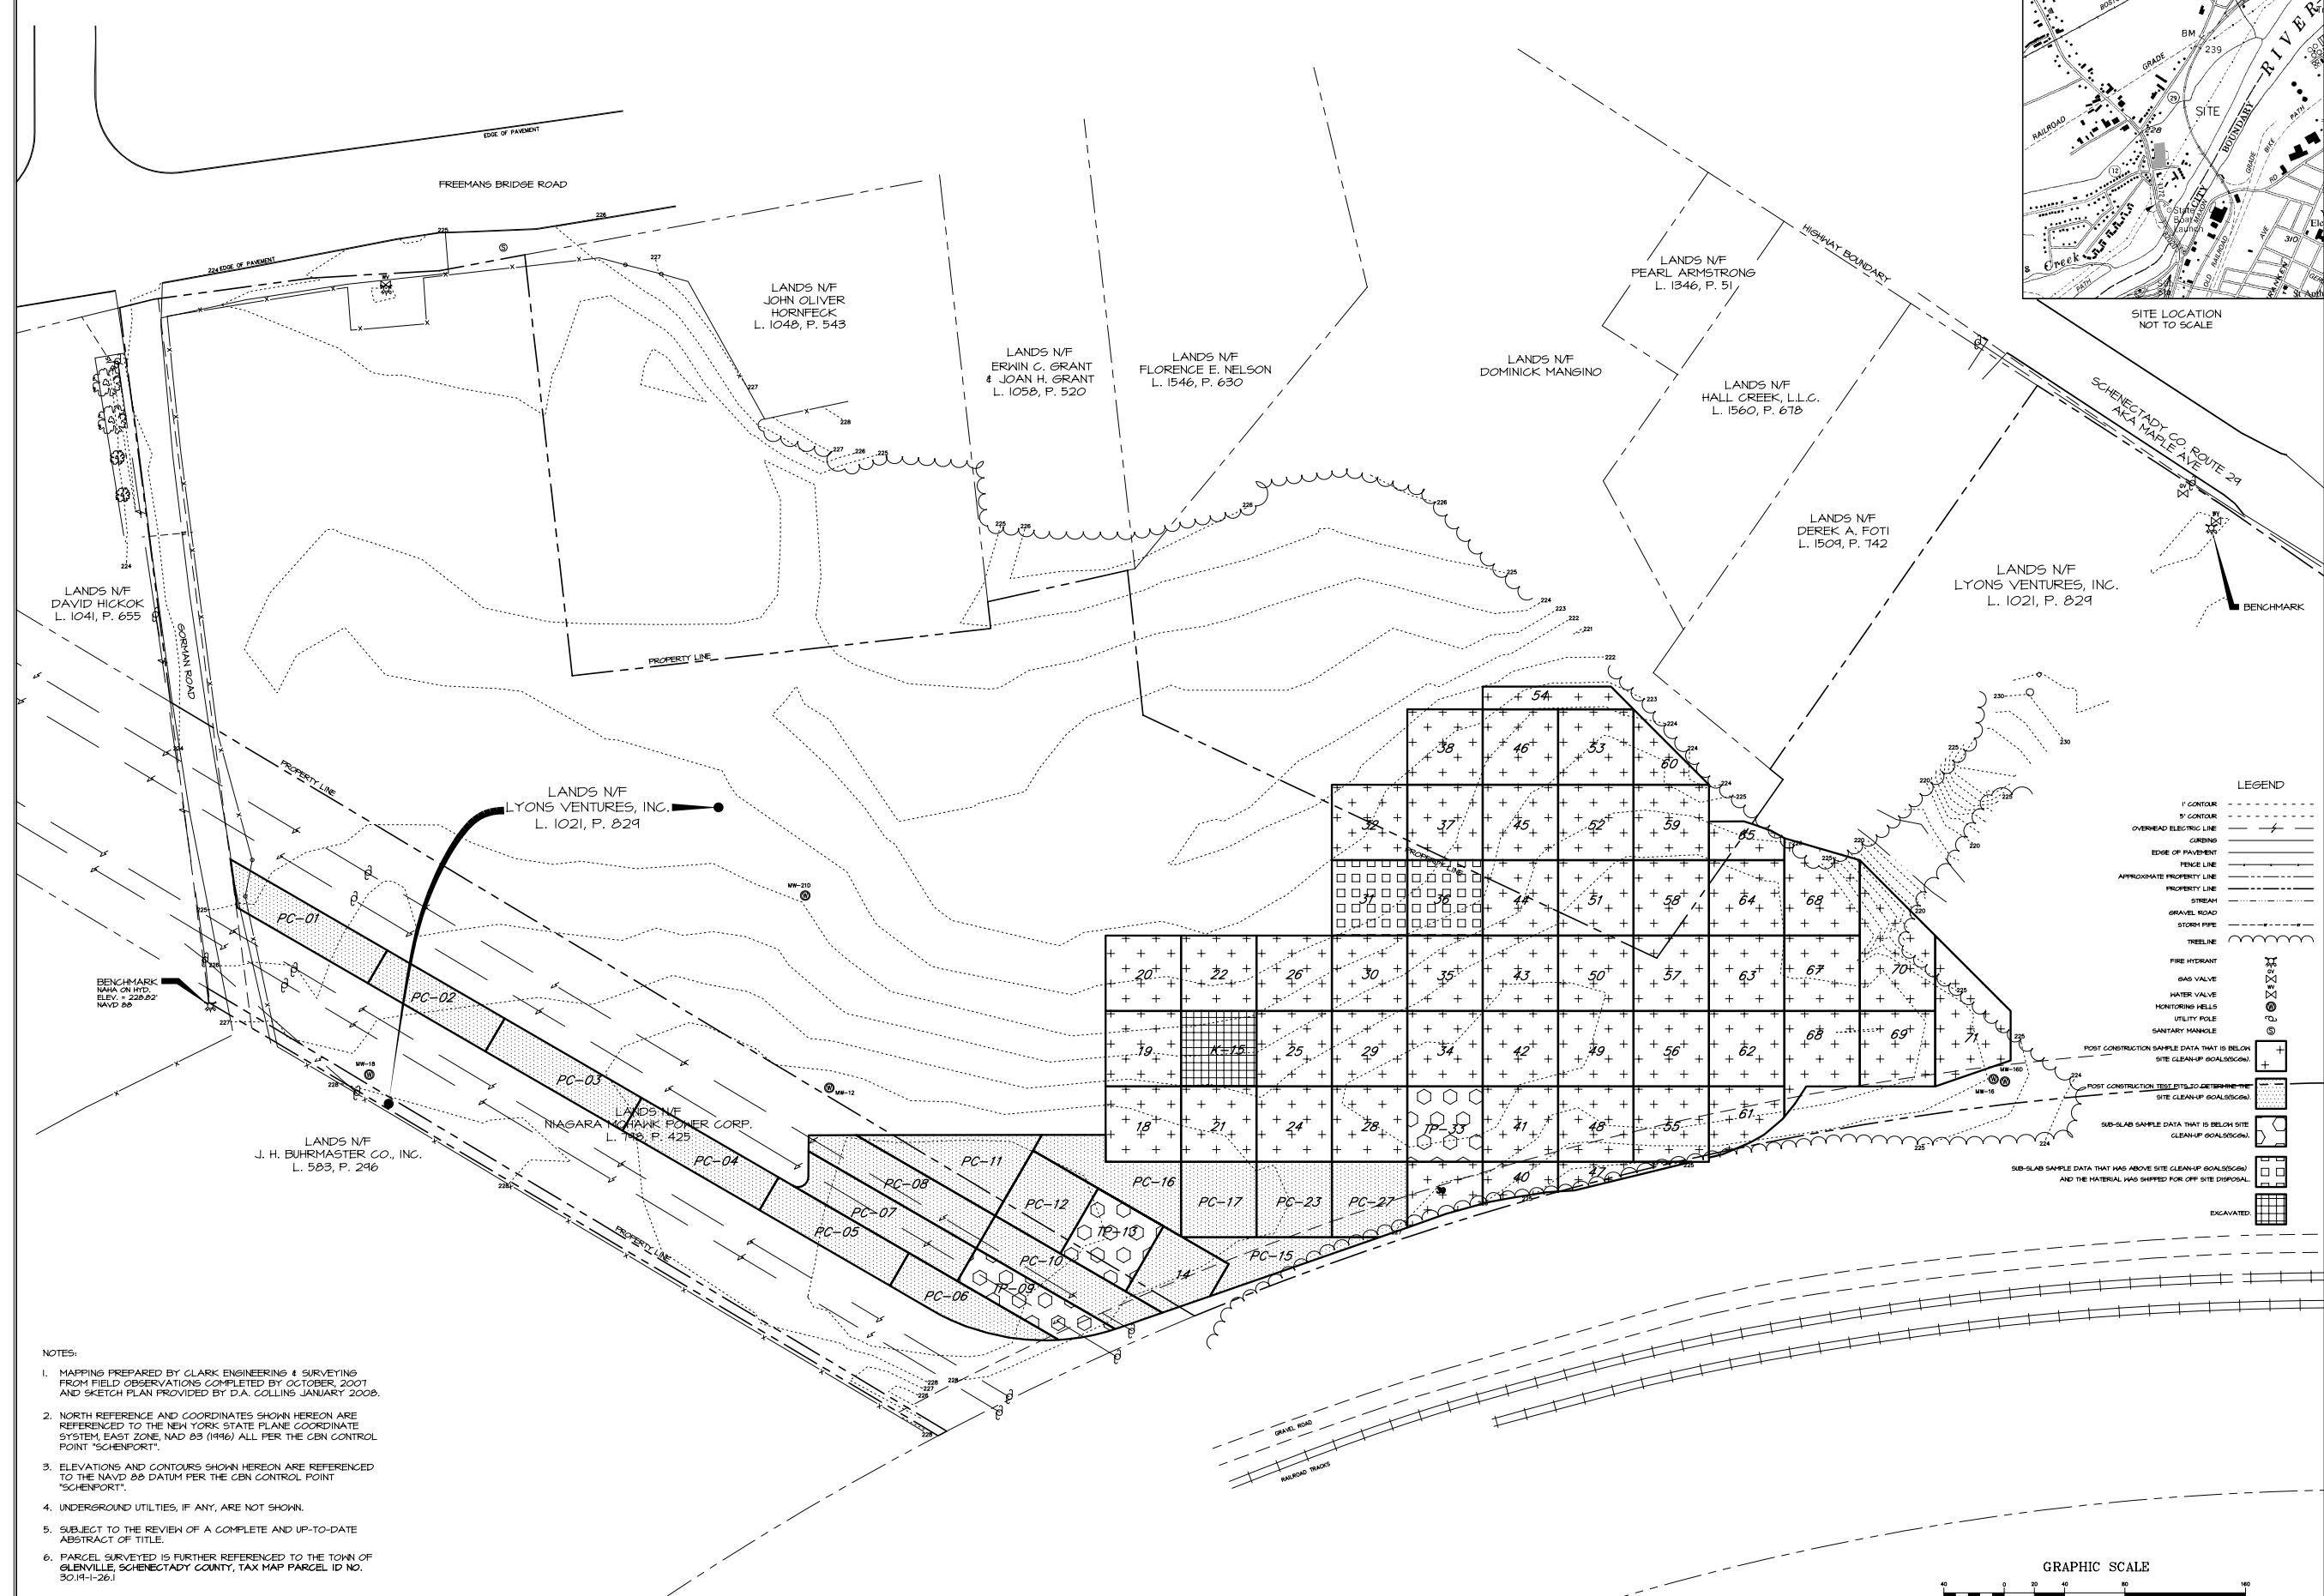
FIGURE 8

- 1' CONTOUR
- 5' CONTOUR
- OVERHEAD ELECTRIC LINE
- CURBING
- EDGE OF PAVEMENT
- FENCE LINE
- APPROXIMATE PROPERTY LINE
- PROPERTY LINE
- STREAM
- GRAVEL ROAD
- STORM PIPE
- TREELINE
- FIRE HYDRANT
- GAS VALVE
- WATER VALVE
- MONITORING WELLS
- UTILITY POLE
- SANITARY MANHOLE
- POST CONSTRUCTION SAMPLE DATA THAT IS BELOW SITE CLEAN-UP GOALS(SCGs)
- POST CONSTRUCTION SAMPLE DATA THAT IS ABOVE SITE CLEAN-UP GOALS(SCGs) AND THE MATERIAL HAS SHIPPED FOR OFF SITE DISPOSAL
- EXCAVATED

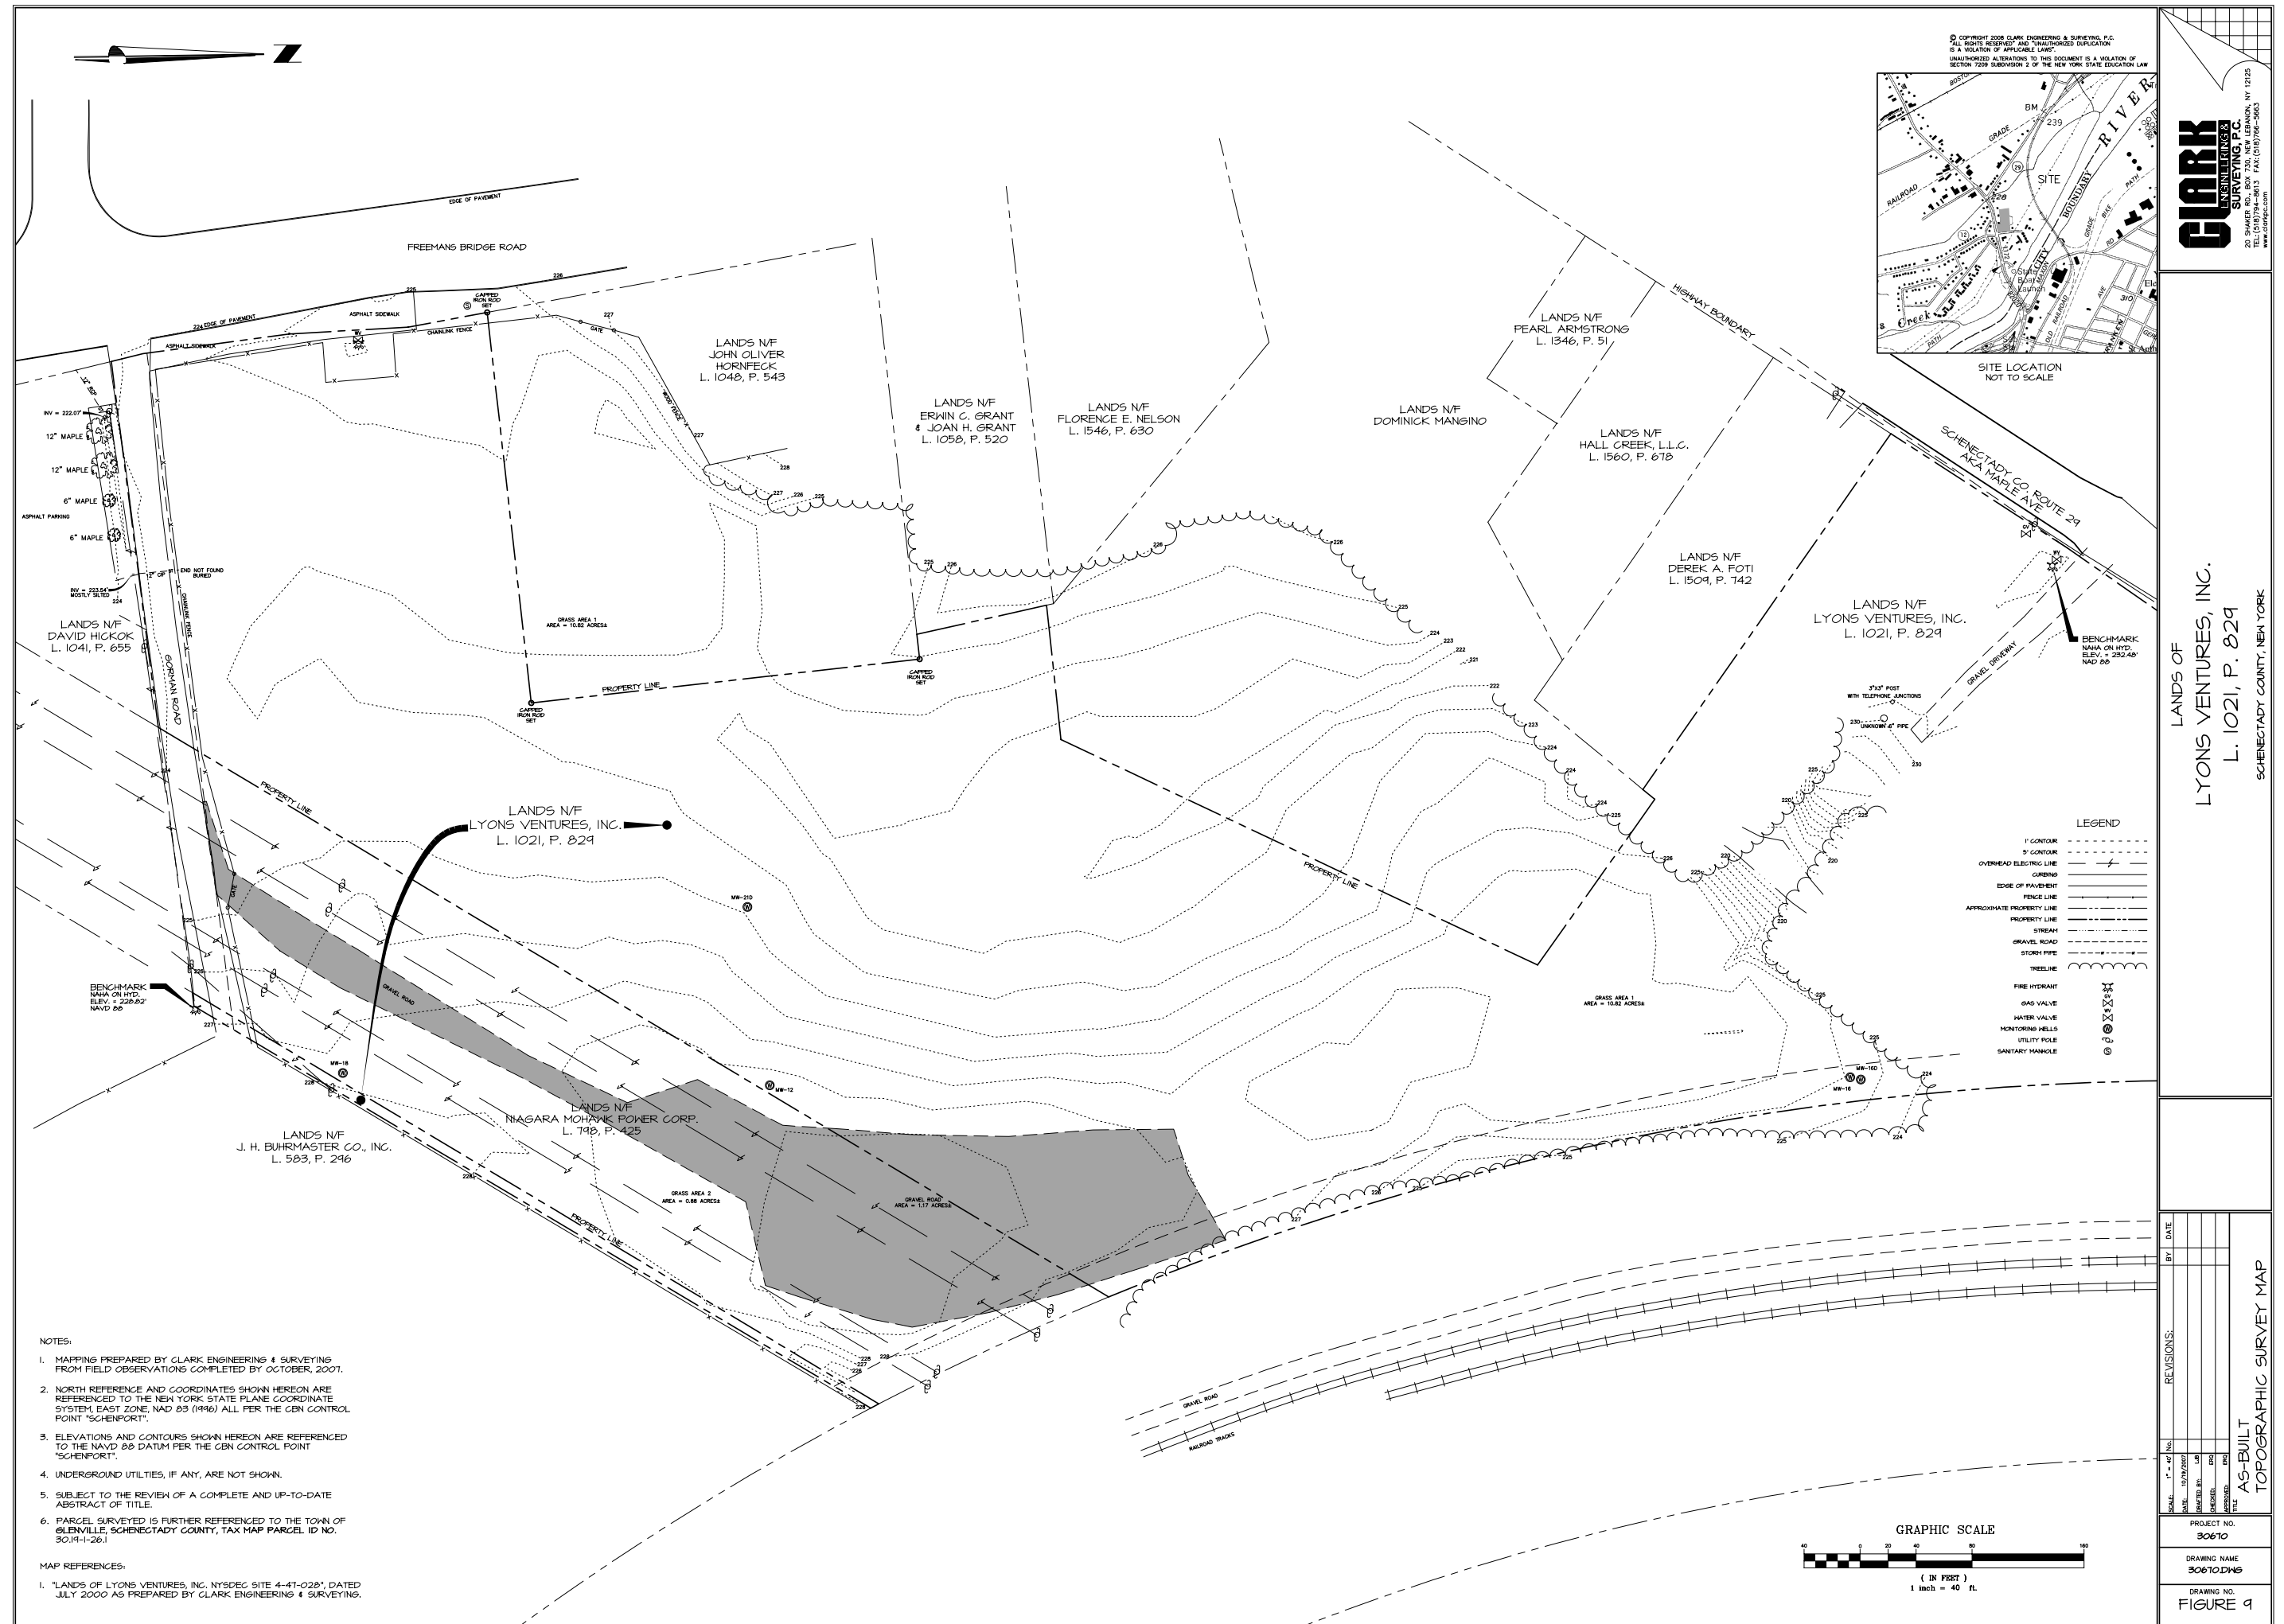
Once the LTD equipment and pads were removed from the Site, DAC performed post-construction soil sampling at the locations previously sampled during pre-construction soil sampling (see Section 3.3). Post-construction soil samples were analyzed for all Site specific contaminants of concern and followed the same sampling grid as the pre-construction sampling locations. All results were consistent with the pre-construction activities, except for cells 23 and 58 (see Table 7). Since the post-construction sampling involved collecting a single grab sample from each cell, the two cells that exhibited impacts were re-sampled using a composite of multiple grab samples from each cell. The re-sampling indicated that the average concentration of these cells was consistent with pre-construction conditions, and therefore no additional excavation was required by the NYSDEC. Post construction soil sample locations are presented in Figure 8.

Post Con 70-092807	194	3240	1570	61	61	ND	0.51	46.2	11.7	Yes	NA
Post Con 71-092807	130	1950	1070	30	30	ND	0.24	21.8	8.39	Yes	NA
Post Construction Test Pit Samples											
TP 08 0'-2' parking lot	22	ND	ND	126	78	48	0.08	32.6	20.5	Yes	NA
TP 08 2'-4- parking lot	18	ND	ND	ND	ND	ND	0.09	38.8	14.6	Yes	NA
TP 08 4'-6' parking lot	17	ND	ND	<b>9800</b>	<b>9800</b>	ND	0.08	31.8	15	Yes	Soil will be left in place.
TP 13 0'-2' parking lot	8	ND	ND	ND	ND	ND	ND	25.1	14.8	Yes	NA
TP 13 2'-4' parking lot	11	ND	ND	ND	ND	ND	ND	34.1	24.6	Yes	NA
TP 13 4'-6' parking lot	58	ND	ND	280	280	ND	ND	24.9	20.4	Yes	NA
TP 33 0'-2' parking lot	16	5000	2400	95	ND	95	1.56	47.3	23.6	Yes	NA
TP 33 2'-4' parking lot	10	6900	3500	ND	ND	ND	1.26	99.7	20.9	Yes	NA
TP 33 4'-6' parking lot	12	18600	7700	320	320	ND	0.36	66.7	24.9	Yes	NA
Notes: <b><i>Bold/italicized text indicates exceedance of established Site Cleanup Goals (SCGs)</i></b> ND - Not Detected at the reporting limit. NA - Not applicable Sample numbers refer to the Post Construction Sampling grid see the Post Construction Sampling Drawing <b>Figure 8</b> . Test Pit 08 is mislabeled. It is actually Test Pit 09. See the Post Construction Sampling Drawing <b>Figure 8</b> .
