*Feasibility Study Report
M. Wallace & Son, Inc. Scrapyard
Cobleskill, New York*

Niagara Mohawk Power Corporation
Syracuse, New York

February 1997

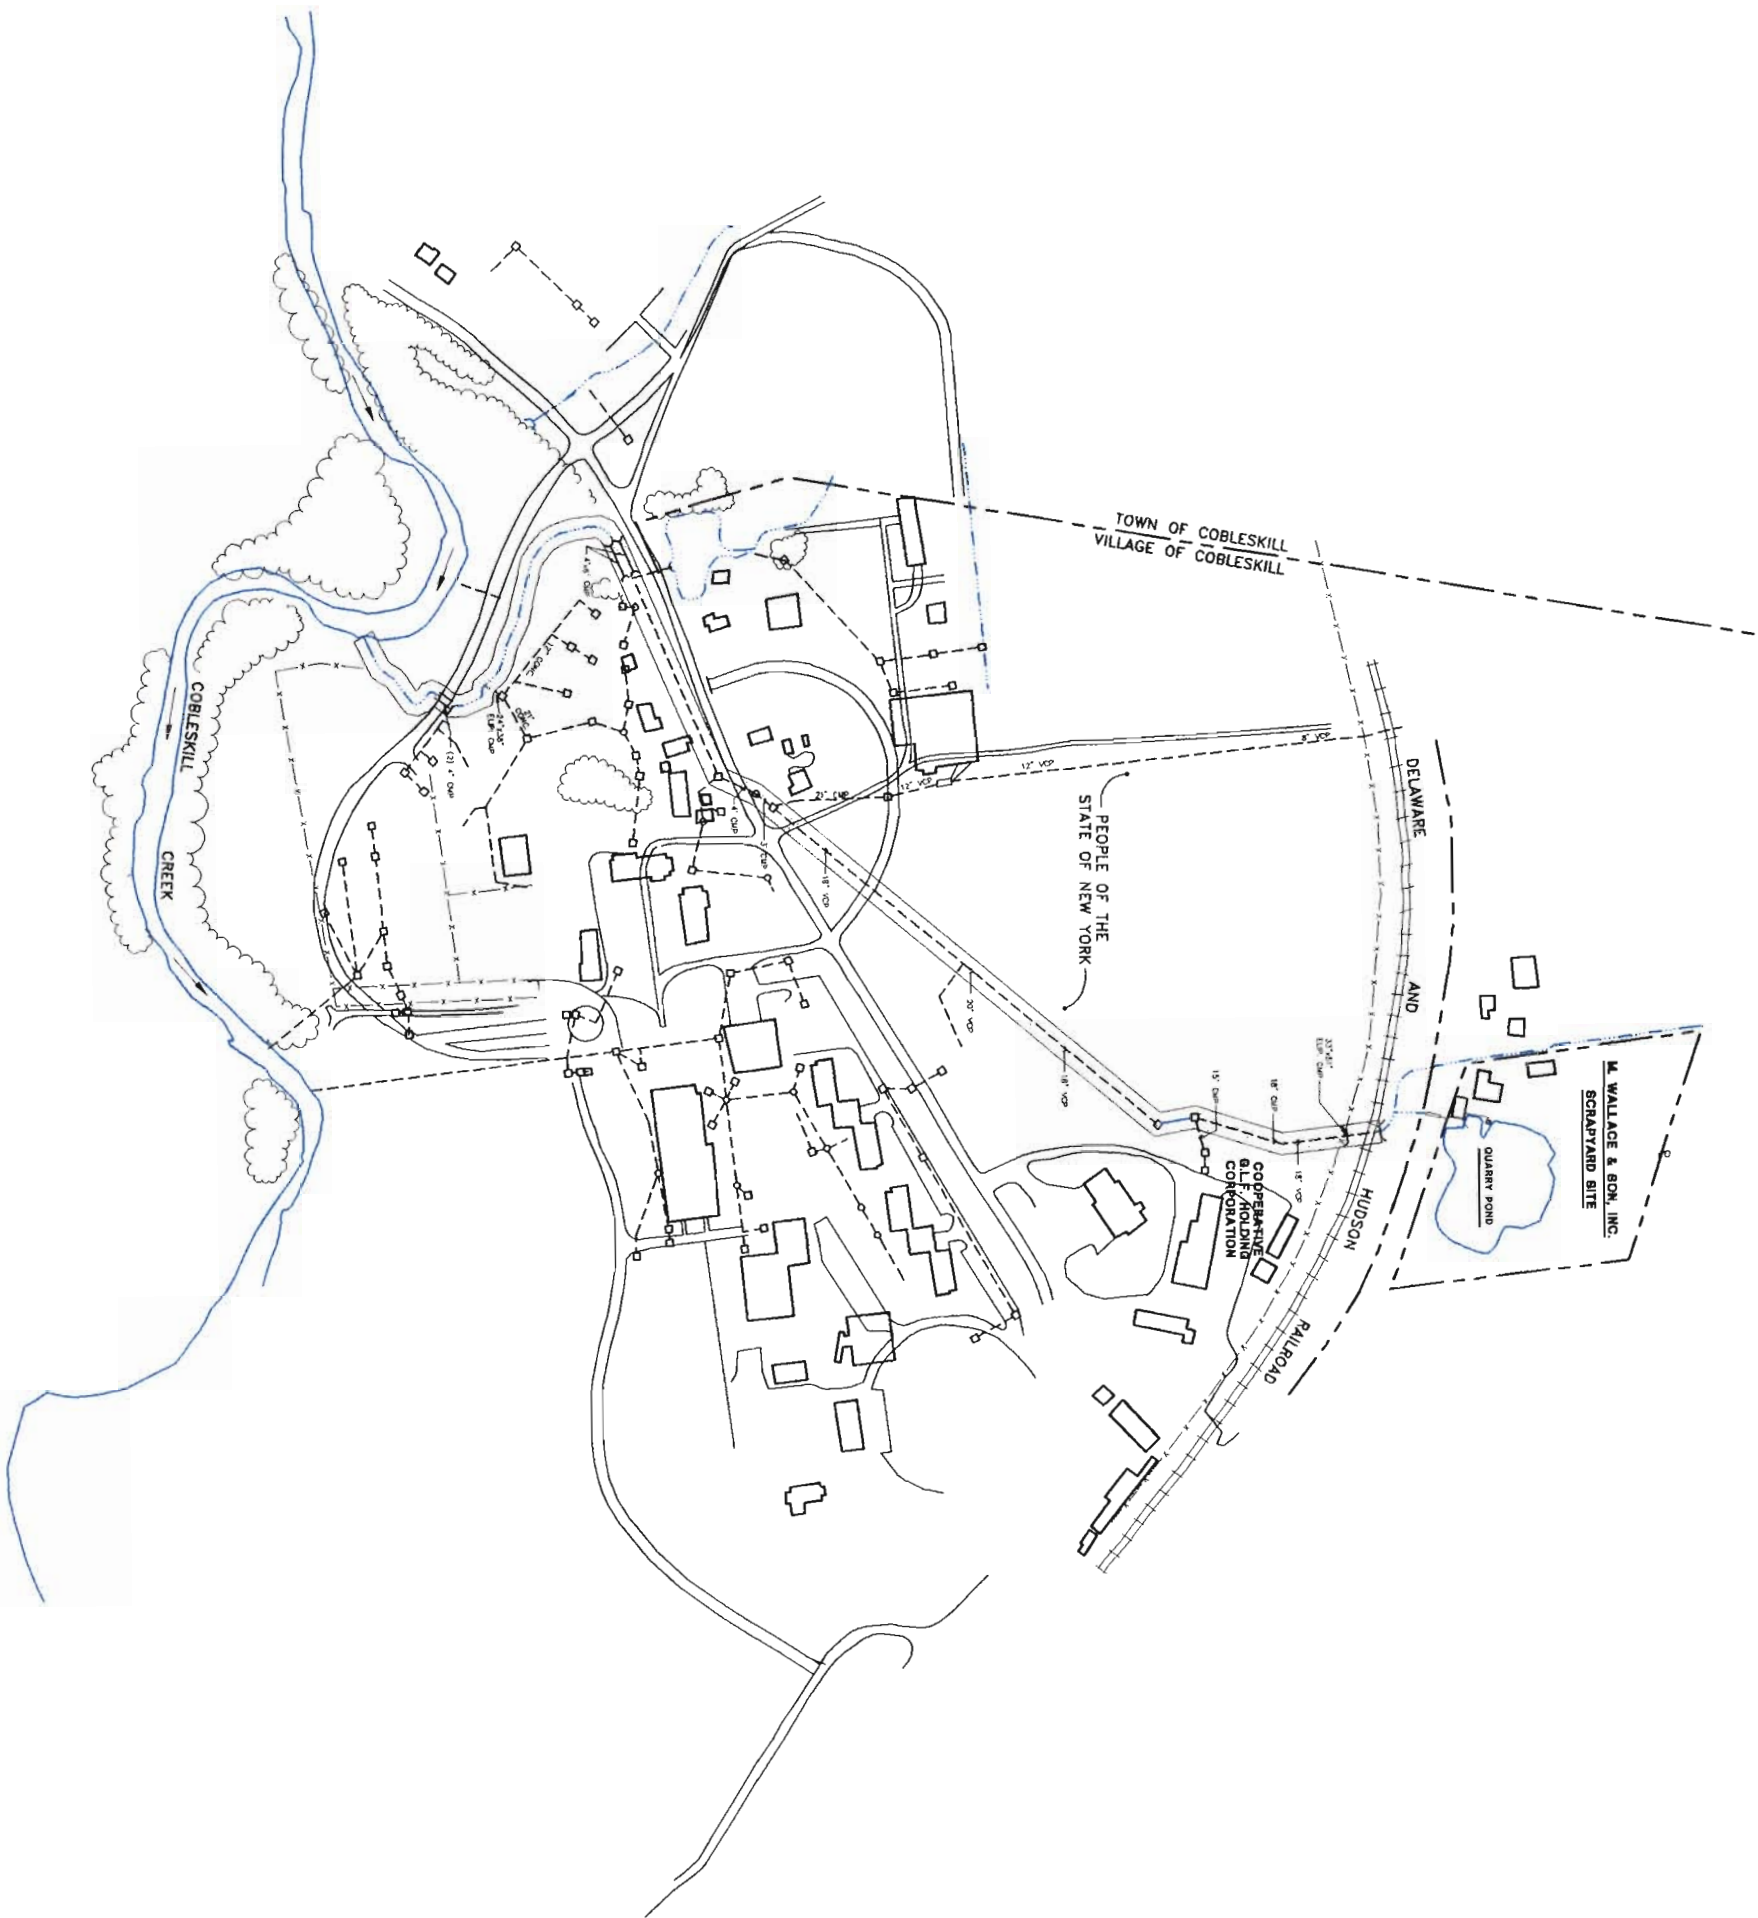
FIGURE
1-1

SURFACE WATER
FEATURES AND SITE
DRAINAGE PATH
