**Report on Implementation of
Remedial Action at Landfill 6 AOC**

**Former Griffiss Air Force Base
Rome, NY**

August 2008

**REPORT ON IMPLEMENTATION OF REMEDIAL ACTION AT
LANDFILL 6
Former Griffiss Air Force Base, Rome, New York**

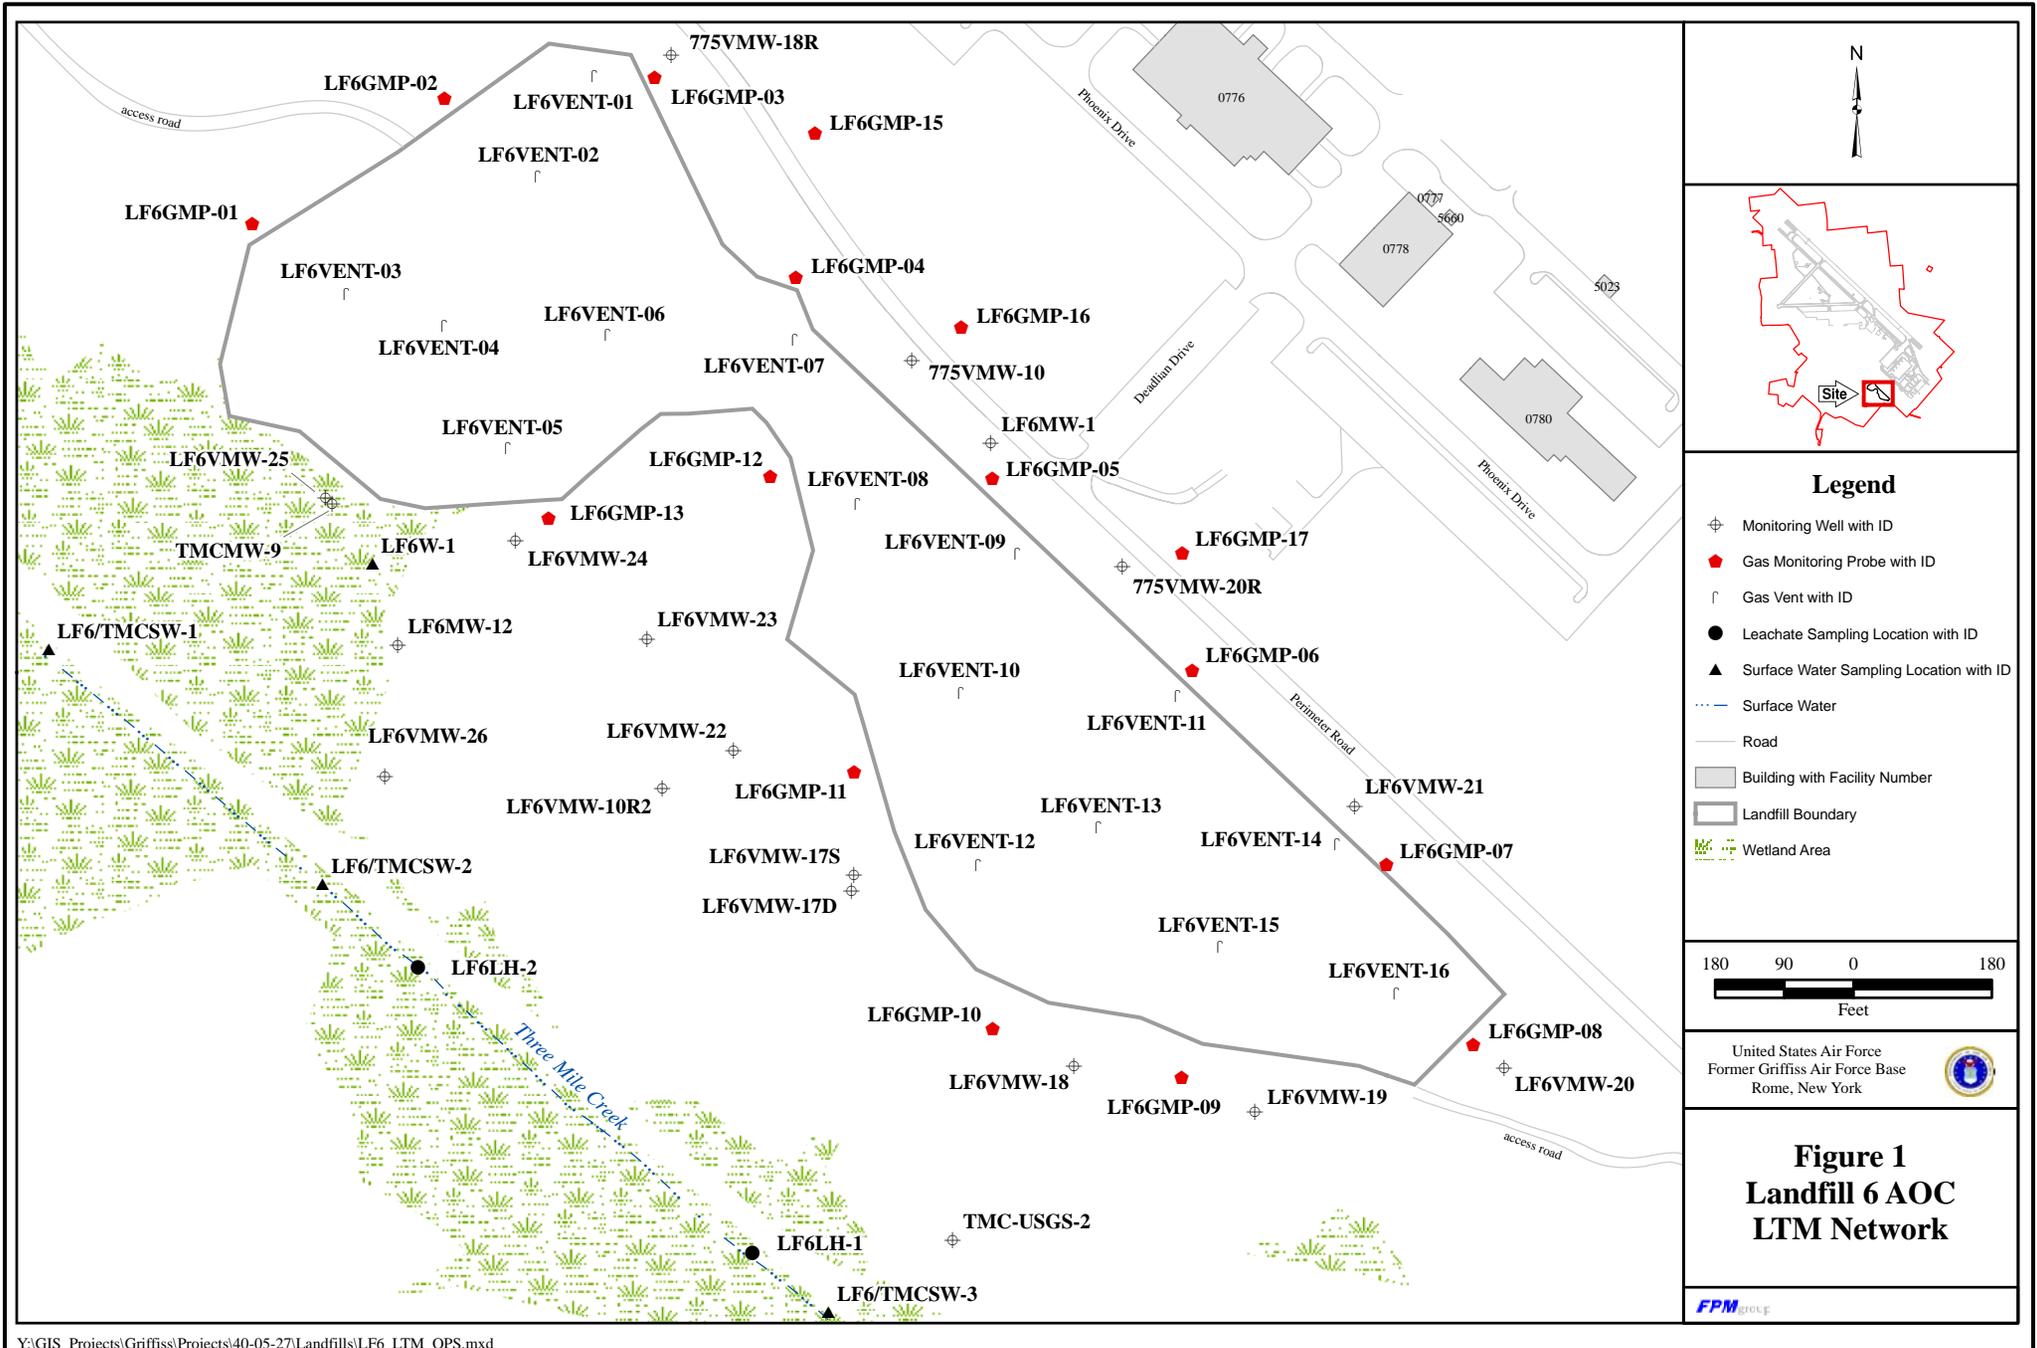
Figure 1 Landfill 6 AOC LTM Network

The LTM groundwater monitoring network at Landfill 6 consists of 19 groundwater monitoring wells (see Figure 1). Target analytes are based on COCs and 6 NYCRR Part 360 baseline (annually) and routine (quarterly) parameters. Data collected from monitoring wells LF6MW-12, LF6VMW-10R2, -17S, -17D, -18, -19, -20, -22, -23, -24, -25, -26, TCMW-9, and TMC-USGS-2 monitor the effectiveness of attenuation process on COCs at the AOC. Upgradient monitoring wells 775VMW-10, -18R, -20R, LF6MW-1, and LF6VMW-21 monitor groundwater conditions prior to migration through the landfill.

The gas monitoring LTM network currently consists of 16 gas monitoring probes and 16 gas vents (see Figure 1). Three gas probes were installed to the east of Perimeter Road to provide additional monitoring of potential gas migration towards the occupied buildings. These three gas monitoring probes will only be sampled if gas monitoring probes west of Perimeter Road show any concentration of methane. Quarterly sampling was conducted at the gas monitoring probes and vents from June 2006 to April 2008 to identify and evaluate trends in landfill gas concentrations and to assure that the landfill continued to comply with 6 NYCRR Part 360-2.17(f).

- Groundwater extraction/ utilization/ consumption by any current or future landowner within the groundwater restriction area (see Figure 1) will not be permitted without prior testing and written approval from the New York State Department of Health (NYSDOH).
- Activities that disrupt or interfere with the post-closure activities will not be permitted.
- Intrusive work within the intrusive area will not be permitted without prior written approval from the Air Force Real Property Agency (AFRPA), New York State Department of Environmental Conservation (NYSDEC), and the United States Environmental Protection Agency (USEPA).
- Intrusive work or other activities that impact the effectiveness or integrity of the landfill closure or effectiveness of post-closure activities will not be allowed within the restricted landfill boundary.

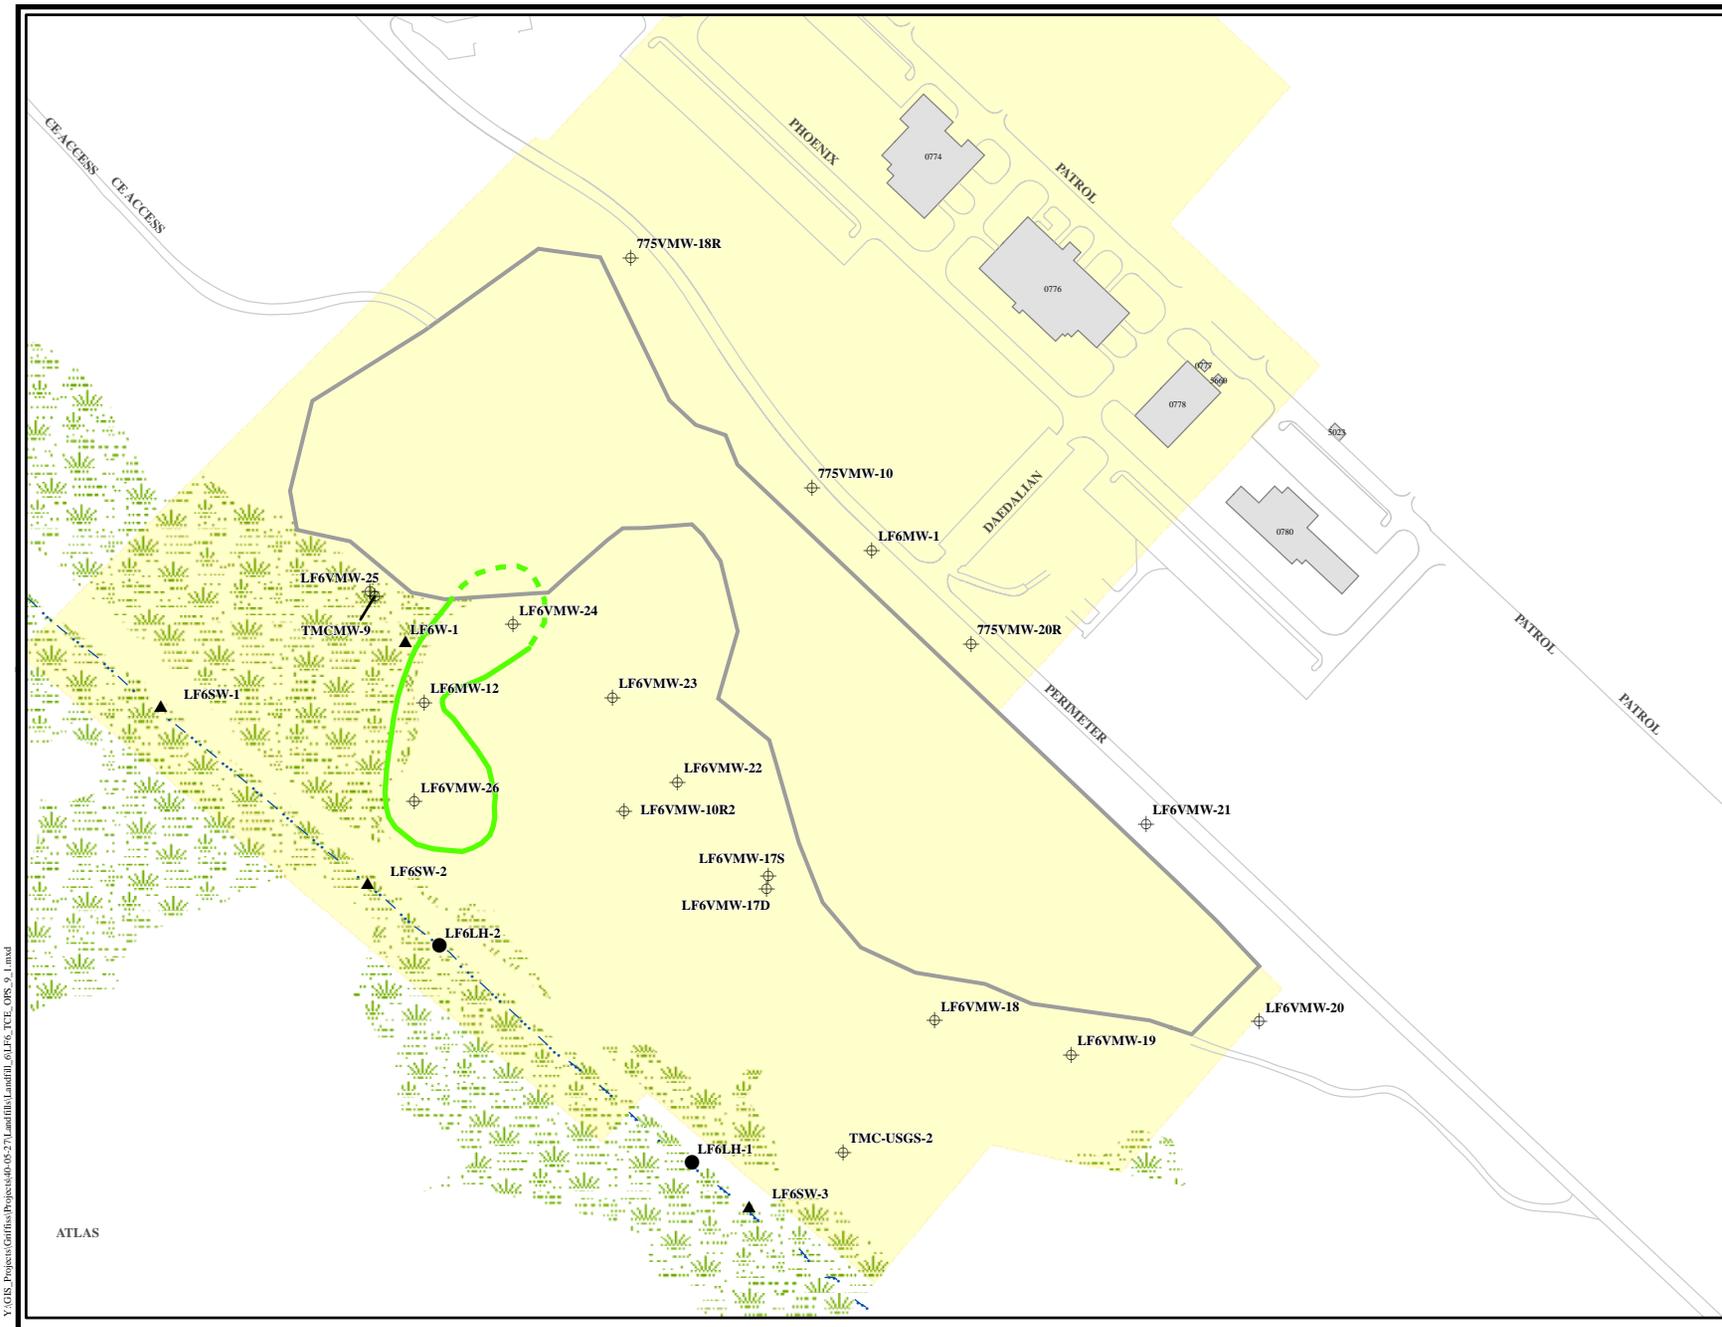
- ⊕ Monitoring Well with ID
- Leachate Sampling Location with ID
- ▲ Surface Water Sampling Location with ID
- 50 ppb TCE plume
- - - 50 ppb plume (dashed)
- Surface Water
- Road
- ▭ Building with Facility Number
- ▭ Landfill Boundary
- Wetland Area
- Groundwater Land Use Restriction
