Figure 9

Primoshield, Inc.  
Site # 633027  
VOC Concentrations in MW 105

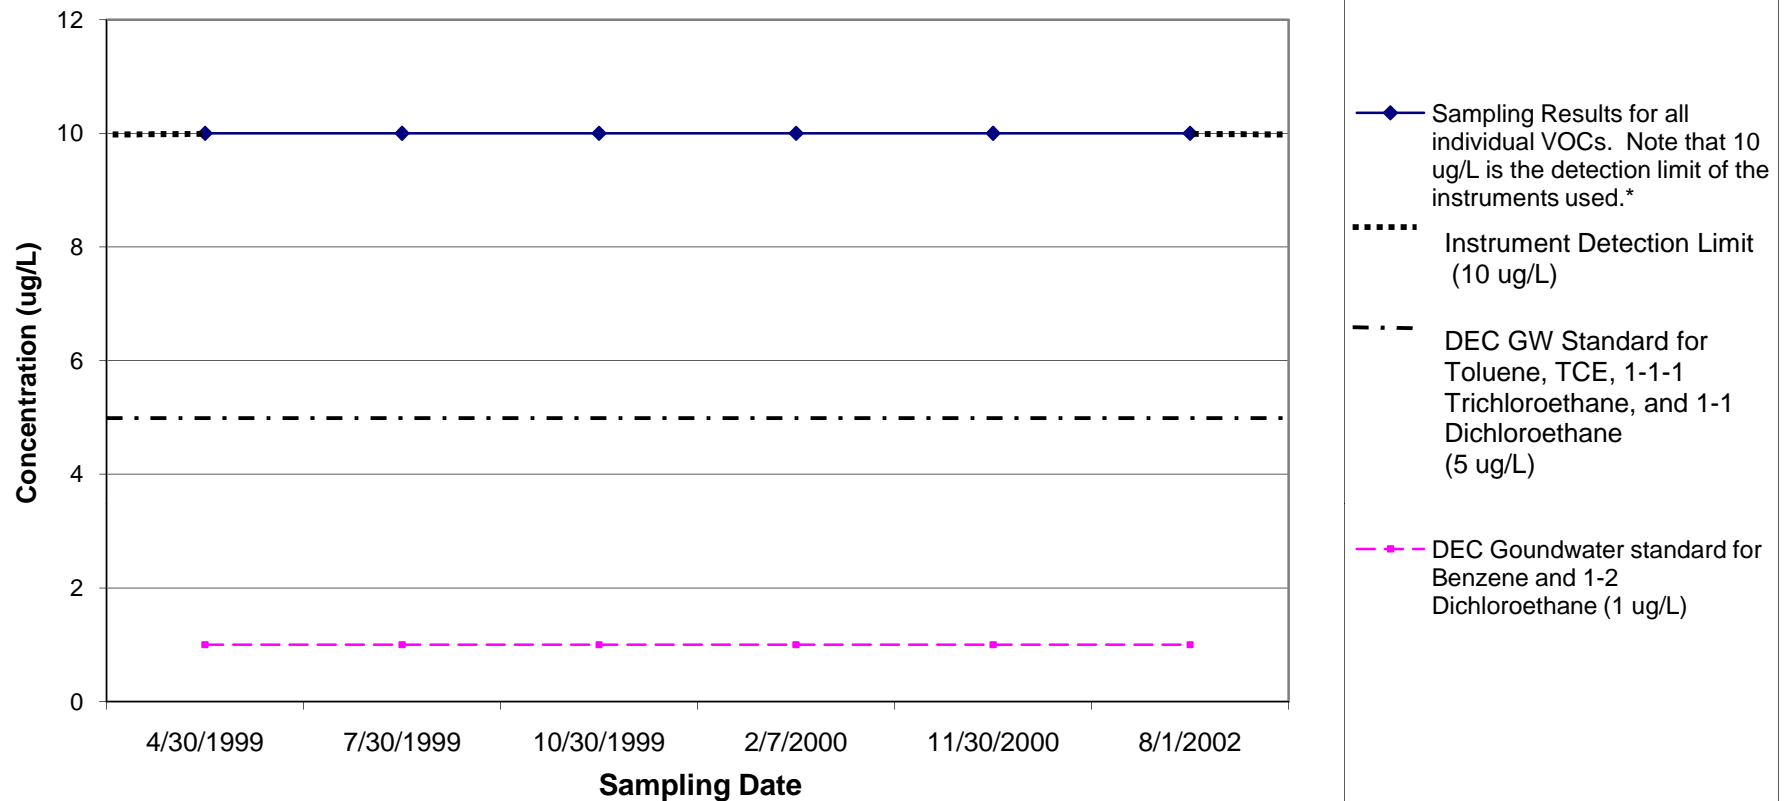
\*Note: For all sampling dates in question, individual VOC compounds were undetected in this well. Therefore, VOC levels in this well may exist below the detection limit of the instrument. It is important to note that the New York State Groundwater Standard for each individual VOC of concern is less than this detection limit. No samples were collected from MW 105 on 10/30/99.
