SUBJECT: April 2015 Operating Report for the Vestal Well field 1-1 Superfund Site, Area 4,
Vestal, New York

SUBJECT: April 2014 Monthly Report on Activities at the Vestal Well field 1-1 Superfund Site, Area 4, Vestal, New York

SITE PHOTO LOG

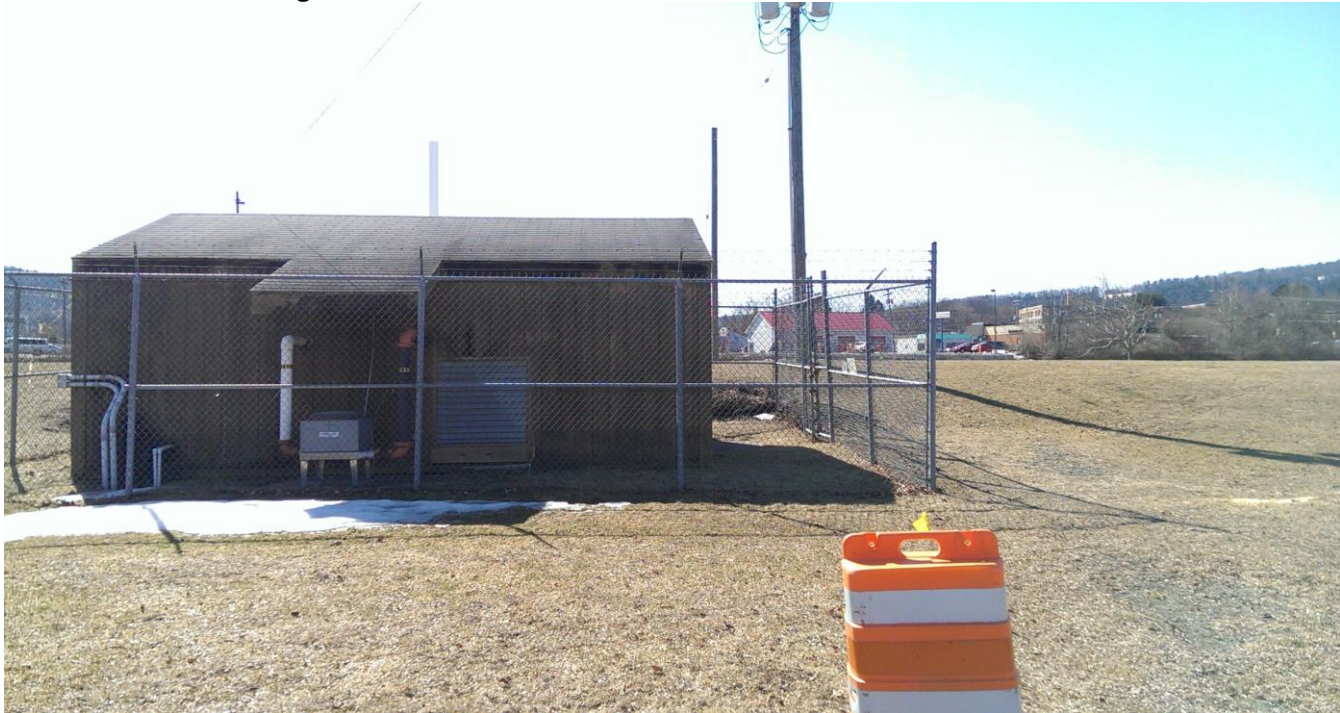
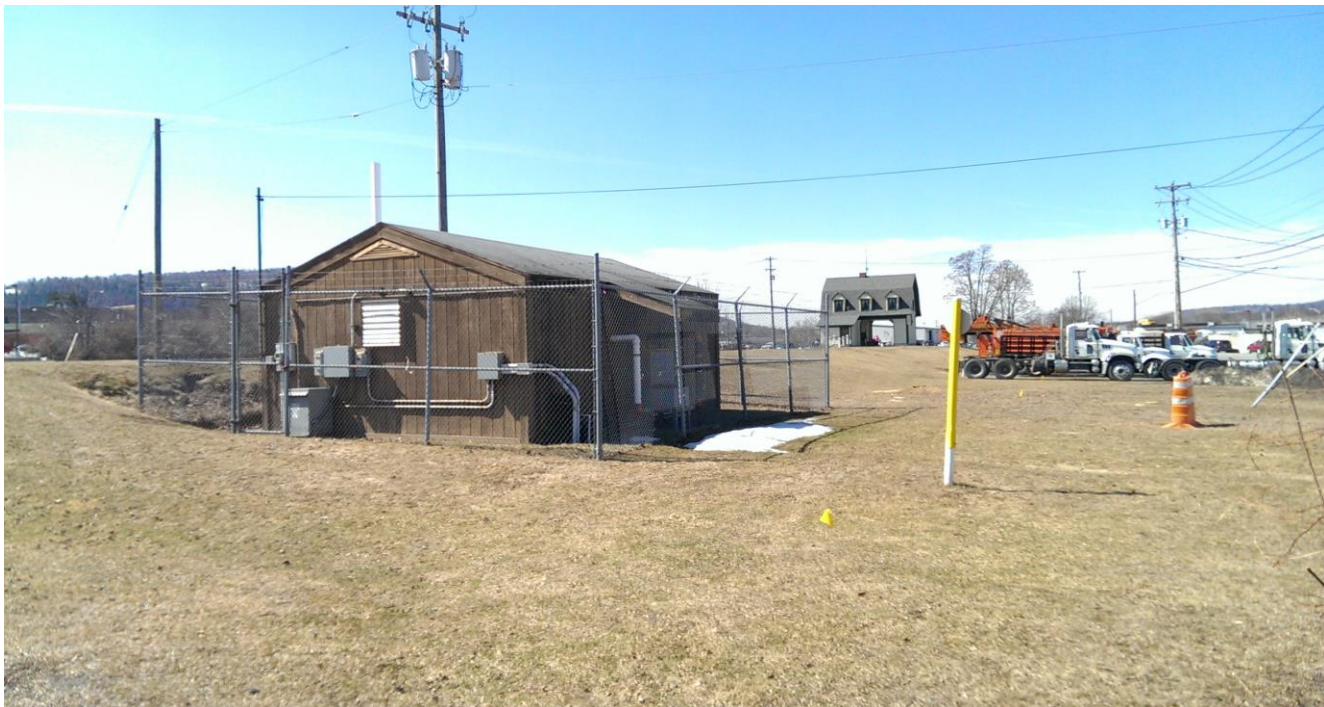
Main Building

No other operational issues were noted during the inspection. Both the distribution buildings and the adjacent parking lot area were inspected and no issues were noted.
