SUBJECT: January 2017 Operating Report for the Vestal Well Field 1-1 Superfund Site, Area 4,  
Vestal, New York

SUBJECT: January 2017 Monthly Report on Activities at the Vestal Well field 1-1 Superfund Site, Area 4, Vestal, New York

**LATA Project # 11202**  
**Contract # W912DQ-09-D-3003,**  
**Task Order # 008**

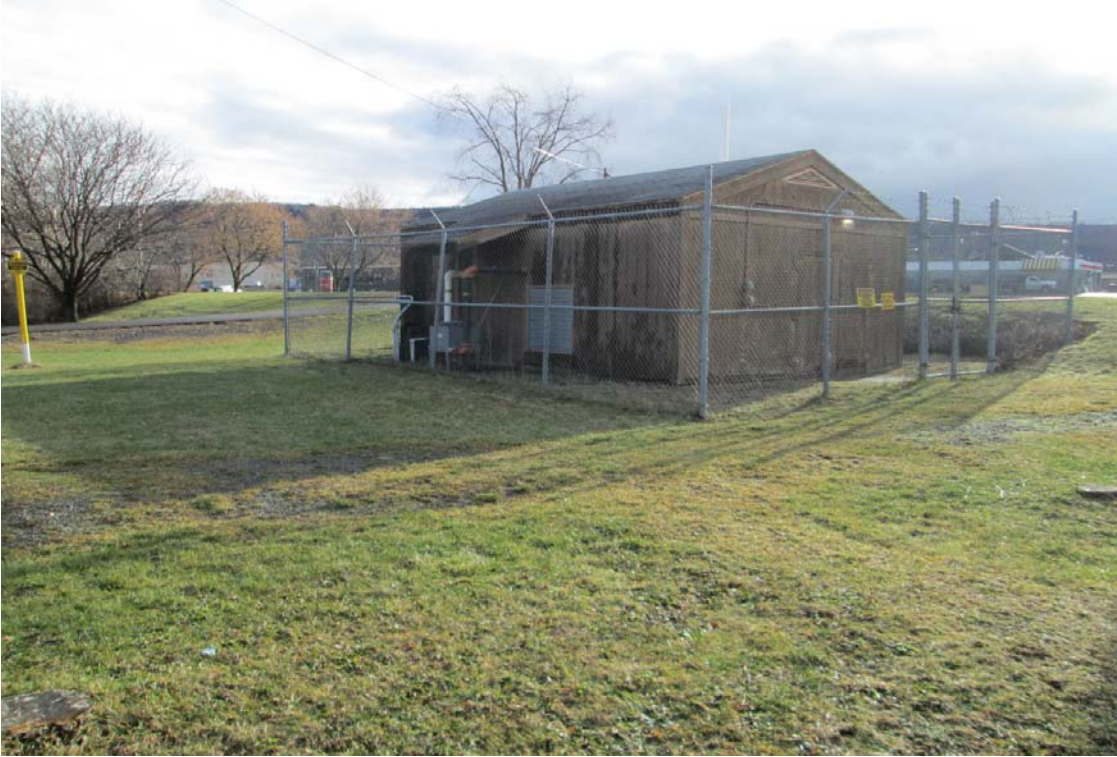
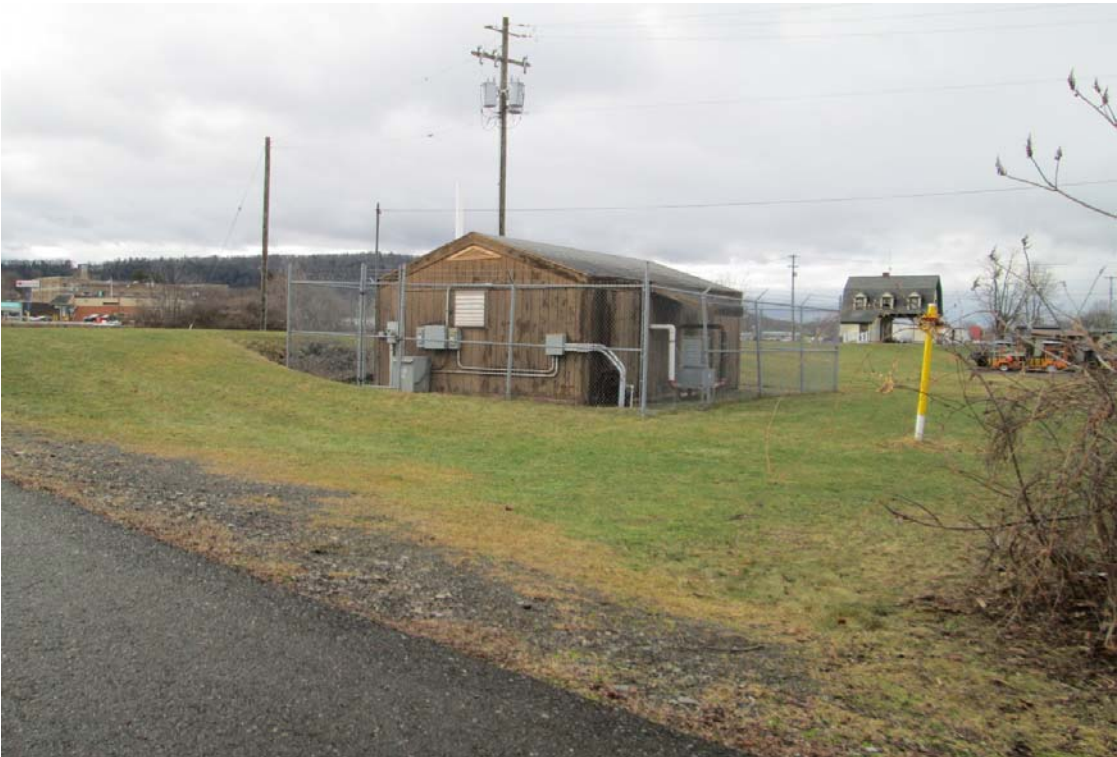
Main Building

No other operational issues were noted during the inspection. Both the distribution buildings and the adjacent parking lot area were inspected and no issues were noted.
