*Bioremediation Field Pilot Study  
Status Report  
Volume I*

**Universal Instruments Corporation  
Kirkwood, Broome County, New York**

**December 2002**

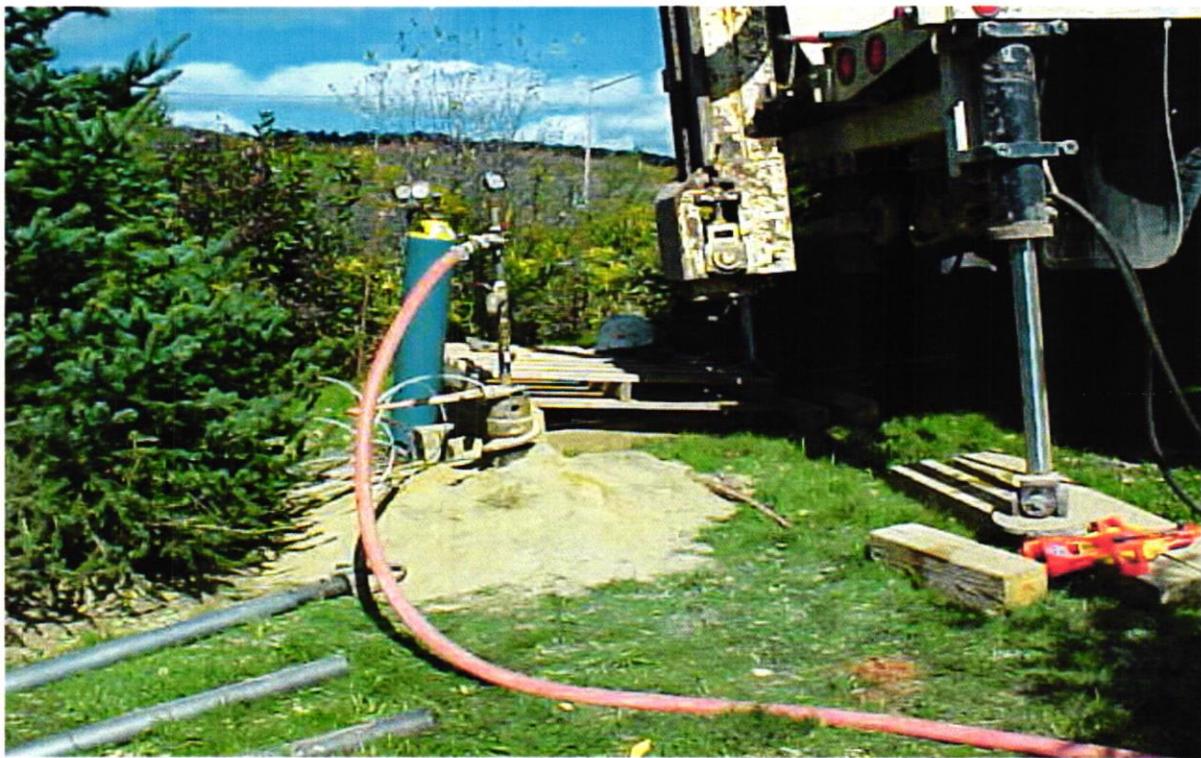
**MW-24 Area – HRC injection at first point (Cylinder for packer inflation w/ inert gas)**

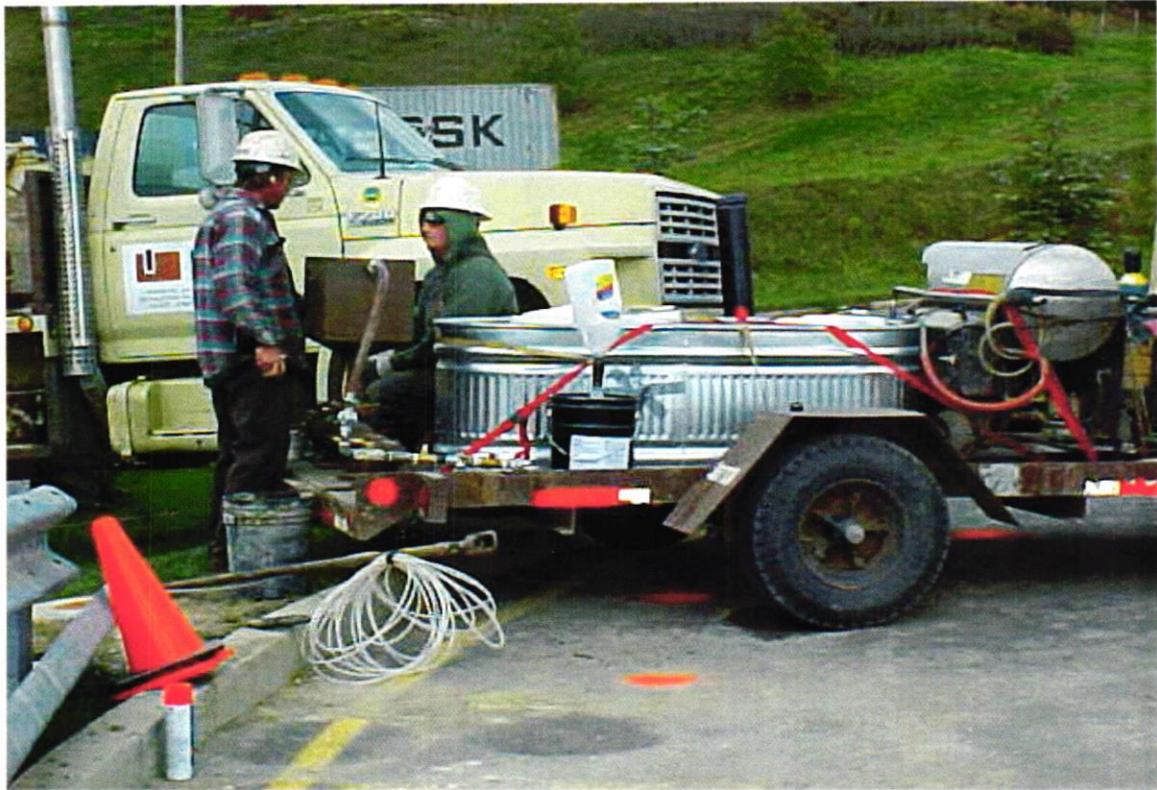
MW-24 Area – HRC injection trailer (pump and hopper, glycerin rinse, and water bath)

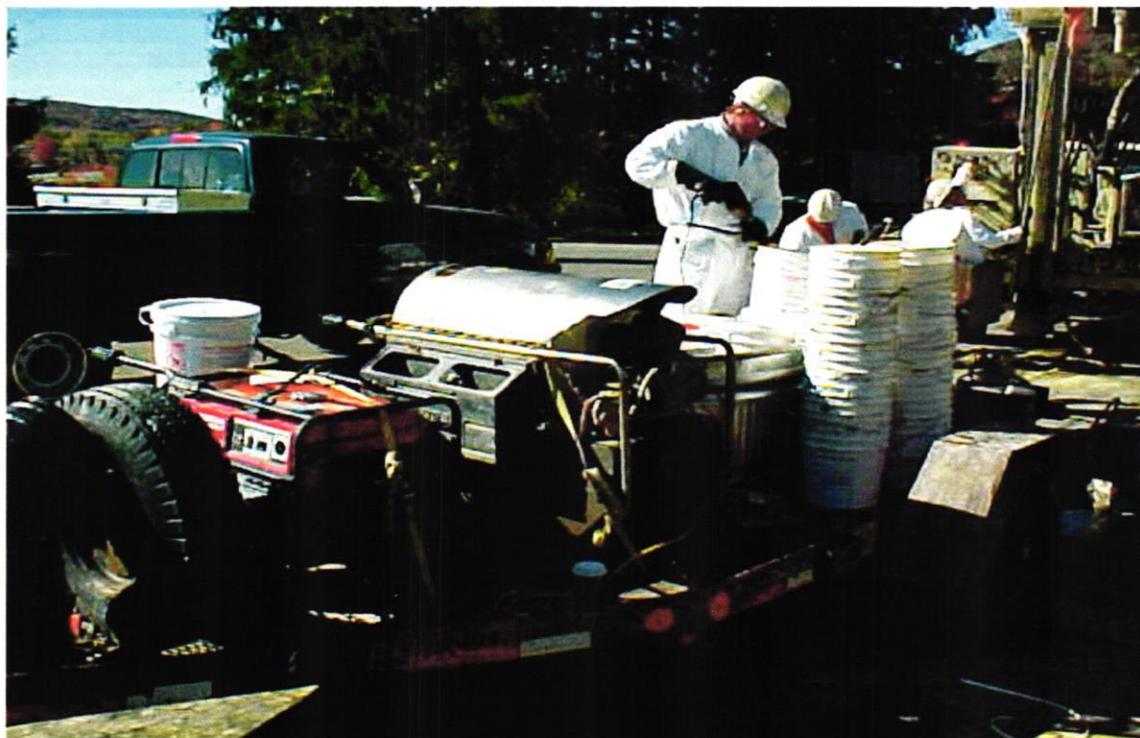
**MW-7A Area – Trailer with generator, pressure washer, hot water bath for HRC**

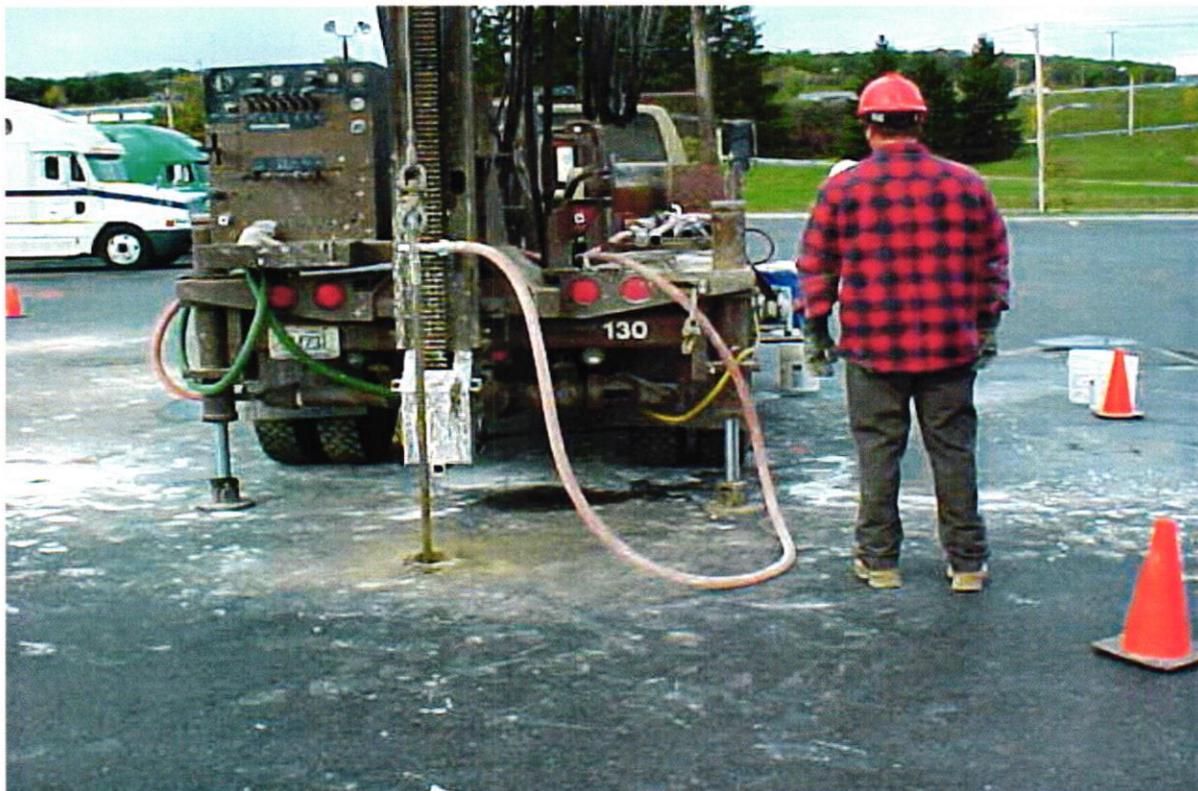
**Pilot Truck Stop – ORC injection (Drill rig with pump and ORC bucket [blue])**

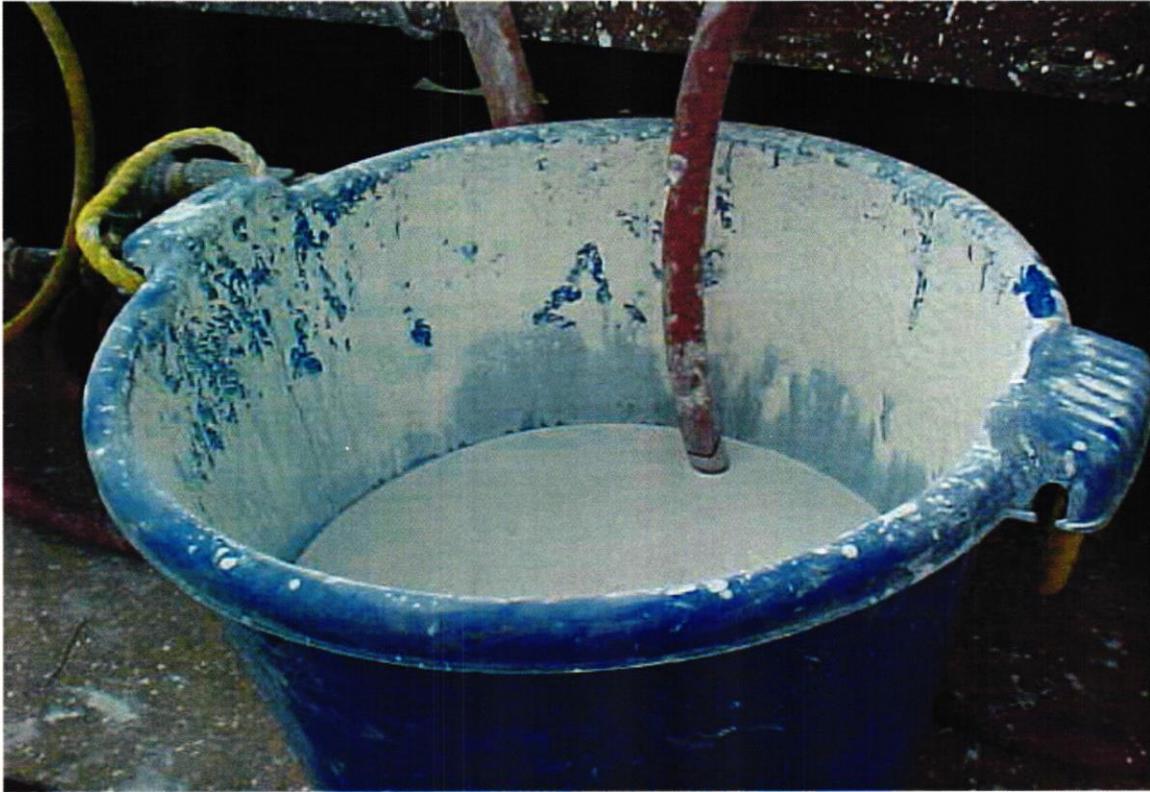
**Pilot Truck Stop – ORC injection (50% solids mix) in progress**

ORC™, which provides oxygen to support the aerobic biodegradation of chlorinated hydrocarbons, such as DCE, and vinyl chloride was injected below the plume to address these reductive dechlorination products. Manufactured as a powder, ORC™ was mixed with water for slurry injection (50% solids) into the saturated zone.
