**Re: Stauffer Management Company, Maestri Site #7-34-025
RW-2 Groundwater Remedial Activities**

On behalf of Stauffer Management Company, LLC (SMC), SPEC Consulting LLC (SPEC) has prepared the following summary of RW-2 Groundwater Remedial Activities at the SMC Maestri Site. SPEC submitted the proposal for this work on January 9, 2006, and the Department granted approval in a letter dated January 17, 2006.

Photographic Log

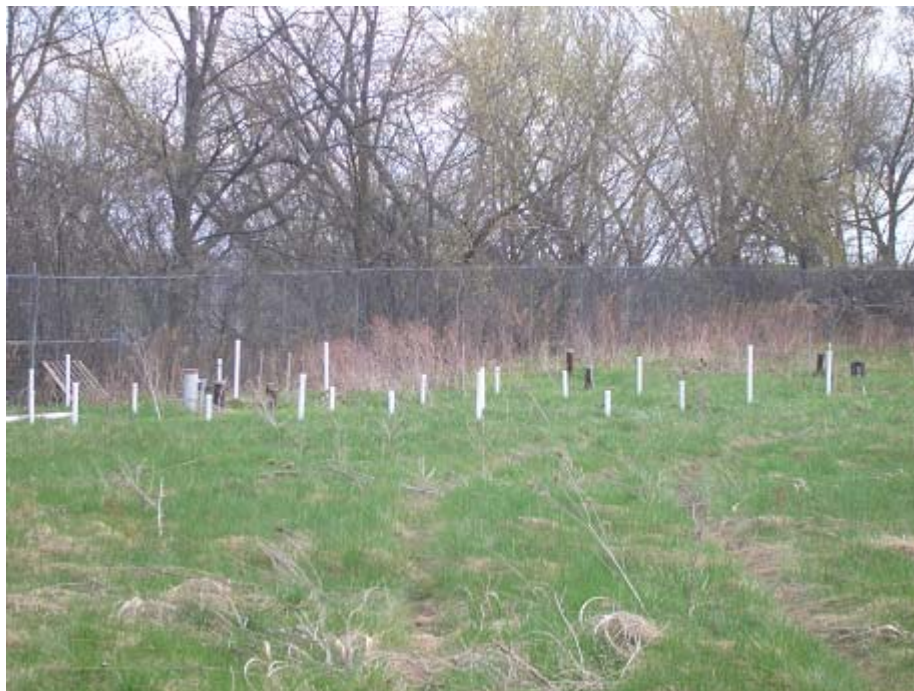
Former ORC
Injection Ports

Site preparatory work began Monday, April 24, 2006, and consisted of removing 25 2-inch PVC Oxygen Release Compound (ORC) injection points that were previously used to for remediation in the vicinity of RW-2. The injection points were removed to 2 feet below ground surface. The pump and associated piping for RW-2 were disconnected, rubber mats were put into place for a temporary road, and a decontamination pad was constructed.

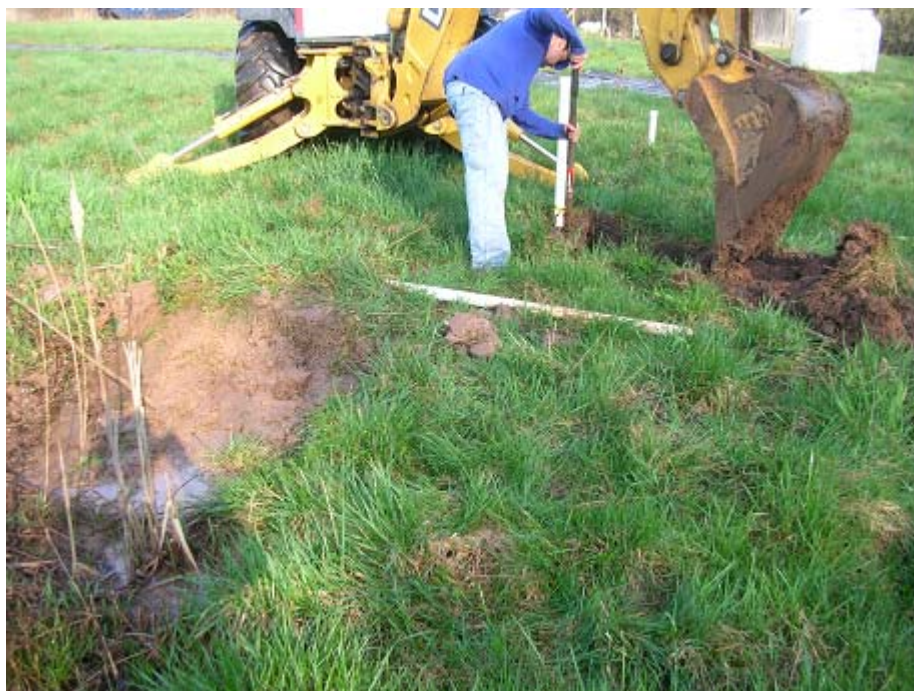
Removal of
ORC Injection Ports

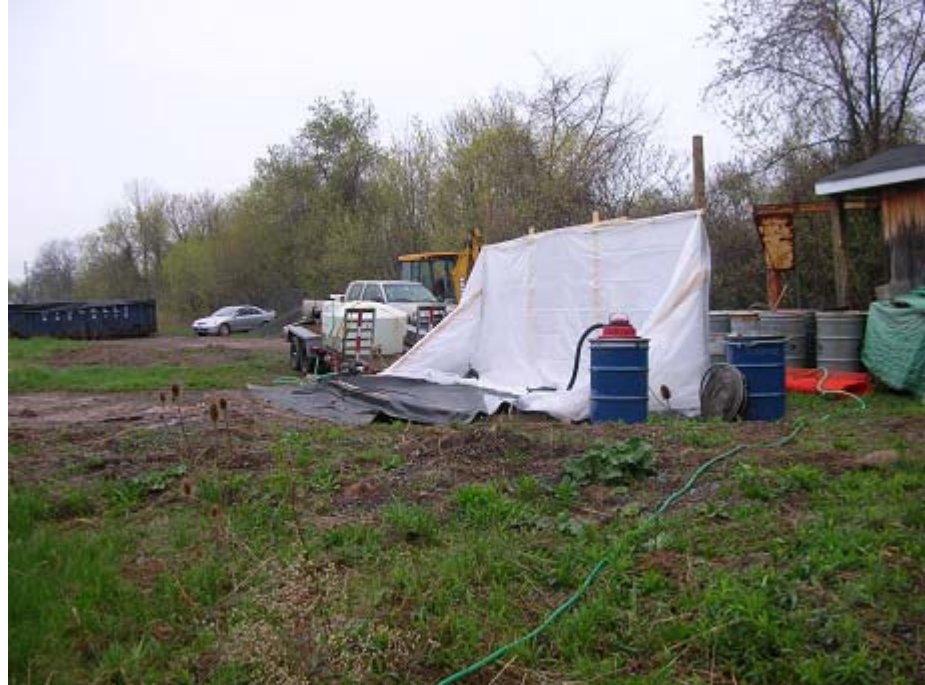
Decontamination Pad

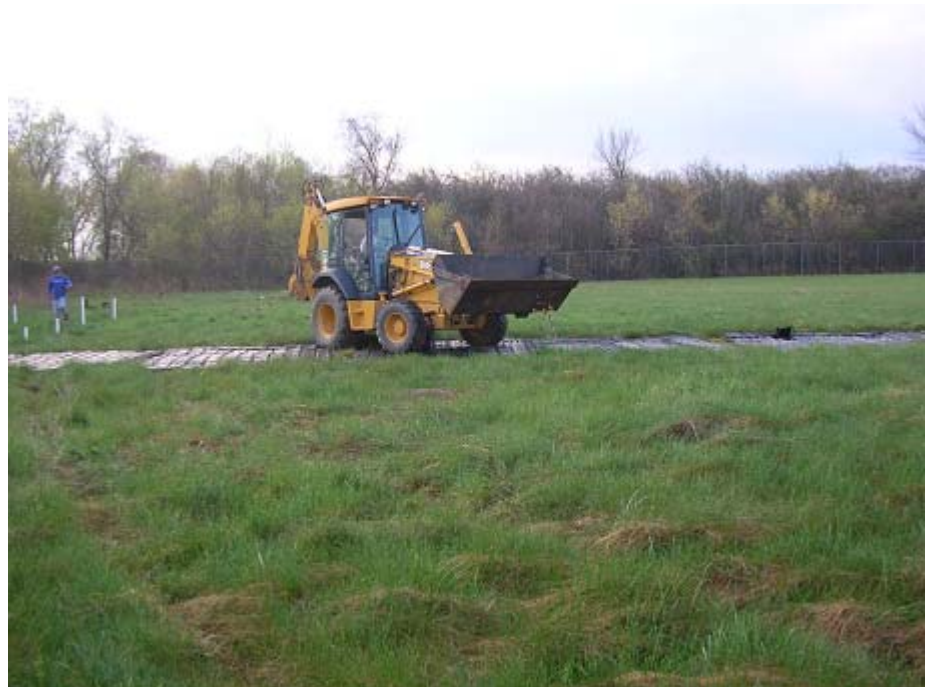
Temporary Rubber
Mat Road

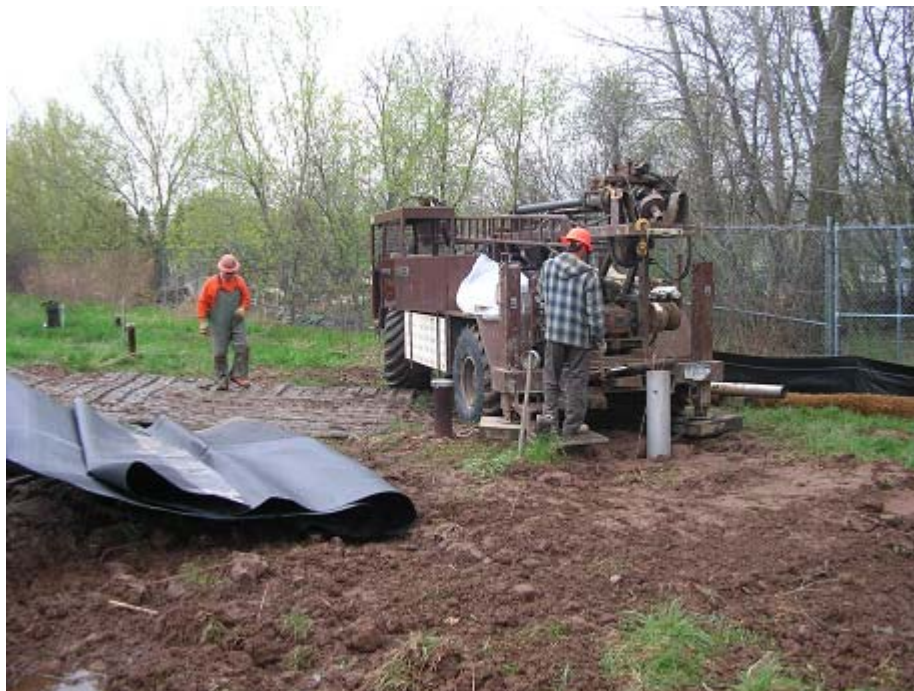
Set-up for Overdrilling
RW-2

On Tuesday, April 25, 2006, Parratt Wolff overdrilled and removed RW-2. Soil cuttings from the drilling operation were collected on poly and shoveled into the backhoe bucket for disposal in the roll-off. Readings taken with a photoionization detector (PID) did not exceed 0.3 parts per million (ppm). Water was captured on poly with booms and quick-dry absorbent. Once the well was removed, it was placed onto poly and inspected. The well screen was fairly clean and was not heavily contaminated as originally expected. Abscope pressure washed the well screen and casing on the decontamination pad so they could be reinstalled as a monitoring well. Water from decontamination activities was pumped to the sump located in the in the shed and treated through the on site treatment system.

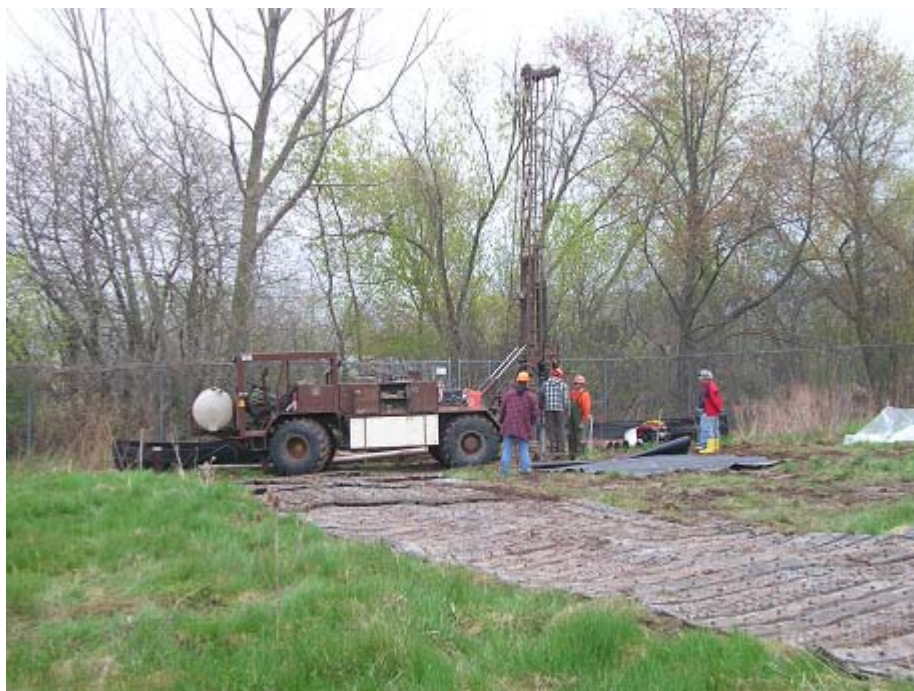
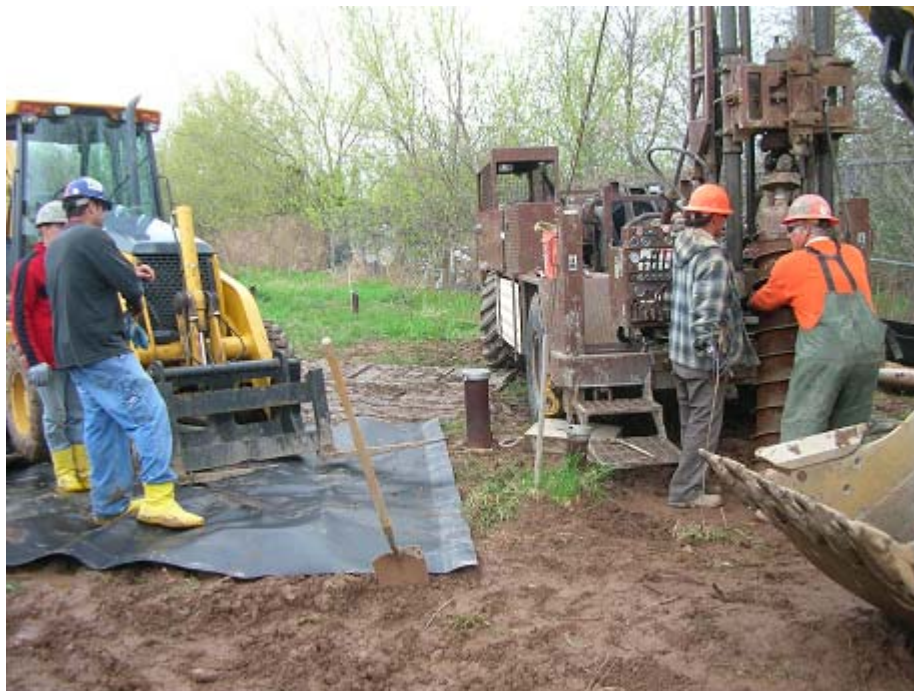
Overdrilling RW-2

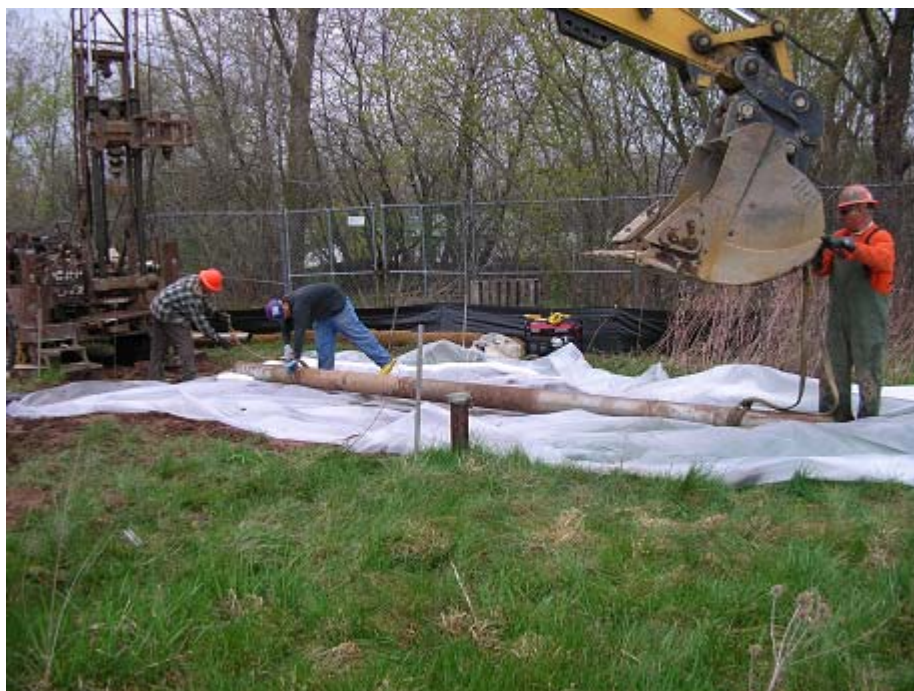
Removing RW-2

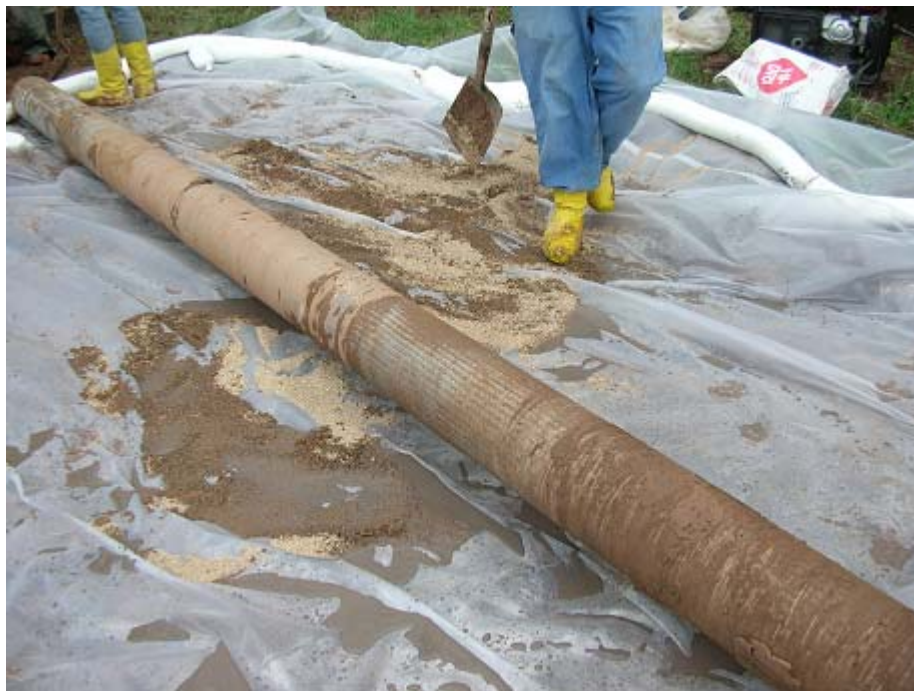
Removed RW-2

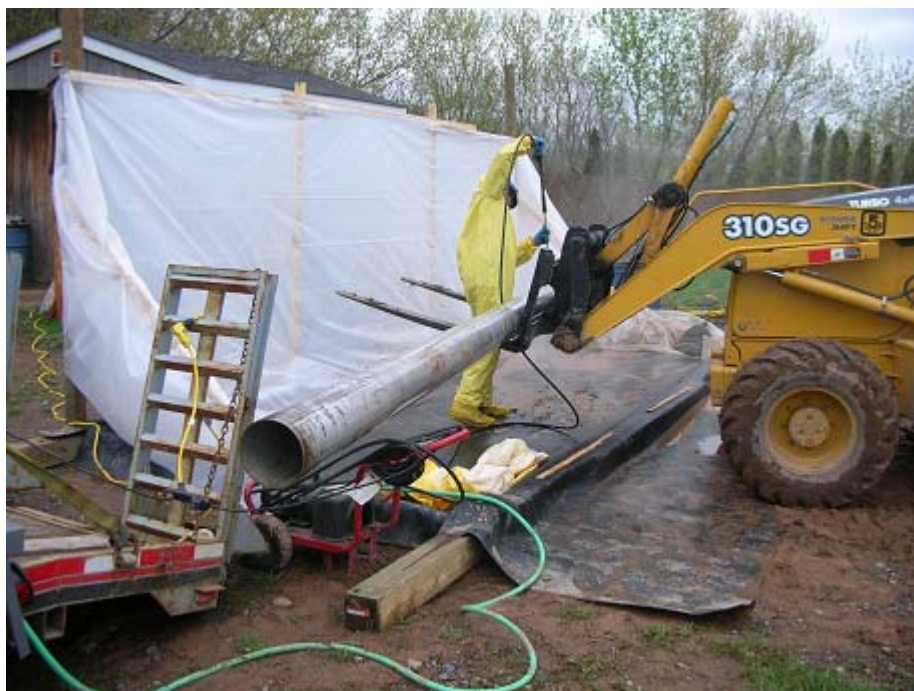
Decontaminating RW-2

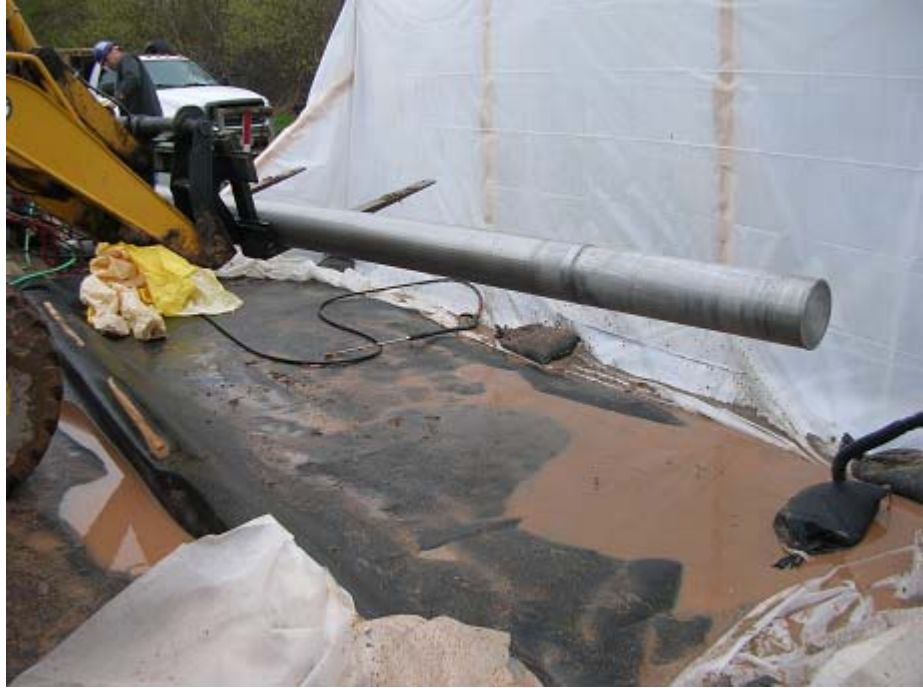
Cleaned RW-2

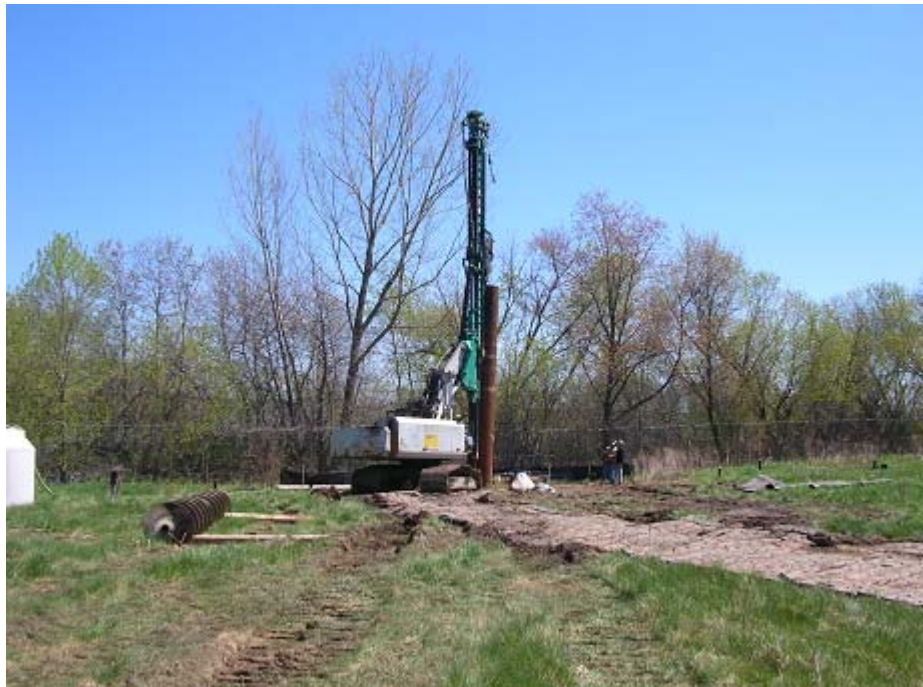
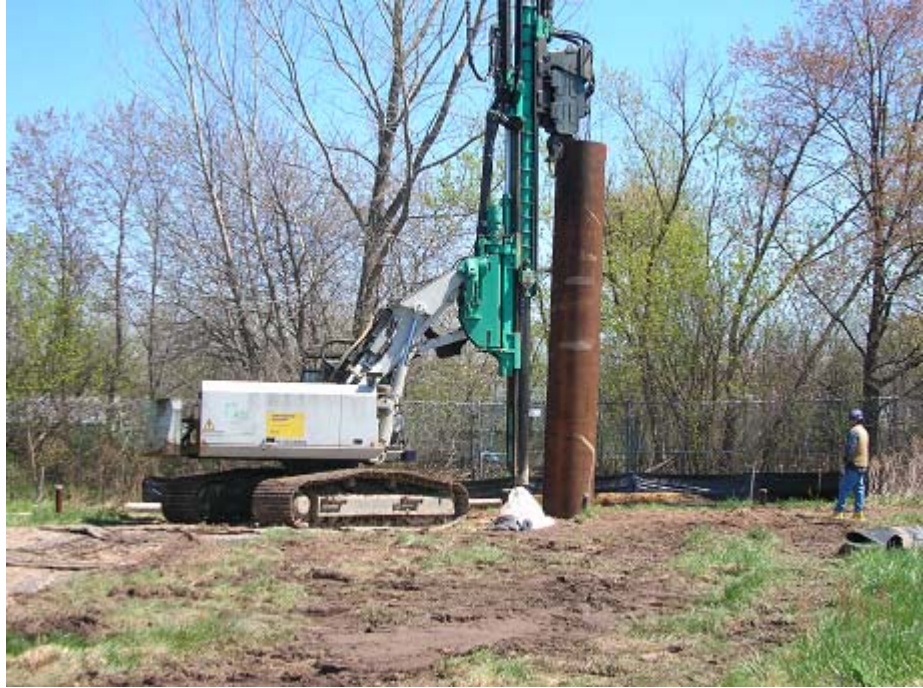
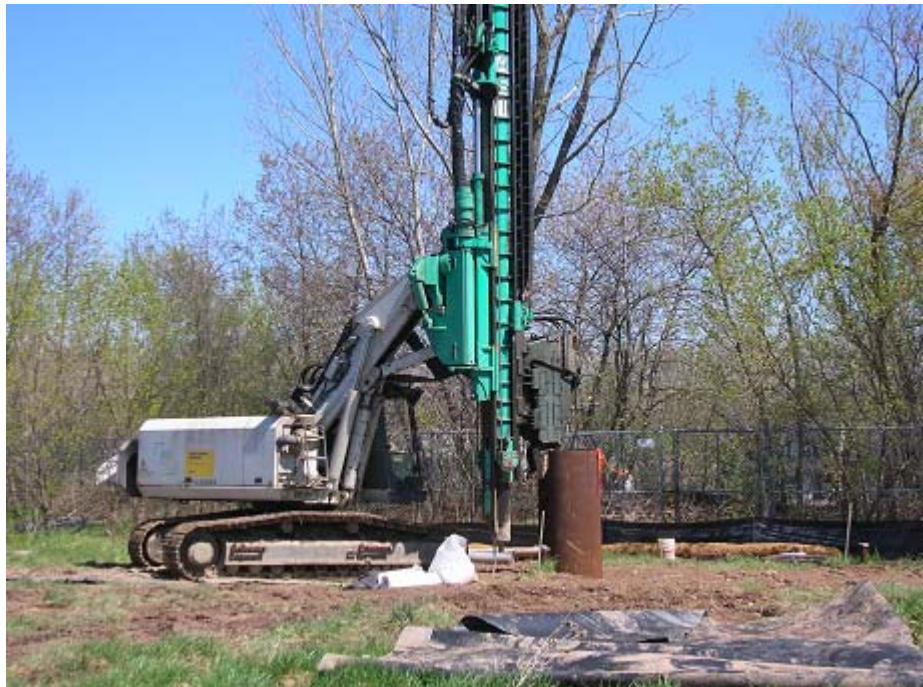
Installing Caisson

The caisson operations began on Wednesday, April 26, 2006. PID readings were taken throughout remedial activities and did not exceed 0.8 ppm. Excavated soil was augered slowly and collected on poly. The casing was advanced to approximately 20 to 21 feet below grade, which was the original depth of RW-2. The soil cuttings resulted in a pile approximately 5-feet high by 8-feet in diameter and appeared to have little to no contamination. The maximum PID

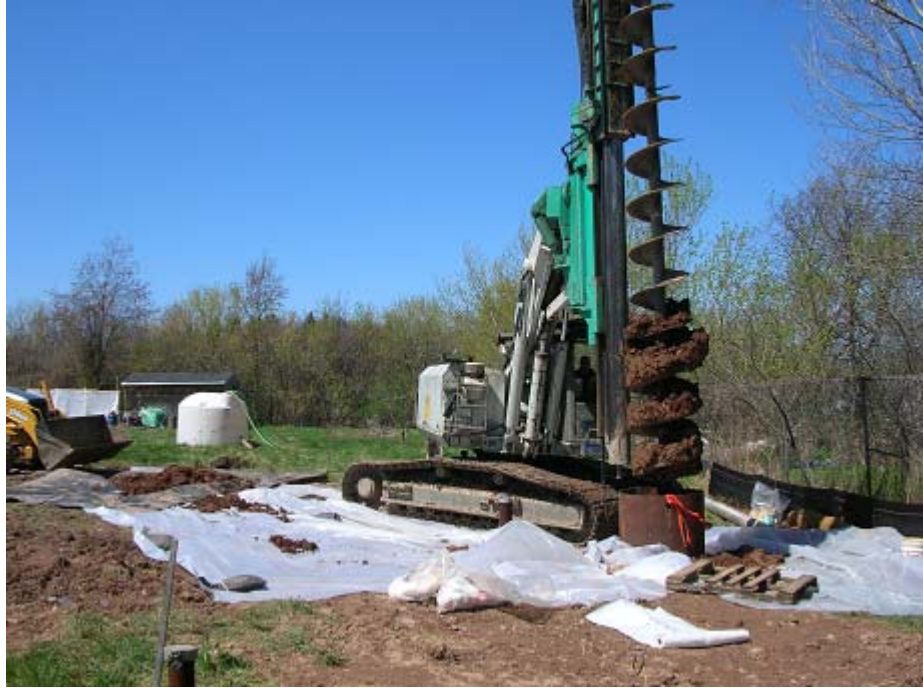
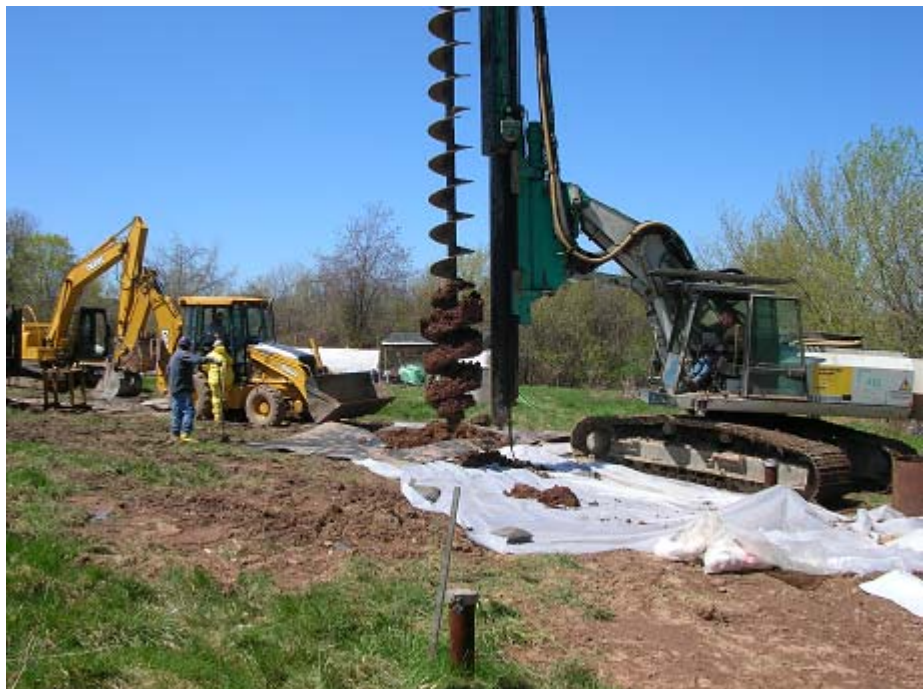
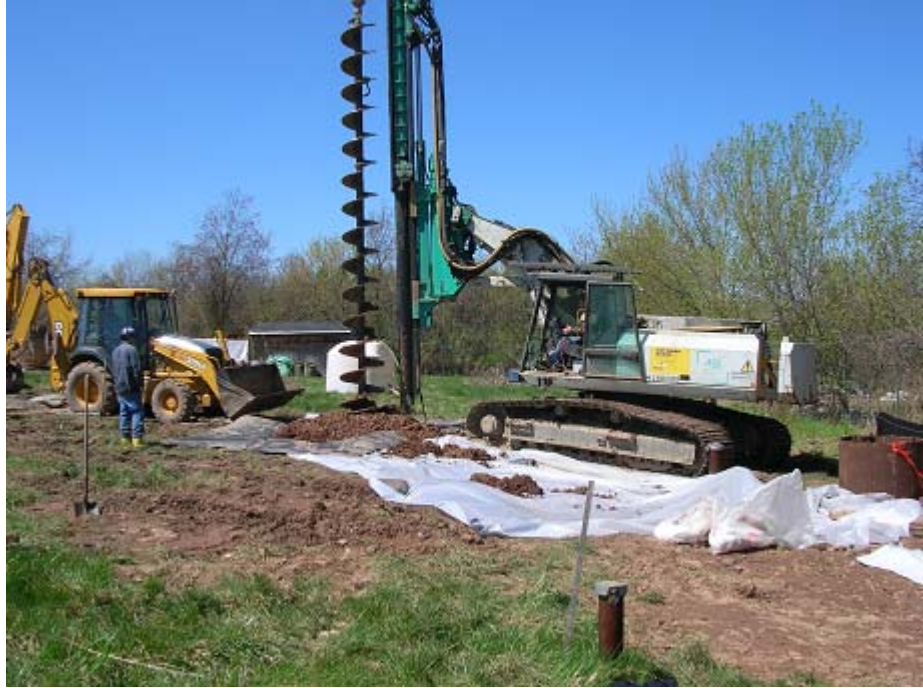
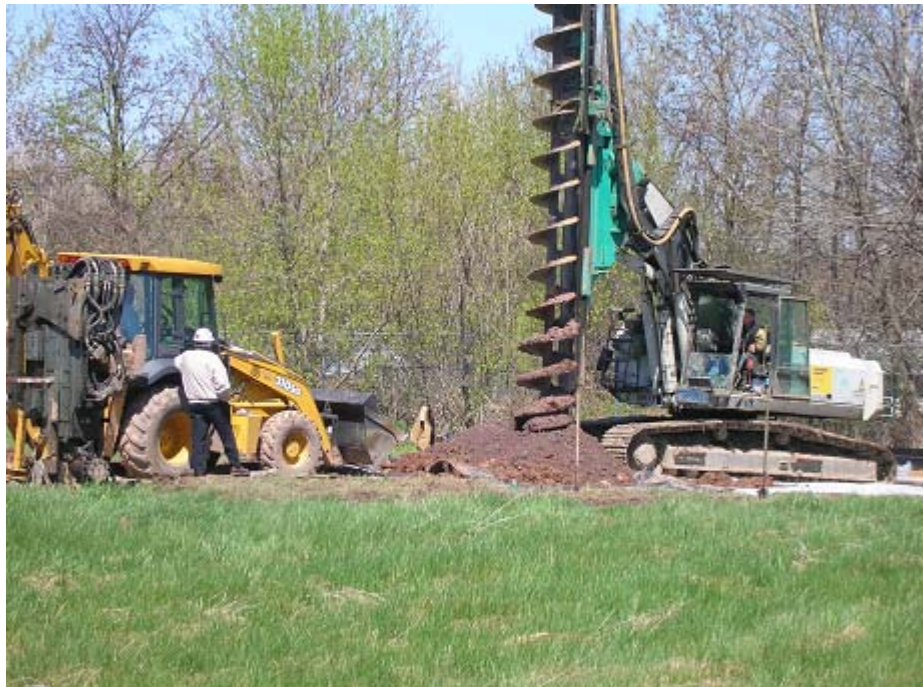
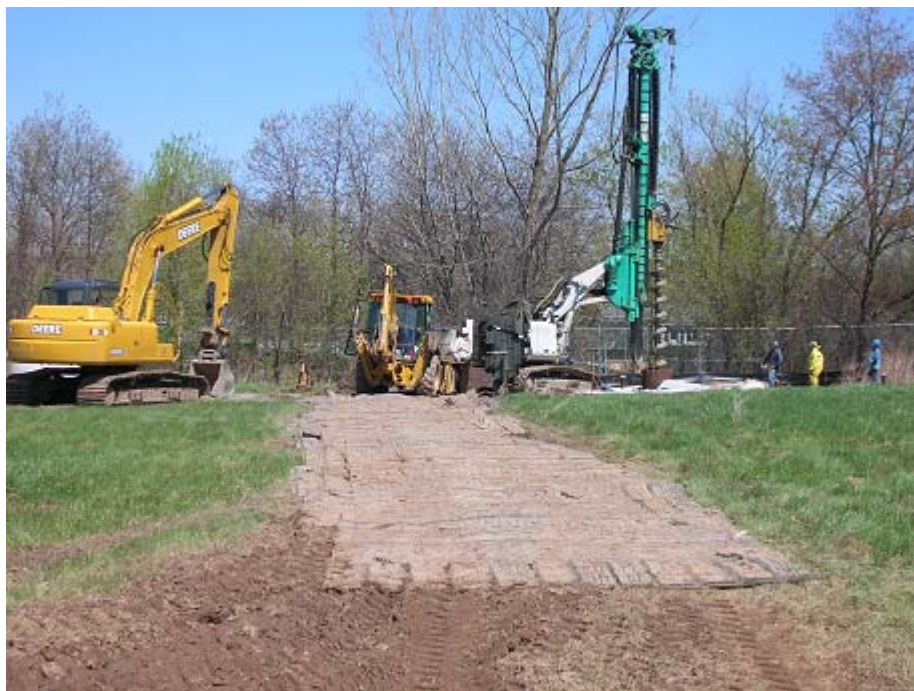
Augering Soil within
Caisson

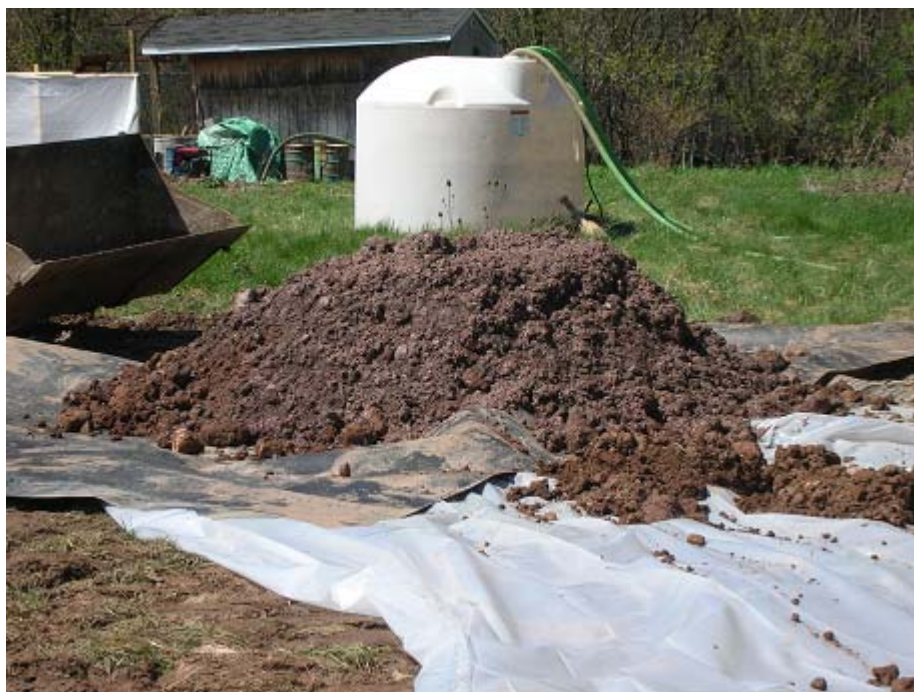
Soil Pile

Cuttings pile 5' high x 8' diameter
 mound

took PID reading of pile → max. was 0.8 ppm
 casing drilled to 25' from top of
 casing

reading taken several inches from the soil was 0.8 ppm. After staging and screening with a PID, the soil from the pile was shoveled into the backhoe bucket and placed into the roll-off for disposal. After soil removal, the original well was re-set into the casing and one excavator bucket of the gravel-nutrient mix was added to stabilize the well. The mix was prepared by adding one half of a 50-pound bag of CBN-Nutrimax to one bucket of gravel. The microbes and nutrients were provided by Enzyme Technologies, Inc. located in Portland, Oregon.

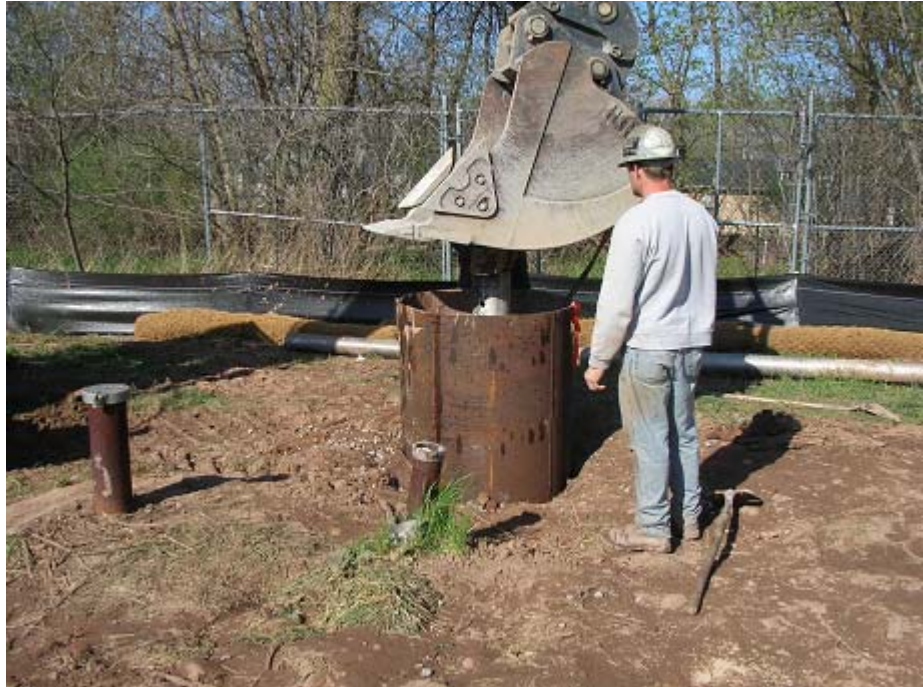
Setting Well

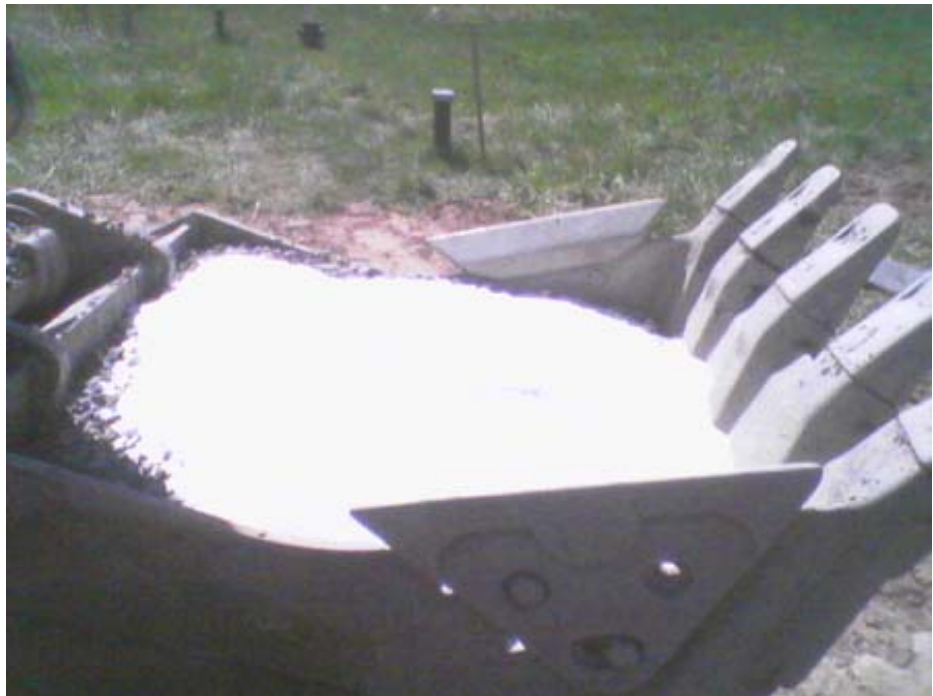
Backfilling with Gravel
and Nutrients

On Thursday, April 27, Abscope decontaminated the augers for the caisson rig. On Friday, April 28, Abscope set the well and continued to backfill the caisson with the nutrient-gravel mix. Five gallons of microbial solution was poured into the backfilled material every 5 feet for the first 15 feet. The casing was removed by Hayward Baker. Abscope then filled the top 2 feet of the excavation with 12 50-pound bags of bentonite overtop of a layer of poly and added water. Finally, Abscope decontaminated the casing and performed site cleanup work including picking up the rubber mats, loading decontaminated equipment, and decommissioning the decontamination pad.

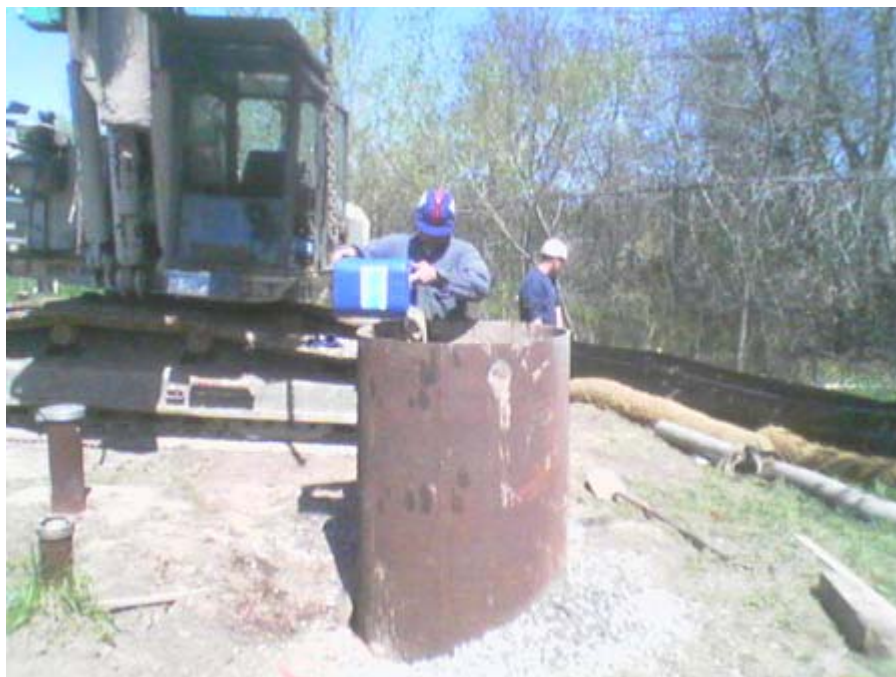
Pouring Microbes into
Gravel/Nutrients

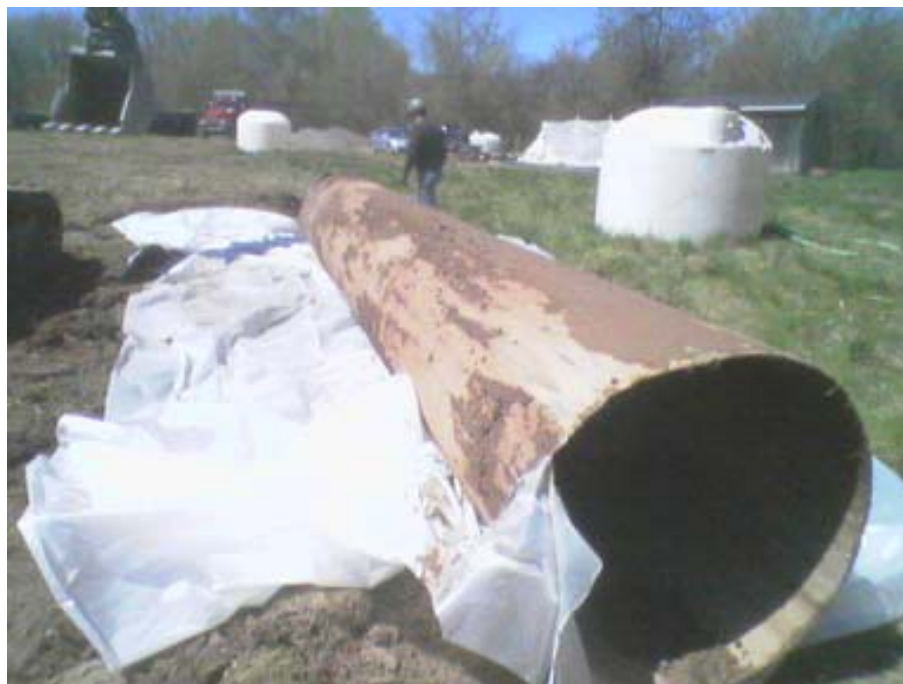
Removed Caisson

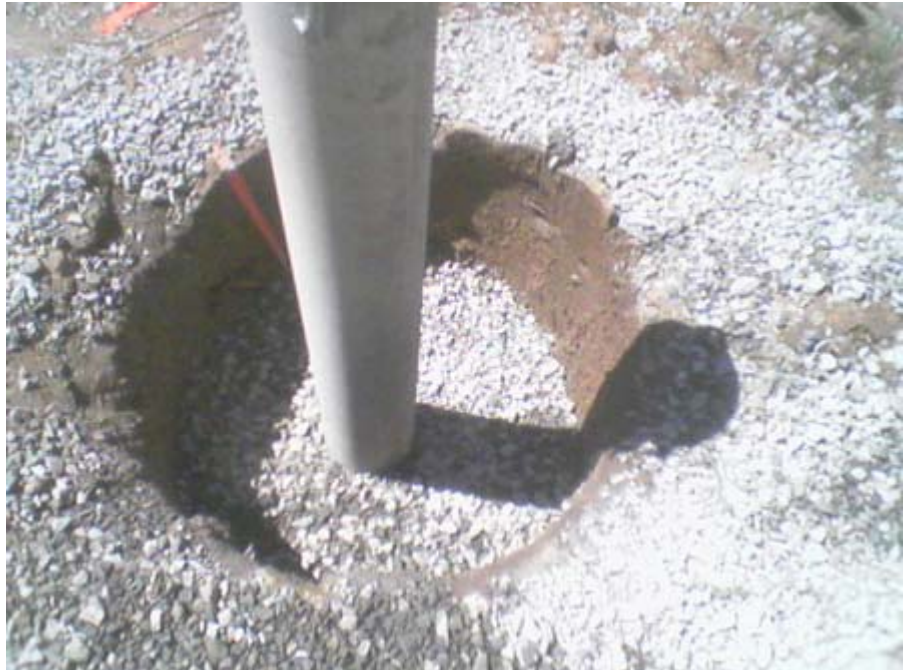
Gravel Surrounding
Well

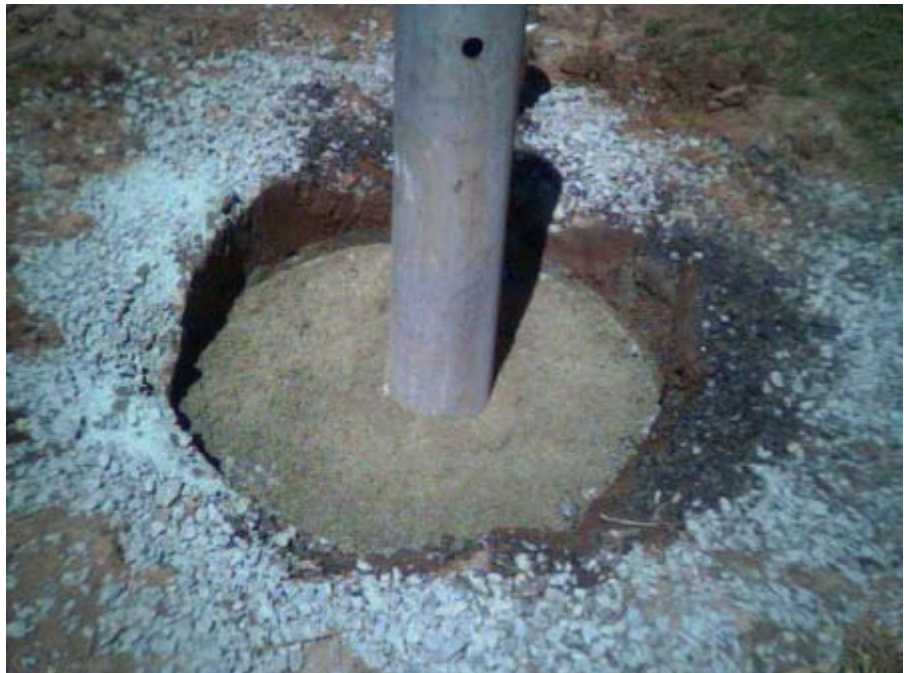
Bentonite

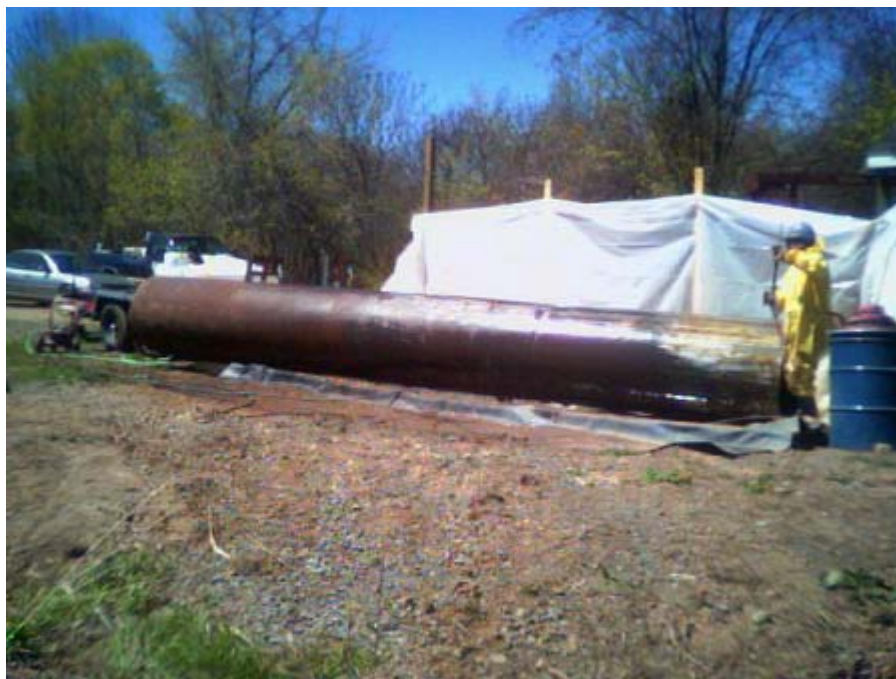
Decontaminating
Caisson
