**SANDERS CREEK
UTC/CARRIER SITE
THOMPSON ROAD, SYRACUSE, NY**
Sampling and Analysis Plan

Corrective Action Order - Index CO 7-20051118-4
NYSDEC Site Registry #734043

SAMPLING AND ANALYSIS PLAN
 UTC/CARRIER SITE - NYSDEC SITE #734043
 SANDERS CREEK, SYRACUSE, NY
 Project No.: 60321789 Date: MAY 2015

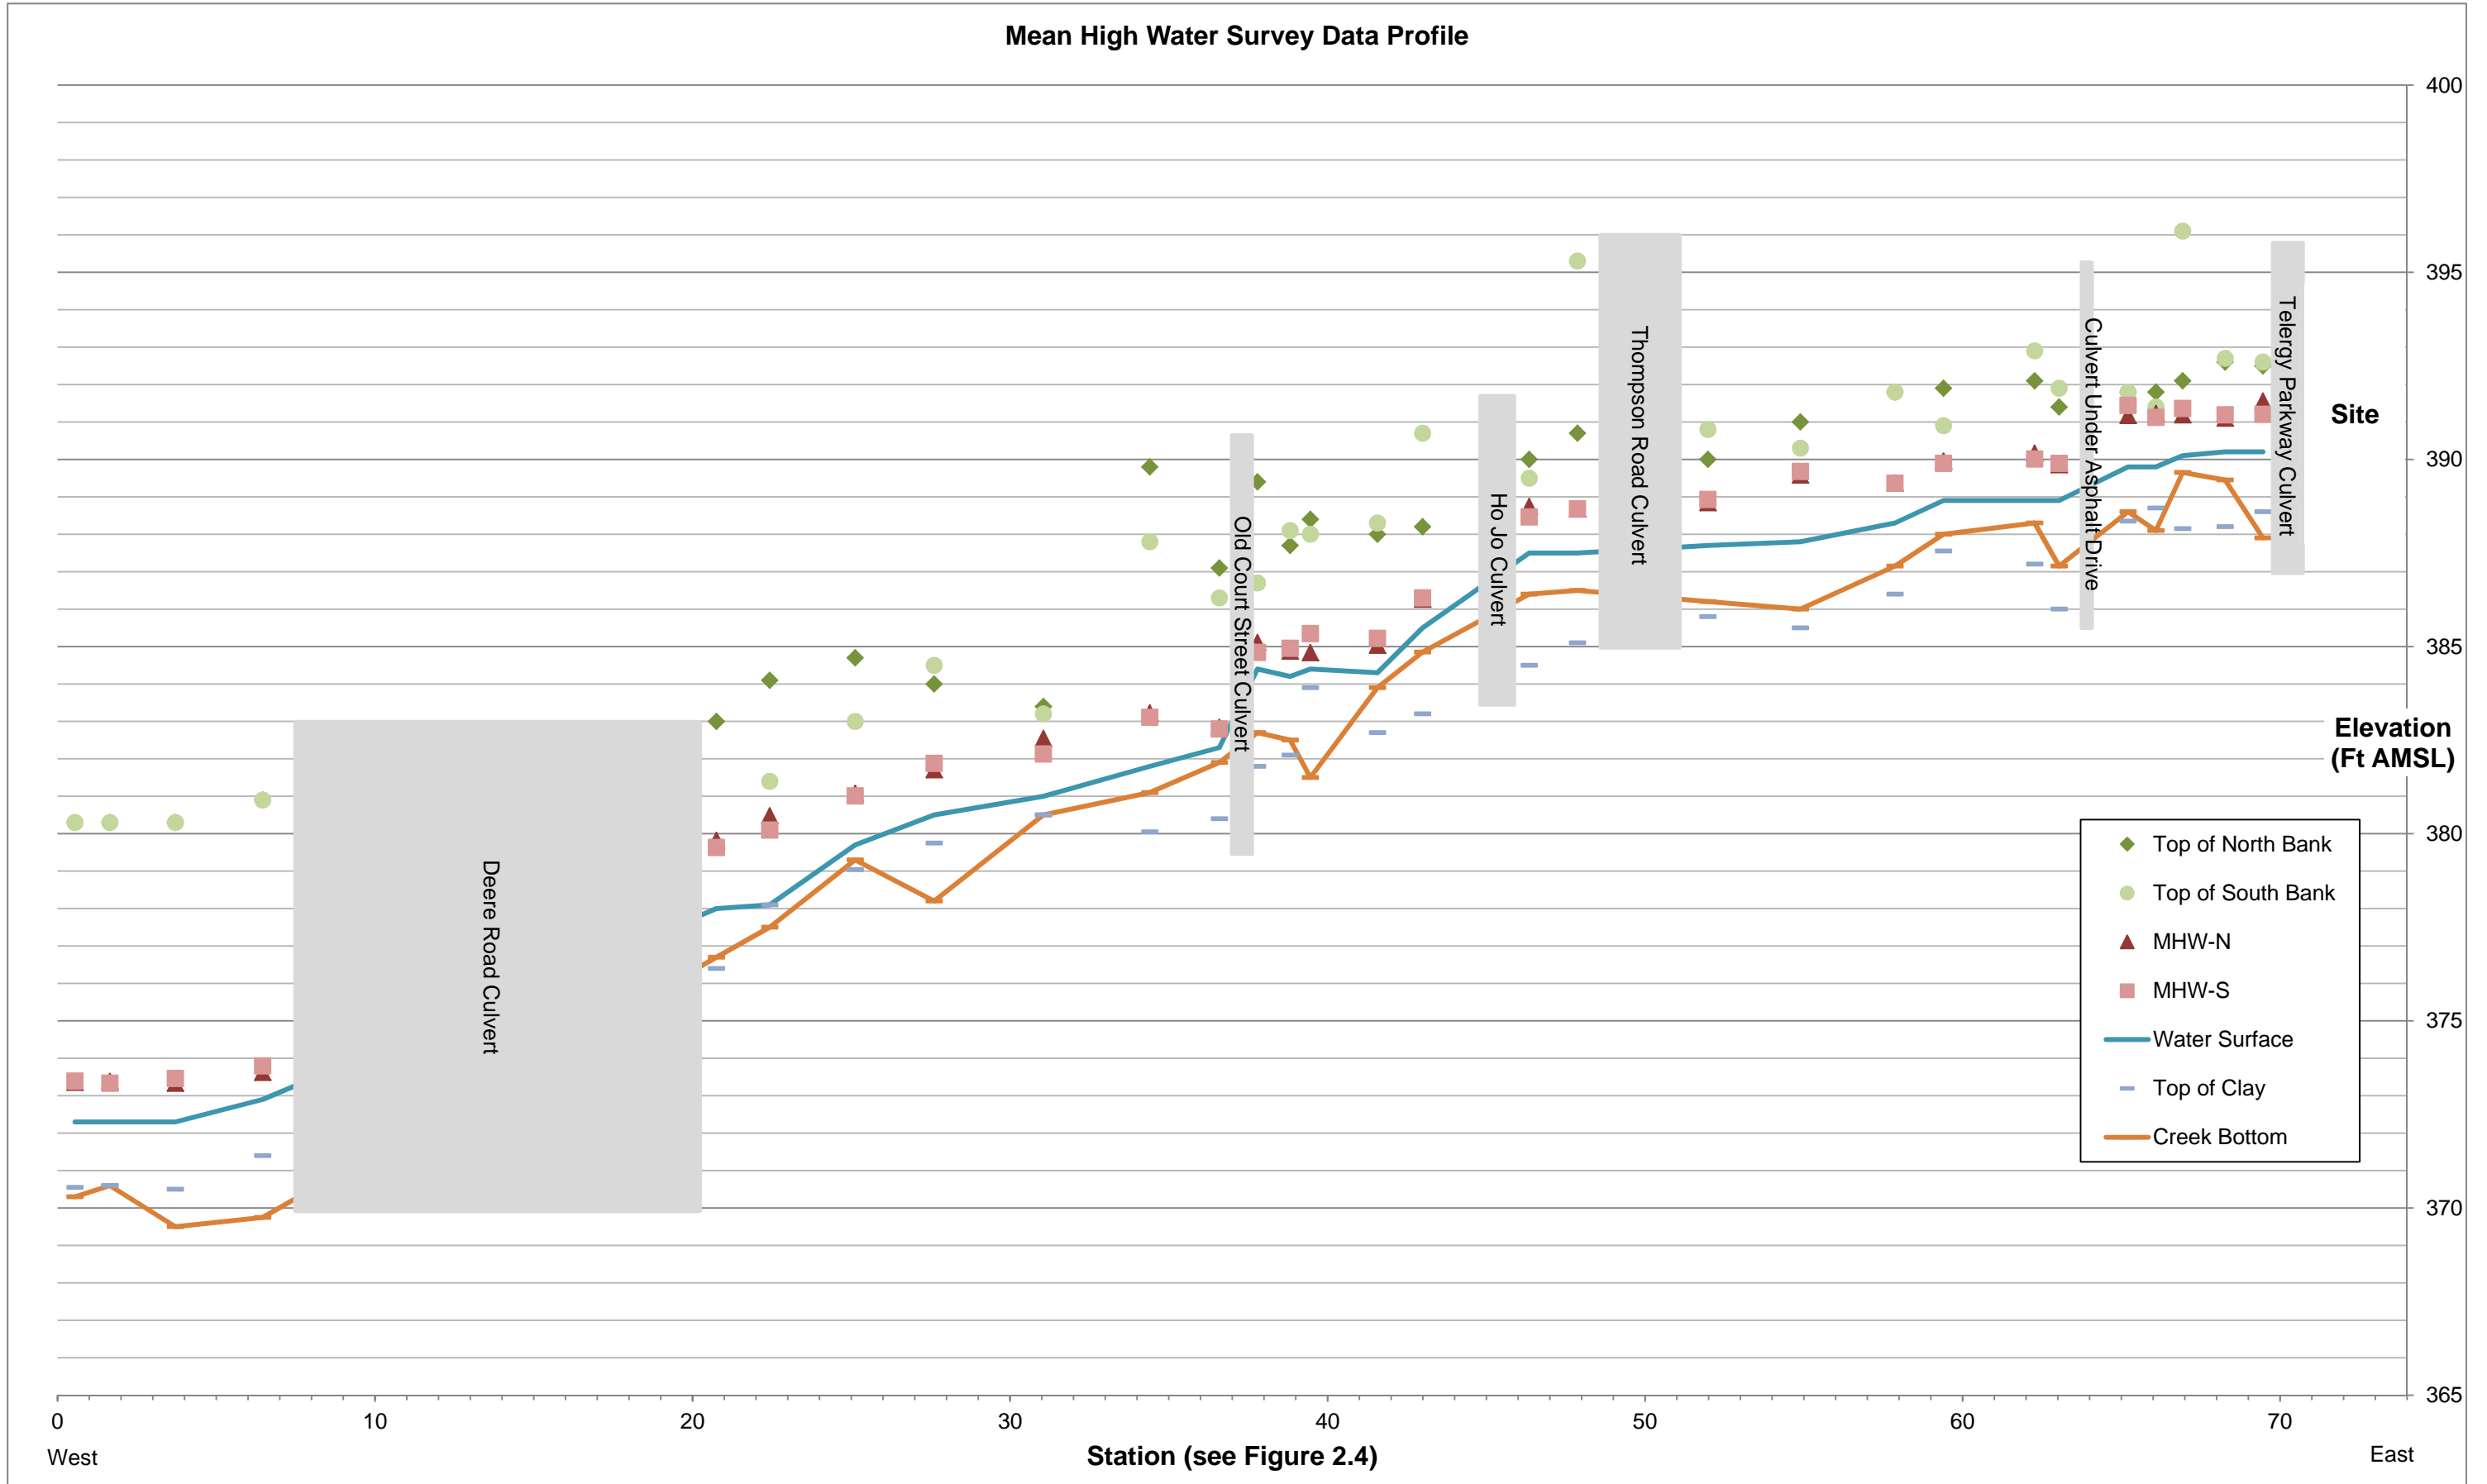
Mean High Water Survey Data Profile

The survey was conducted during relatively low flow conditions at the end of a descending limb of a recent rain event as monitored at the United States Geological Survey (USGS) station on Ley Creek. Flow was measured in Sanders Creek each of the two days (2.8 cubic feet per second [cfs] and 1.7 cfs, respectively). At each transect (located by global positioning system [GPS]), both edges of the stream and the MHW were marked and surveyed. The depth to clay was determined at one or both edges of the stream. Measuring the depth of clay at the edge of the stream allowed a visual assessment of the surface material and for GPS survey, as well as improving sample recovery from the core, all of which are made more difficult by standing in turbid water as was present in the middle of the stream. Other ancillary measurements were taken (i.e., stream depth and width, width at MHW, and height of adjacent bank). The MHW was also marked and surveyed at each culvert. The MHW survey locations are presented on **Figures 2.4-1 through 2.4-10** and MHW survey results are shown graphically on **Figure 2.5**.

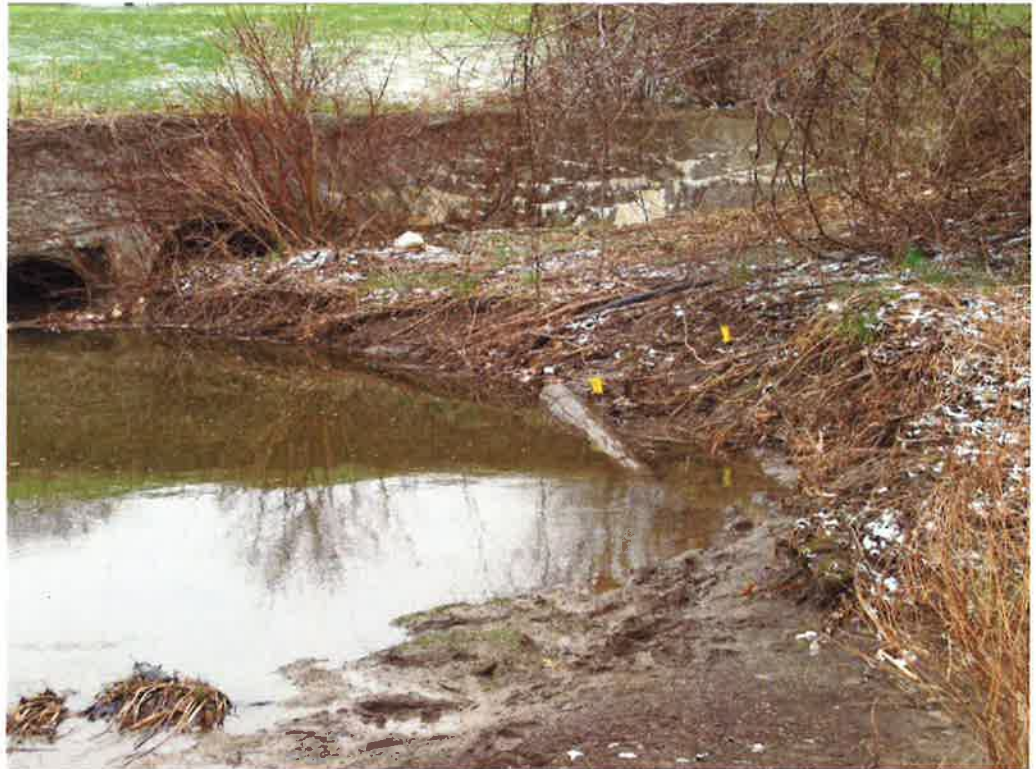
Transect A02-005 a.
South bank of stream.
Lower yellow flag at current water elevation;
upper flag at MHW.
Bankfull bench forming in foreground.

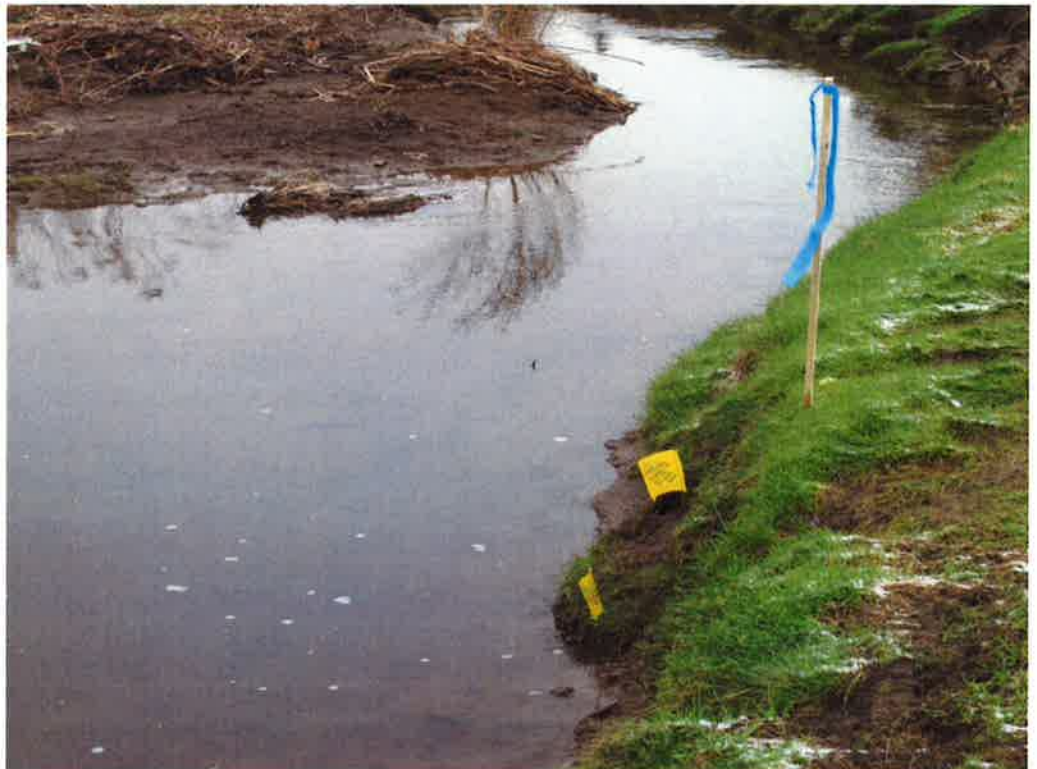
Photo No.
2

Transect A02-005 b.
Lower yellow pin flag at current water elevation;
upper yellow pin flag at MHW. Stake with blue flag shows historical sediment sample location.
Bankfull bench and undercut banks in distance.

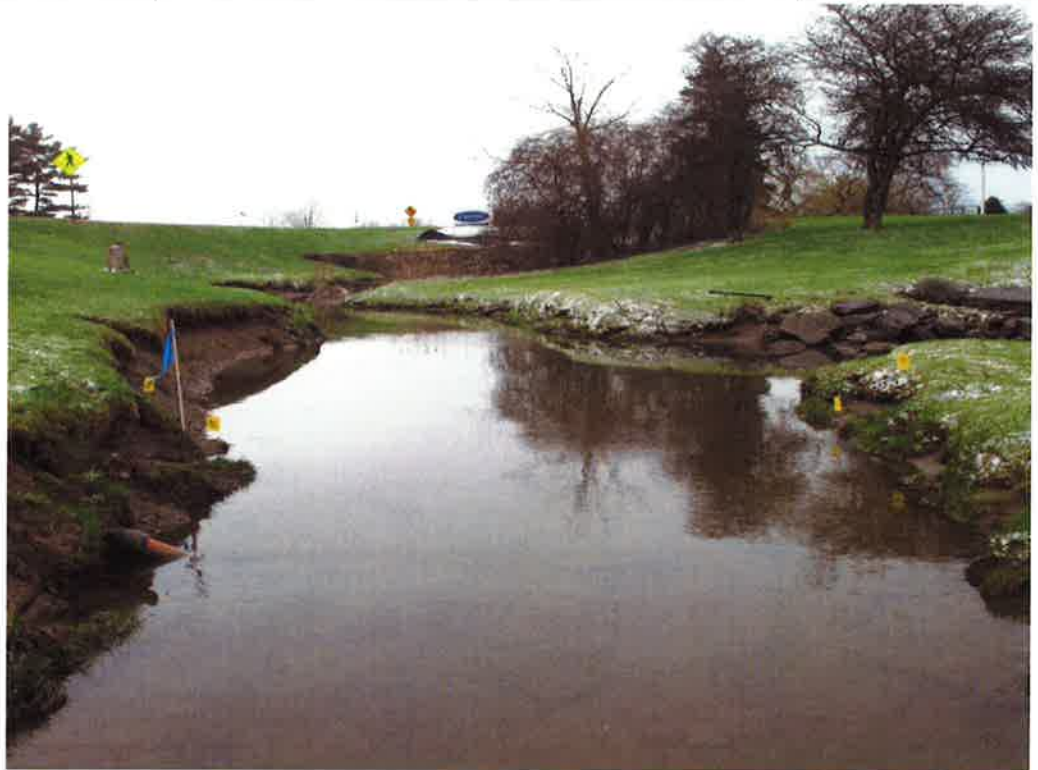
Photo No.
4

Transect A02-006.
Two lower yellow pin flags at current water elevation; 2 upper yellow pin flags at MHW. Stake with blue flag shows historical sediment sample location.

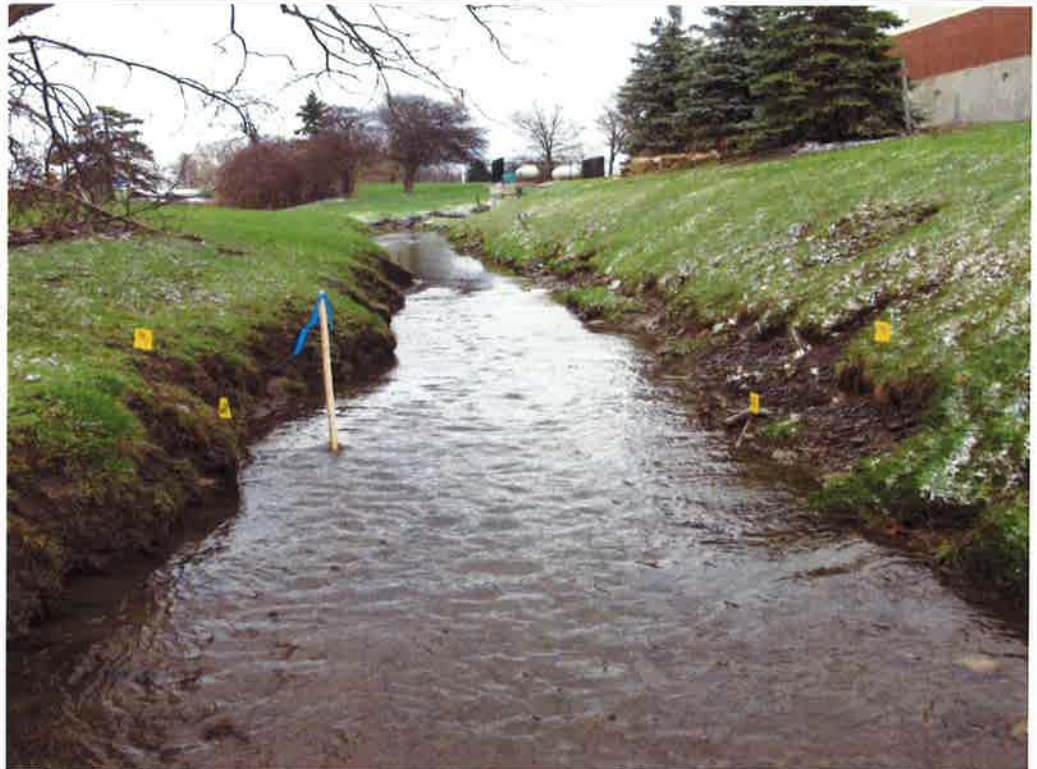
Transect A02-007.
Two lower yellow pin flags at current water elevation; 2 upper yellow pin flags at MHW. Stake with blue flag shows historical sediment sample location.

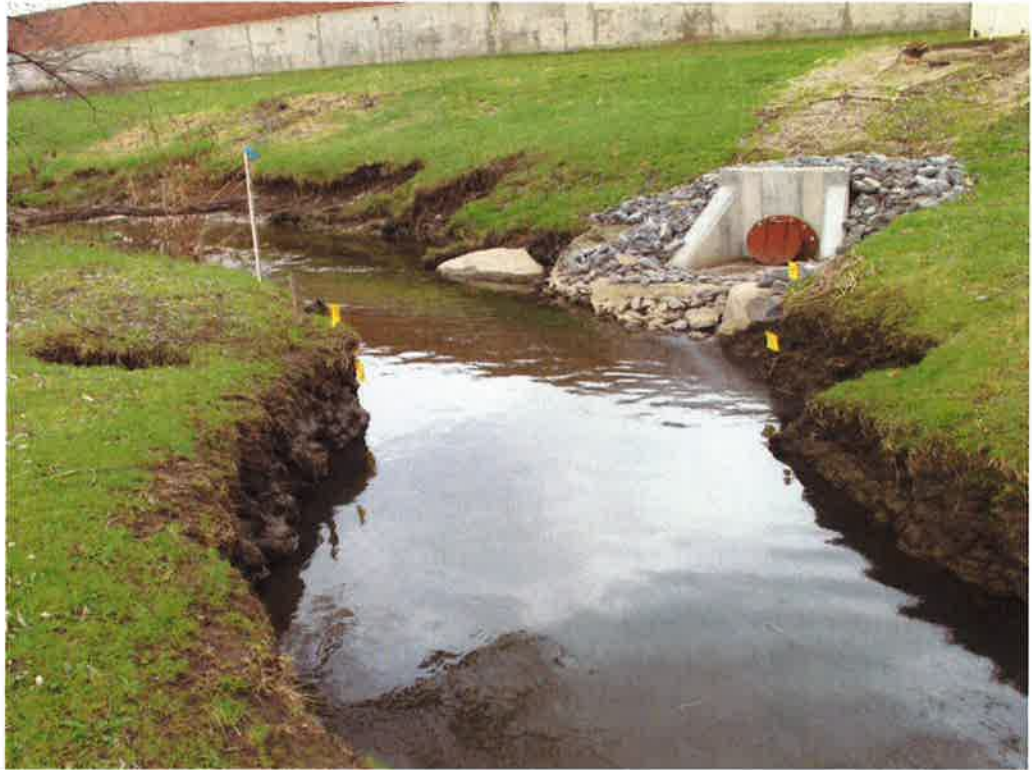
Transect A02-008.
Two lower yellow pin flags at current water elevation; 2 upper yellow pin flags at MHW. Stake with blue flag shows historical sediment sample location.

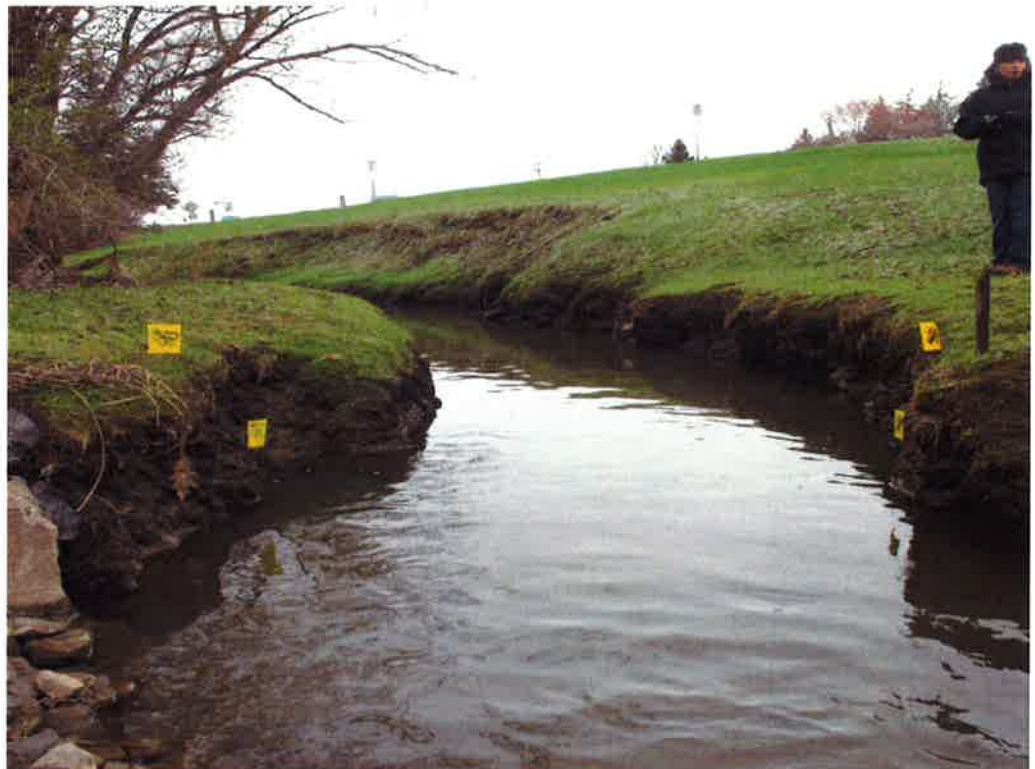
Photo No.
6

Transect A02-008
Two lower yellow pin flags at current water elevation; 2 upper yellow pin flags at MHW.

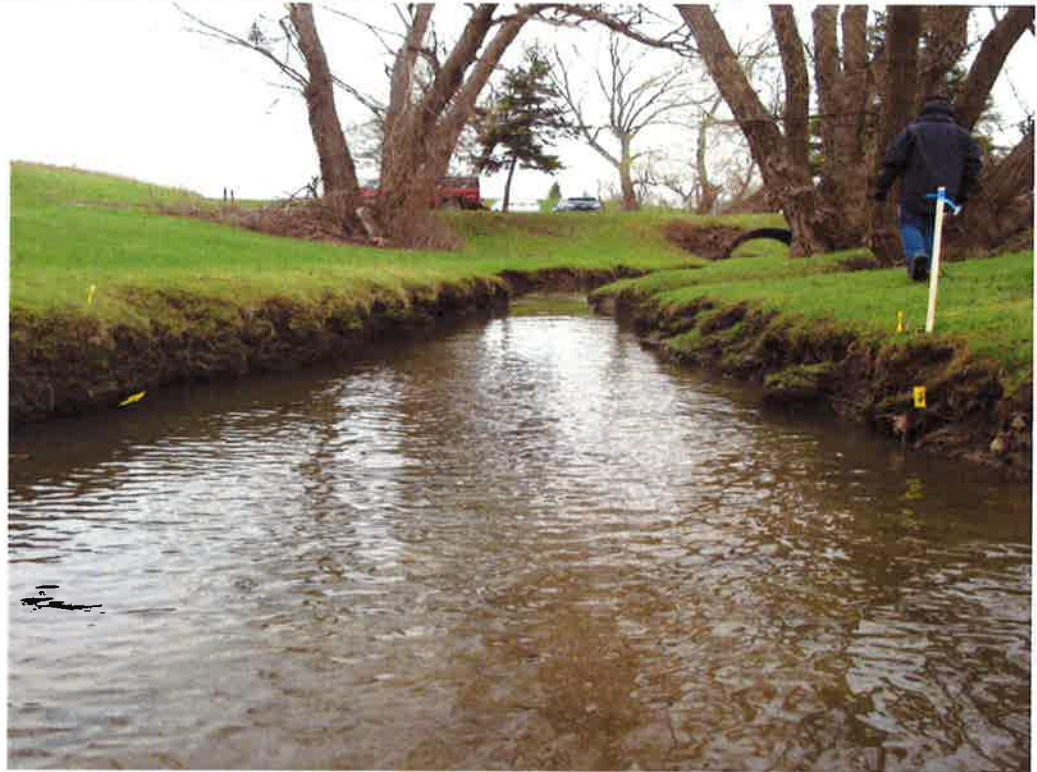
Photo No.
8

Transect A02-009. Two lower yellow pin flags at current water elevation; 2 upper yellow pin flags at MHW. Stake with blue flag shows historical sediment sample location.

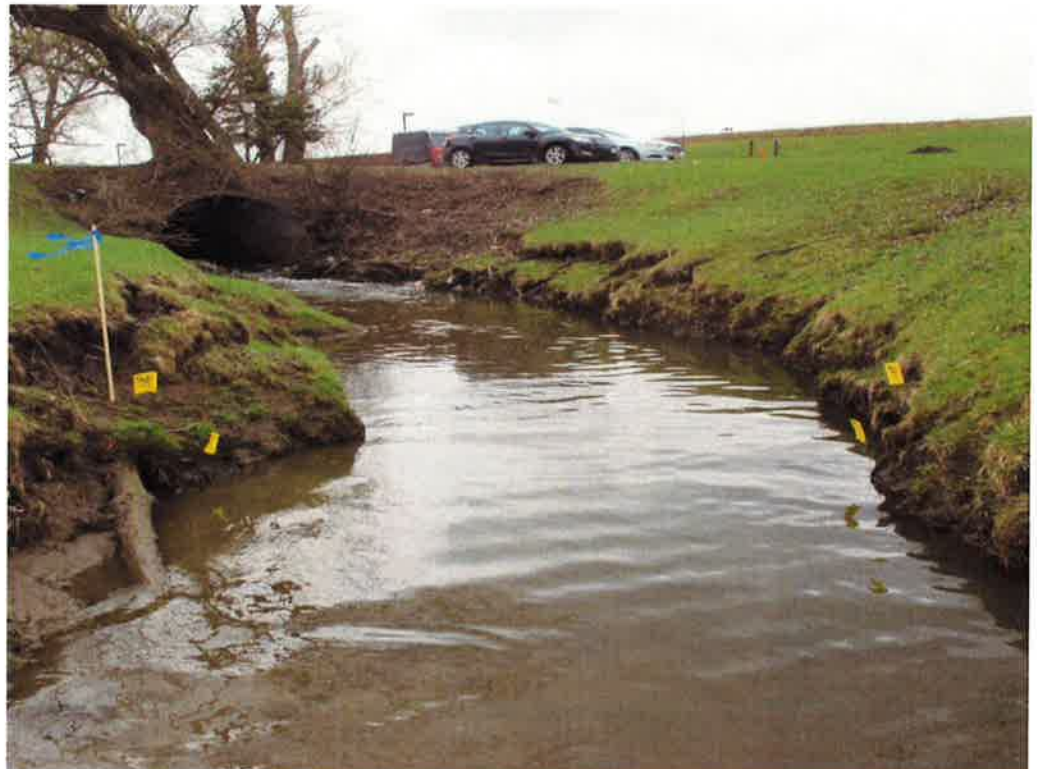
Transect A02-010. Two lower yellow pin flags at current water elevation; 2 upper yellow pin flags at MHW. Stake with blue flag shows historical sediment sample location. Shows upper bank collapsed (left and background) into area below MHW due to undercutting erosion.

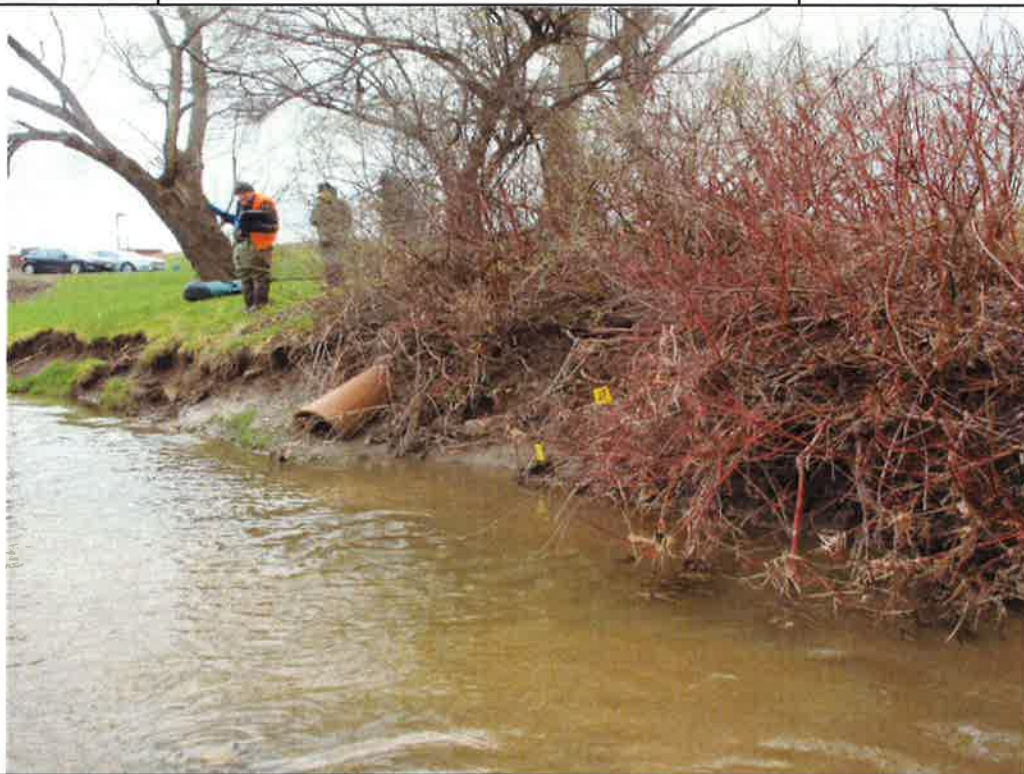
Transect A02-011 a. Lower yellow pin flag at current water elevation; Upper yellow pin flag at MHW.

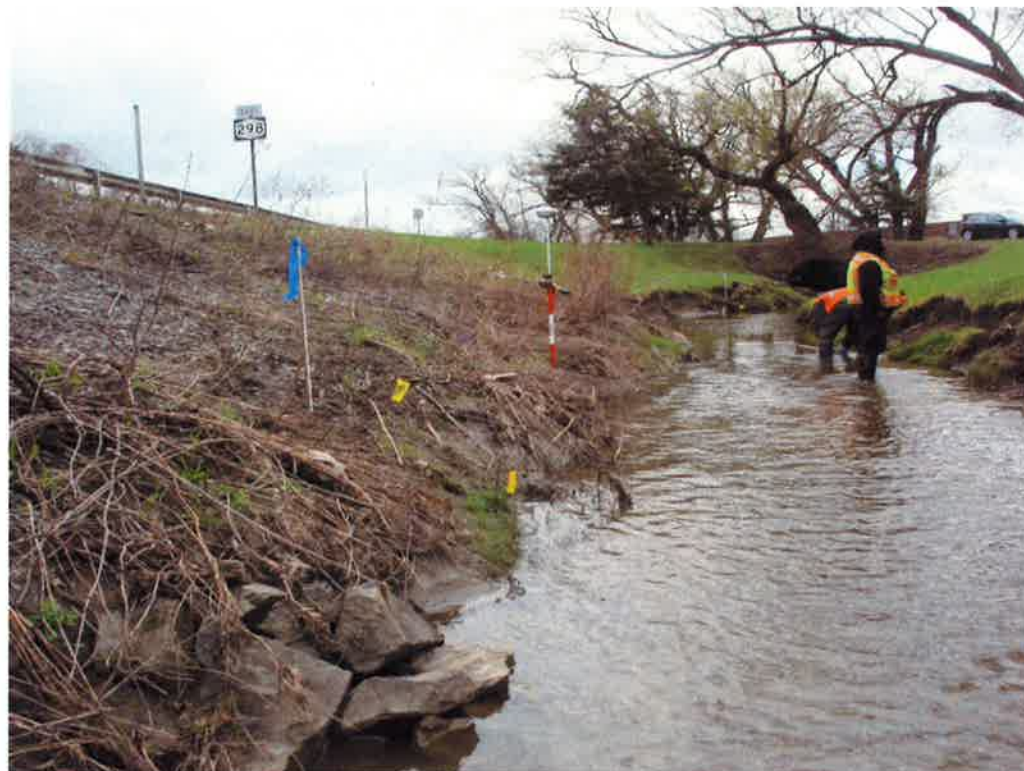
Photo No. 10
Date: 4/23/15

Transect A02-011 b. North bank. Lower yellow pin flag at current water elevation; Upper yellow pin flag at MHW. Stake with blue flag shows historical sediment sample location.

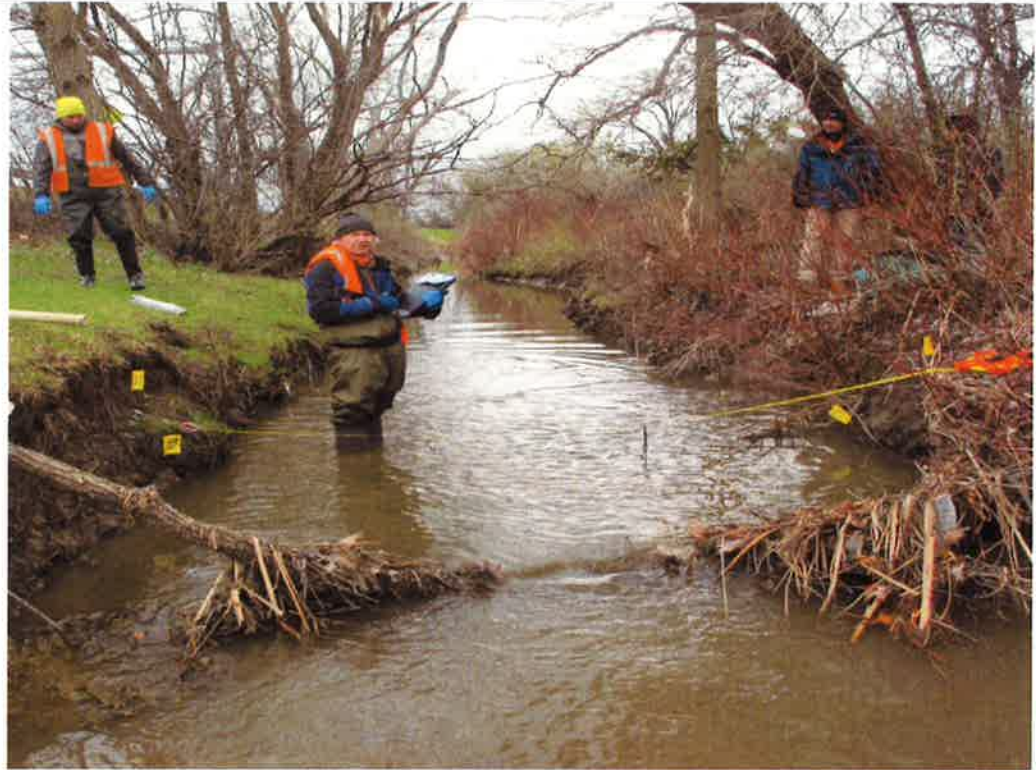
Transect A02-012.
Two lower yellow pin flags at current water elevation; 2 upper yellow pin flags at MHW. Shows upper bank collapsed (left) into area below MHW due to undercutting erosion.

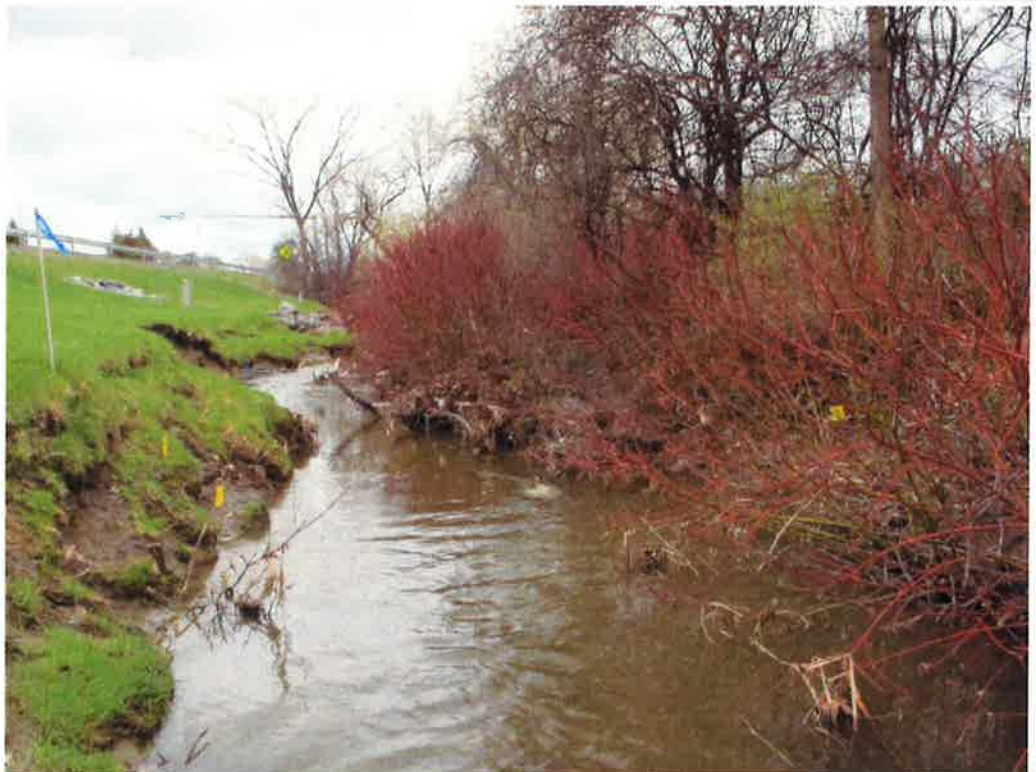
Transect A02-013.
Two lower yellow pin flags at current water elevation; 2 upper yellow pin flags at MHW. Stake with blue flag shows historical sediment sample location. Shows upper bank collapsed (left) into area below MHW due to undercutting erosion.

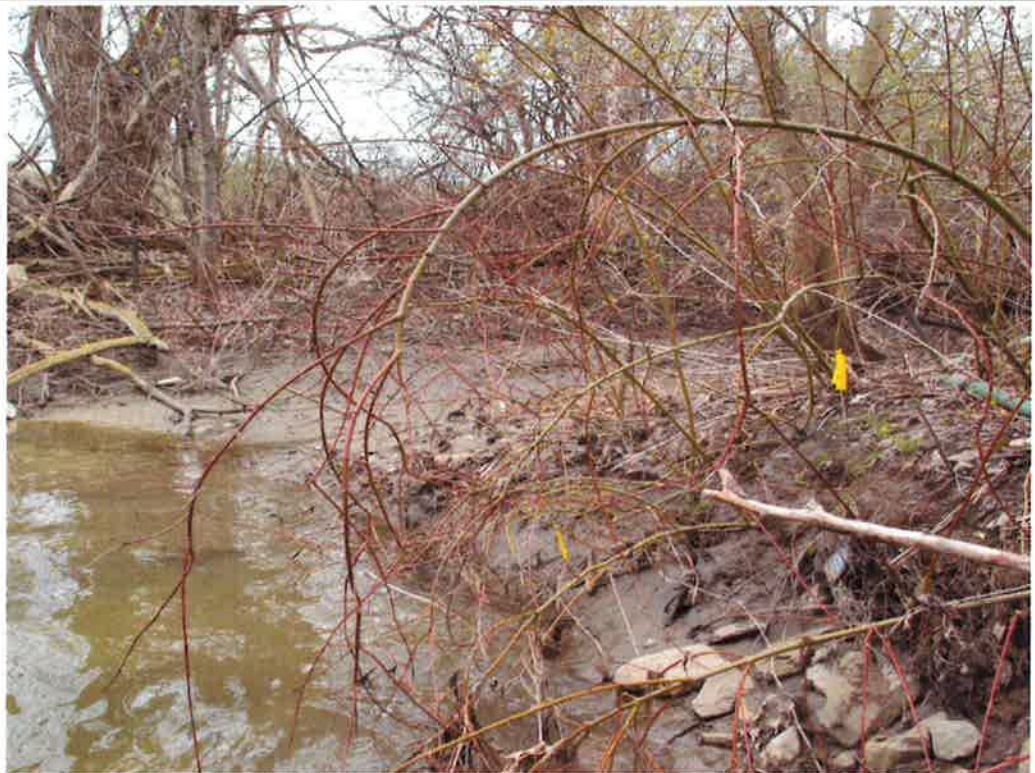
Transect A02-014 a (south bank). Yellow pin flag at MHW. Notice bank swept clean of debris.

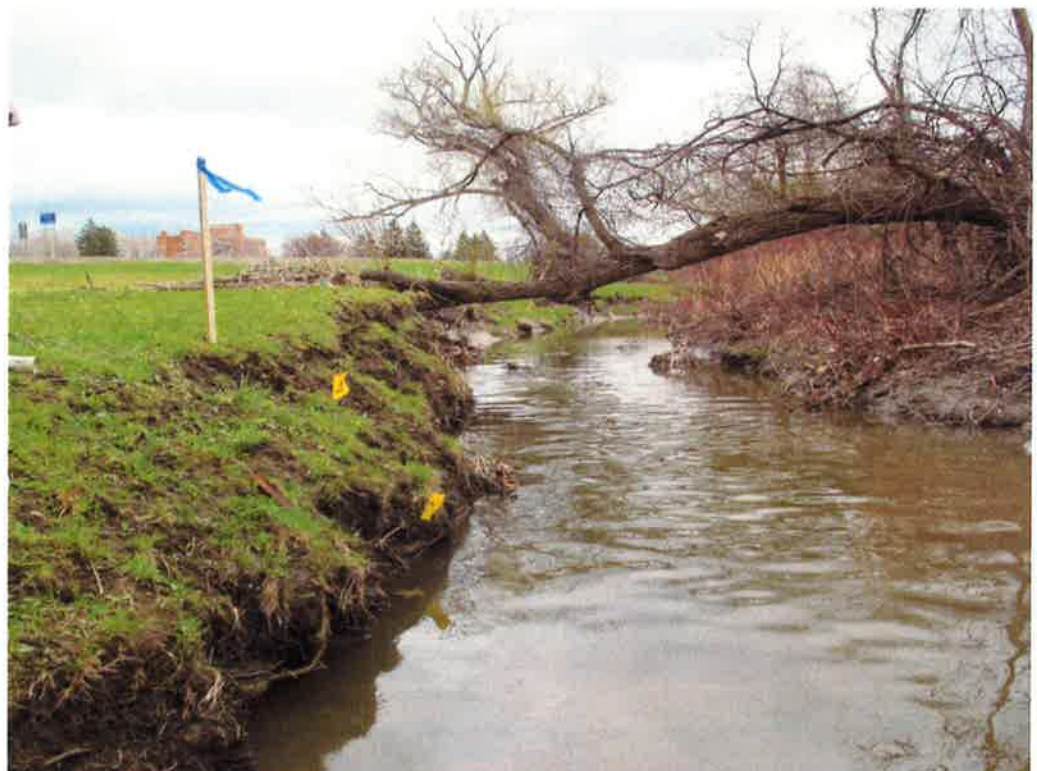
Transect A02-014 b (north bank). Lower yellow pin flag at current water elevation; Upper yellow pin flag at MHW. Stake with blue flag shows historical sediment sample location. Shows upper bank collapsed (left) into area below MHW due to undercutting erosion.

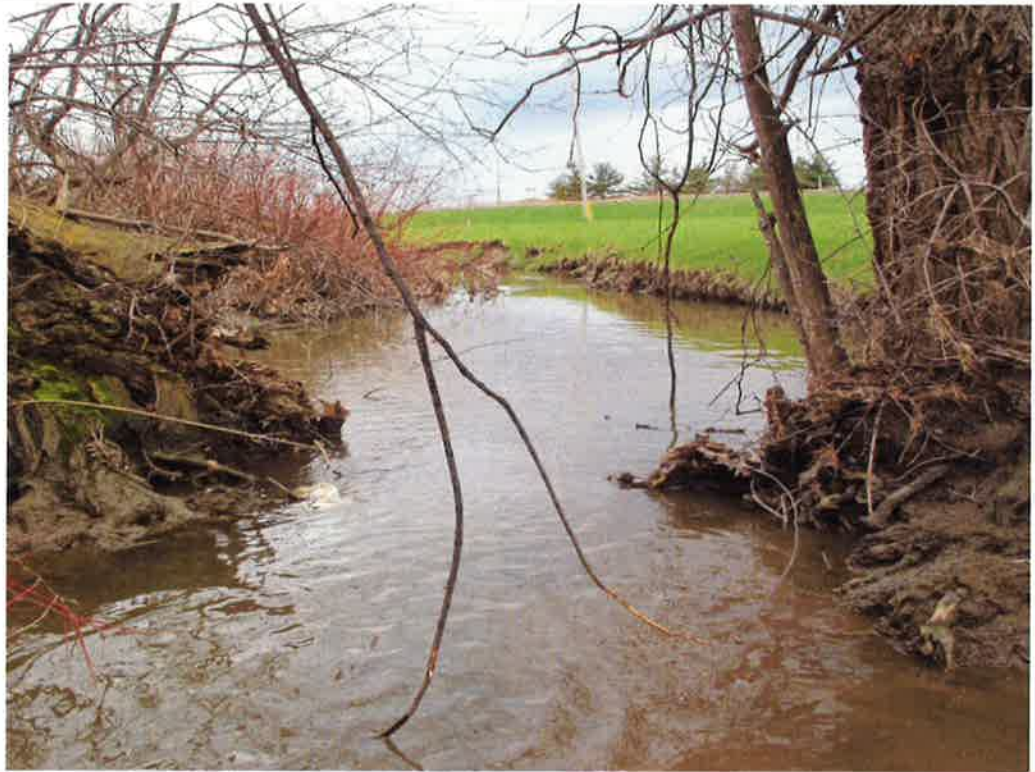
Photo No.
16

Downstream restriction. Note difference between current water level and MHW at A02-014 b (previous photo) is greater here than at other sites due to this downstream restriction of channel width.

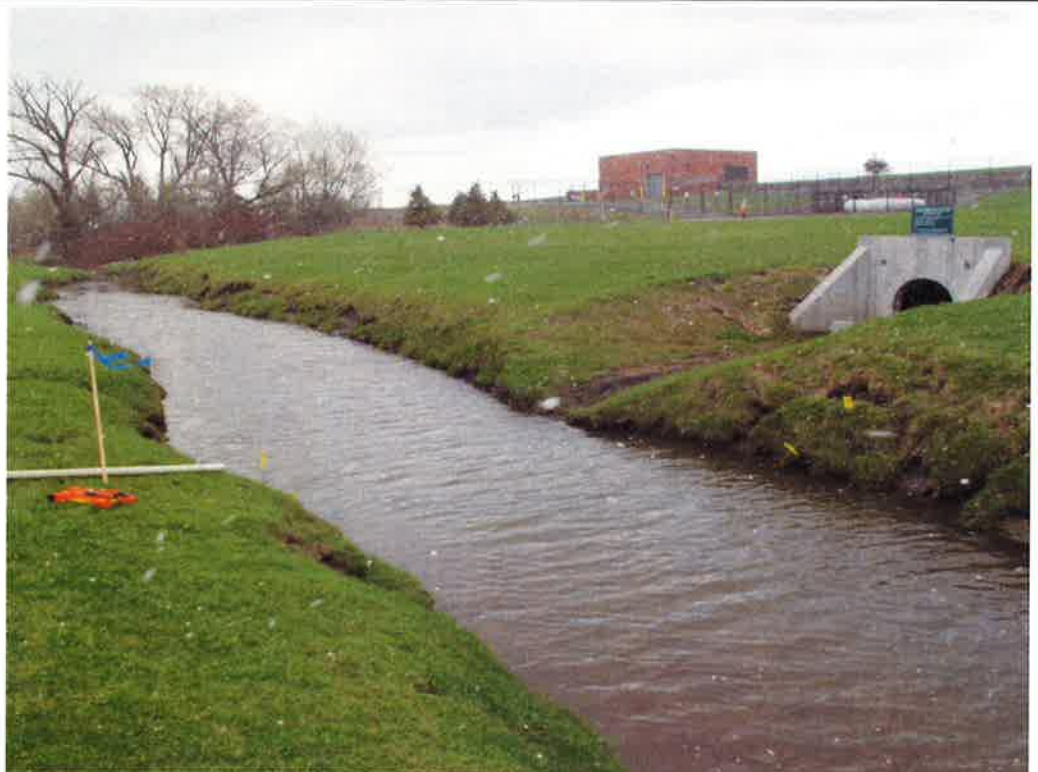
Transect A02-015 a. Lower yellow pin flag at current water elevation; Upper yellow pin flag at MHW. Stake with blue flag shows historical sediment sample location. Left pin flags not visible.

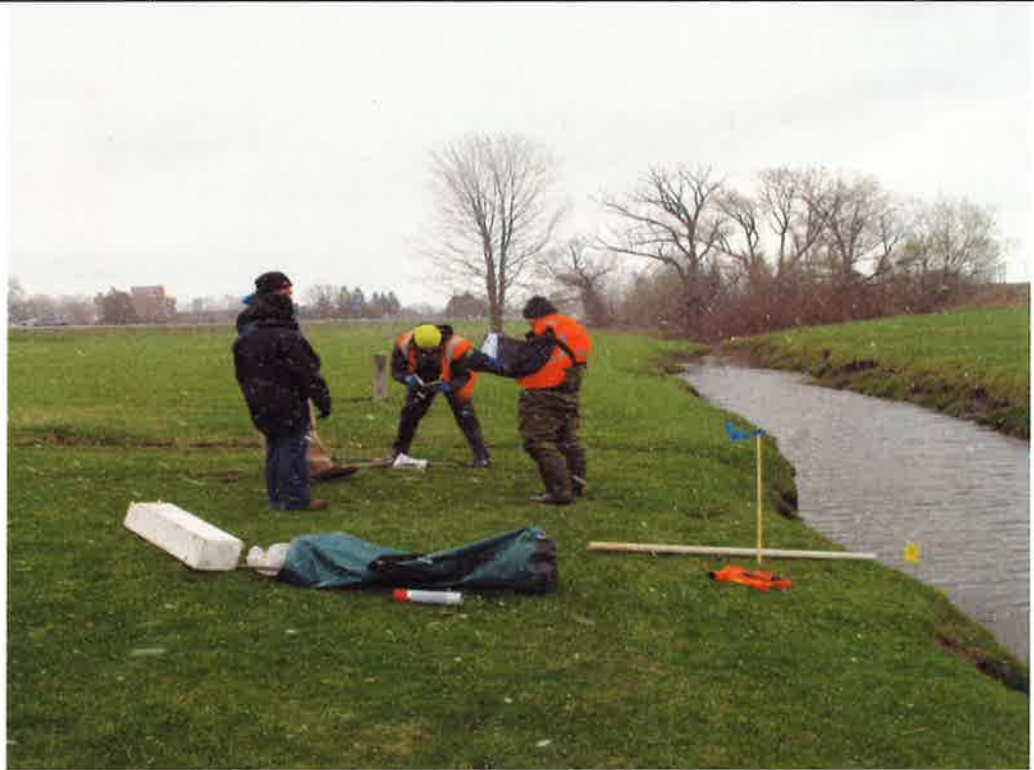
Transect A02-015 b with crew. Upper yellow pin flag at MHW. Stake with blue flag shows historical sediment sample location. Note grass sod collapsed into the area of MHW due to undercutting erosion (right).

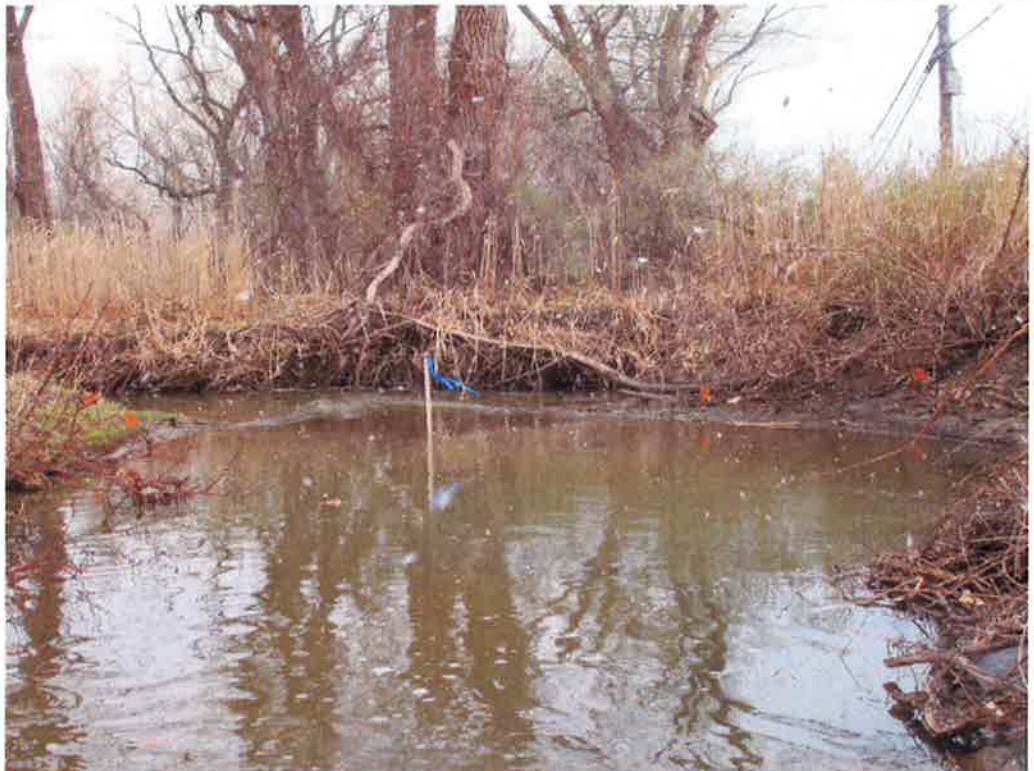
Photo No.
18

Transect A03-001. Lower orange pin flags at current water elevation; Upper orange pin flags at MHW. Stake with blue flag shows historical sediment sample location.

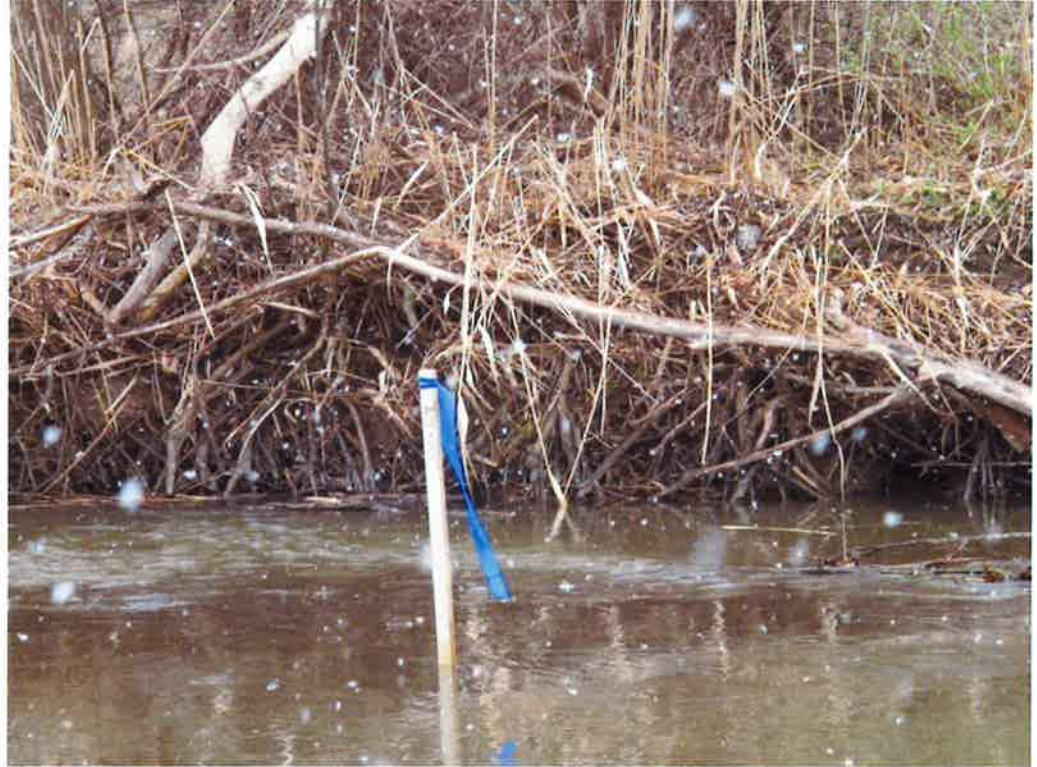
Transect A03-001. North bank showing undercutting. Stake with blue flag shows historical sediment sample location.

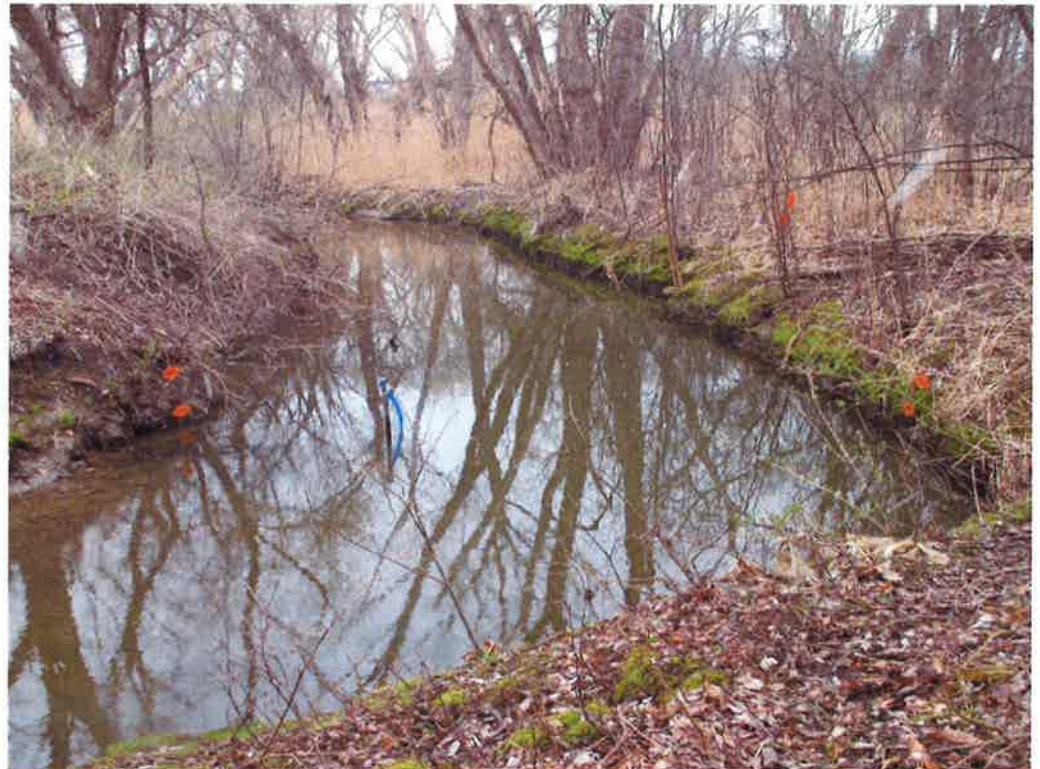
Transect A03-002A. Two lower orange pin flags at current water elevation; 2 upper orange pin flags at MHW. Stake with blue flag shows historical sediment sample location. Stable river channel with MHW at bankfull elevation.

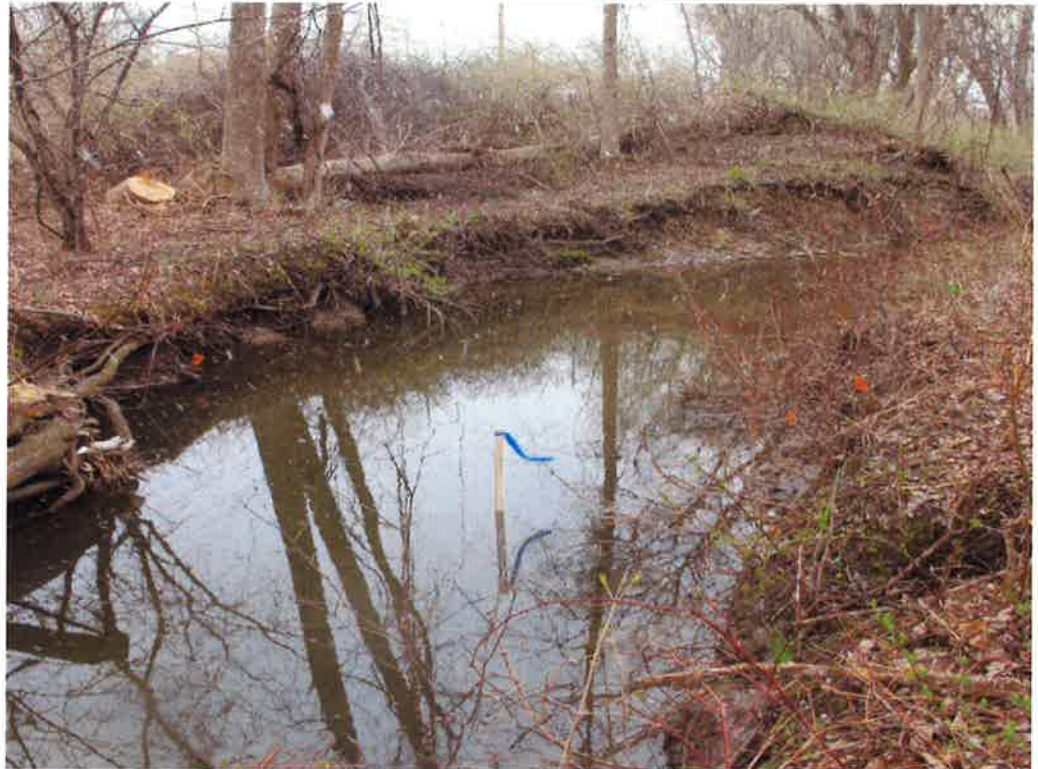
Transect A03-003. Two lower orange pin flags at current water elevation; 2 upper orange pin flags at MHW. Stake with blue flag shows historical sediment sample location. Tree roots on opposite bank show undercutting at MHW elevation

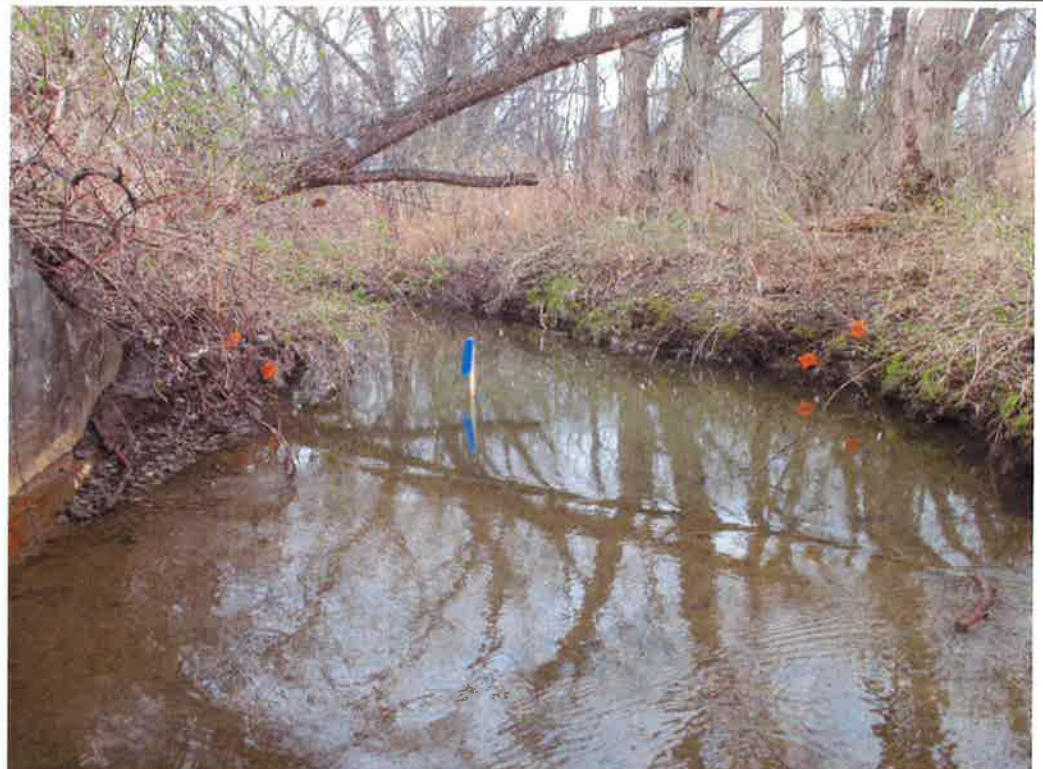
Transect A03-004. Two lower orange pin flags at current water elevation; 2 upper orange pin flags at MHW. Stake with blue flag shows historical sediment sample location. Note MHW staining on wing wall of culvert (left) and undercutting of bank (right).
