**SANDERS CREEK
UTC/CARRIER SITE
THOMPSON ROAD, SYRACUSE, NY**
Sampling and Analysis Plan

Corrective Action Order - Index CO 7-20051118-4
NYSDEC Site Registry #734043

SAMPLING AND ANALYSIS PLAN
 UTC/CARRIER SITE - NYSDEC SITE #734043
 SANDERS CREEK, SYRACUSE, NY
 Project No.: 60321789 Date: MAY 2015

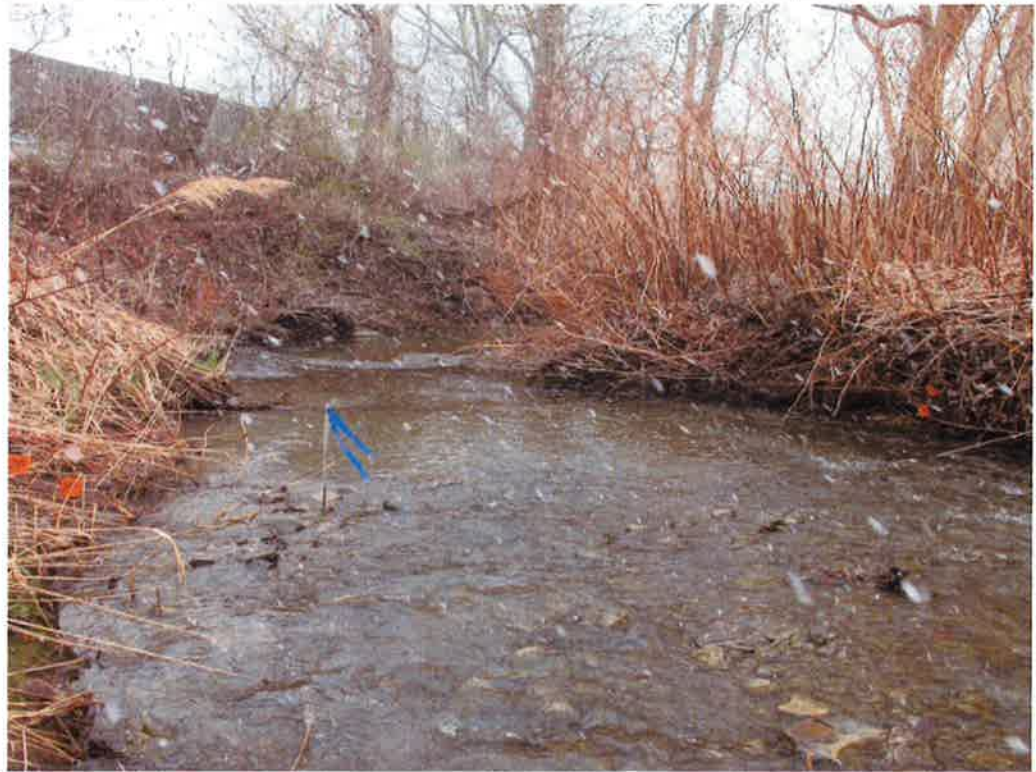
Photo No. 24 **Date: 4/24/15**

Transect A03-005. Two lower orange pin flags at current water elevation; 2 upper orange pin flags at MHW. Stake with blue flag shows historical sediment sample location. Note undercutting of bank at MHW (right).

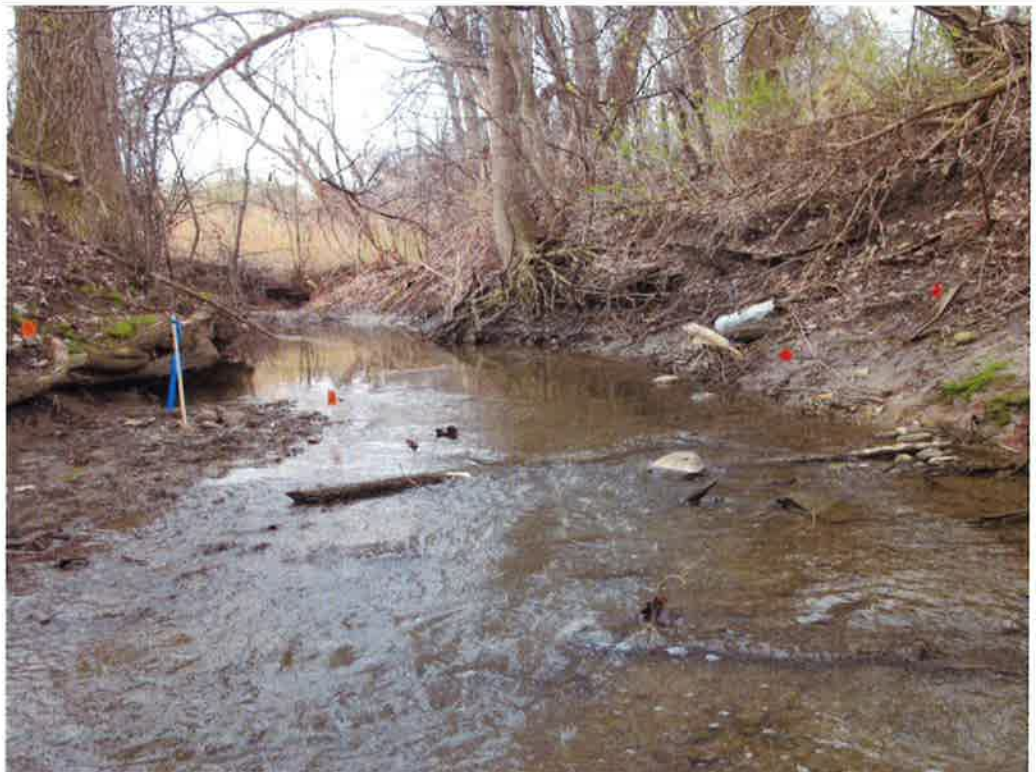
Transect A03-006. Two lower orange pin flags at current water elevation; 2 upper orange pin flags at MHW. Stake with blue flag shows historical sample location. Note undercutting and staining of tree roots (left beyond blue flag) and accumulation of forest debris above roots.

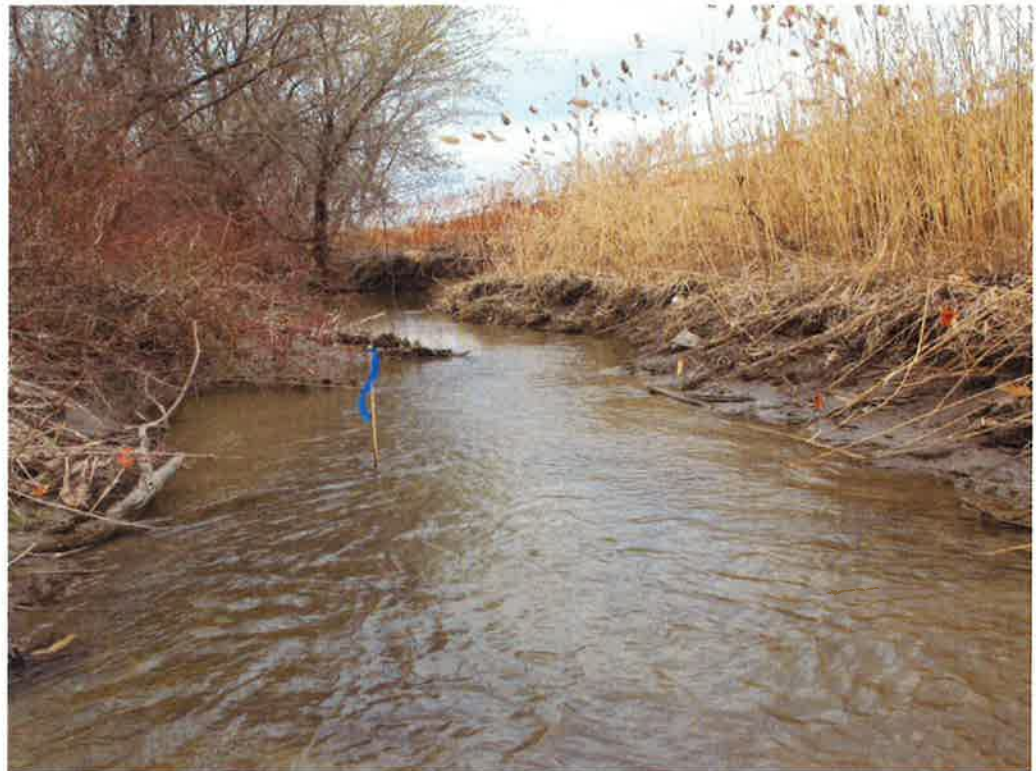
Photo No. 26 **Date: 4/23/15**

Transect A03-007 (wide view). Two lower orange pin flags at current water elevation; 2 upper orange pin flags at MHW. Stake with blue flag shows historical sediment sample location. Note undercutting of roots and slumping bank (right)

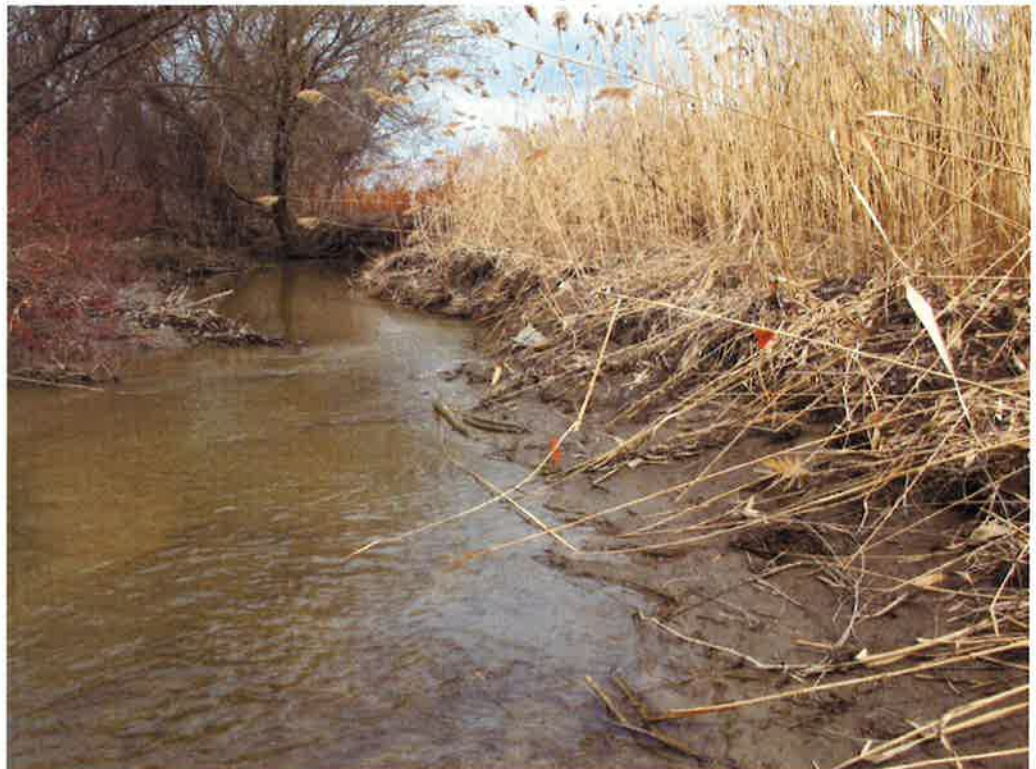
Transect A03-007 b. Close up view of right bank showing slumping from MHW and undercut of vegetation roots.

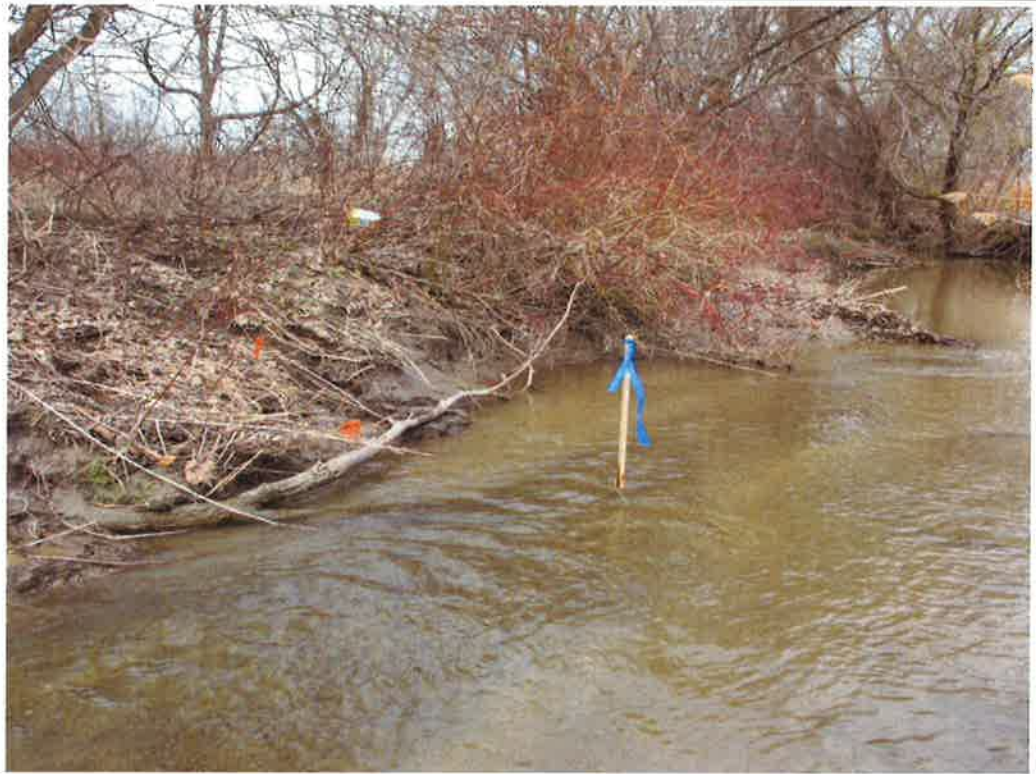
Photo No.
28

Transect A03-007 c. Left bank showing bank swept clear of debris to MHW. Lower orange pin flag at current water elevation; upper orange pin flag at MHW. Stake with blue flag shows historical sediment sample location.

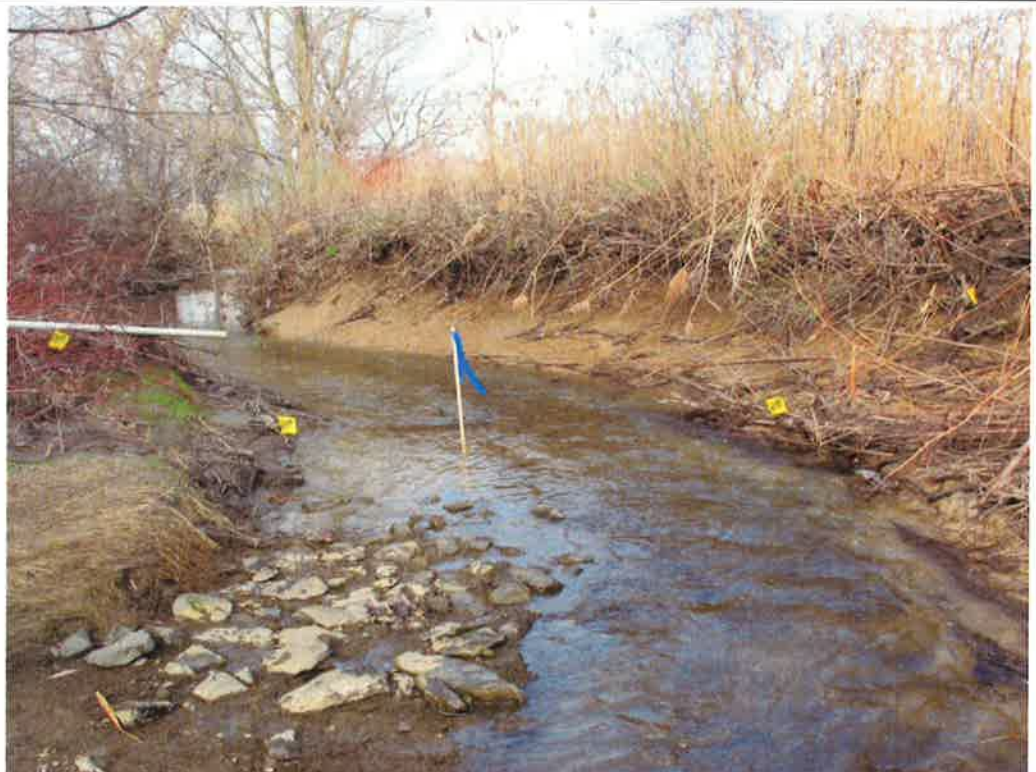
Transect A03-008. Two lower yellow pin flags at current water elevation; 2 upper yellow pin flags at MHW. Stake with blue flag shows historical sediment sample location. Bank over flow (left) swept bank clean; undercutting of bank and slumping (background).

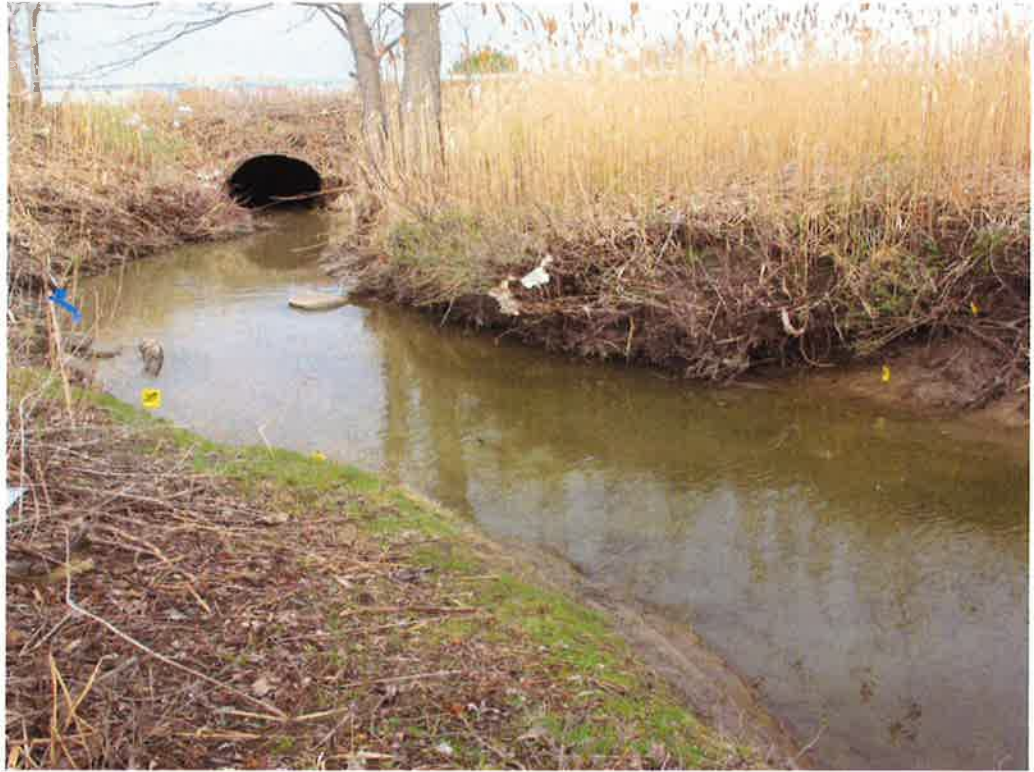
Photo No.
30

Transect A03-009. Right lower yellow pin flag at current water elevation (left not visible); 2 upper yellow pin flags at MHW. Stake with blue flag shows historical sediment sample location.

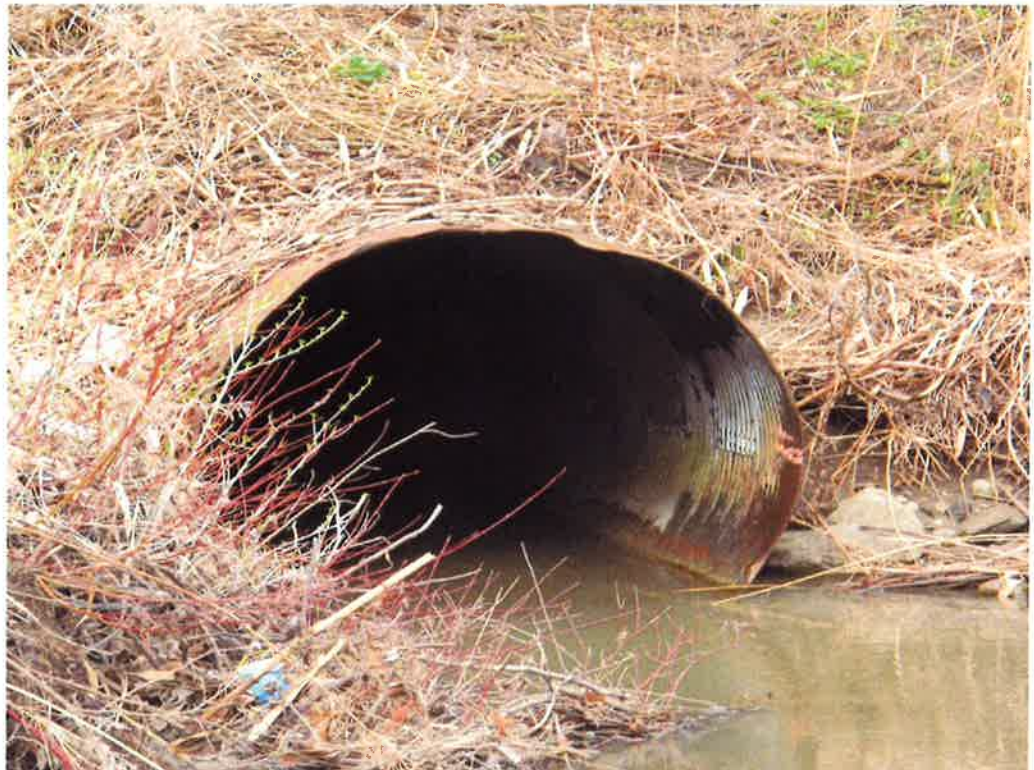
A03-009 Culvert upstream opening showing MHW elevation marked with paint (approximately 1/2 the pipe height).

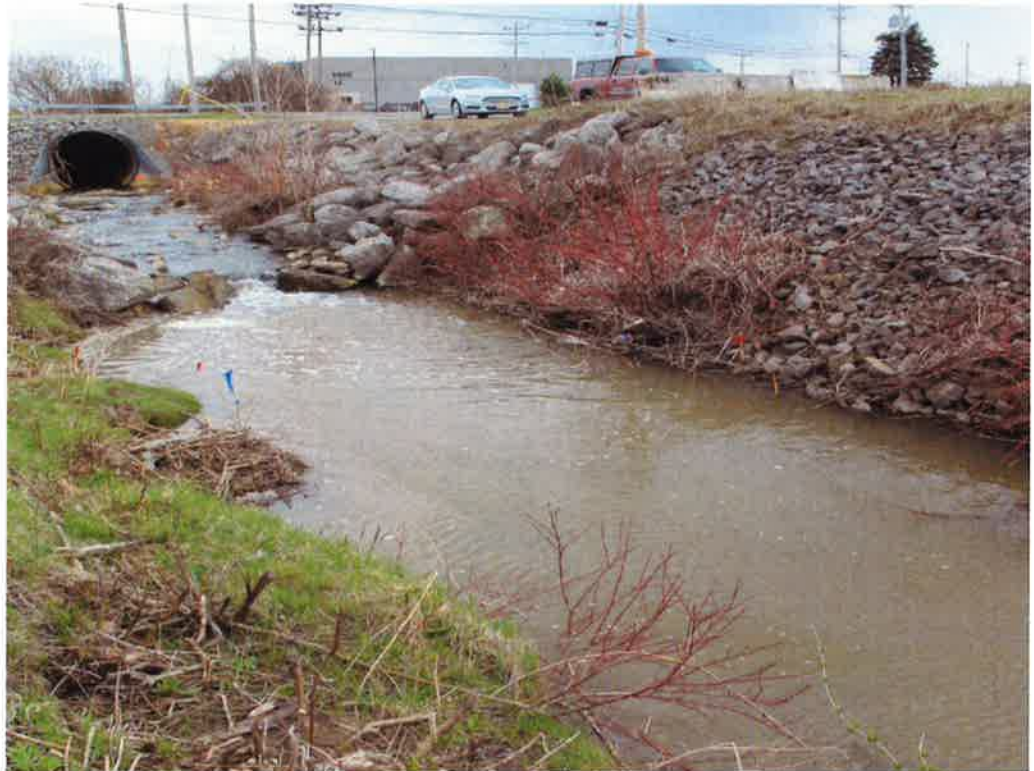
Transect A03-010 (wide view).
Two lower orange pin flags at current water elevation; 2 upper orange pin flags at MHW. Stake with blue flag shows historical sediment sample location.

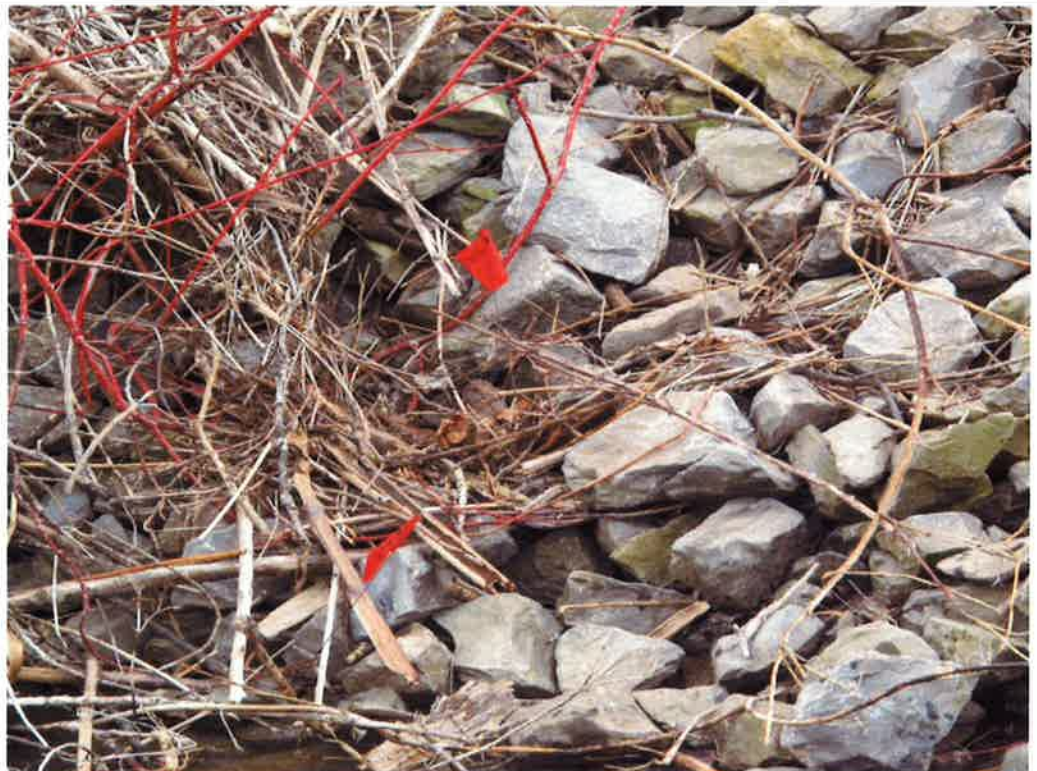
Transect A03-010 close up view of south bank.
Lower orange pin flag at current water elevation; upper orange pin flag at MHW.

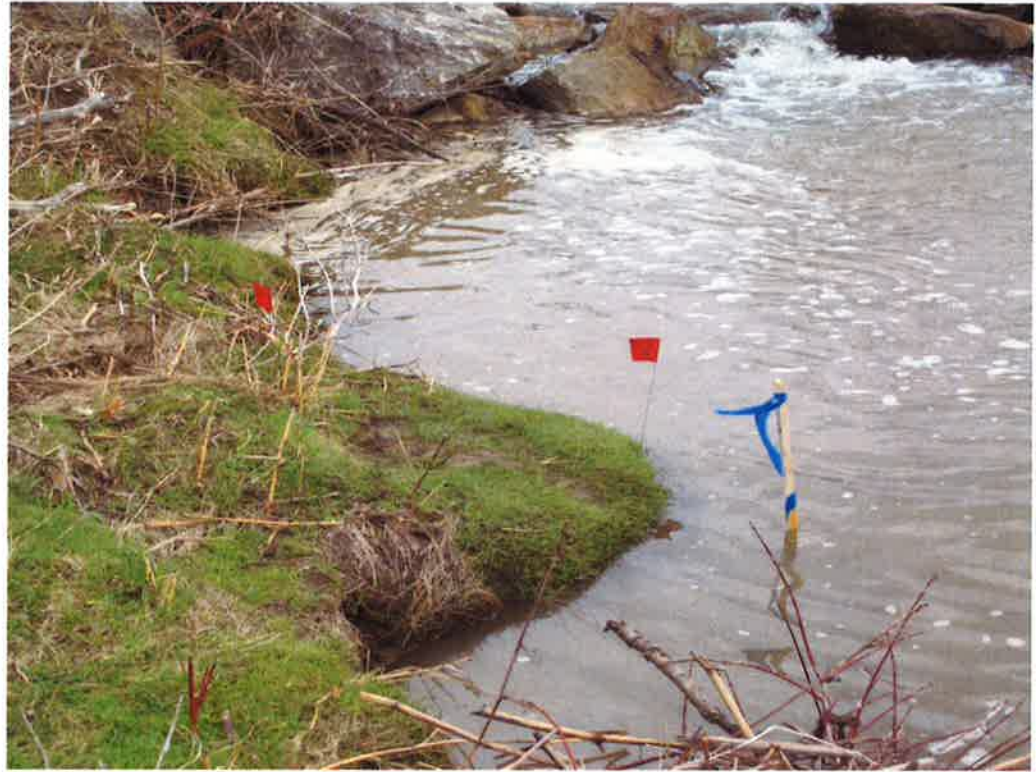
Photo No.
34

Transect A03-010
Close up of north bank. Lower orange pin flag at current water elevation; upper orange pin flag at MHW. Stake with blue flag shows historical sediment sample location.

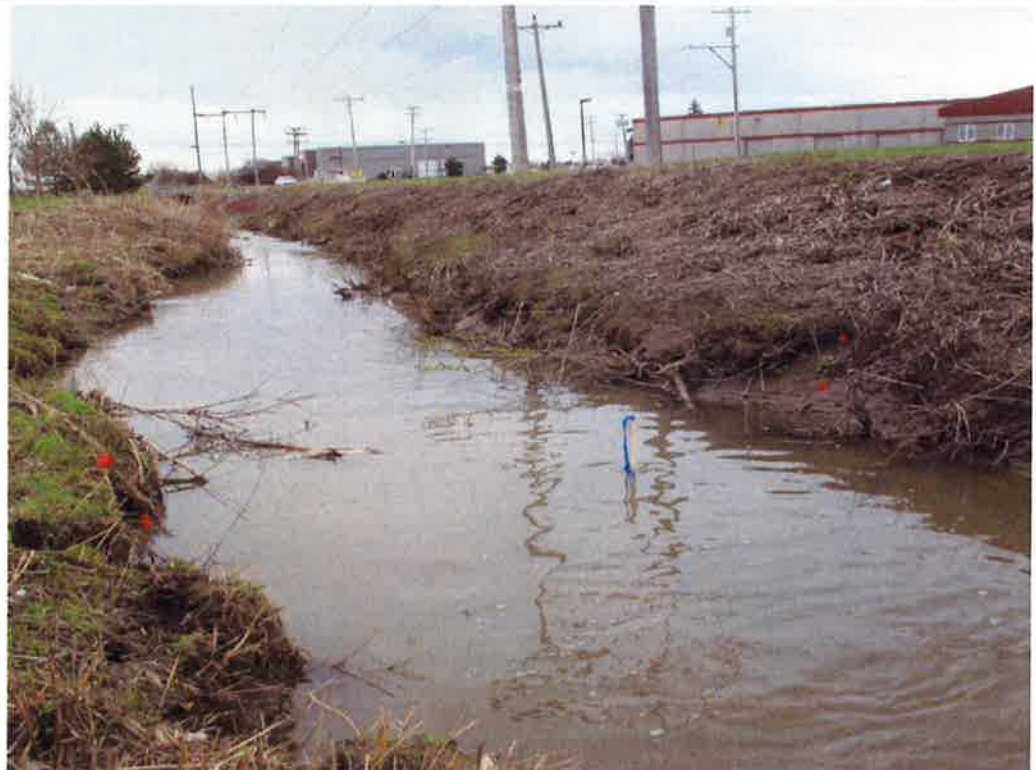
Transect A03-011.
Two lower orange pin flags at current water elevation; 2 upper orange pin flags at MHW. Stake with blue flag shows historical sediment sample location. Note slumping of undercut bank (left).

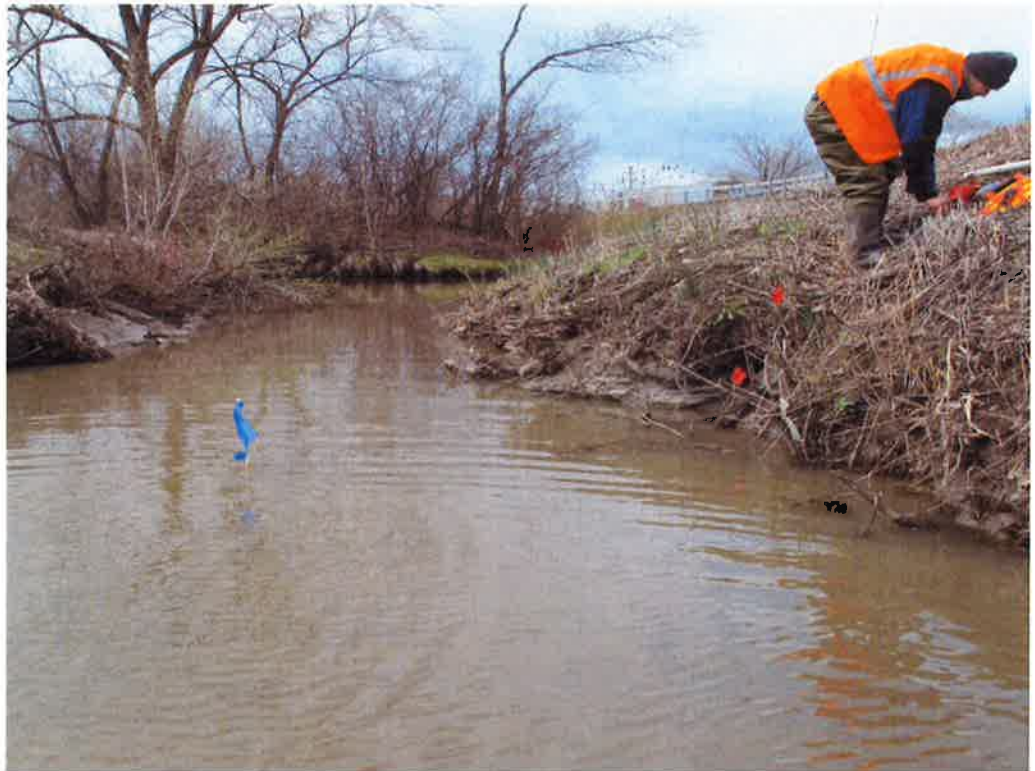
Transect A03-013. Right bank. Lower orange pin flags at current water elevation; upper orange pin flag at MHW. Stake with blue flag shows historical sediment sample location. Near confluence with Ley Creek

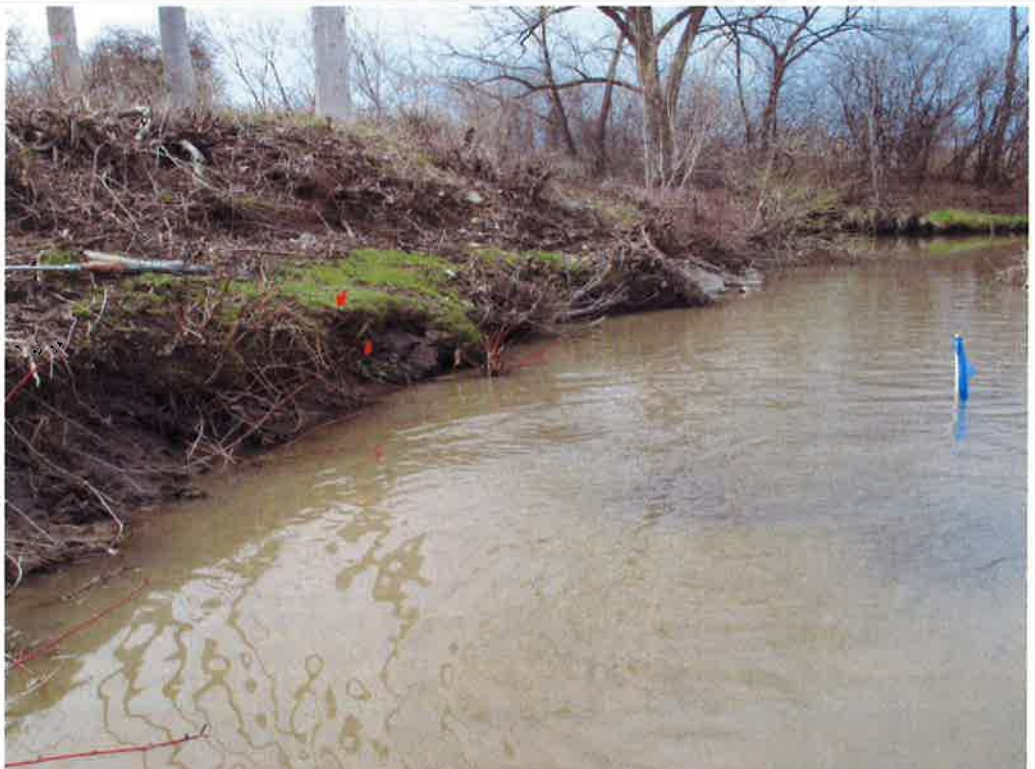
Photo No.
36

Transect A03-013 left bank. . Lower orange pin flags at current water elevation; upper orange pin flag at MHW. Stake with blue flag shows historical sediment sample location. Near confluence with Ley Creek

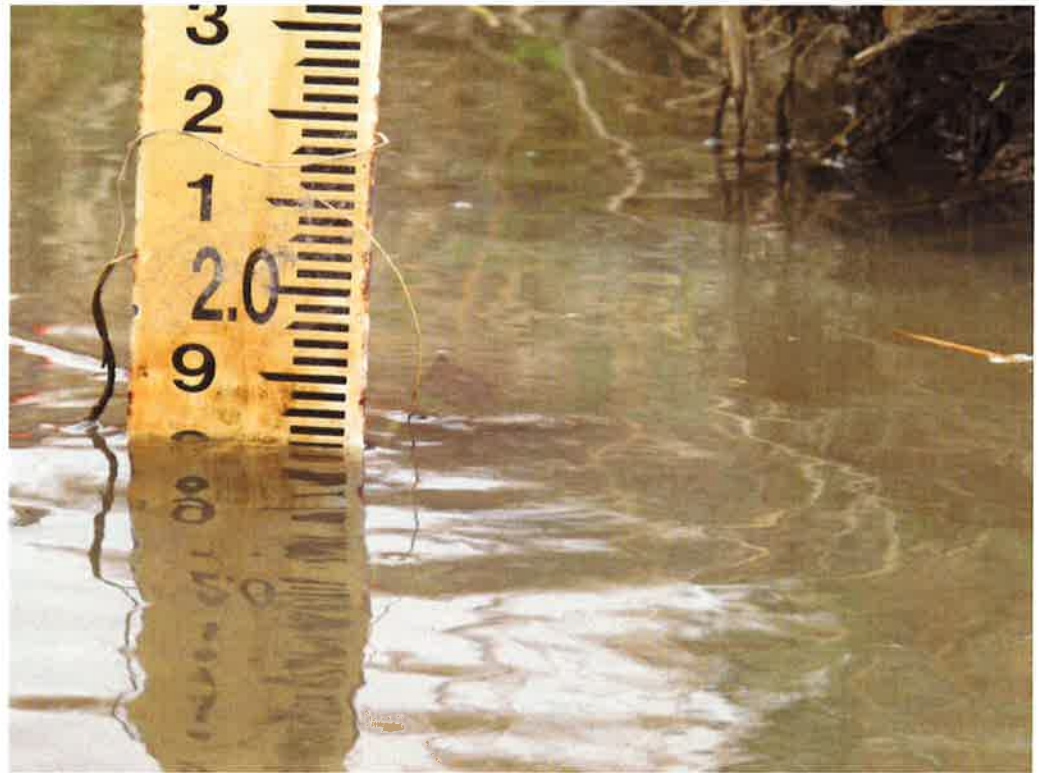
Photo No.
38

A03-013 Staff Gage showing current water level at time of visit.

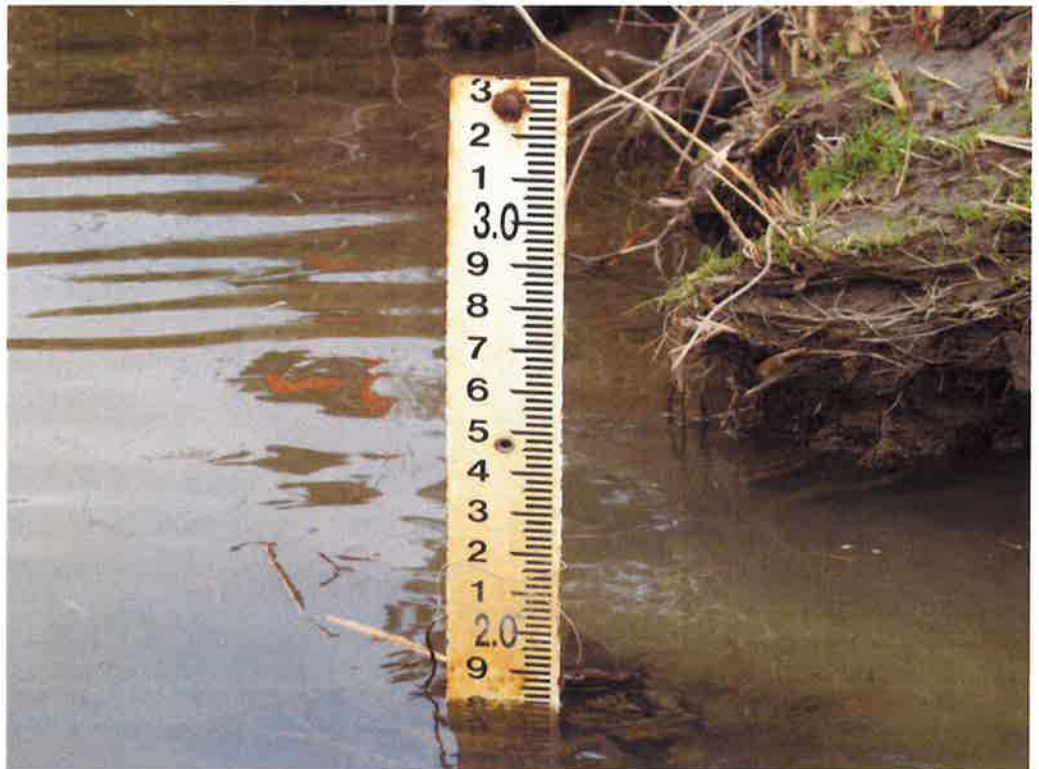
A03-013 Staff Gage wide view showing bank context.

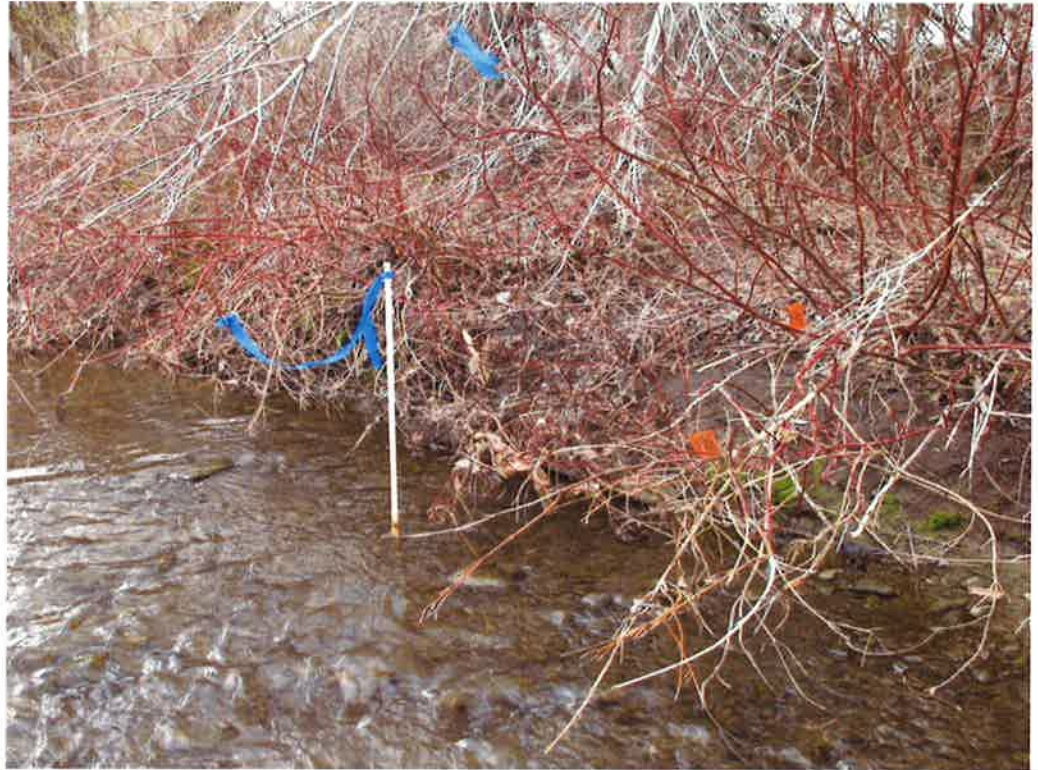
Photo No.
40

Transect A03-018 a. Lower orange pin flag at current water elevation; upper orange pin flag at MHW. Stake with blue flag shows historical sediment sample location. Note cleared bank below MHW under the red osier dogwood.

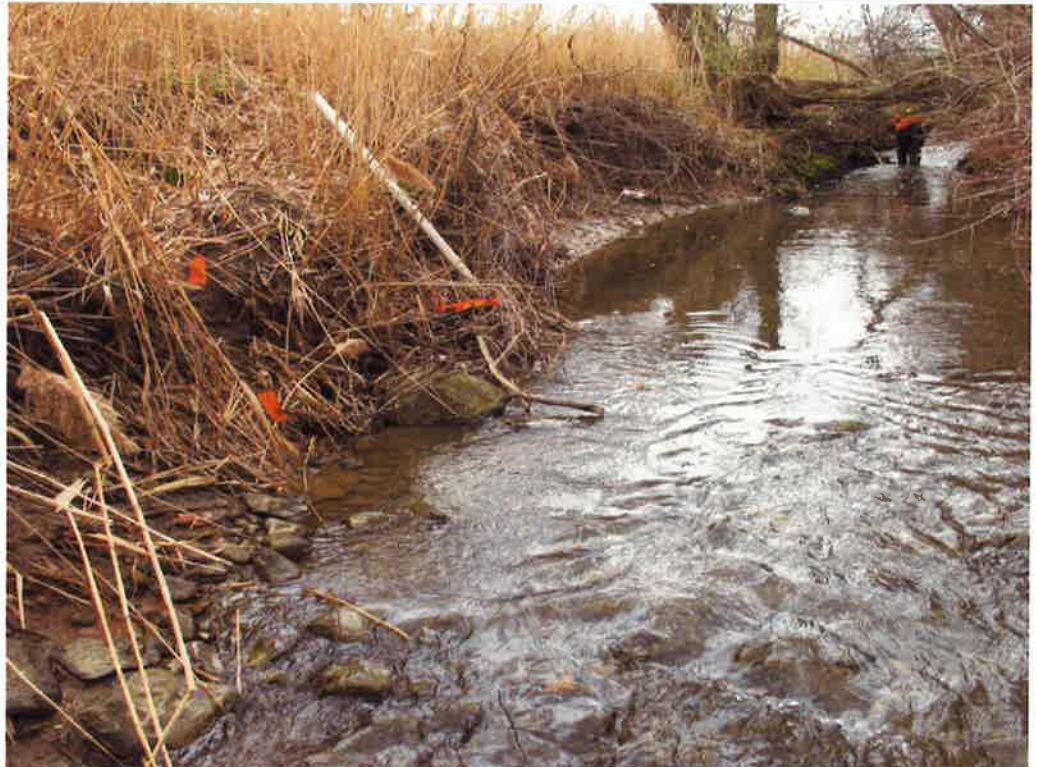
Transect A03-018 b. Lower orange pin flag at current water elevation; upper orange pin flag at MHW. Bank undercut at MHW line. Collapsed bank in background. Top of bank well above MHW.

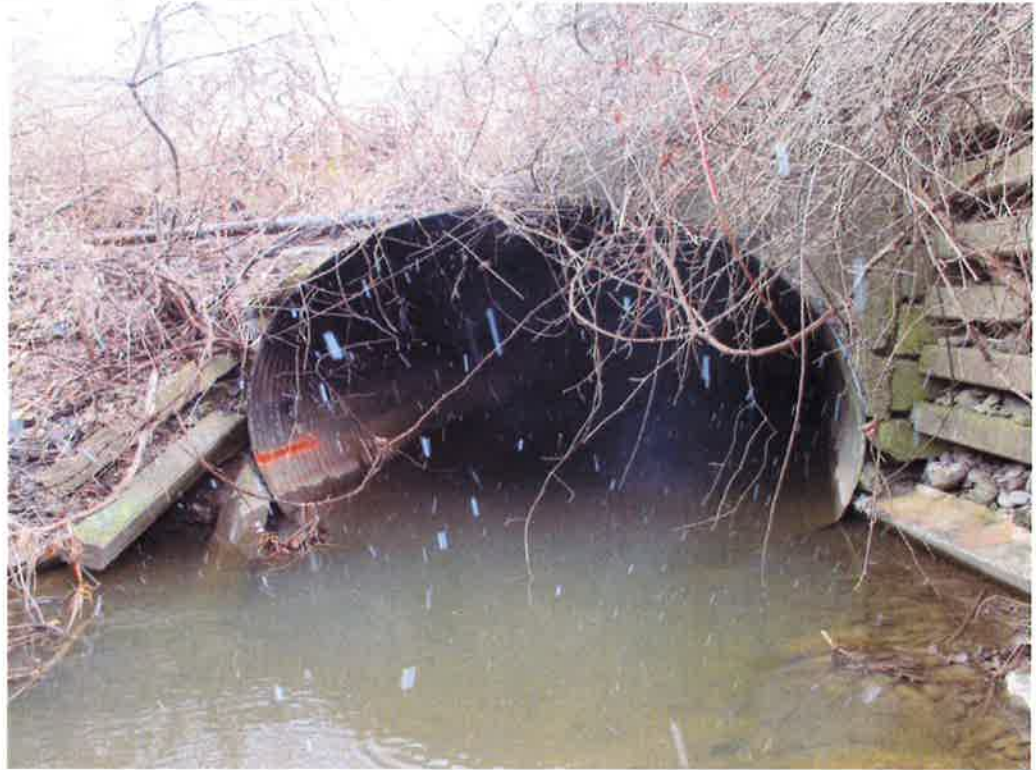
Howard Johnson Culvert outfall with MHW marked in orange

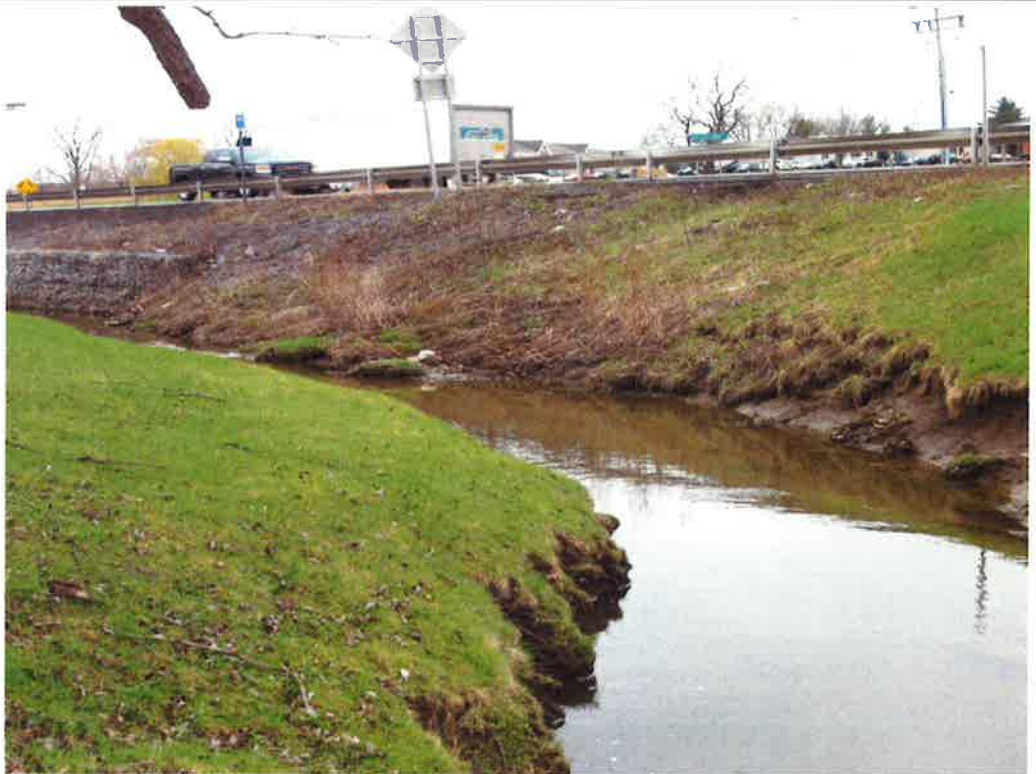
Sanders Creek @ Gabion 1- showing grass sod collapsed from undermining at the MHW level

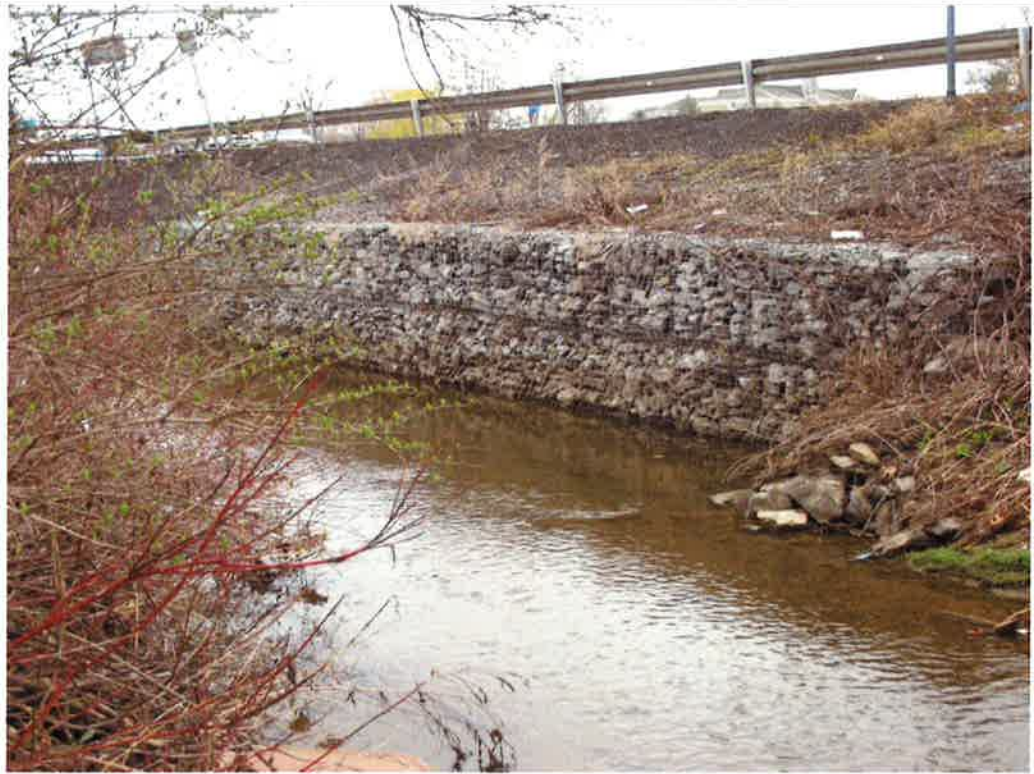
Photo No.
44

Sanders Creek @ Gabion 2- showing MHW staining just below seam between upper and lower gabion baskets

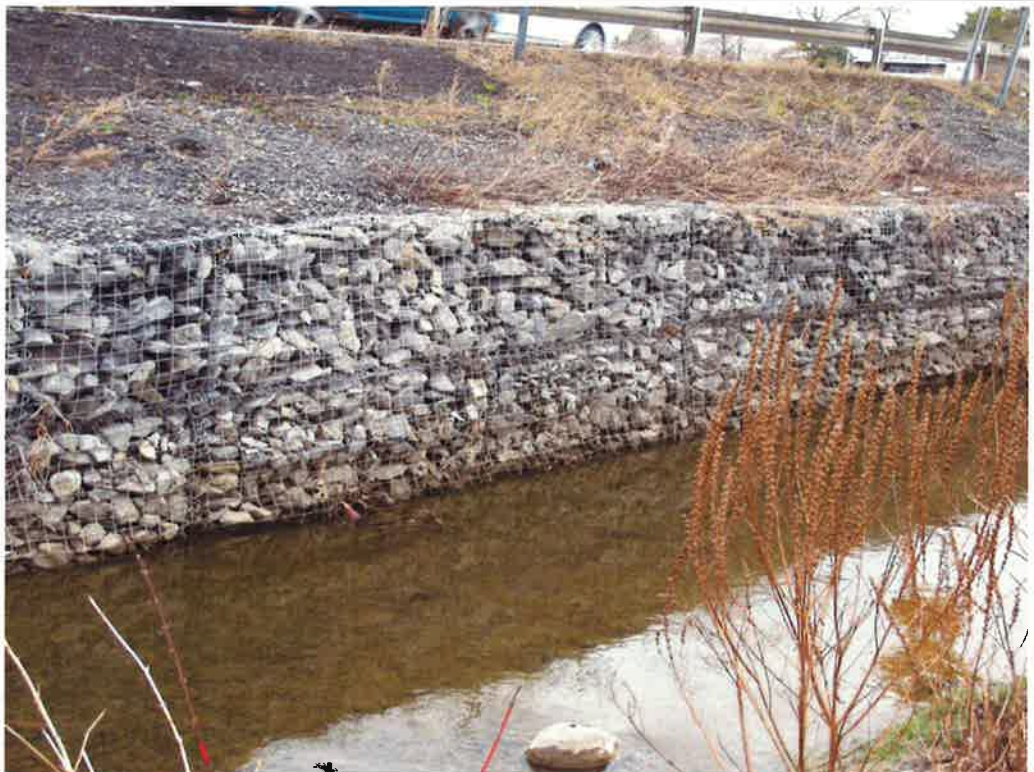
Sanders Creek @ Gabion 3 - showing MHW staining just below seam between upper and lower gabion baskets

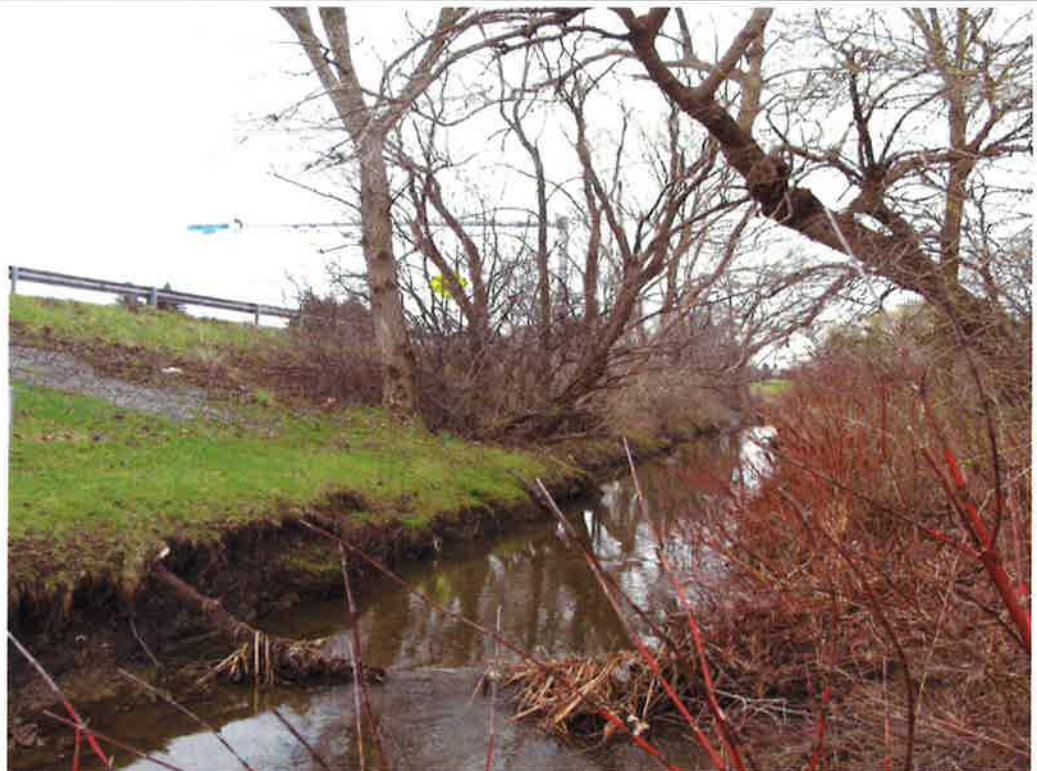
Photo No.
46

Sanders Creek Below Gabion 2- showing flood debris collected on branch. Bank in photo shows MHW at bankfull (behind left) and undercutting bank (forward left).

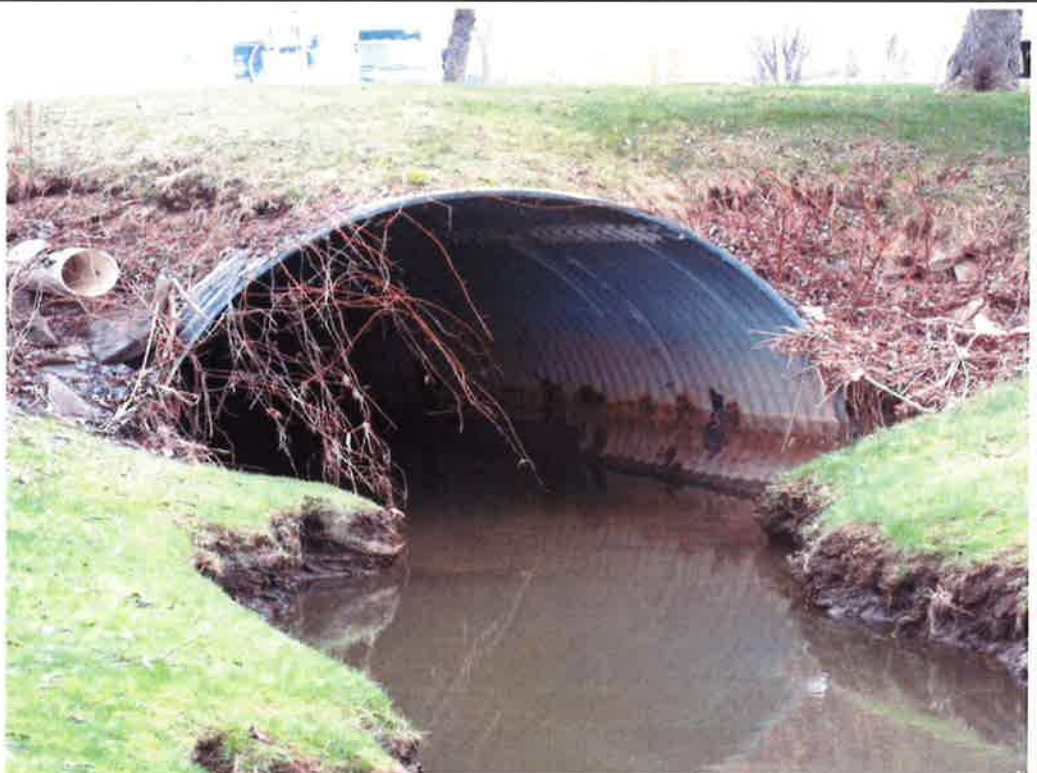
UTC Culvert @ pulloff Upstream MHW staining inside culvert. MHW just above bankfull on left and right banks.

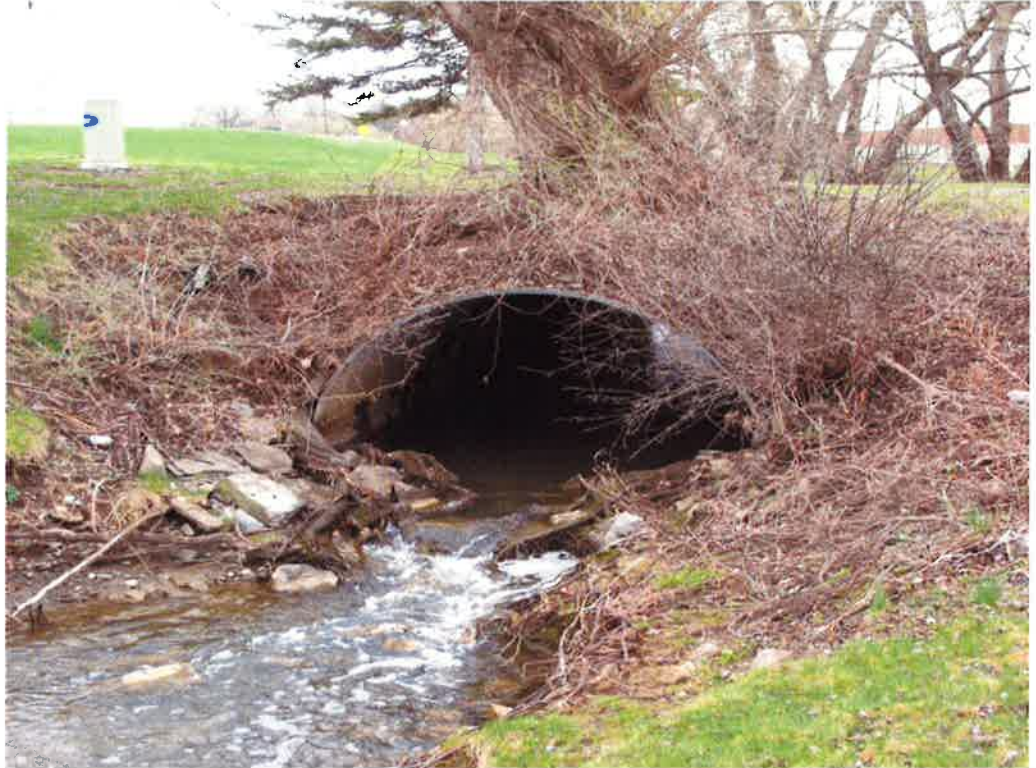
Photo No.
48

UTC Culvert @ pulloff downstream end. MHW stain visible in culvert. MHW drops as stream drops.

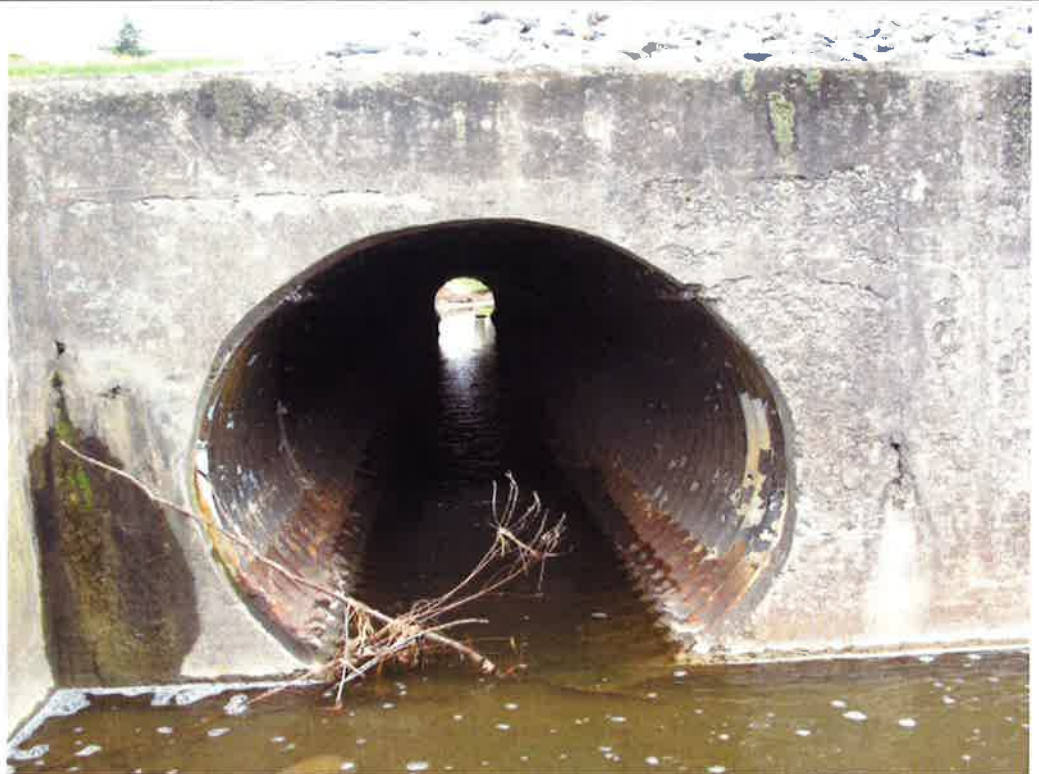
UTC Gate Culvert 1- MHW staining inside culvert about 1/3 pipe height

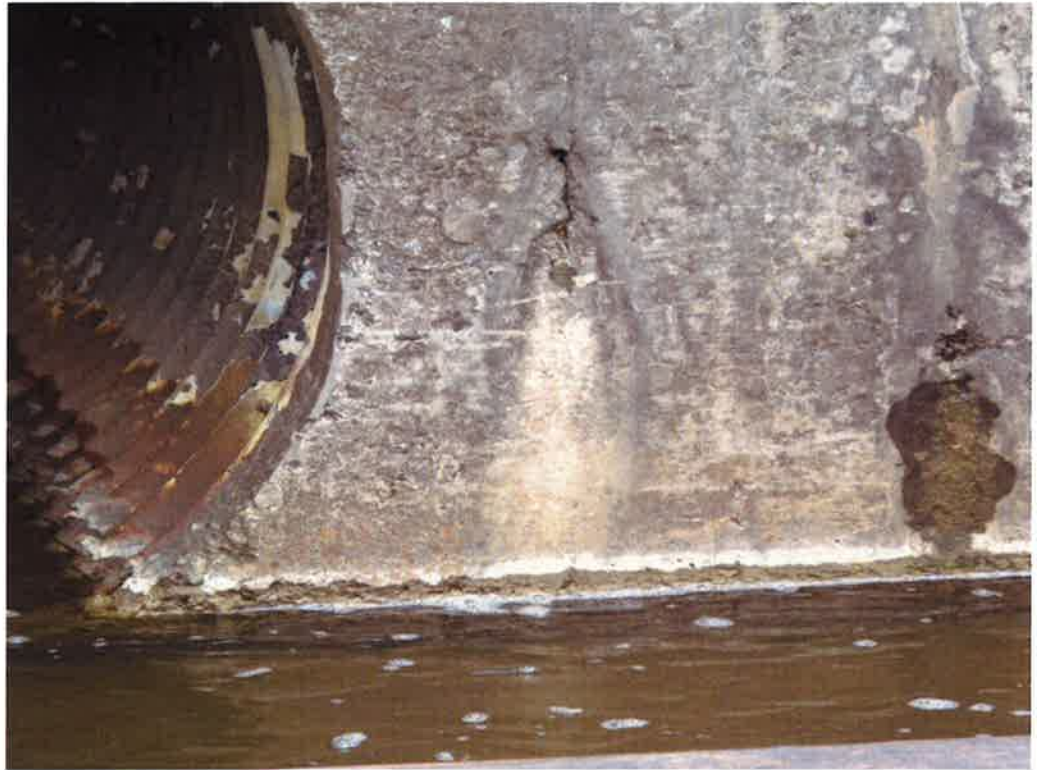
UTC Gate Culvert 2
