**SANDERS CREEK
UTC/CARRIER SITE
THOMPSON ROAD, SYRACUSE, NY**
Sampling and Analysis Plan

Corrective Action Order - Index CO 7-20051118-4
NYSDEC Site Registry #734043

SAMPLING AND ANALYSIS PLAN
 UTC/CARRIER SITE - NYSDEC SITE #734043
 SANDERS CREEK, SYRACUSE, NY
 Project No.: 60321789 Date: MAY 2015

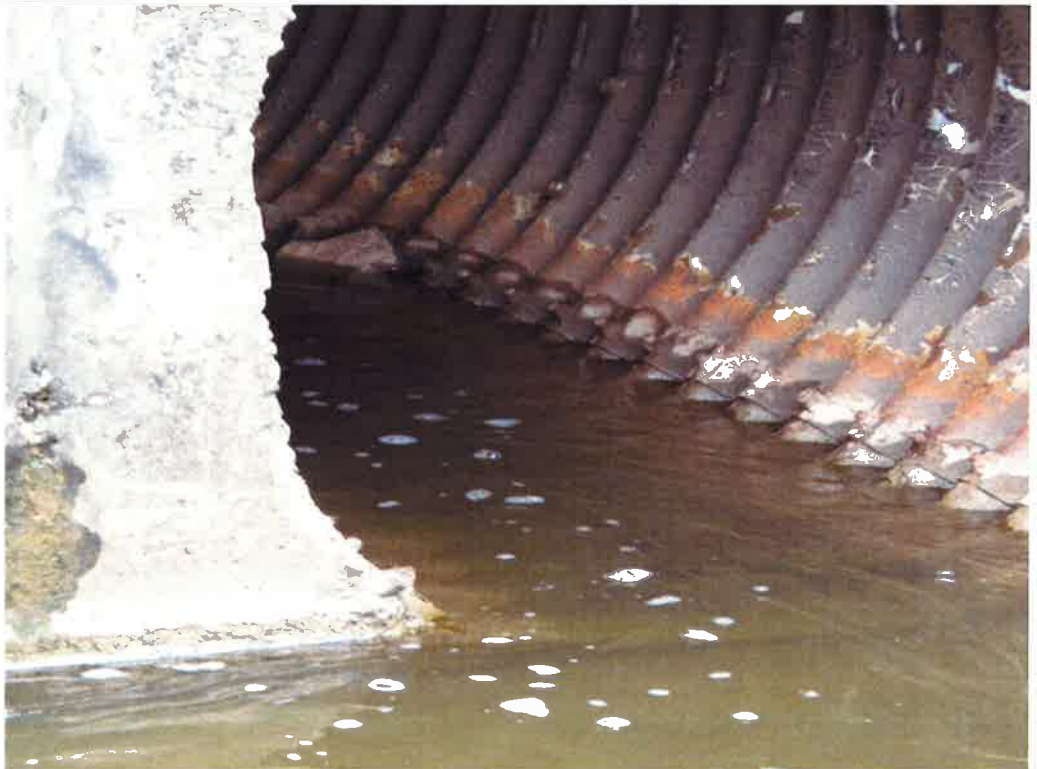
Photo No.
50

UTC Gate Culvert 3 upstream

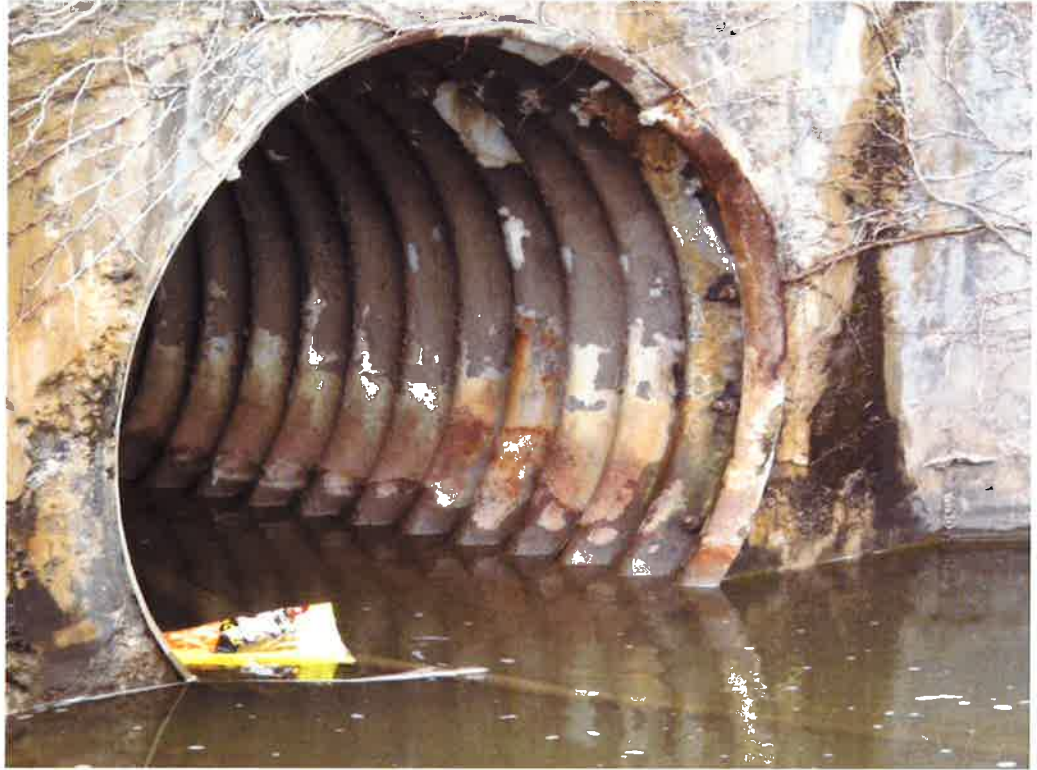
Photo No.
52

UTC Gate Culvert downstream end showing inside coating removed at approximately MHW level.

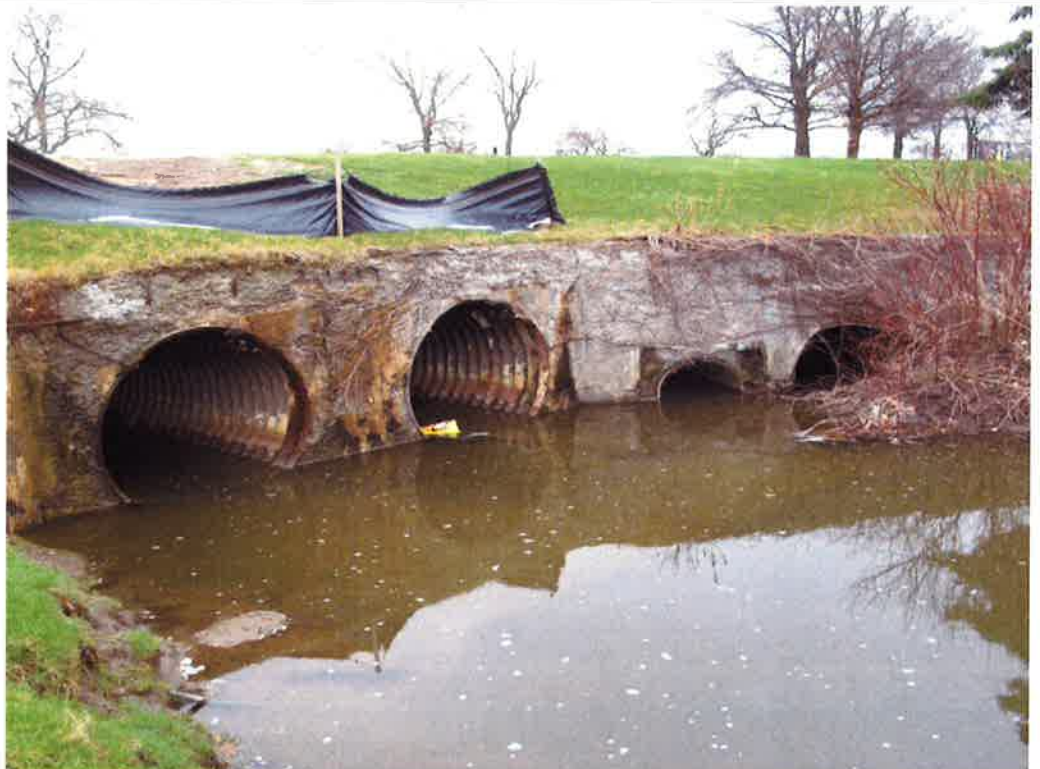
UTC Gate Culverts downstream ends (outfalls)

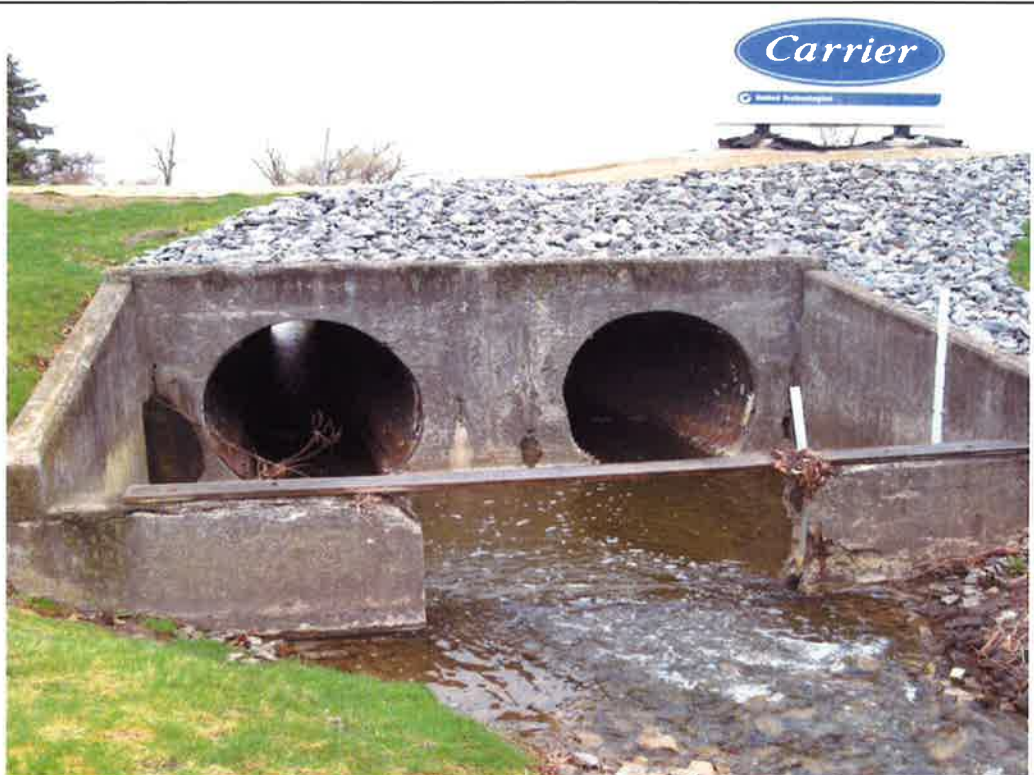
UTC Gate Stilling well for staff gage

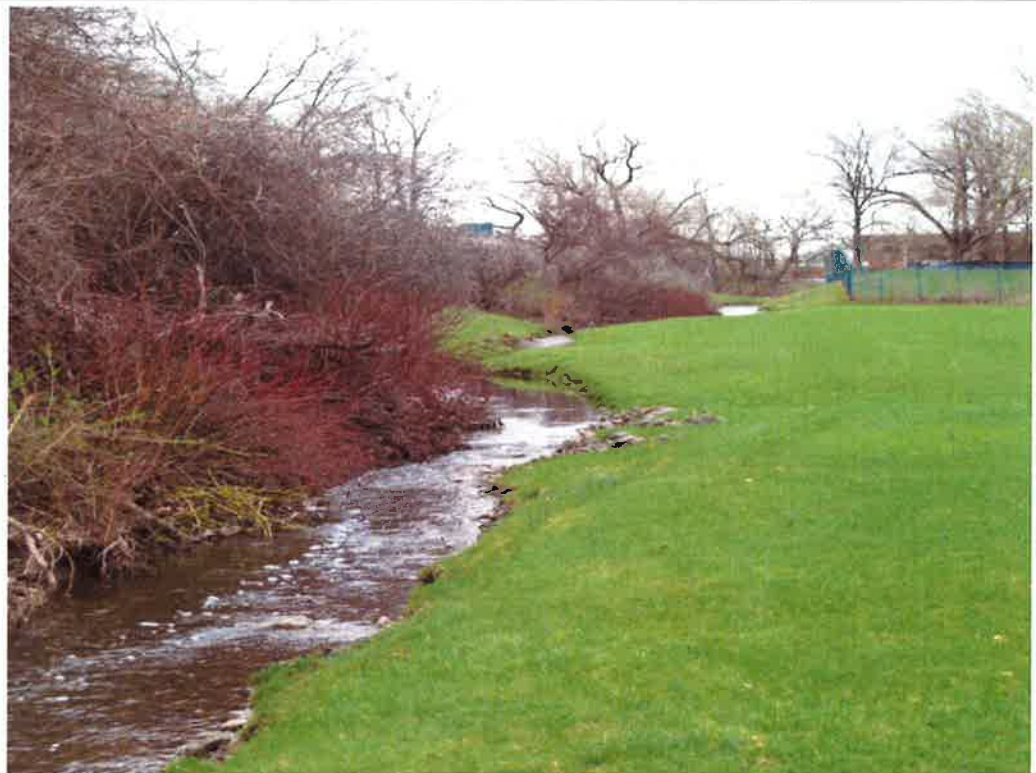
Photo No.
56

Upstream from UTC Gate culvert "normal" flow.

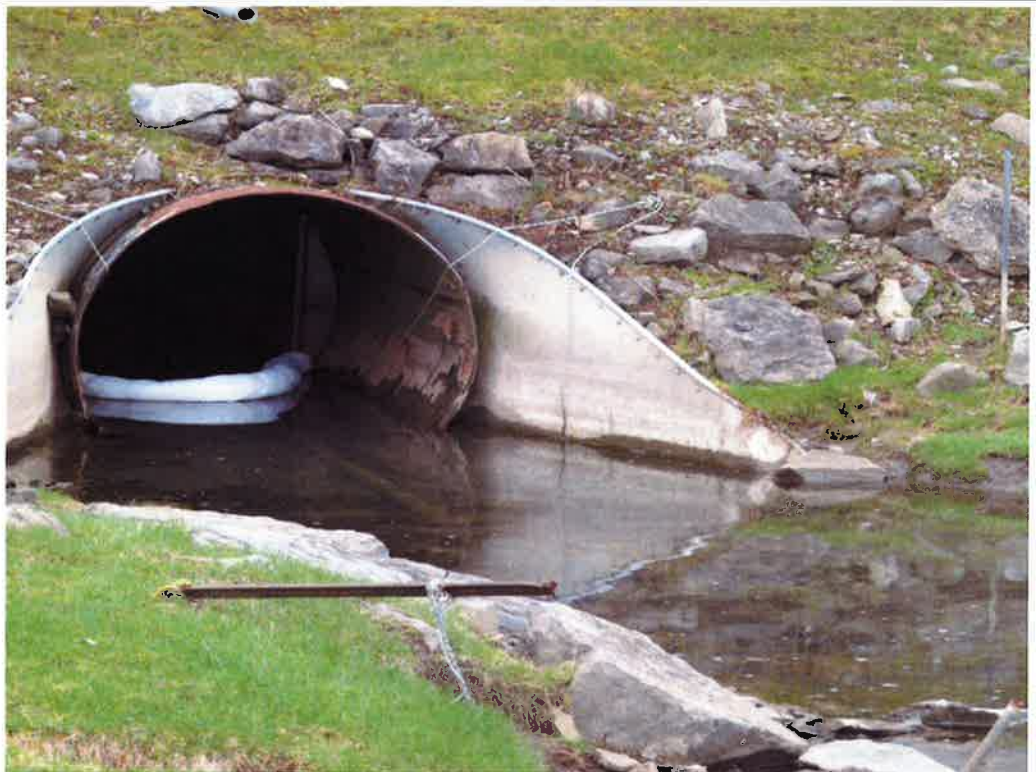
UTC Outfall 1 Shows boom in place and MHW staining on culvert walls approximately 1/2 pipe height.

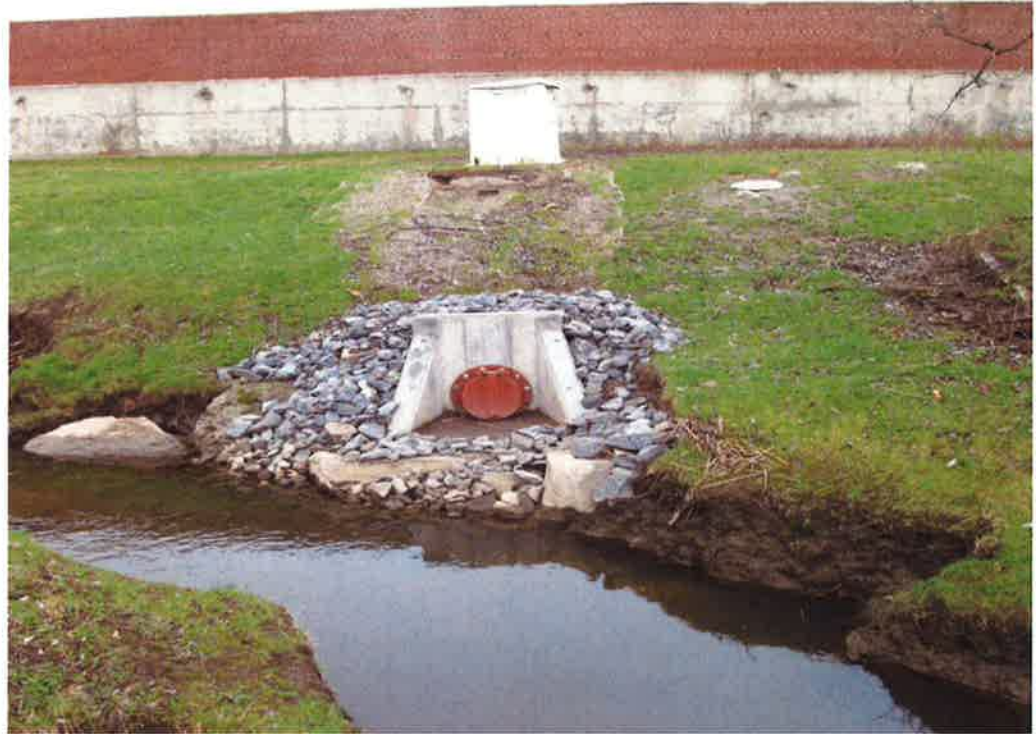
Photo No.
58

UTC Outfall. MHW approximately at bankfull in the stream. Outfall cover plate will be approximately $\frac{3}{4}$ submerged at MHW.

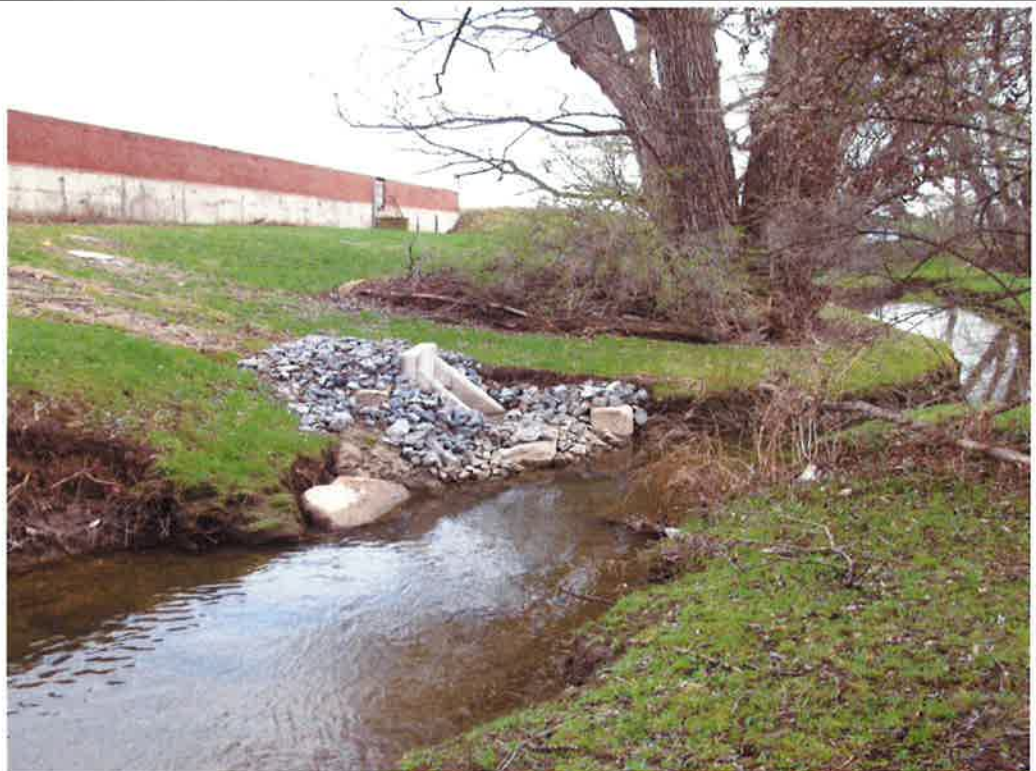
UTC Outfall from opposite direction of previous photo.

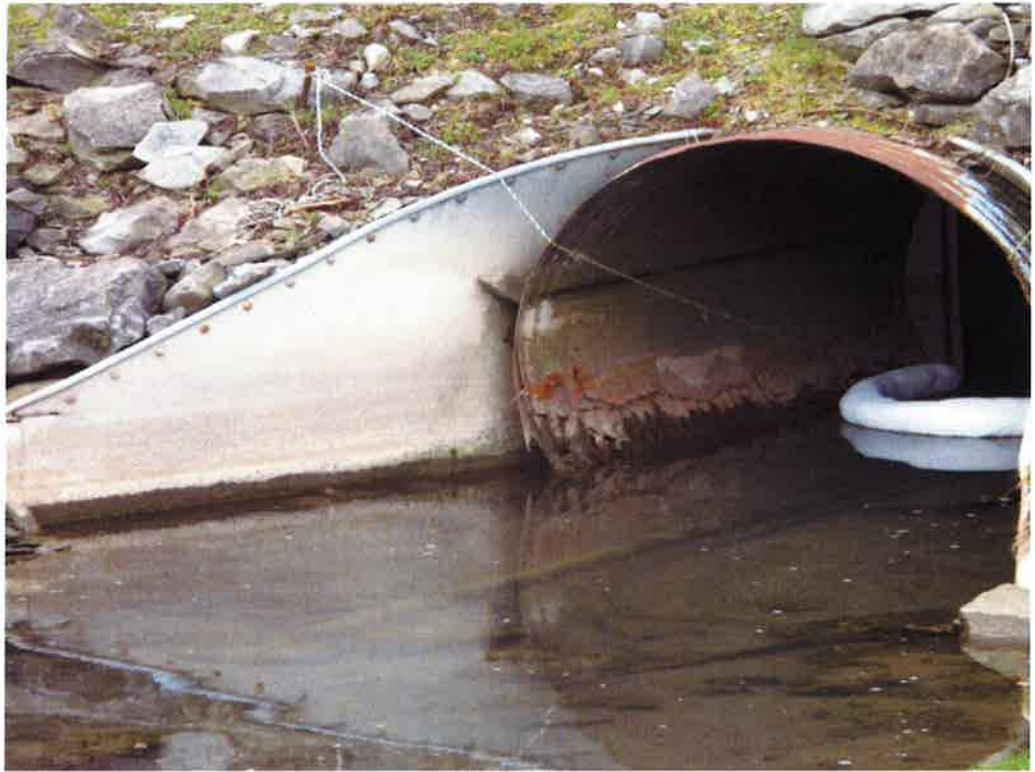
UTC Outfall MHW Stain on east wall.
