**THIRD FIVE-YEAR REVIEW REPORT  
VOLNEY MUNICIPAL LANDFILL SUPERFUND SITE  
OSWEGO COUNTY, NEW YORK**

**U.S. Environmental Protection Agency  
Region 2  
New York, New York**

**August 2015**

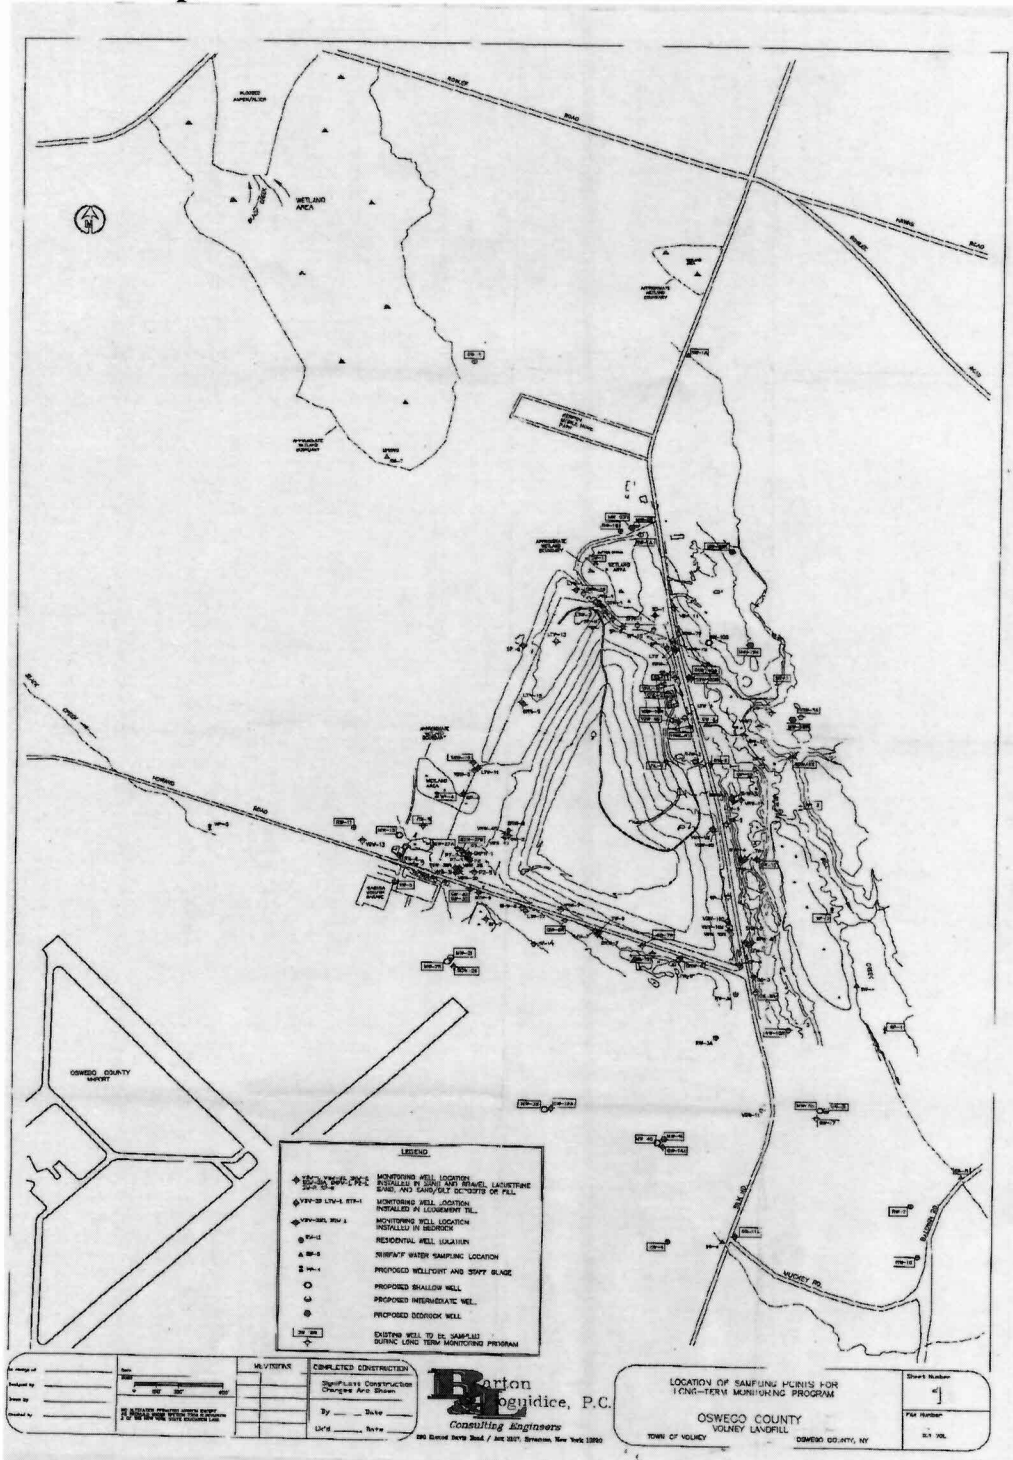
**Figure 1: Site Map**

µg/L, 5.3 µg/L, 5,400 µg/L, 19 µg/L, and 8.6 µg/L, respectively. Figure 1 depicts the monitoring well locations and Table 2b a lists the observed WQSGV exceedances. Groundwater contamination appears to be sporadic and limited to the landfill property and the immediate surrounding area.
