**Remedial Investigation Report  
JCI/Jones Chemicals, Inc. Facility  
Caledonia, New York  
Administrative Order on Consent,  
Index No. II CERCLA-10210**

**June 8, 1999  
3165.01-003**

Prepared for  
JCI/Jones Chemicals, Inc.  
100 Sunny Sol Boulevard  
Caledonia, New York 14423

Prepared by  
LFR Levine-Fricke  
3382 Capital Circle, N.E.  
Tallahassee, Florida 32308-1568

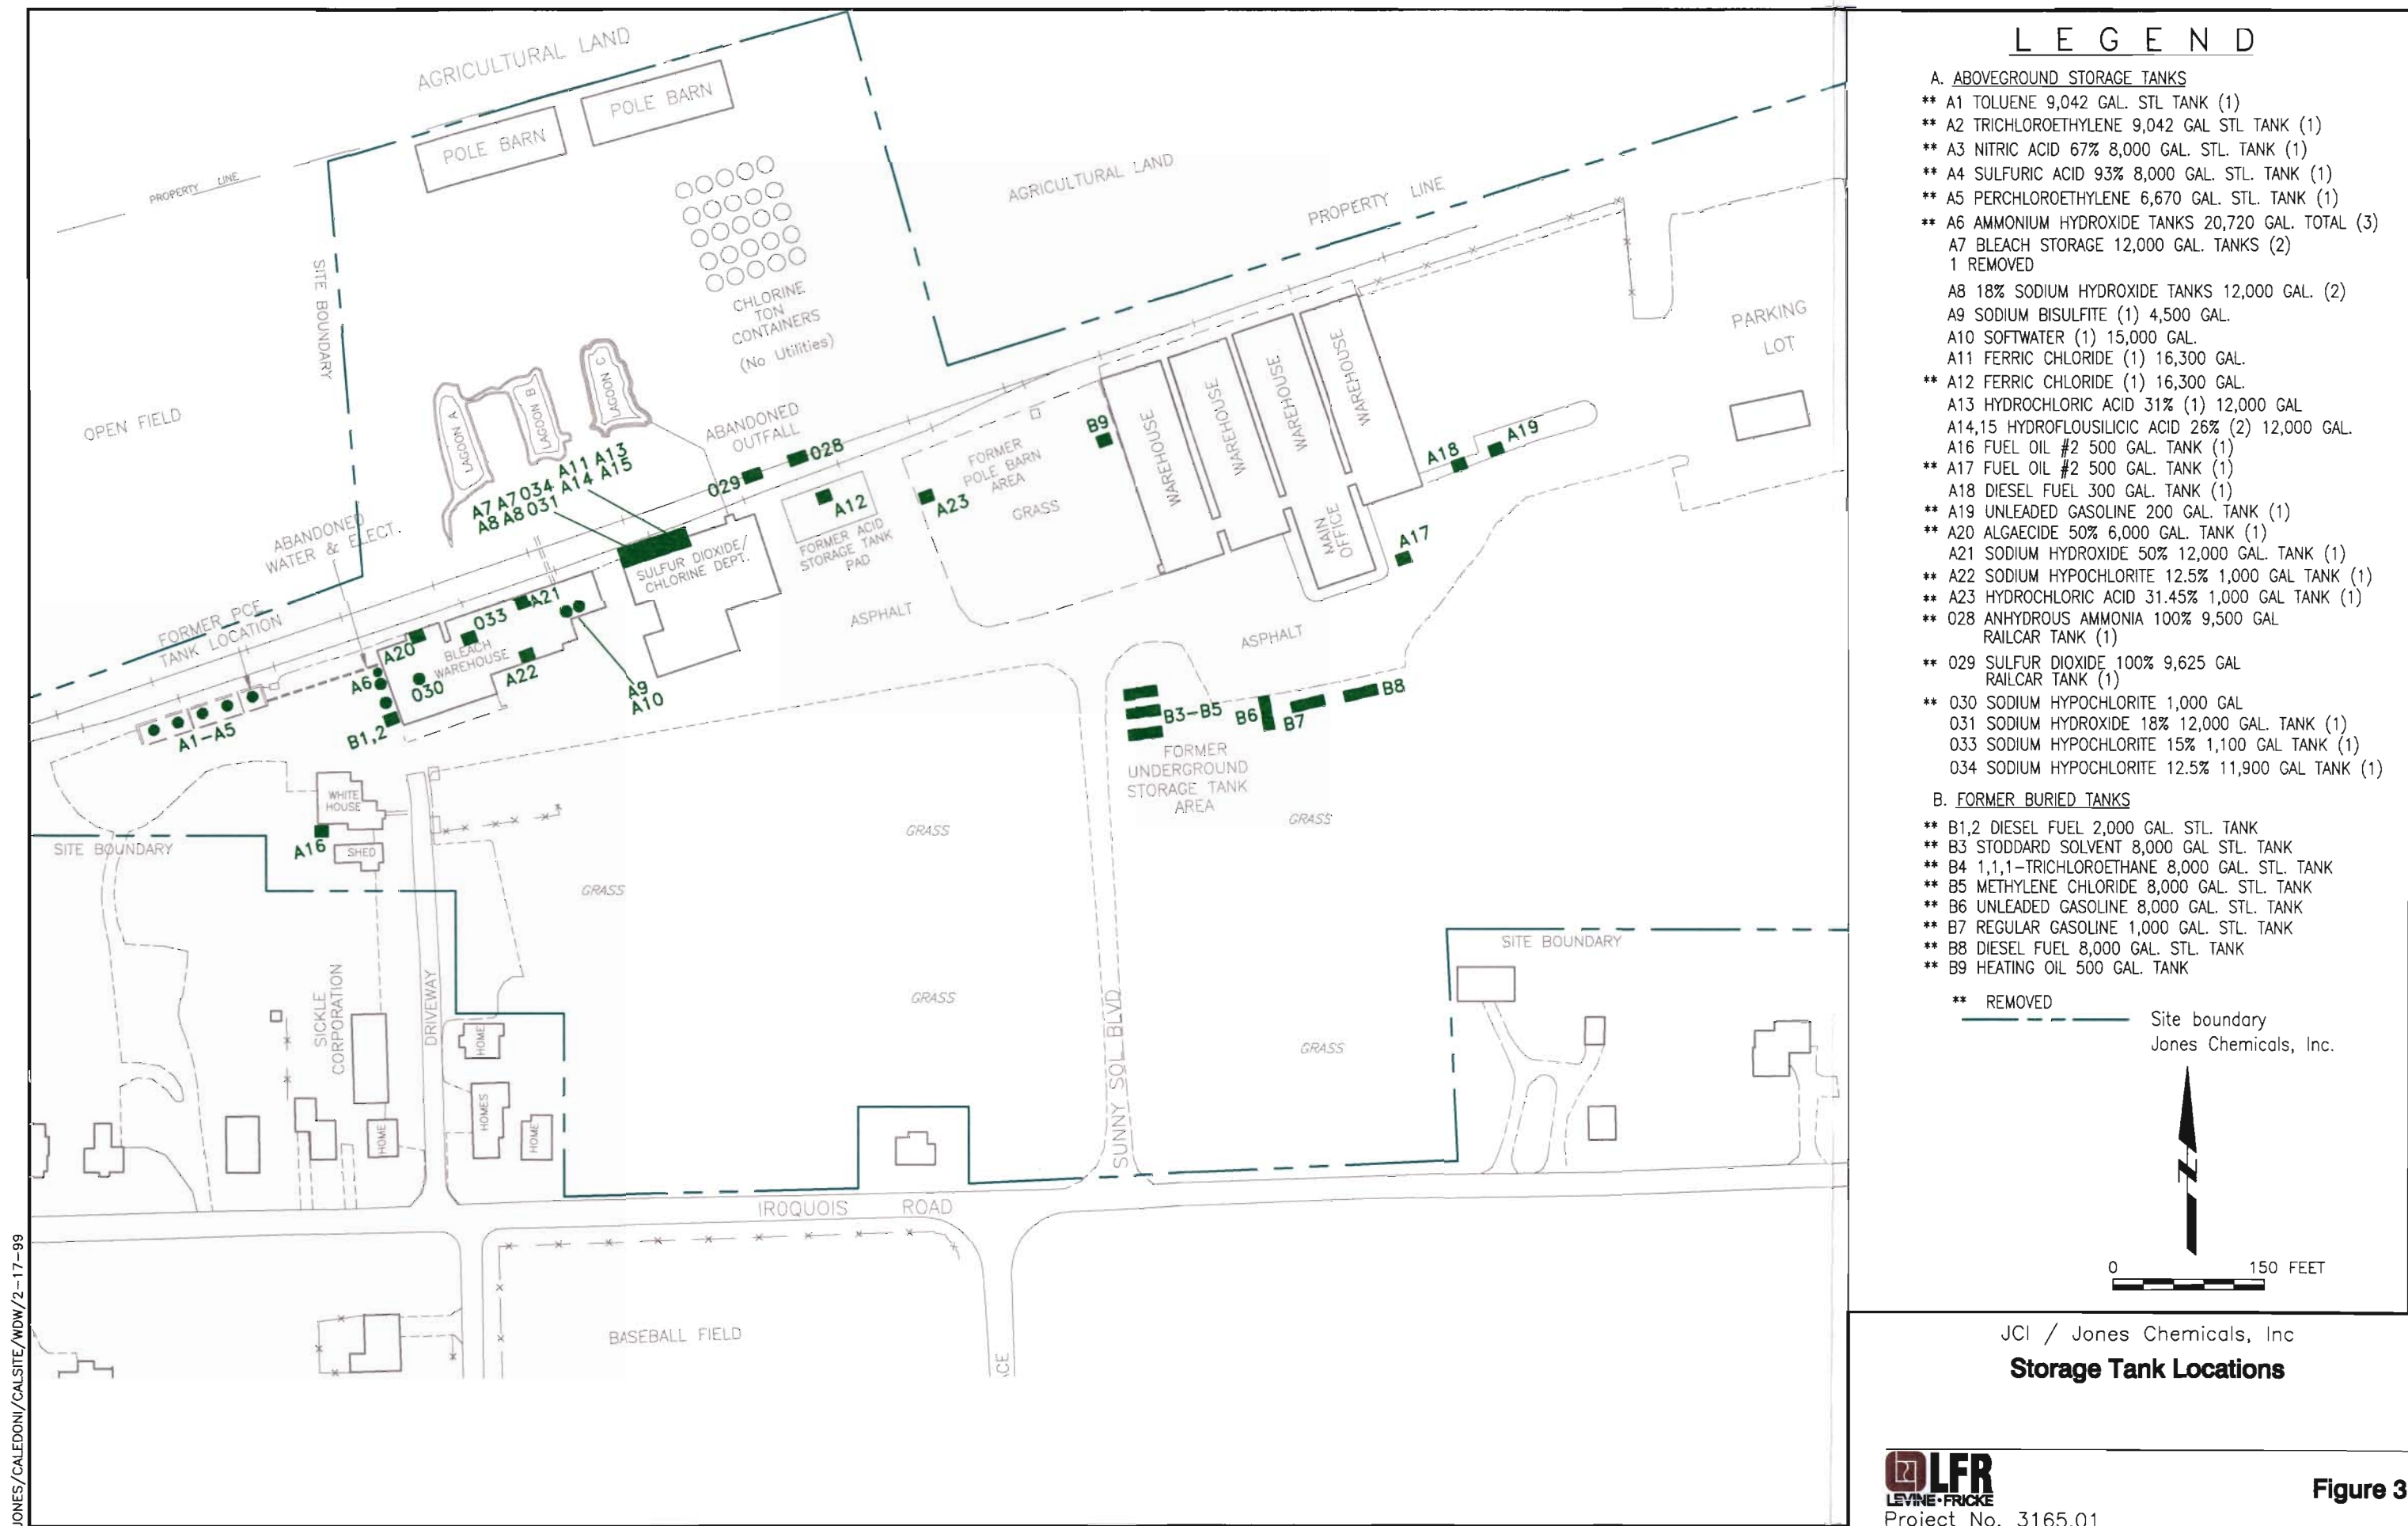
Figure 2

The Site has nine buildings that comprise office space, drum storage sheds, interconnected warehouse buildings, a bleach manufacturing building, and chlorine and sulfur dioxide repackaging building (Figure 2). A railway line known as the Main Service Railway enters from west, extends to within the eastern boundary, and runs to the north of the buildings.

The Soil and Water Conservation District map for Livingston County shows that the Site lies in a zone characterized by Palmyra type soils (USDA 1956). Palmyra soils are stony (up to 25 percent fragments greater than three inches) and are rated highly permeable, prone to seepage, and very poor for maintenance of swampy or surface water bodies. The natural surface-water features on the Site and its vicinity have been altered through the construction of asphalt pavement, grass areas, and the lagoon system. Surface water on Site infiltrates directly into the underlying soils; off-site migration of surface water was found to be none or minimal. The nearly flat topography and highly permeable soil are compatible with observations of the absence of surface water runoff from the Site. In the vicinity of the lagoon system on the north property, surface water drains directly into the lagoons. Storm-water drains are present in paved areas (Figure 2) to channel surface water to the underlying soil.

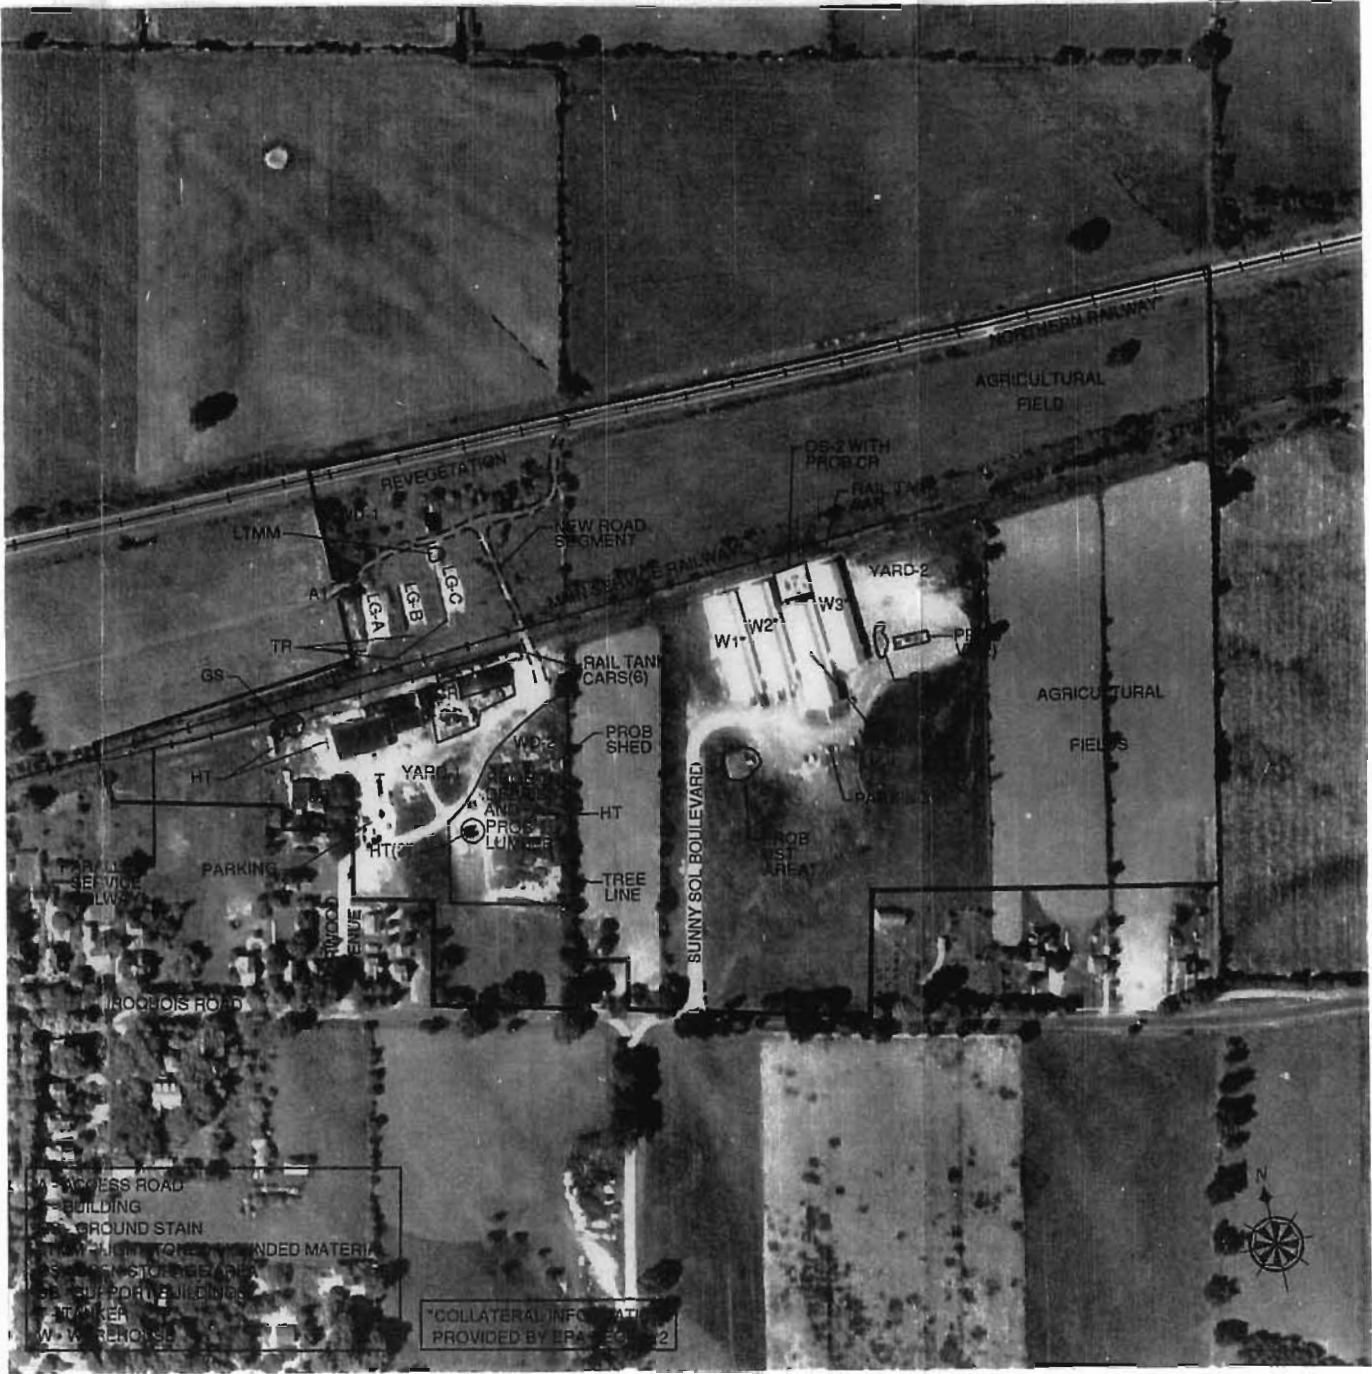
Fig. A-2 Jones Chemical, Inc., site, August 27, 1954. Approximate scale 1:3,570.

In the southwestern portion of the site, facility development is evident by the addition of an asphalt yard (Yard-1) containing an industrial building (B3), an open storage area (OS-1), a waste disposal area (WD-2), support buildings (SB), and vehicles (not annotated). Yard-1 extends from the main service railway to the southern boundary of waste disposal area WD-2. The easternmost end of the Main Service Railway now ends within the eastern boundary of the site. A new rail spur extending from the Main Service Railway and lying adjacent to the northern side of buildings B2 and B3 is identified as a Parallel Service Railway\*. Six rail tank cars adjacent to the northern side of buildings B2 and B3 are probably associated with rail transshipment operations. West of building B3 there are two horizontal tanks and ground stains (GS). Adjacent to building B2, open storage area OS-1 contains crates and boxes (CR). Waste disposal area WD-2 is located in the southeast quadrant of Yard-1, and contains probable debris and stacked accumulations of probable lumber, three horizontal tanks, and a probable roofless shed.

In the eastern portion of the site, the facility is comprised of three warehouses\* (W1, W2, and W3), open storage area OS-2 that contains probable crates and boxes, a dirt yard (Yard-2) that contains two probable vertical tanks (VT) and ground stains, a partially vegetated area probably pertaining to an underground storage tank\* (UST), and a Main Office\*. A rail tank car is adjacent to the northern side of the warehouses.
