**DELPHI CORPORATION
REMEDIAL INVESTIGATION - LEXINGTON AVENUE FACILITY
ROCHESTER, NEW YORK**

SITE PLAN

OCTOBER 2005

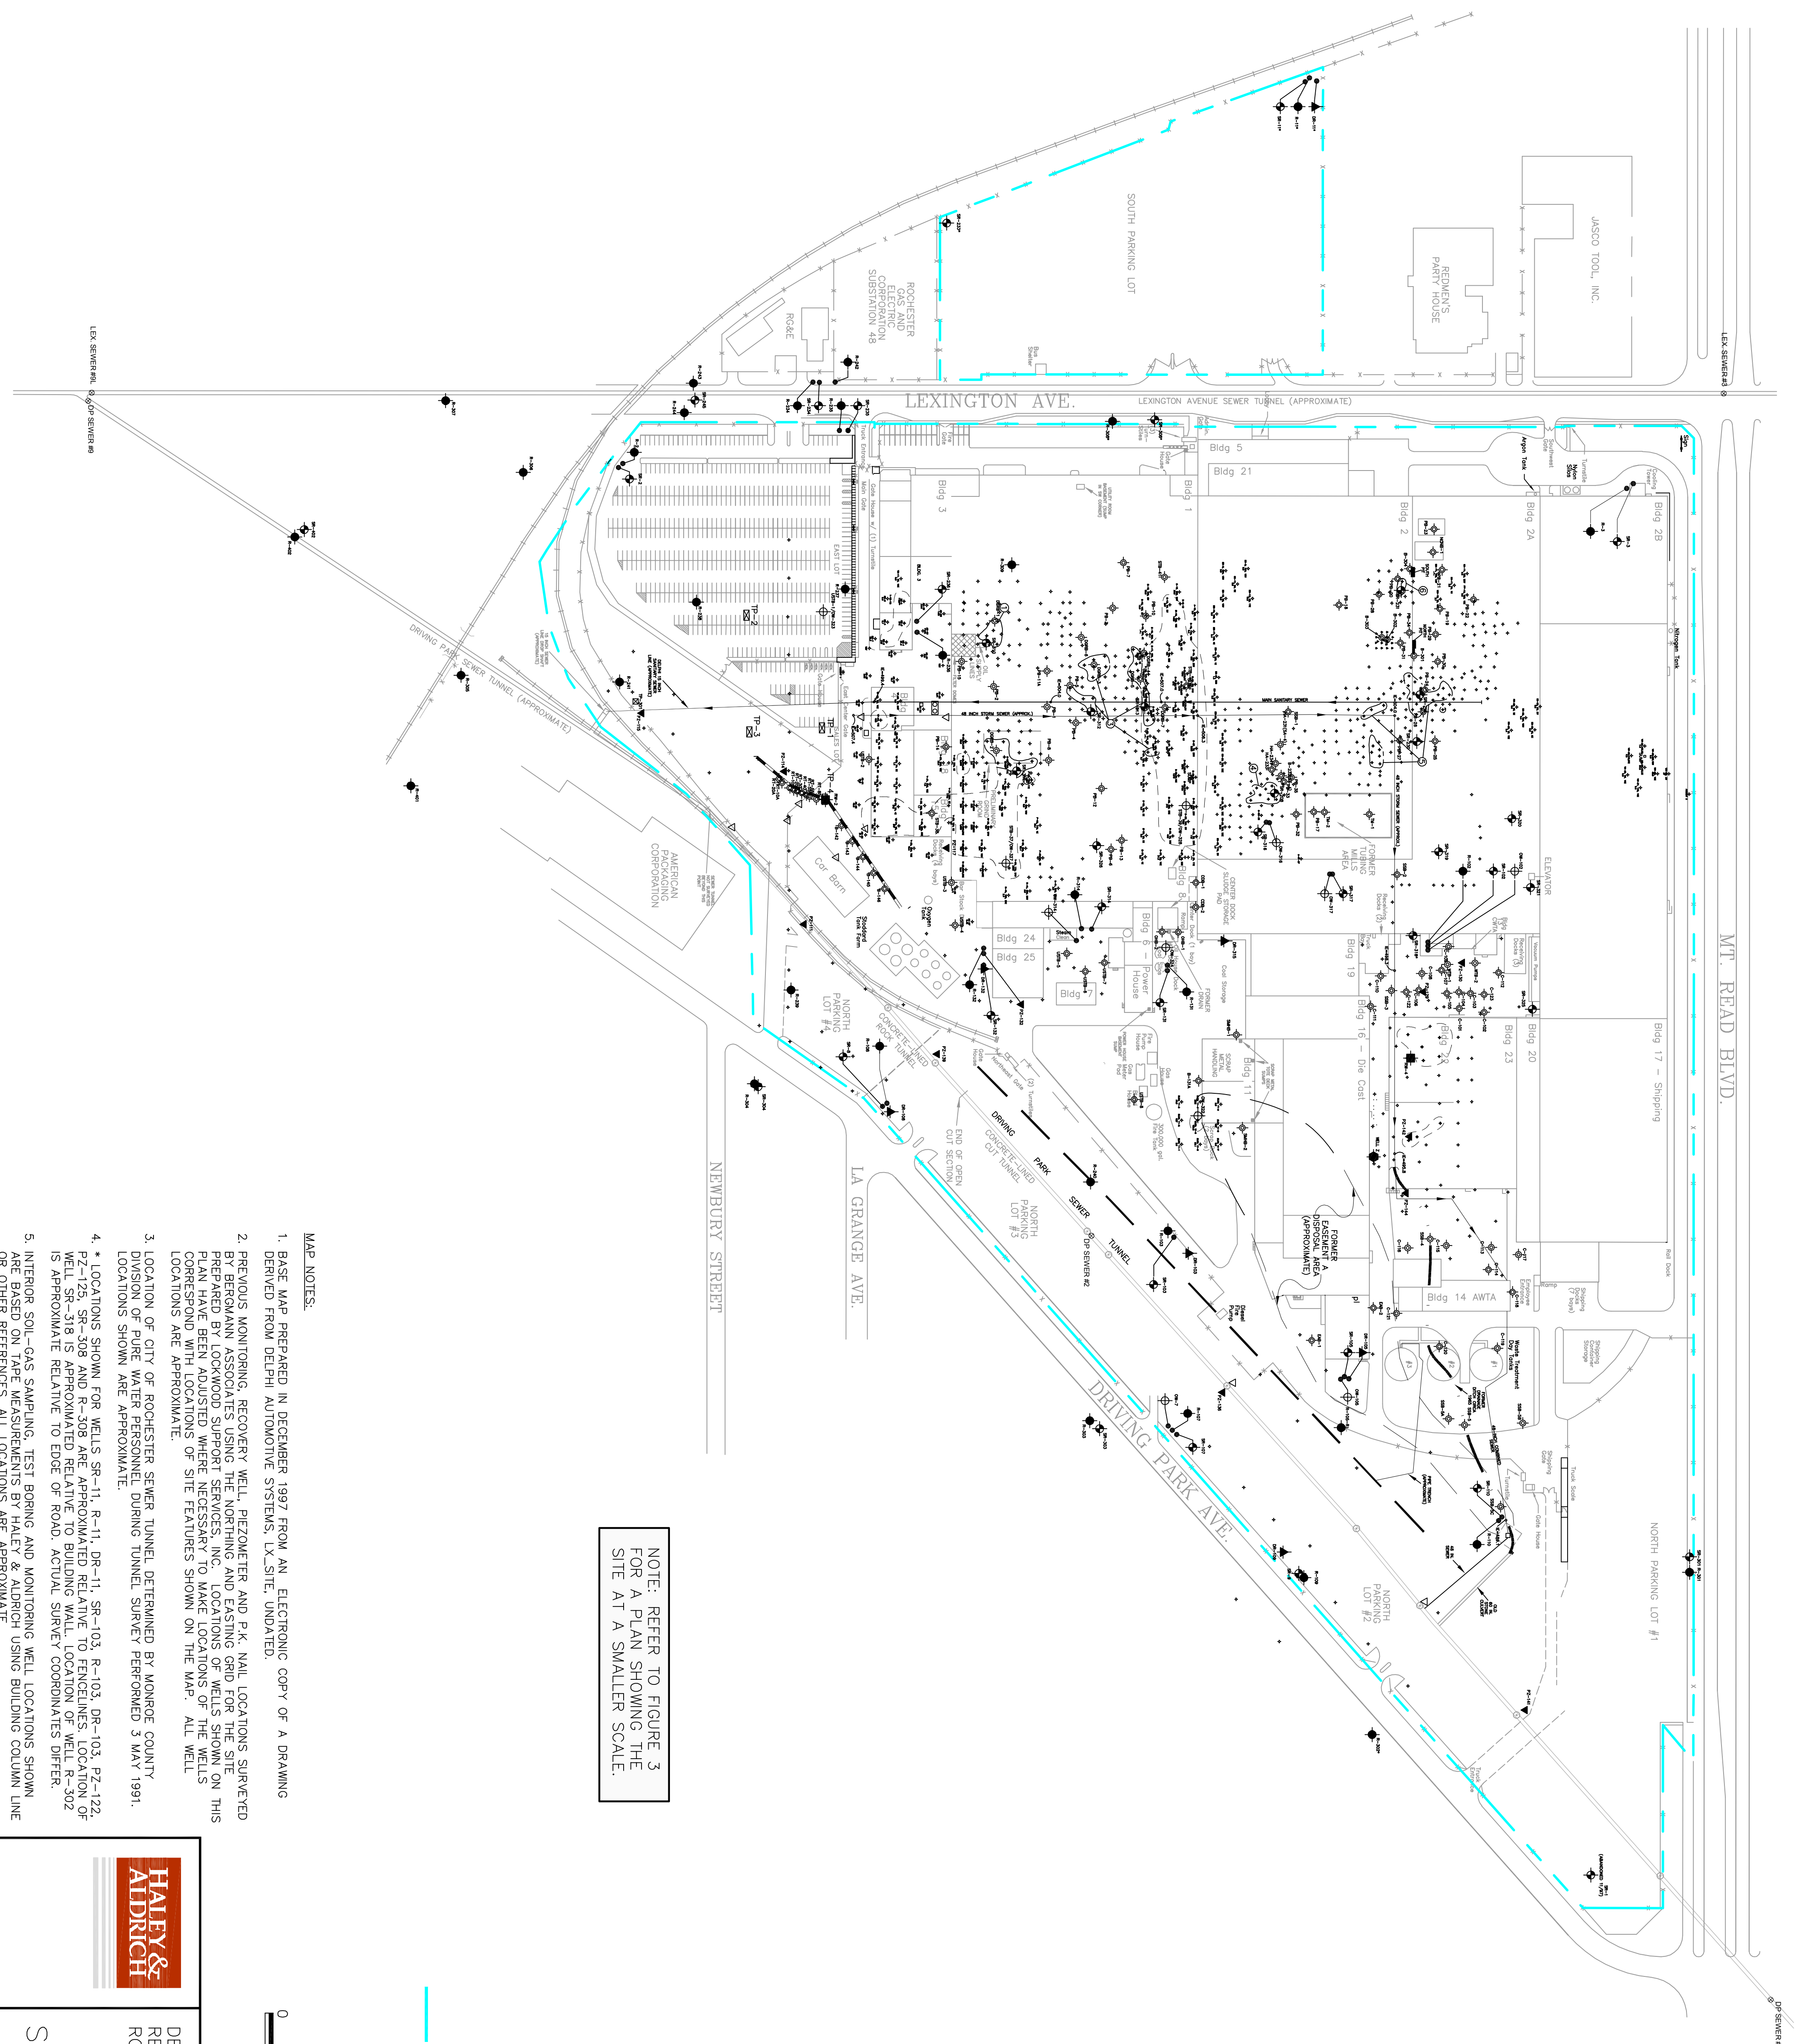
FIGURE 2

5. INTERIOR SOIL-GAS SAMPLING, TEST BORING AND MONITORING WELL LOCATIONS SHOWN ARE BASED ON TAPE MEASUREMENTS BY HALEY & ALDRICH USING BUILDING COLUMN LINE OR OTHER REFERENCES. ALL LOCATIONS ARE APPROXIMATE.
