# RECORD OF DECISION

Former Rochester Metal Etching Company  
State Superfund Project  
Rochester, Monroe County  
Site No. 828100  
March 2011

Prepared by  
Division of Environmental Remediation  
New York State Department of Environmental Conservation

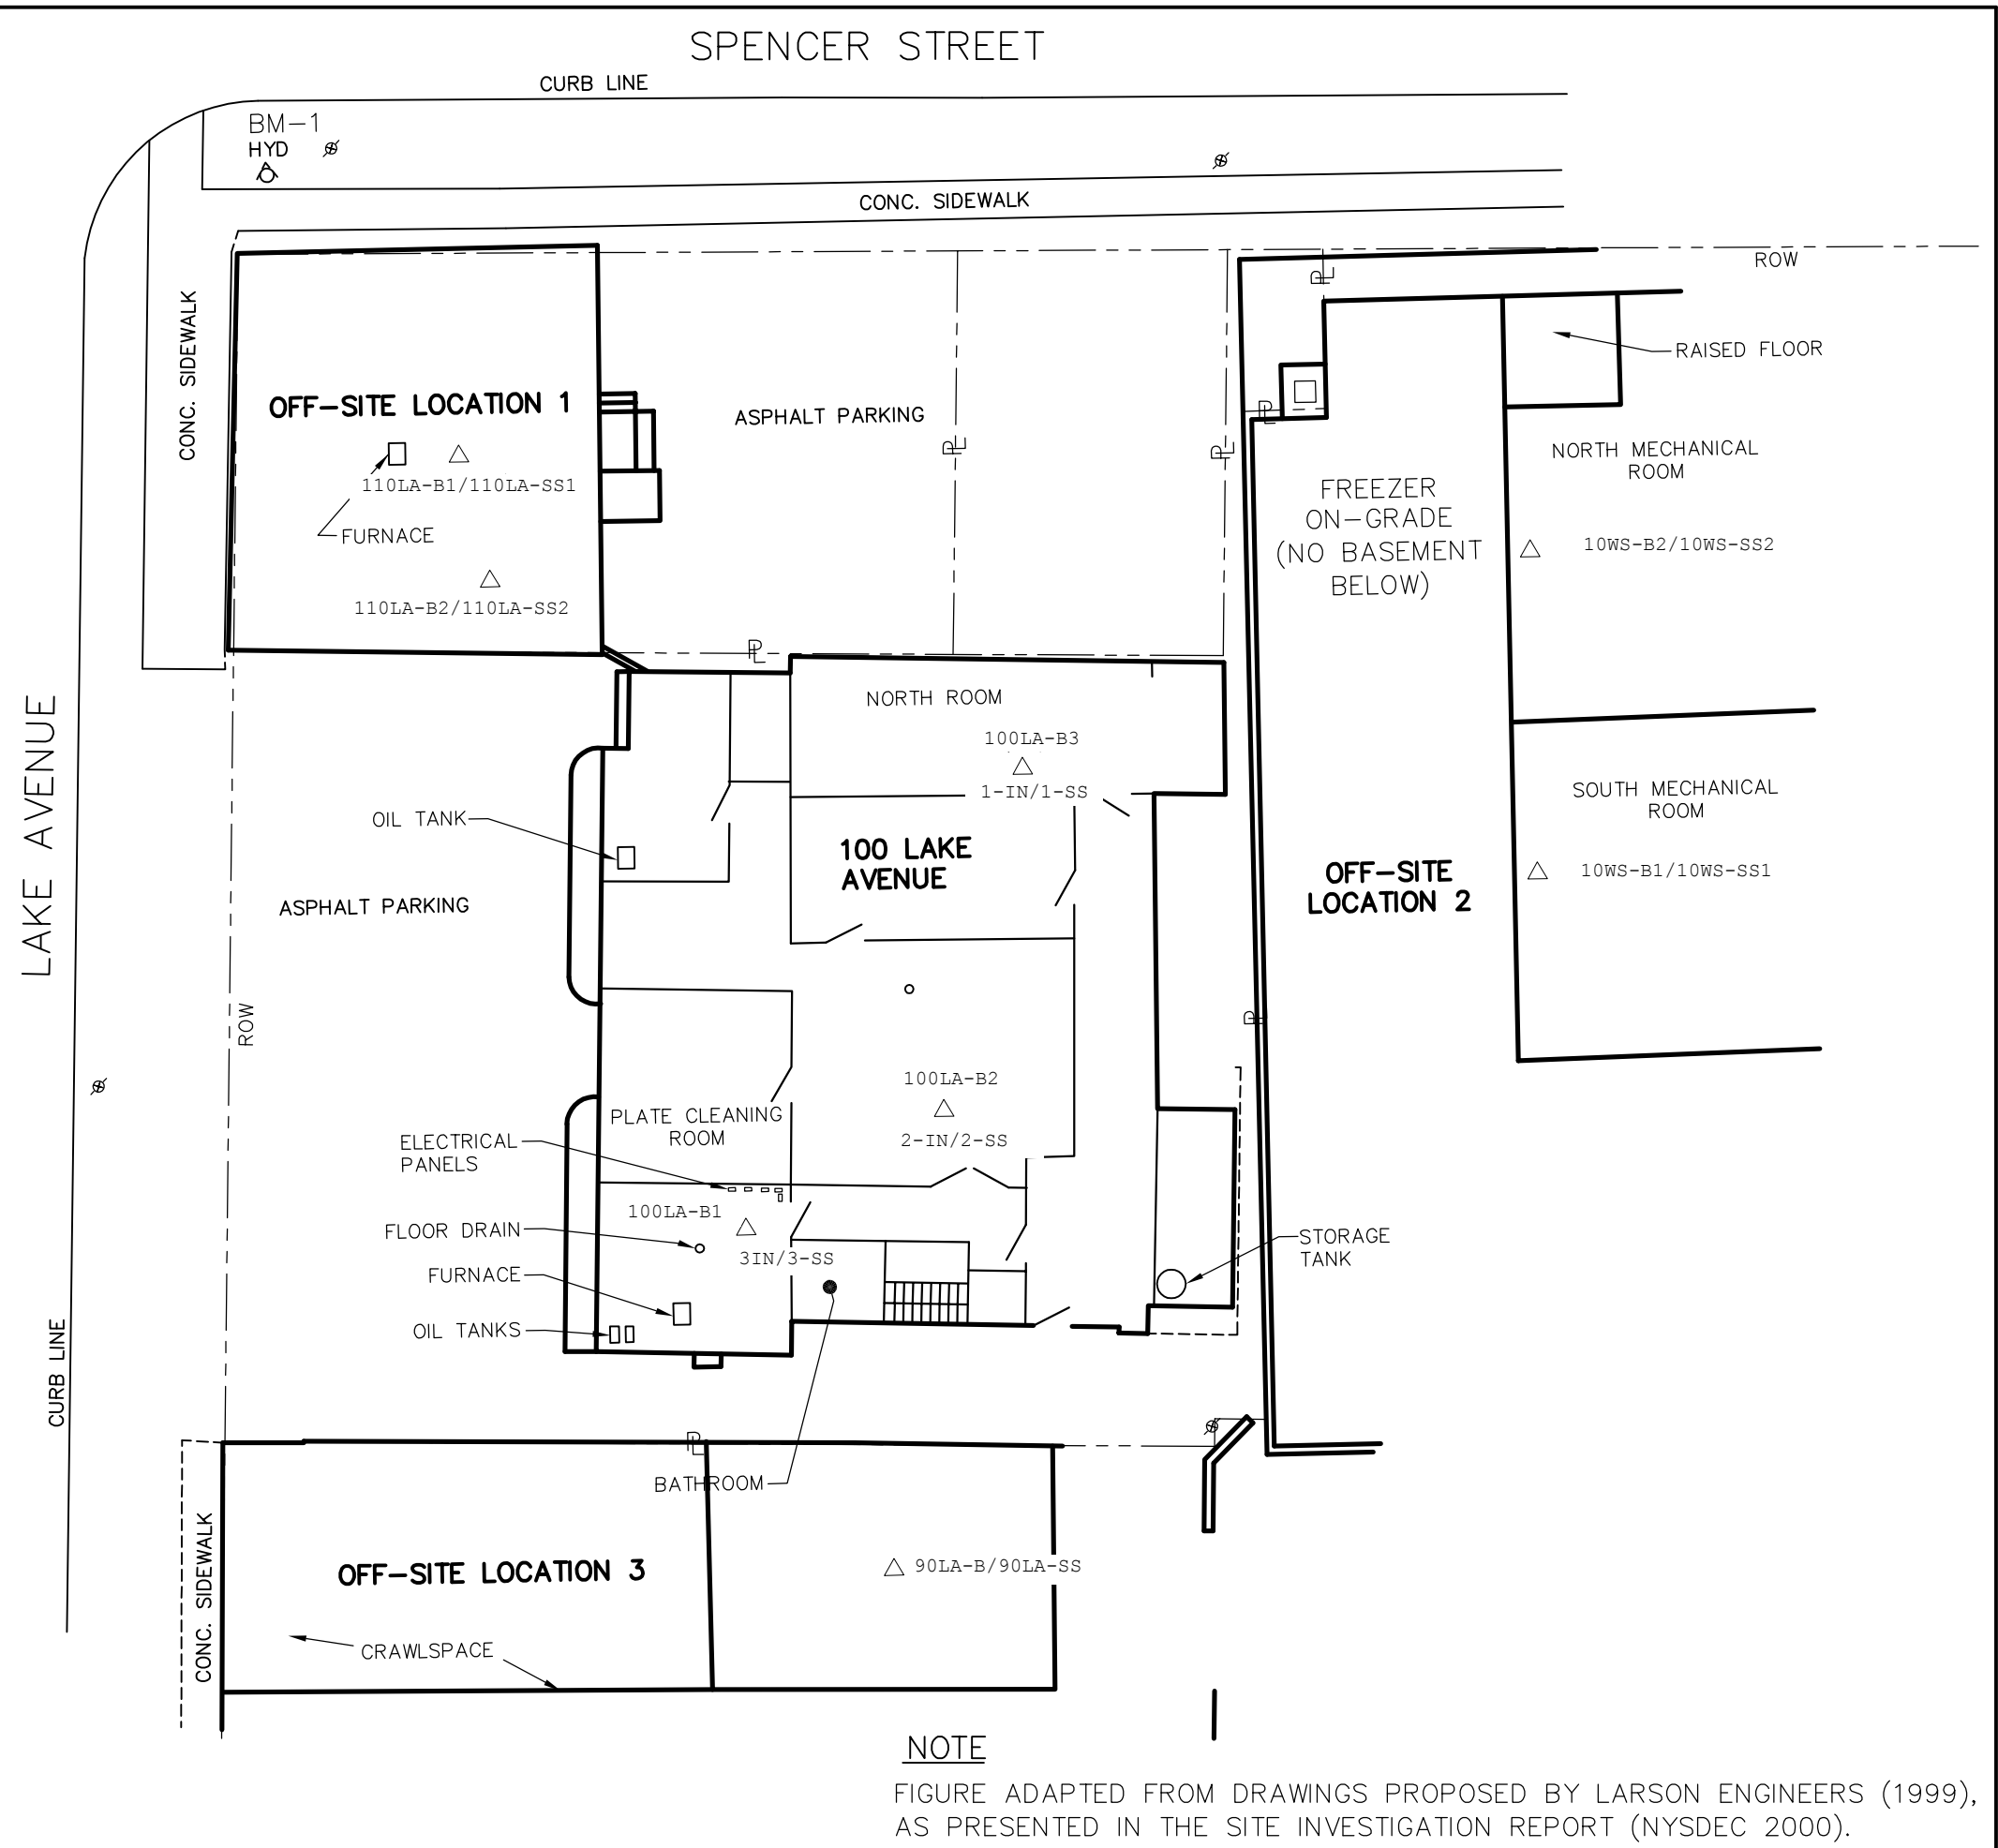
# FIGURE 6

△ PAIRED INDOOR AND SUB-SLAB SAMPLE LOCATION
