RECORD OF DECISION

Rolling Plains Development
State Superfund Project
Honeoye Falls, Monroe County
Site No. 828138
June 2020

Prepared by
Division of Environmental Remediation
New York State Department of Environmental Conservation

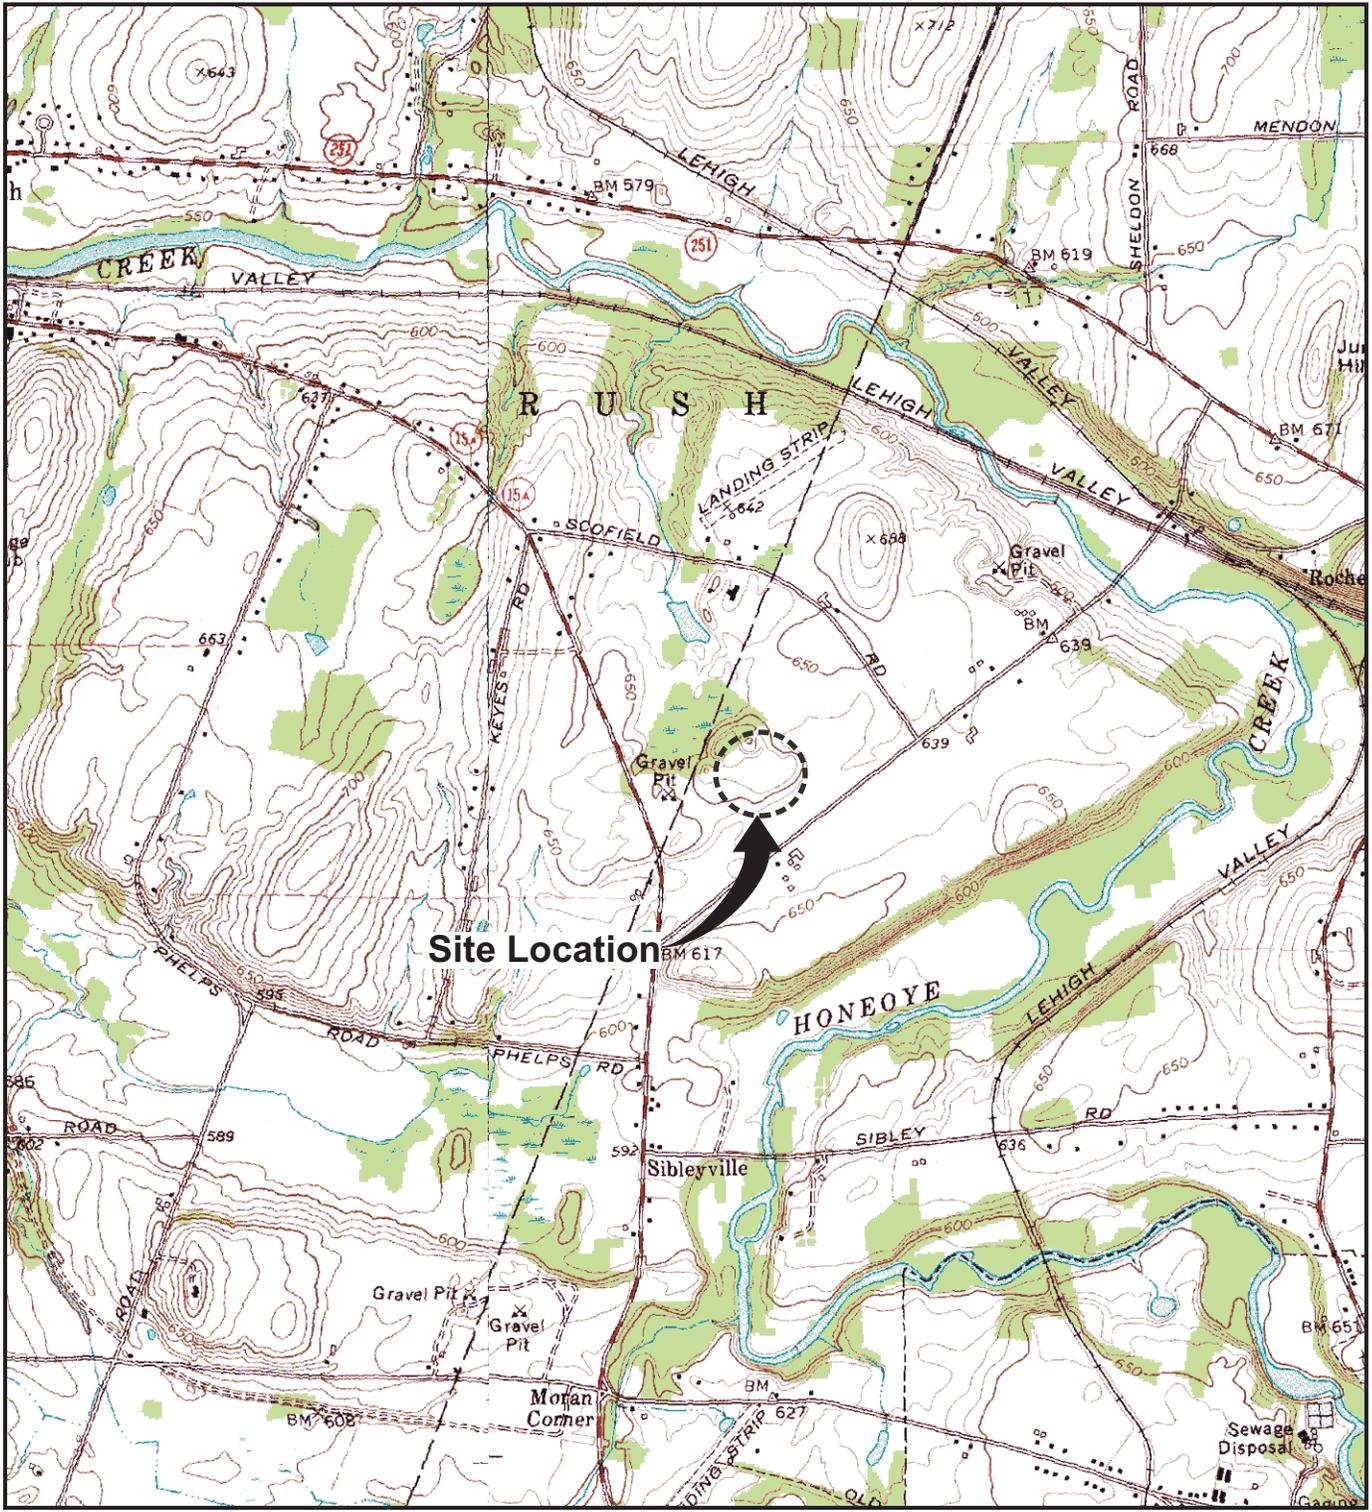
FIGURE
1

SITE LOCATION MAP

A site location map is attached as Figure 1.

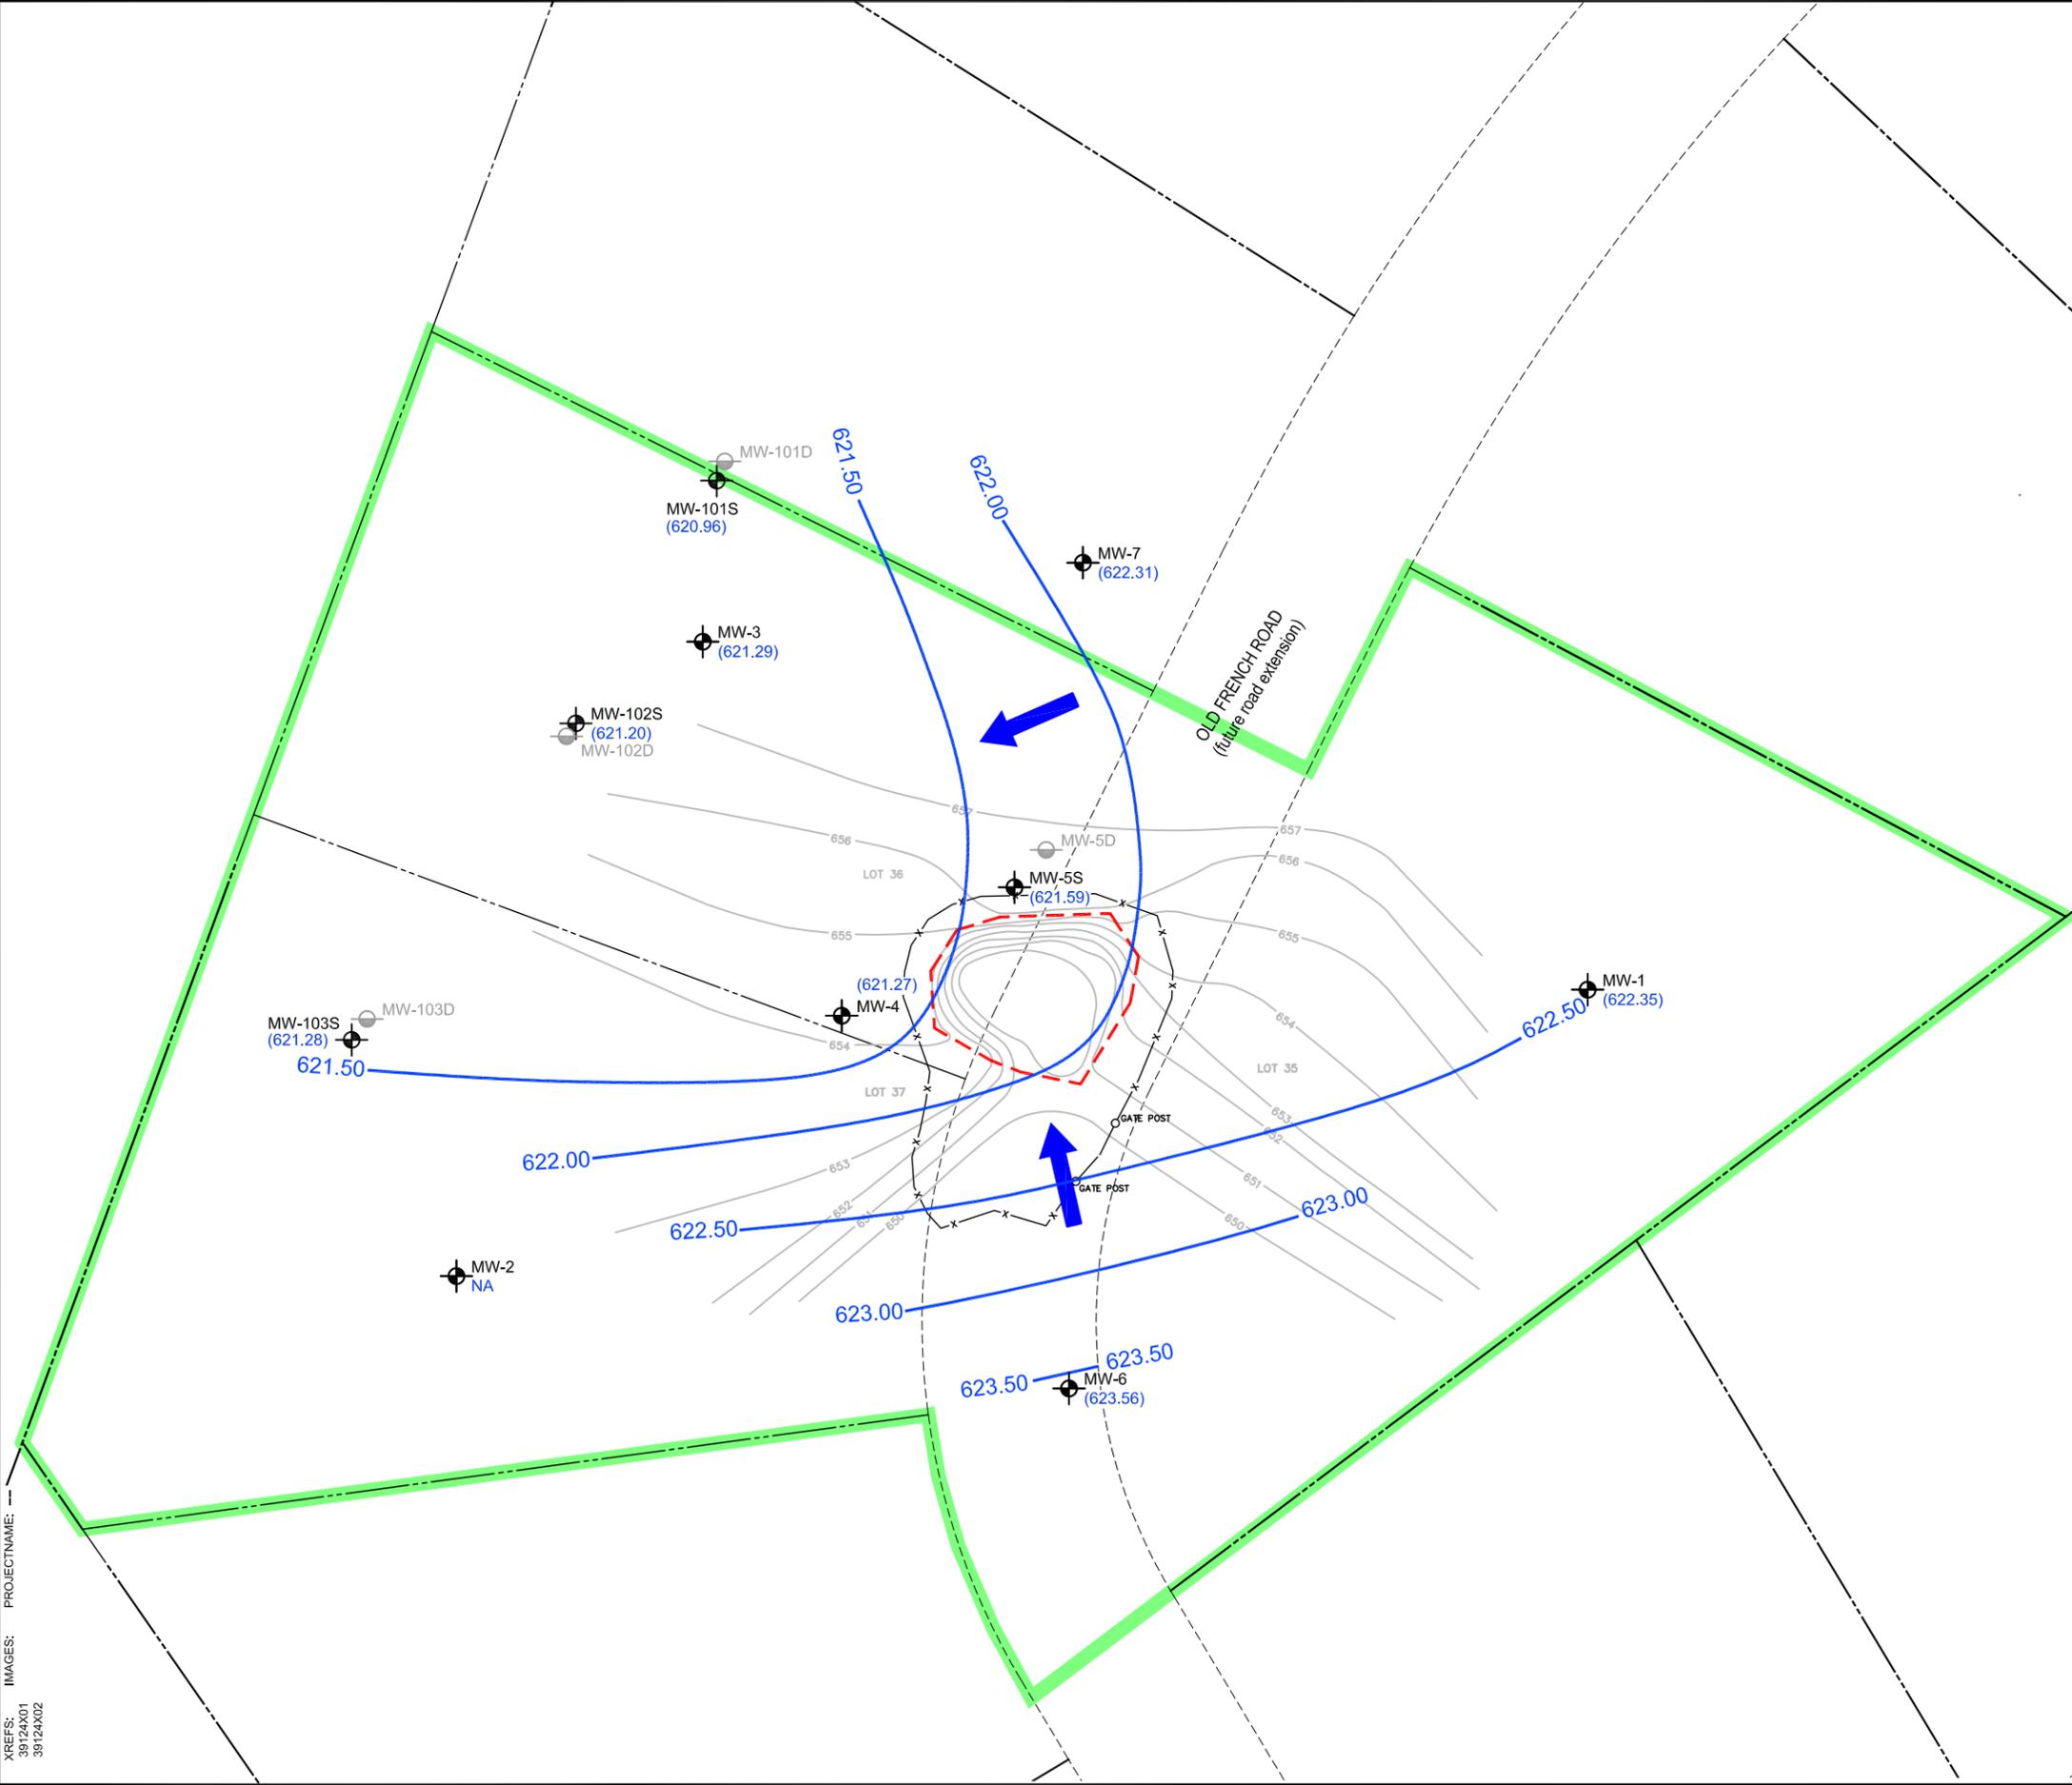
HANSON AGGREGATES NEW YORK, INC. ROLLING PLAINS DEVELOPMENT SUPERFUND SITE MENDON, NEW YORK REMEDIAL INVESTIGATION REPORT	
DEEP GROUNDWATER ELEVATIONS MAY 2013	
	FIGURE 4

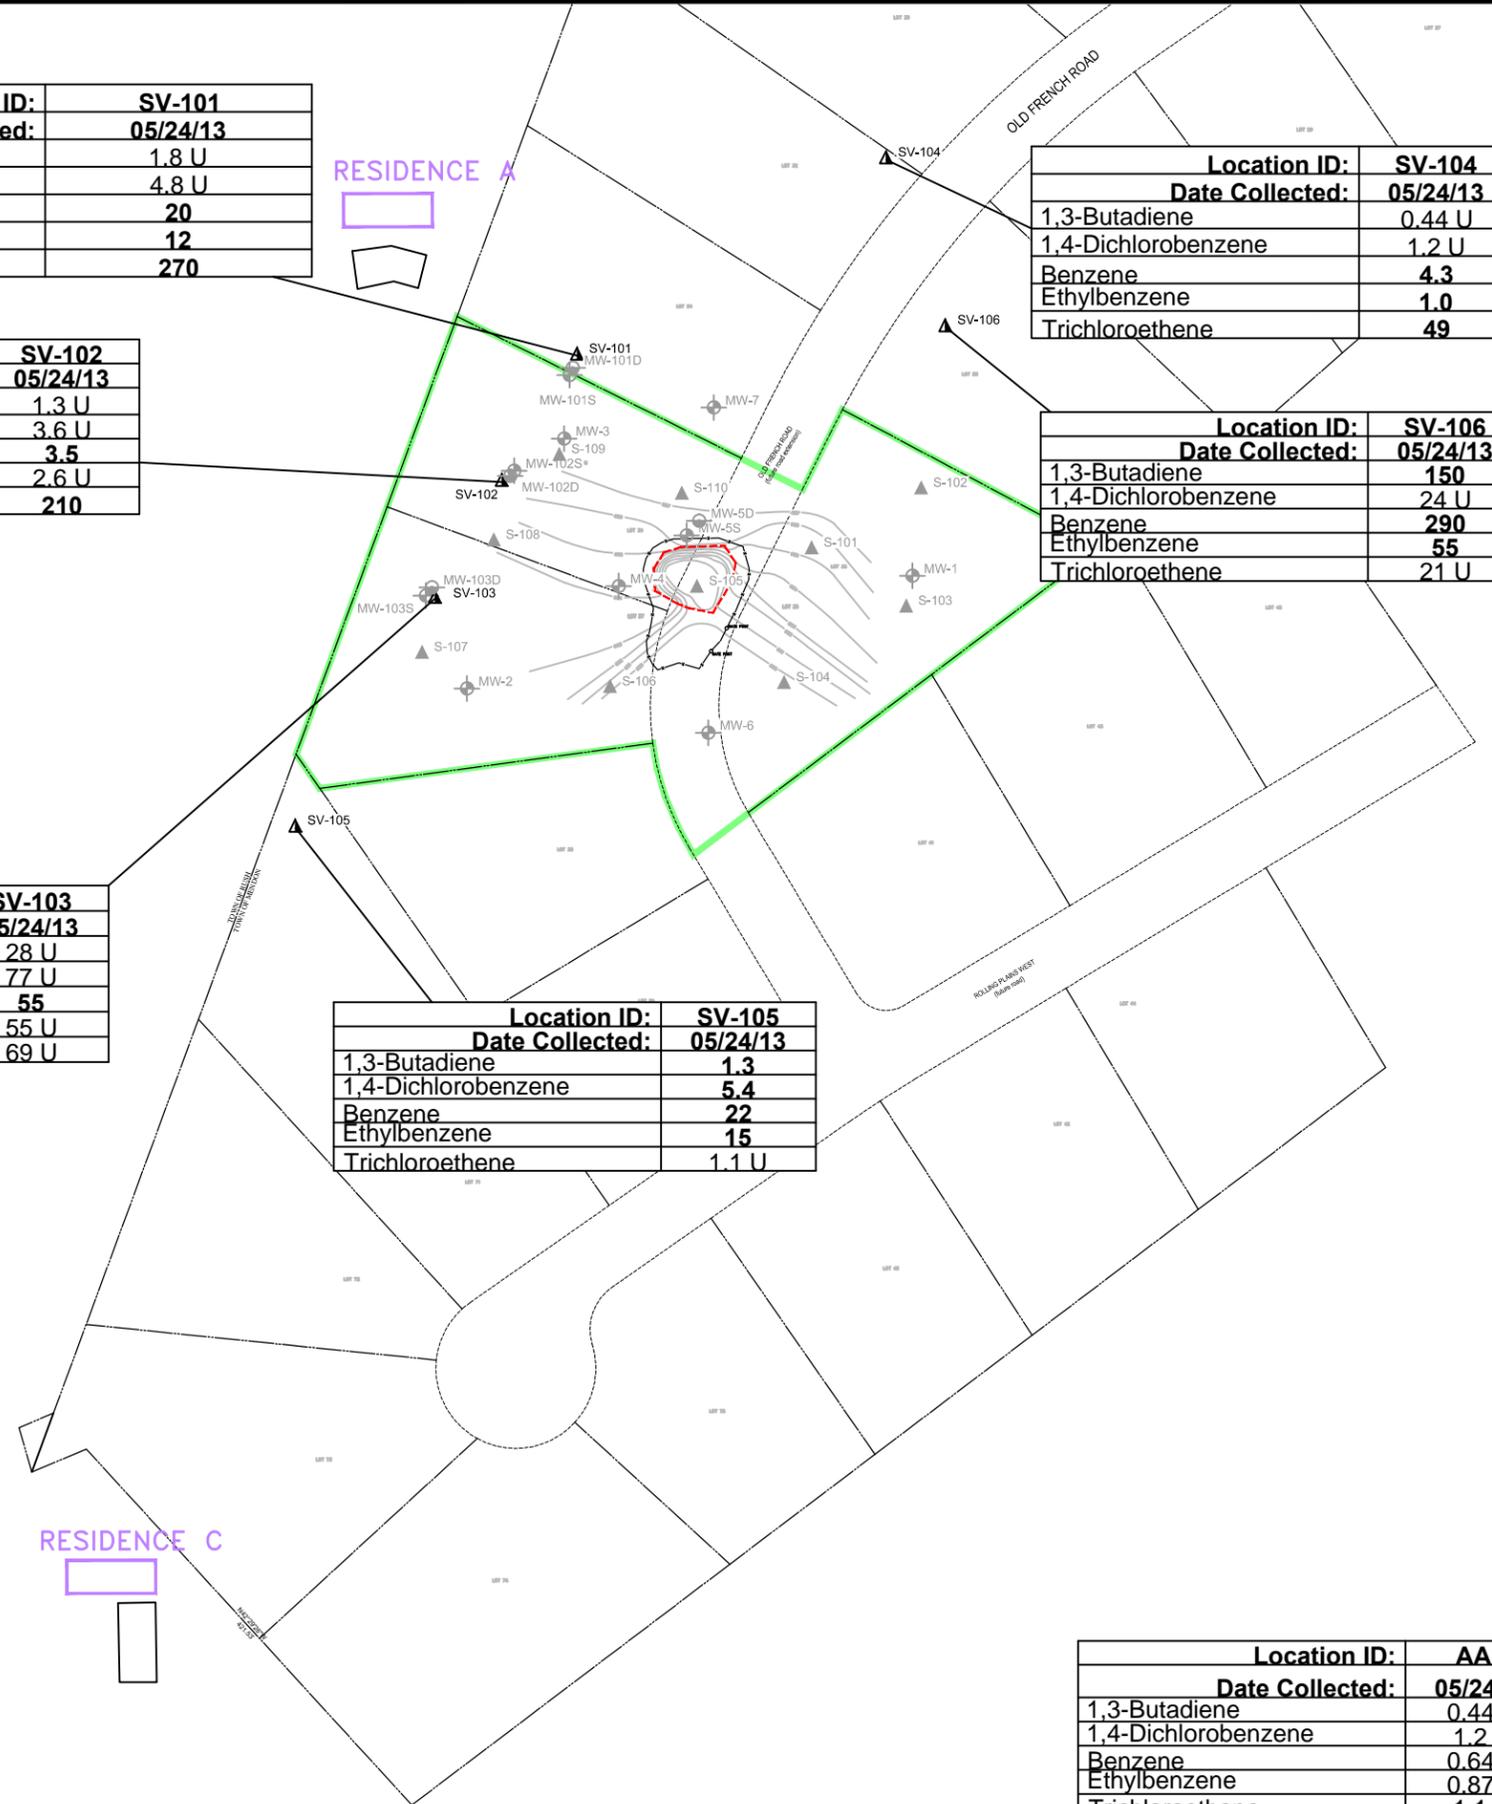
Location ID:	SV-106
Date Collected:	05/24/13
1,3-Butadiene	150
1,4-Dichlorobenzene	24 U
Benzene	290
Ethylbenzene	55
Trichloroethene	21 U

Location ID:	AA-1
Date Collected:	05/24/13
1,3-Butadiene	0.44 U
1,4-Dichlorobenzene	1.2 U
Benzene	0.64 U
Ethylbenzene	0.87 U
Trichloroethene	1.1 U

To determine whether actions were needed to address exposure related to soil vapor six temporary soil vapor sampling points were installed in 2013. Each soil vapor point was installed at a depth approximately one to two feet above the groundwater table. Concentrations of benzene in the soil vapor samples ranged from 3.5 µg/m³ to 290 µg/m³. Concentrations of TCE ranged from non-detectable at 3 locations up to 270 µg/m³ at SV-101. Ethylbenzene concentrations ranged from non-detectable at 2 locations up to 55 µg/m³ at SV-106.
