PROJECT:	1000 Turk Hill Road (Site No. 828161)
ADDRESS:	1000 Turk Hill Road, Fairport, Monroe County, New York
PREPARED BY:	Roux Environmental Engineering and Geology, D.P.C.
DATE:	July 11, 2025
WEATHER:	Temp: 87° Fair, Wind: SW @ 4 mph

Remedial Action Work Summary

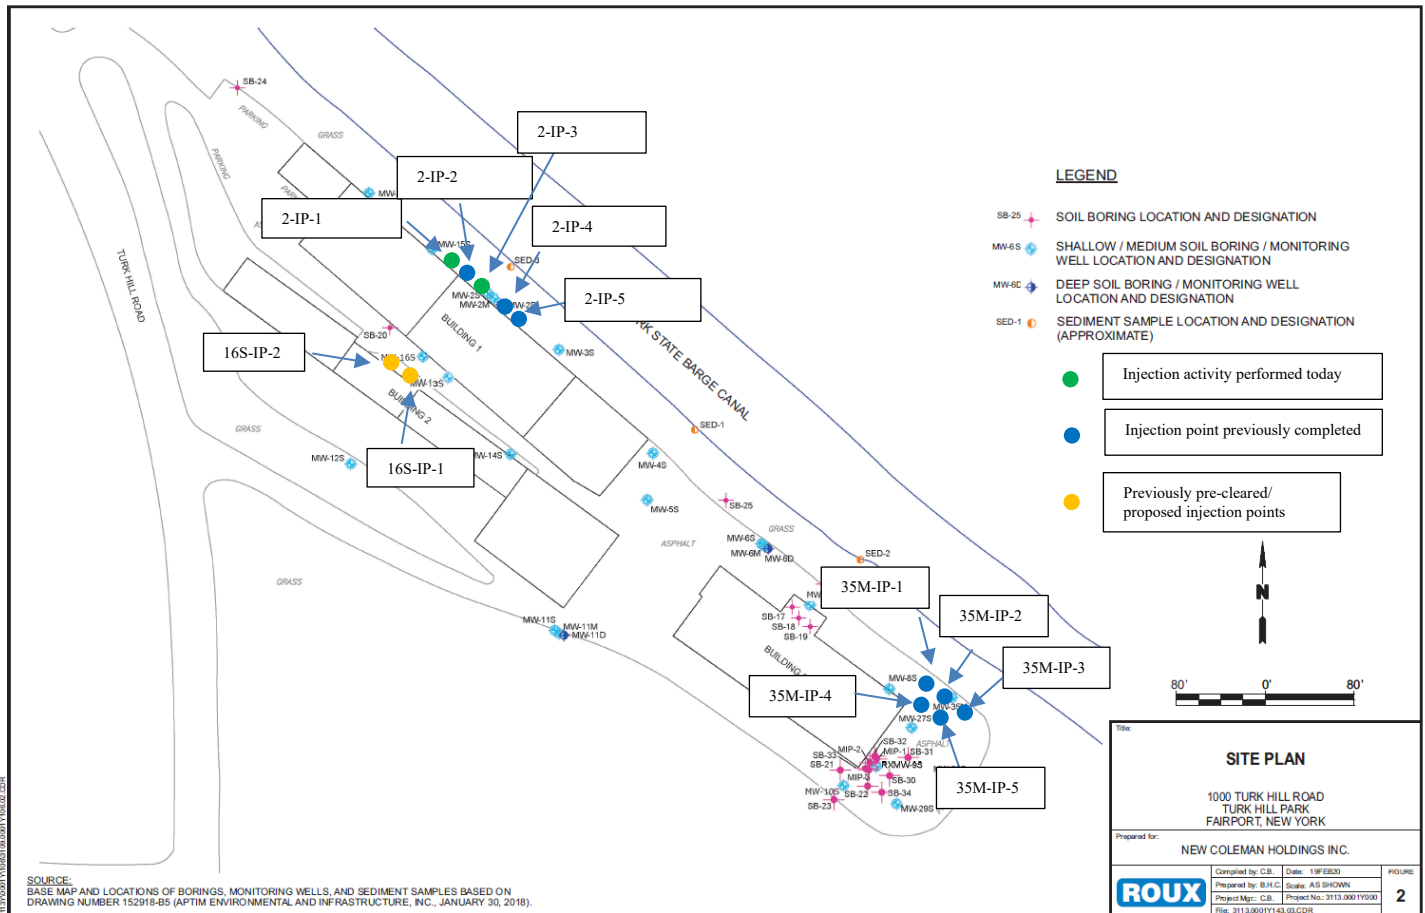
Site Map

Roux was onsite to coordinate with the subcontractor performing the injection remedy. TREC Environmental, Inc. activity related to the injection remedy at two injection locations in the vicinity of monitoring wells MW-2S/M/D: 2-IP-1 and 2-IP-3. A Geoprobe direct push drill rig was used to inject the ABC+ and ZVI into the points.

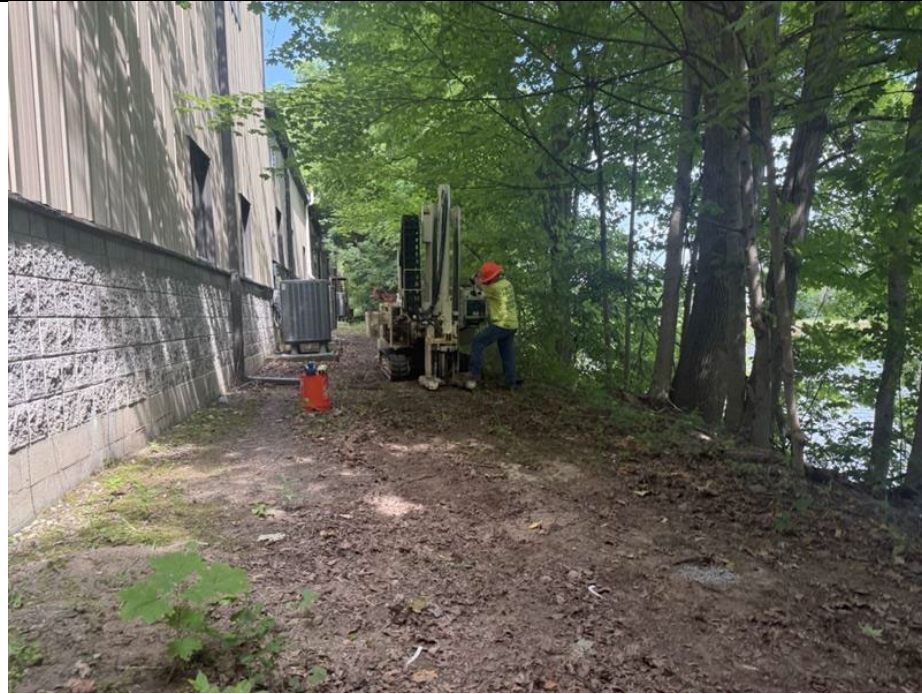
Photo 1:

View of TREC Environmental performing injection remedy at injection point 2-IP-3 in the vicinity of monitoring wells MW-2 S/M/D.

- Injection point 2-IP-1 was installed to 16' below grade and received ~705 gallons of injection fluid.
- Injection point 2-IP-3 was installed to 13' below grade and received ~705 gallons of injection fluid.

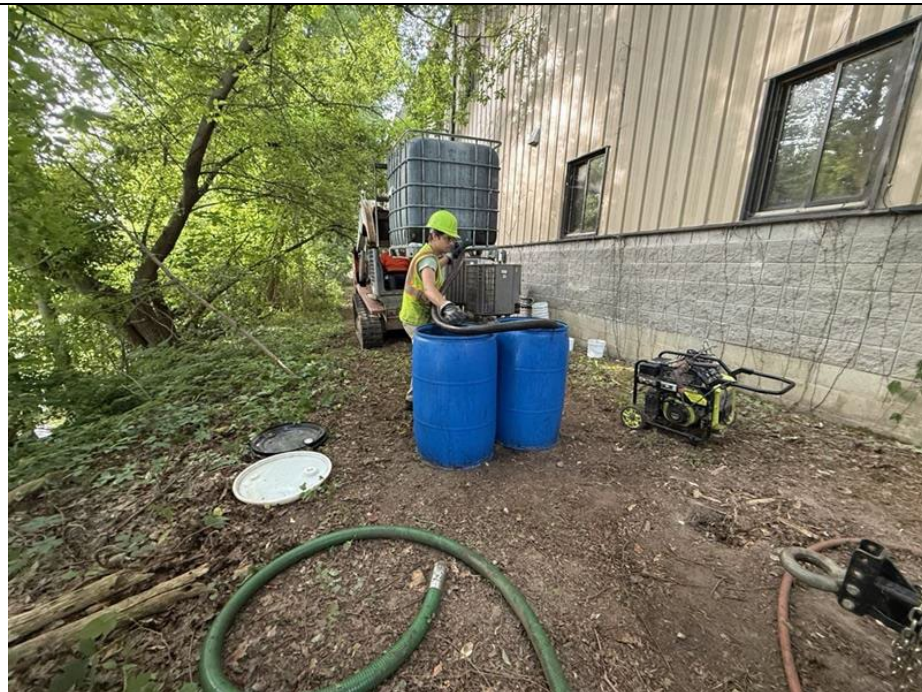
Photo 2:

View of TREC Environmental mixing solution to inject in injection points in the vicinity of monitoring well MW-2S/M/D.
