FINAL STATEMENT OF BASIS CORRECTIVE MEASURES SELECTION

Former Hampshire Chemical Corp. Facility

Site Wide Remedial Elements

Site No. 850001A

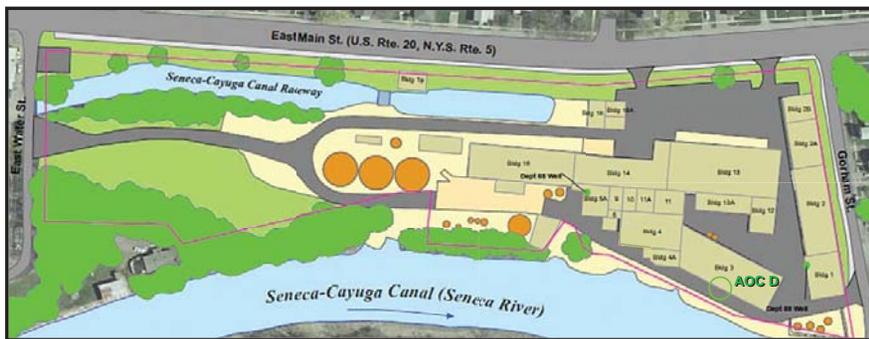
Figure 2-6
 AOC D - MW-11S
 Conceptual Site Model
 Sitewide Corrective Measures Study
 Former Hampshire Chemical Corp. Facility
 Waterloo, New York

Legend	
●	Piezometer
●	Monitoring Well
 	AOC Locations
←	Groundwater Flow Direction
