RECORD OF DECISION (ROD)

TWENTY NO ACTION SWMUs (SEADs 7, 9, 10, 18, 19, 20, 21, 22, 33, 35, 36, 37, 42, 47, 49, 51, 53, 55, 65, and 68) AND EIGHT NO FURTHER ACTION SWMUs (SEADs 28, 29, 30, 31, 32, 34, 60, and 61)

SENECA ARMY DEPOT ACTIVITY (SEDA)

September 2003

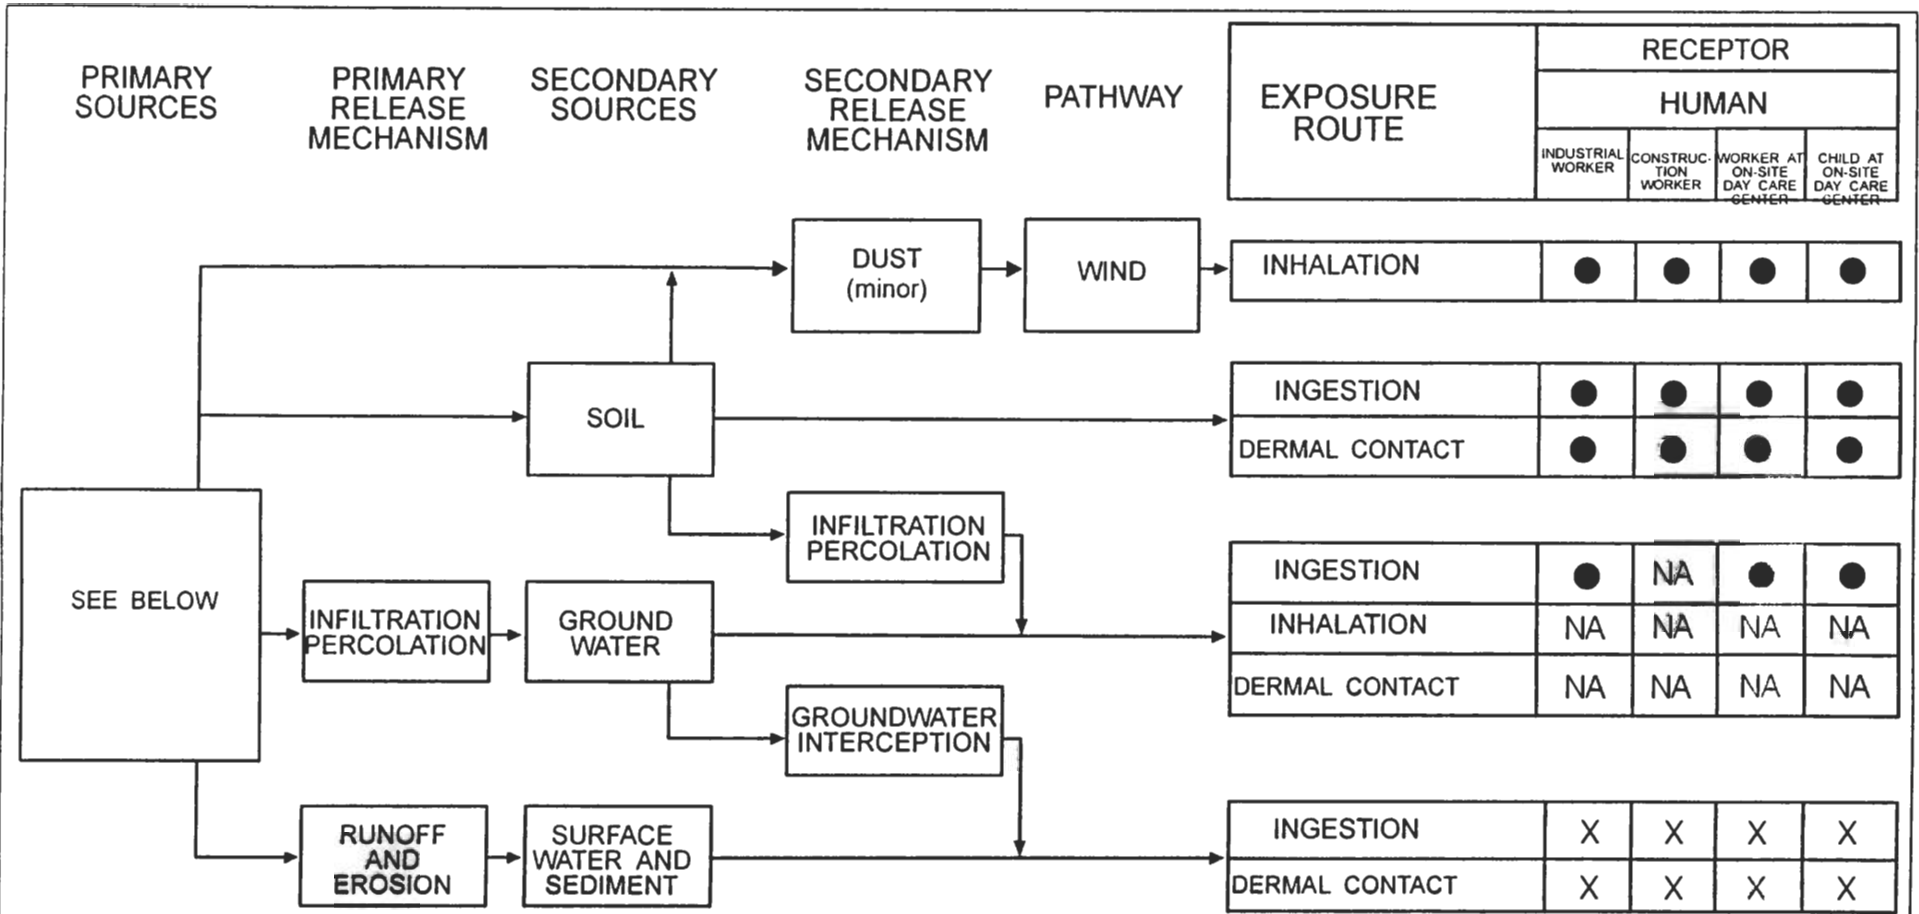
FIGURE 6
 EXPOSURE ASSESSMENT
 PROCESS

NOTE: EXPOSURE ROUTES APPLICABLE BASED ON PRESENCE OF MEDIA AT SITE AS SHOWN BELOW.

SEAD	PRIMARY SOURCE	SOIL	GW
9	OLD SCRAP WOOD SITE	✓	✓
68	PESTICIDE CONTROL SHOP	✓	NA

- *Hazard Identification*--identified the chemical of concern (COC) based on several factors such as toxicity, frequency of occurrence, and concentration.
- *Exposure Assessment*--estimated the magnitude of actual and/or potential human exposures, the frequency and duration of these exposures, and the pathways by which humans are potentially exposed.
- *Toxicity Assessment*--determined the types of adverse health effects associated with chemical exposures, and the relationship between magnitude of exposure (dose) and severity of adverse effects (response).
- *Risk Characterization*--summarized and combined the outputs of the exposure and toxicity assessments to provide a quantitative assessment of site-related risks (for example, one-in-a-million excess cancer risk).
